12th International Conference on Structural Analysis of Historical Constructions

PERFORMANCE OF UNREINFORCED MASONRY STRENGTHENED WITH BED JOINT REINFORCED REPOINTING

LUCIA LICCIARDELLO¹, JAN G. ROTS², RITA ESPOSITO^{2*}

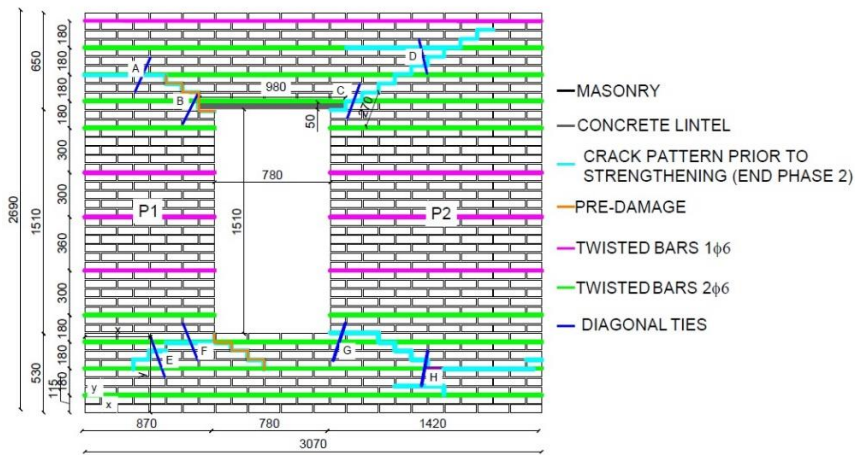
The layout of the bed joint reinforcement mainly reflected the application in practice. The areas above and below the window opening are the most prone to vertical damage due to settlement. Consequently, to counteract the settlement damage two twisted steel bars were installed in the mortar joints in the area above and below the window opening every three mortar courses (green lines in Figure 1a); additionally one bar every five/six mortar courses (pink line in Figure 1a) was installed in the piers (vertical masonry portion next to the window opening) and diagonal ties (blue lines in Figure 1a) were installed in correspondence of the existing diagonal cracks at the corners of the window opening. Figure 1b shows the detail of a strengthened section and Table 2 lists the properties of the cement-based repair mortar, twisted steel bars and diagonal ties used for the strengthening.

(a)

(b)

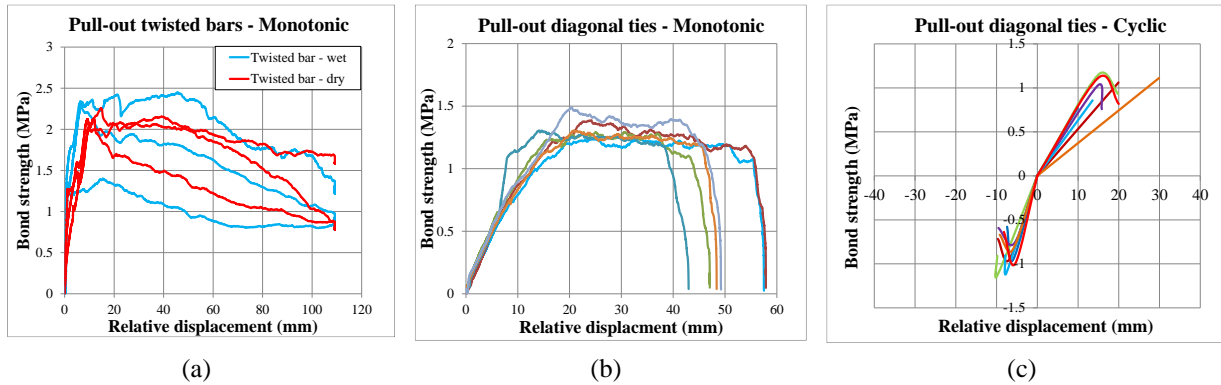
Figure 2: Bond-strength versus relative displacement curve: (a) monotonic test on twisted steel bars; (b) monotonic test on diagonal ties; (c) cyclic test on diagonal ties.

tests were also performed [17]. Figure 2 shows the experimental results in terms of bond-strength versus relative displacement curve. For the cyclic tests, the envelope curve was calculated considering the force and the displacement in correspondence of the peak force and in correspondence of a drop of 20% of the maximum force [17]. These curves can serve as input for numerical analyses.

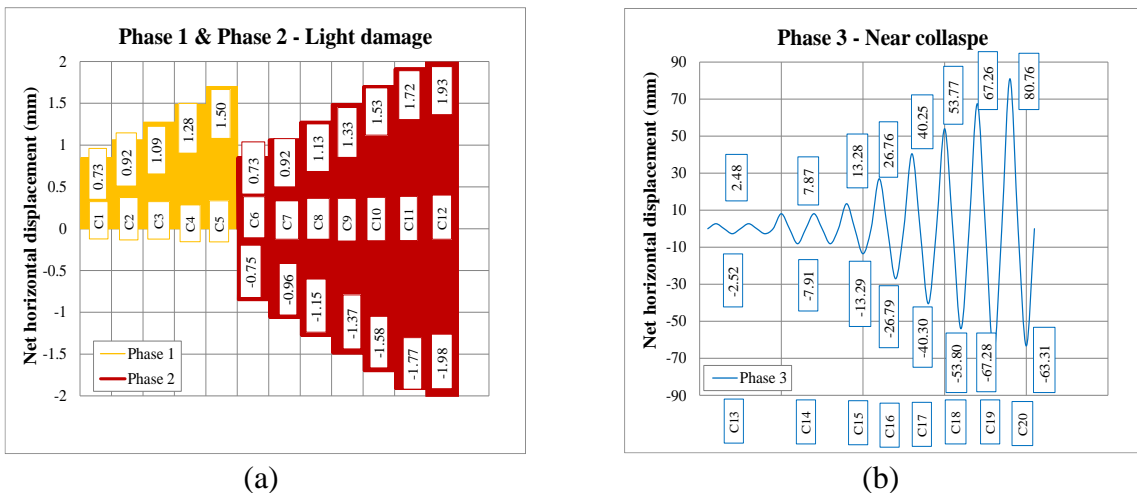
Figure 4: Loading scheme: (a) light damage phases 1 and 2; (b) near collapse phase 3.

The walls were tested under a quasi-static cyclic lateral in-plane load in a cantilever configuration by controlling the horizontal displacement of the jack and the net horizontal displacement was calculated as the displacement of the top beam with respect to the external reference excluding possible rotations of the set-up and possible horizontal displacement of the bottom beam with respect to the external reference. In Figure 4 the net horizontal displacement is shown and it is similar for the unstrengthened and strengthened configuration. The lateral load was applied in three phases: phase 1 and phase 2 up to light damage state with the same loading protocol as used in Ref. [2]; phase 3 up to near collapse state with the loading protocol derived from a previous study and representative of a Groningen type earthquake [18]. In phase 1 and 2 each cycle was composed of 30 runs, in phase 3 the first two cycles were composed on 2 runs and the remaining were composed of a single run (Figure 4). A cycle is defined as the time interval in which the same target horizontal displacement was applied with the same rate. A run is defined as the time needed to impose the target displacement in the positive and negative loading direction up to returning to the original position of the wall. During the light damage phase, the lateral load was applied with a

constant rate equal to 0.125 mm/s; during the near-collapse phase, the load-rate varied between 0.03 to 1 mm/s so that each cycle lasted 5 min (except for the last cycle that lasted 4 min because the test was stopped as it is explained in section 3).

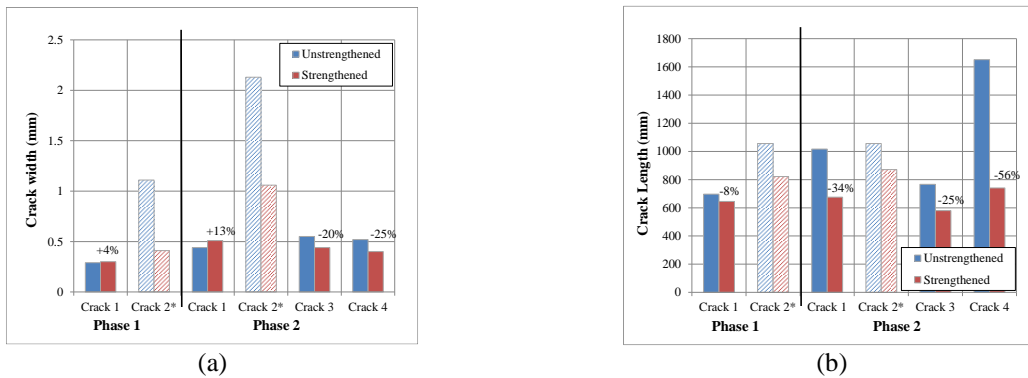
Figure 6: Performance during light damage phase test in terms of: (a) crack width; (b) crack length.

Figure 6 shows the comparison in terms of crack width and length for the four main stepwise cracks formed at the window corners at the end of phase 1 ($d = 1.50$ mm) and at the end of phase 2 ($d = 1.93/-1.98$ mm). A reduction in crack width between - 20 and 25% and in crack length between - 25 and 56% was observed. Due to the different shape of Crack 2* for the strengthened wall, horizontal crack rather than stepwise crack, this is not included in the comparison. A delay at the onset of cracking was also observed: during phase 1 crack 2 started at cycle C2 ($d = 0.91$ mm) and at cycle C4 ($d = 1.28$ mm) for the unstrengthened and strengthened wall, respectively; during phase 2 crack 3 started at cycle C7 ($d = 0.94/-0.96$ mm) and at cycle C8 ($d = 1.13/-1.15$ mm) for the unstrengthened and strengthened configuration, respectively. For the near collapse phase a quantitative comparison in terms of crack width and length cannot be performed since the accuracy of the DIC for crack width larger than 2 mm is significantly reduced. In correspondence of cycle C18 ($d = 53.77/-53.80$ mm), which corresponds to the end of the test for the unstrengthened configuration, it can be observed qualitatively that the crack width was smaller in the strengthened wall.

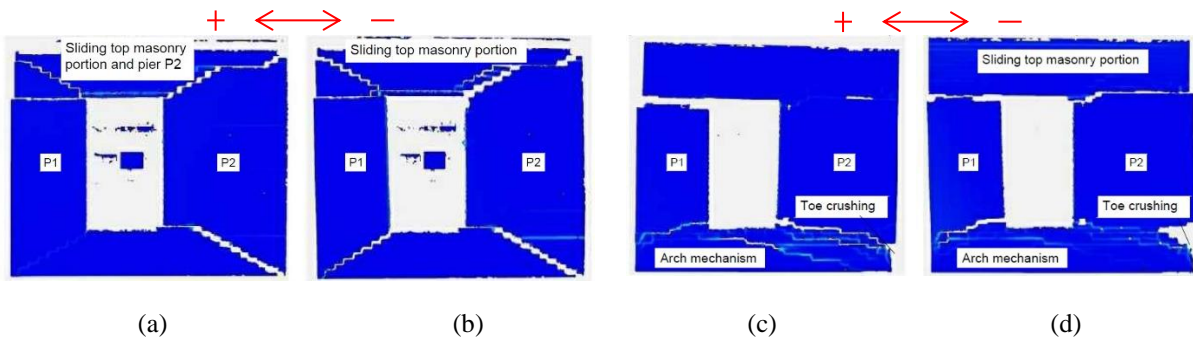
Figure 7: Relevant failure mechanism observed through DIC analysis at the end of the near collapse phase (phase 3): (a)-(b) unstrengthened wall; (c)-(d) strengthened.

Figure 7 shows the failure mechanisms of the masonry components during the near collapse phase (phase 3) for both unstrengthened and strengthened wall. Relevant load levels, corresponding to the occurrence of failure mechanisms, are identified and indicated with markers in Figure 5. Four main failure mechanisms are considered: rocking of one of the piers (marker A), sliding between two part of the wall (marker B), arch mechanism below the window opening (marker C) and toe crushing (marker D). Considering the unstrengthened wall, until cycle C14 ($d = 7.89/-7.97$ mm) the rocking of the piers was the prevailing mechanisms in both loading directions (point 14-A). At cycle C15 ($d = -12.82$ mm), sliding of the top masonry portion with respect to the piers (point 15-B) started in the negative loading direction. Until cycle 17 the prevailing mechanisms were rocking of the piers in the positive loading direction and sliding of the top masonry portion with respect to the piers for the negative loading direction. At cycle 18 ($d = 43.63$ mm) also sliding of the top masonry portion and of the pier P2 occurred with respect to the pier P1 and the bottom masonry portion in the positive loading direction (point 18-B). Considering the strengthened wall, until cycle C17 rocking of the piers was the prevailing mechanism in both loading directions (points 14-A and 15-A). At cycle C18 ($d = 53.77/-53.80$ mm) an arch mechanism formed in the area below the window opening thanks to the presence of the bars (point 18-C). At cycle 20 ($d = 80.96/-63.31$ mm) toe crushing (Figure 8a) of the bottom right corner (point 20-D) and sliding of the top masonry portion with respect to the piers (point 20-B) occurred for the positive and negative loading direction, respectively. The test on the strengthened wall was stopped due to excessive out-of-plane deformation of the piers (Figure 8b).

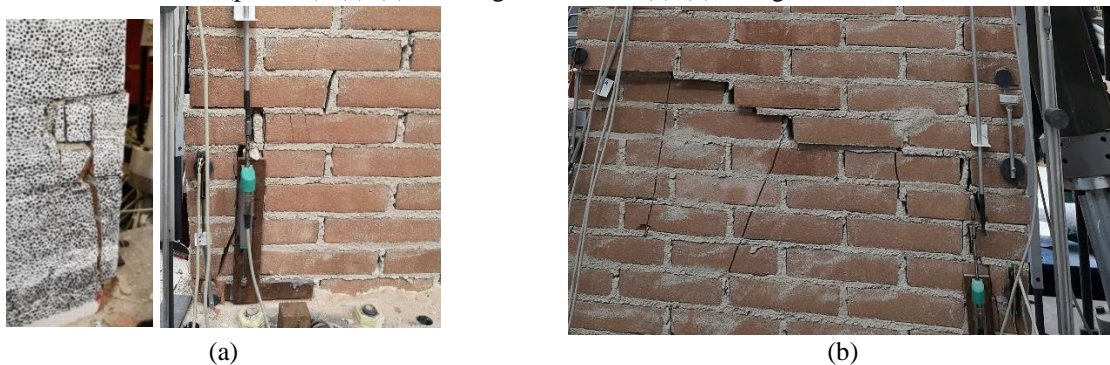
Figure 8: Detail of some mechanisms: (a) toe crushing and cracks in the brick at bottom right corner; (b) out-of-plane of the pier P1 and cracks in the brick at bottom left corner.

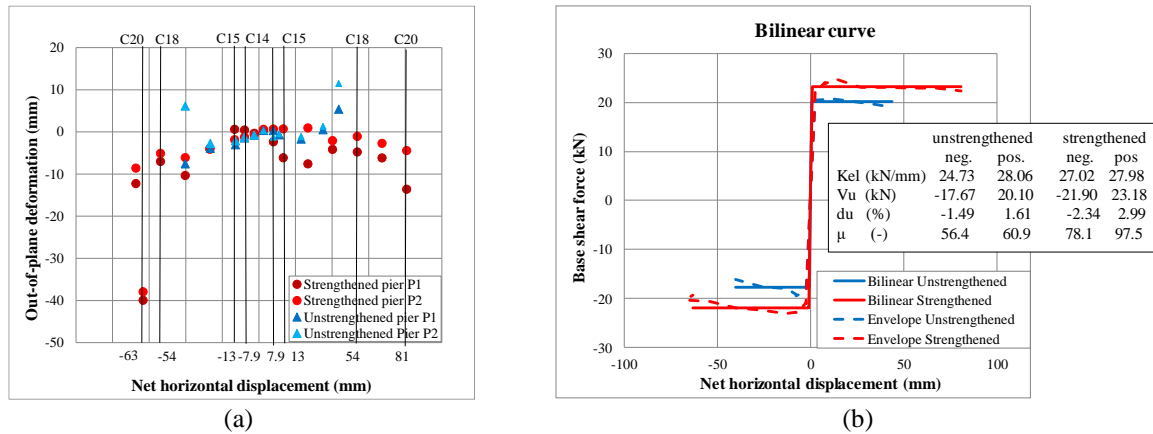
Figure 9: (a) Out-of-plane deformation; (b) bilinear curve.

Figure 9a shows the out-of-plane deformation versus the net horizontal displacement for the unstrengthened (blue triangles) and strengthened wall (red circles). For the unstrengthened wall a maximum out-of-plane deformation of 10 mm was observed in the last cycle C18. For the strengthened wall a similar magnitude of out-of-plane deformation is observed at cycle C15 ($d = 13.28/-13.29$ mm) especially for the narrow pier P1. In the last cycle (C20, $d = -63$ mm) both piers experience a significant out-of-plane deformation of approximately 40 mm for

the negative loading direction. The cause of this excessive out-of-plane deformation can be ascribed to the asymmetric position of the twisted steel bars in the thickness of the wall, which becomes of relevance for extensive in plane damage

To compare the seismic performance of the strengthened and unstrengthened wall, the equivalent bilinear curve was adopted [19] (Figure 9b). The strengthened wall showed a slight increment (+15%) in terms of base shear force, but a substantial increment in terms of displacement capacity (+40-45%) and ductility (+30-40%) was observed. The ultimate drift increased from 1.61 to 2.99% and from -1.49 to -2.34% in the positive and negative loading direction, respectively.
