An Advanced Tool for Evaluating the Probability of Failure of Existing Tailings Dams

A Scientific Approach Supporting the Prioritisation of Mitigating Measures and Minimise Risk within the 'As Low As Reasonably Practicable' Principle

**Master of Science
in Applied Earth Sciences**

**Master of Science
in Civil Engineering**

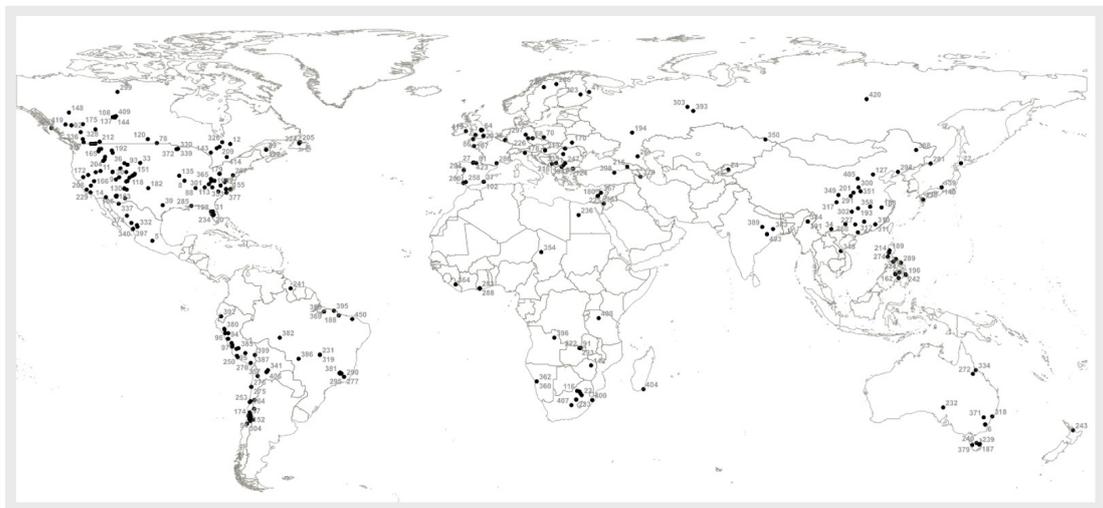
Figure 5.20: Geographical Distribution of Failures in the Database

Similar patterns may be observed in other countries. For instance, in countries like Chile, Peru, Mexico, Brazil, India, China, Russia, and parts of western and southern Africa, a higher number of failures are expected when comparing mining density (Figure 5.19) with the distribution of reported failures (Figure 5.20). Several other factors may contribute to the underreporting of failures. For instance, in countries like China and Russia, the political situation may also play a role in the scarcity of failure reporting.

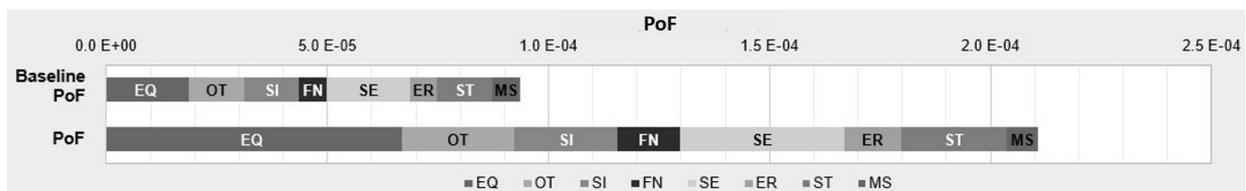
Figure 9.1: Probability of Failure (PoF) Failure Case Compared to the Baseline Probability of Failure (PoF) (EQ: Earthquake Induced, ER: External Erosion, FN: Foundation deficiency, MS: Mine Subsidence, OT: Overtopping: SE: Excessive Seepage and Internal Erosion, SI: Slope Instability, ST: Structural Inadequacy)

The anticipated PoF stands at 2.1 E-04, which is tolerable if ALARP according to the thresholds defined by FERC (2016) shown in Figure 3.3 in Section 3.2.1, knowing that the failure did not result in any fatalities. Nevertheless, the PoF is double the baseline PoF, as illustrated in Figure 9.1. Notably, it reveals a substantially increased probability of EQ failure. A more than two-fold increase in FN is also evident when examining the estimated PoF values presented in Table 9.2.

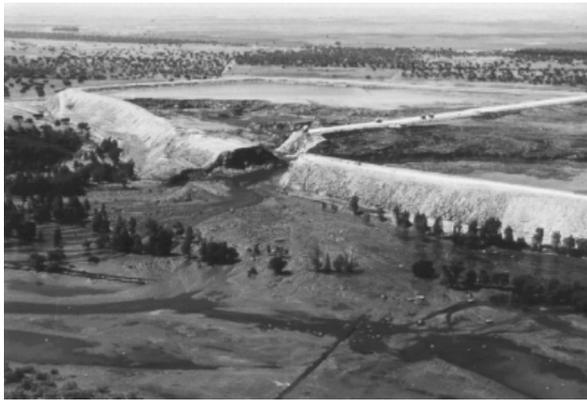
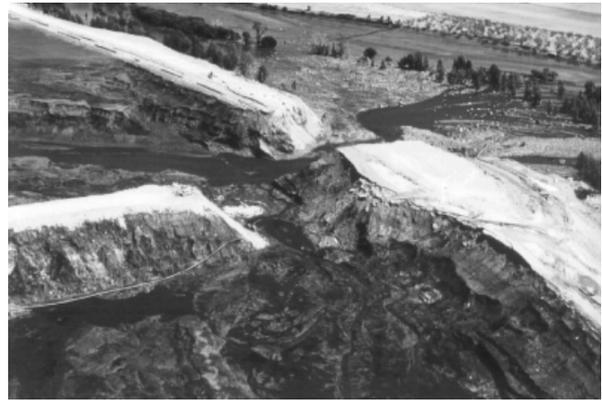
(a) View from the East (Alonso & Gens, 2006a)

(b) Detail of Breach (Alonso & Gens, 2006a)

Figure C.3: Aerial View of Tailings

Various potential factors for the failure were postulated, encompassing the expansive foundation clay, chemical erosion induced by the acidic pyritic slurry, and the effects of blasting activities in the proximate open pit mine. However, the eventual cause was determined to be a profound deep translational sliding motion. This sliding plane developed progressively at a depth of 26 meters, just north of the jetty structure. The sliding plane throughout the embankment is schematically shown in Figure C.2. The shear plane in the material is shown in Figure C.7. The magnitude of the failure, along with its depth and configuration, categorises this incident as exceptional. An aerial view of the failure is shown in Figure C.3.

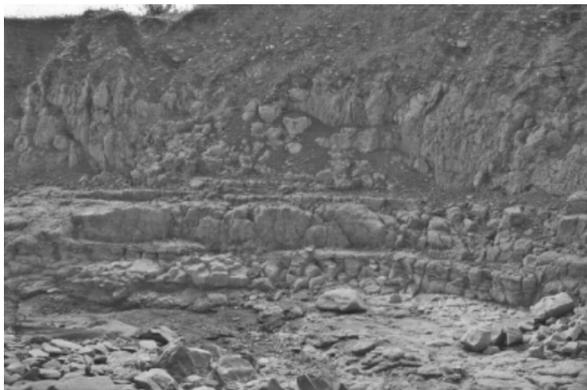
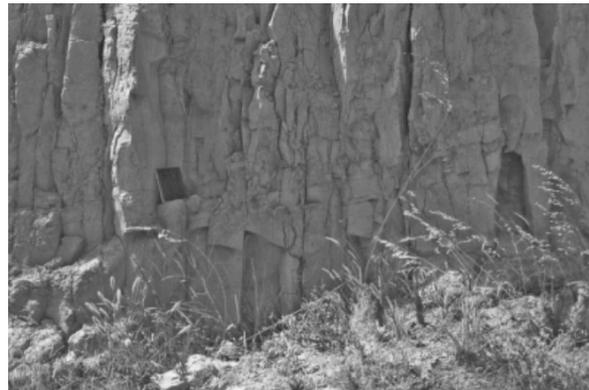
(a) Horizontal Bedding Planes (Alonso & Gens, 2006a)

(b) Vertical Jointing (Alonso & Gens, 2006a)

Figure C.4: Discontinuity Sets (Alonso & Gens, 2006a)

Although, the homogenous characterisation of the clay would imply a rotational failure mode; however, the failure was controlled by failure surfaces. Two prominent discontinuity sets were identified in the clays: sub-horizontal bedding planes (shown in Figure C.4a), dipping at an angle of 2-4 degrees in an SSE direction, spaced at intervals of 2-2.5 meters; and a vertical jointing system aligned along the N-S/NE-SW directions (shown in Figure C.4b), characterised by a spacing of 2-5 meters, featuring smooth, slickensided joints (Shown in Figure C.5). These discontinuities were attributed to deep-seated fractures within the Paleozoic basement, facilitating the development of a failure plane.

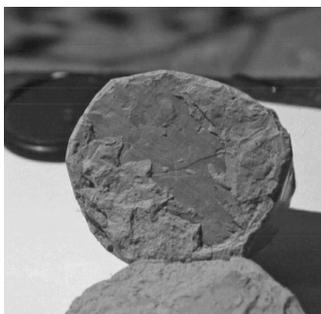
Figure C.5: Slickensides (Alonso & Gens, 2006a)

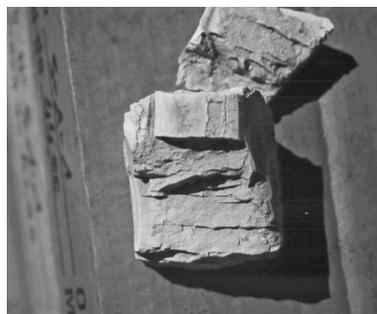
Figure C.6: Stratification of Clay (Alonso & Gens, 2006a)

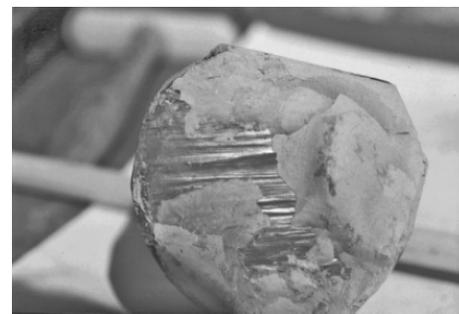
Figure C.7: Sliding Plane (Alonso & Gens, 2006a)
