Investigating apparent plateau phases in fatigue after impact damage growth in CFRP with ultrasound scan and acoustic emissions

Biagini, Davide; Pascoe, John Alan; Alderliesten, René

International Journal of Fatigue

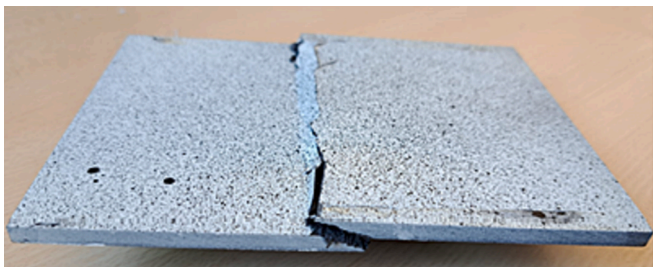
Fig. 4. Failed specimen after the CFAI test.

In all specimens, final failure was characterized by unstable delamination propagation in multiple interfaces and fiber kinking. The fractured specimens appear very similar to previous static CAI tests previously conducted by the authors, showing a final fracture that runs in the centre of the specimen, perpendicular to the loading direction (Fig. 4).
