The fatigue failure study of repaired aluminum plates by composite patches using Acoustic Emission

Maleki, Abdullah; Saeedifar, Milad; Ahmadi Najafabadi, Mehdi; Zarouchas, Dimitrios

Engineering Fracture Mechanics

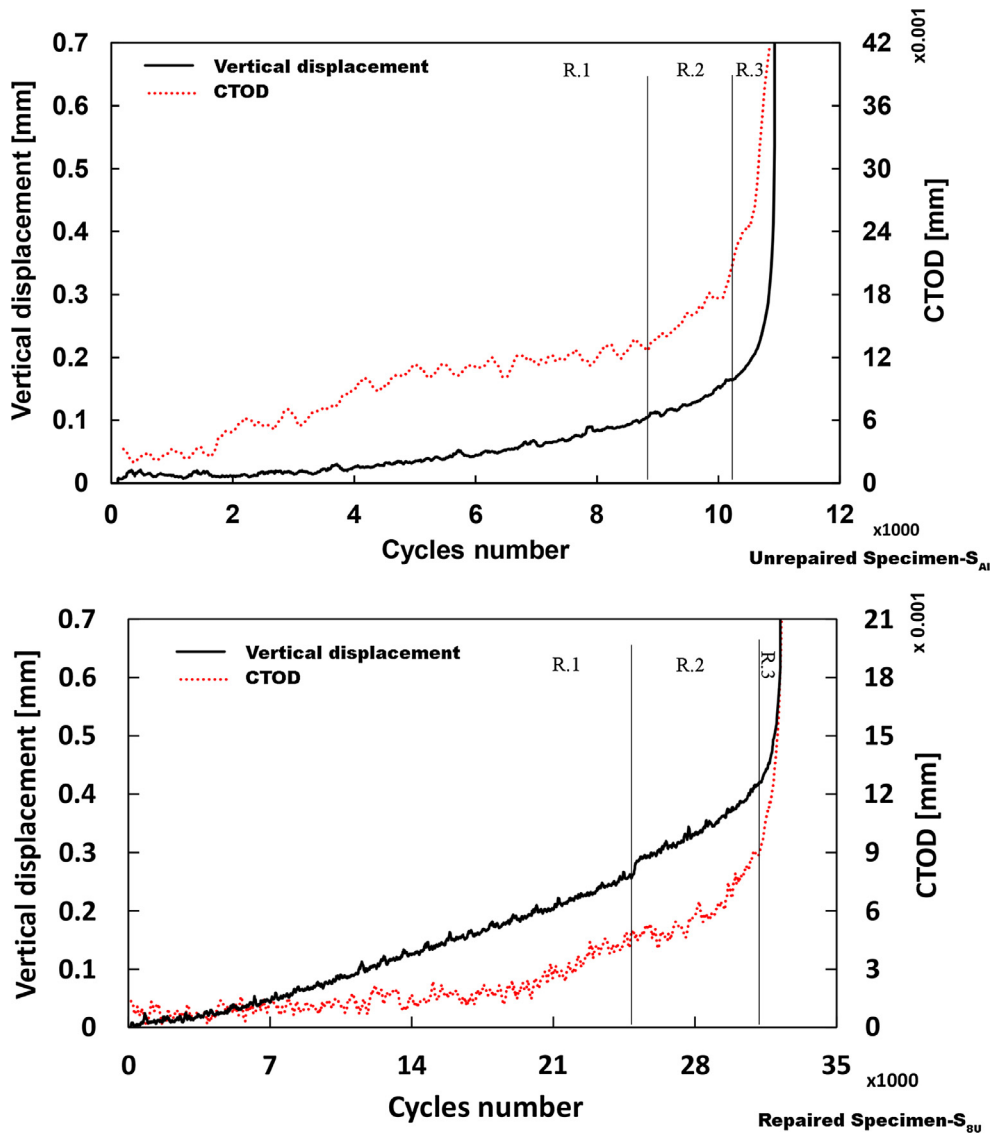
Fig. 3. The vertical displacement and CTOD versus the cycles number for the unrepaired and the repaired specimens.

Fig. 3 shows the vertical displacement and Crack Tip Opening Displacement (CTOD) versus the cycles number curves for the unrepaired (S_{Al}) and the repaired (S_{8U}) specimens. The values of CTOD were calculated by counting the number of pixels at the crack tip using the image processing technique during the fatigue test. The displacement curve of the unrepaired specimen can be divided into three regions. In the first region (R.1), the vertical displacement increases with an infinitesimal rate until 8600 cycles. This region corresponds to the brittle fatigue crack growth. At cycles number 8600, the length of the crack has been increased considerably, thus, the effective stress at the crack tip is high. Therefore, size of the plastic zone at the crack tip gets larger and consequently the behavior of crack propagation switches from the brittle fracture to the ductile tearing. Thus, in the second region (R.2), the displacement increases rapidly. At the third region (R.3), the ligament length has been very small, thus, the aluminum specimen is completely fractured suddenly at the cycles number 10,915. The CTOD curve also consists with the displacement curve. Accordingly, the CTOD increases with a small rate in the first region. While, increasing rate of CTOD significantly rises at the beginning of the second region. At the final region, the CTOD increases sharply.

The displacement curve of the repaired specimen (S_{8U}) can be divided into three regions as similar to the unrepaired specimen. At the first region which the patch is firmly attached to the aluminum, the vertical displacement increases with a low rate. The rate of vertical displacement in this region for the repaired specimen is 15% less than the rate of vertical displacement for the unrepaired specimen which is due to the effect of patch. This region is extended to 26,000 cycles. In this region, the CTOD increases with an infinitesimal rate. This is due to the fact that the patch is still attached to Al, thus a major portion of the applied load has been carried by the patch and the effective applied load on Al is small. At cycles number 26,000, there is a big jump in the displacement curve which corresponds to the failure of the adhesive layer and local separation of the composite patch from the aluminum plate. The experimental observations also detect this phenomenon. After adhesive layer failure, the effective applied load on Al increases and consequently the vertical displacement and CTOD increase faster. The increasing rate of displacement is almost constant up to 32,000 cycles. The rate of vertical displacement in the second region for the repaired specimen is 58% less than the rate of vertical displacement for the unrepaired specimen. At this cycle number, the behavior of fracture changes from the brittle fatigue crack growth to the ductile tearing. Thus, at the third region, vertical displacement and CTOD increase precipitately and consequently the final fracture of the aluminum specimen occurs at cycles number 33,000.

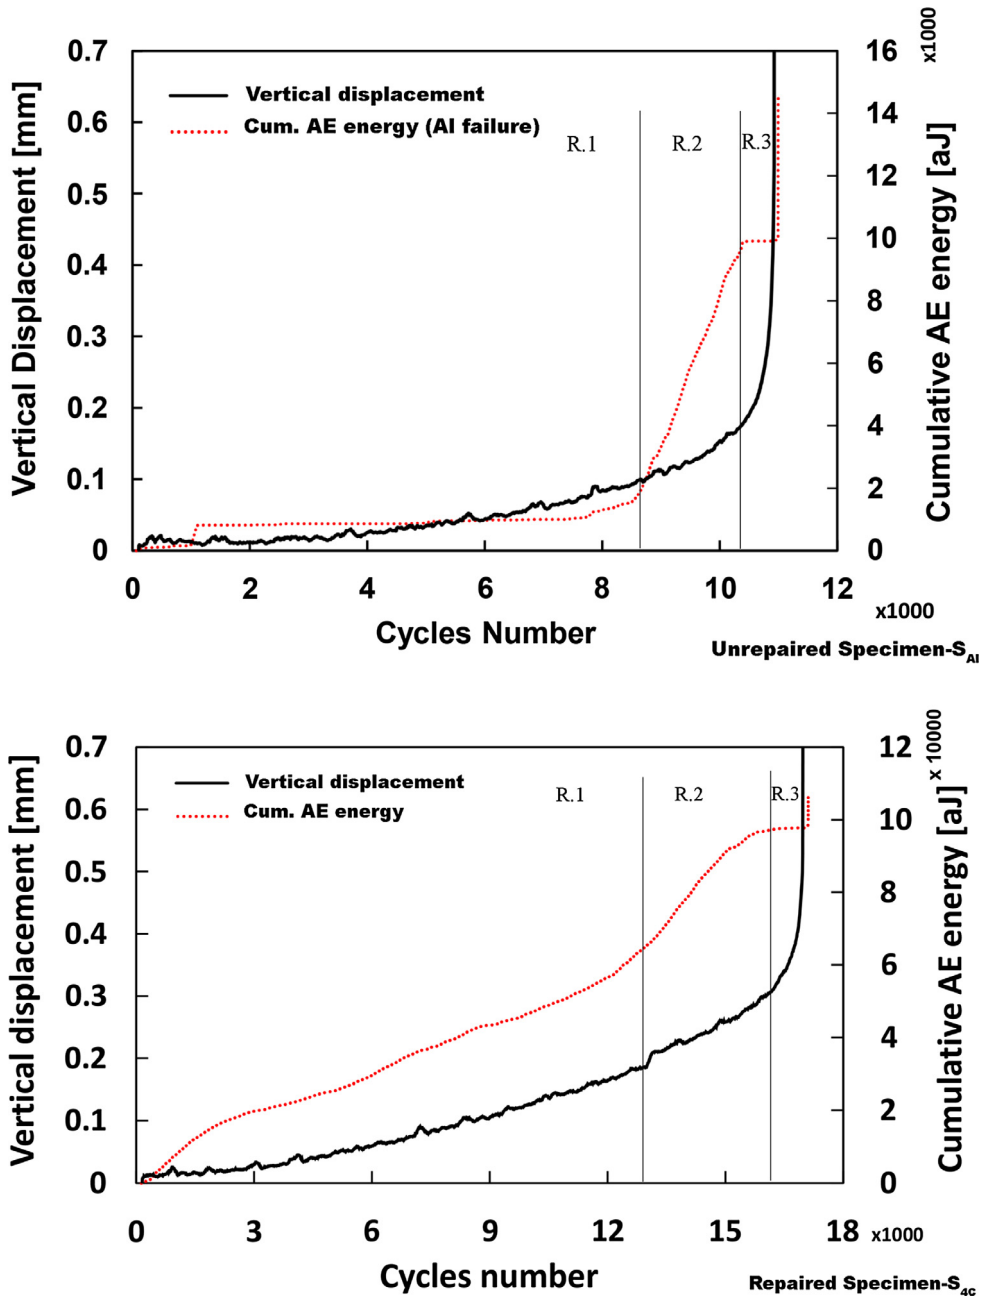
Fig. 7. The cumulative AE energy and vertical displacement versus the cycles number for the unrepaired and repaired specimens.

Fig. 7 shows the cumulative AE energy and vertical displacement versus the cycles number for the unrepaired and repaired specimens. The cumulative AE energy for the unrepaired specimen increases with an infinitesimal rate in the brittle fatigue crack growth region, while, in the ductile tearing region, it increases rapidly. At cycles number 10,915 which the specimen is fractured suddenly, the cumulative AE energy rises by a big jump.

The cumulative AE energy curve of the repaired specimen is divided into three regions as same the regions of Fig. 3. In the first region which the patch is firmly attached to the aluminum, the slope of the cumulative AE energy curve is low. In this region, composite patch carries a considerable portion of the applied load, thus the rate of crack growth in aluminum and consequently the AE activities of the specimen are low. At the point of the adhesive layer failure (cycles number 12,800), the vertical displacement rises by a significant jump and the slope of cumulative AE energy curve increases. The increase of cumulative AE energy is due to the generating of adhesive layer failure signals. In the second region, the cumulative AE energy increases with a higher rate in comparing with the first region. In this region, due to the failure of the adhesive layer, the applied load is completely carried by Al. Therefore, the crack growth rate and consequently AE activities of the specimen increase. In the ductile tearing region, which the damage evolution has accelerated, the cumulative AE energy increases with the maximum rate. Due to the mixing of AE signals of Al cracking and adhesive layer failure, it is not possible to individually investigate the state of each damage mechanism during the test. In order to detect the failure of adhesive layer and separation of the patch with more accurate, it is needed to distinguish the AE signals of adhesive layer failure from the Al failure.

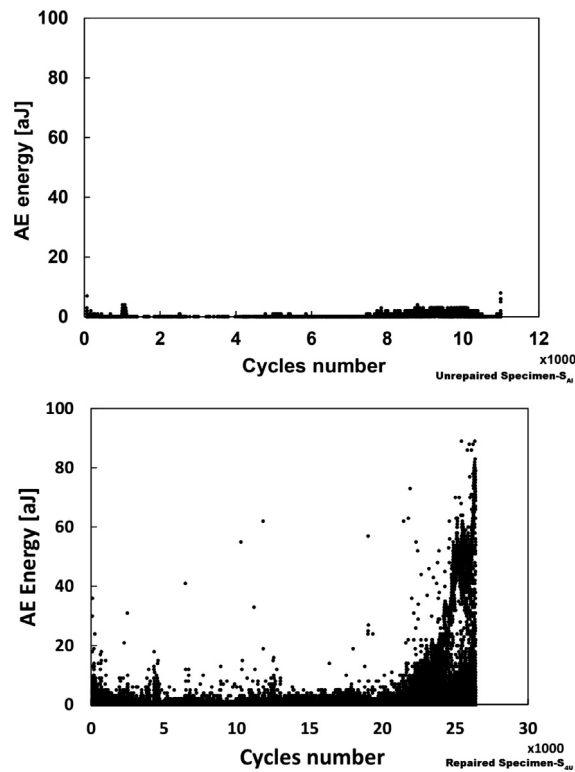
Fig. 9. The AE energy versus cycles number for the unrepaired and repaired specimens.

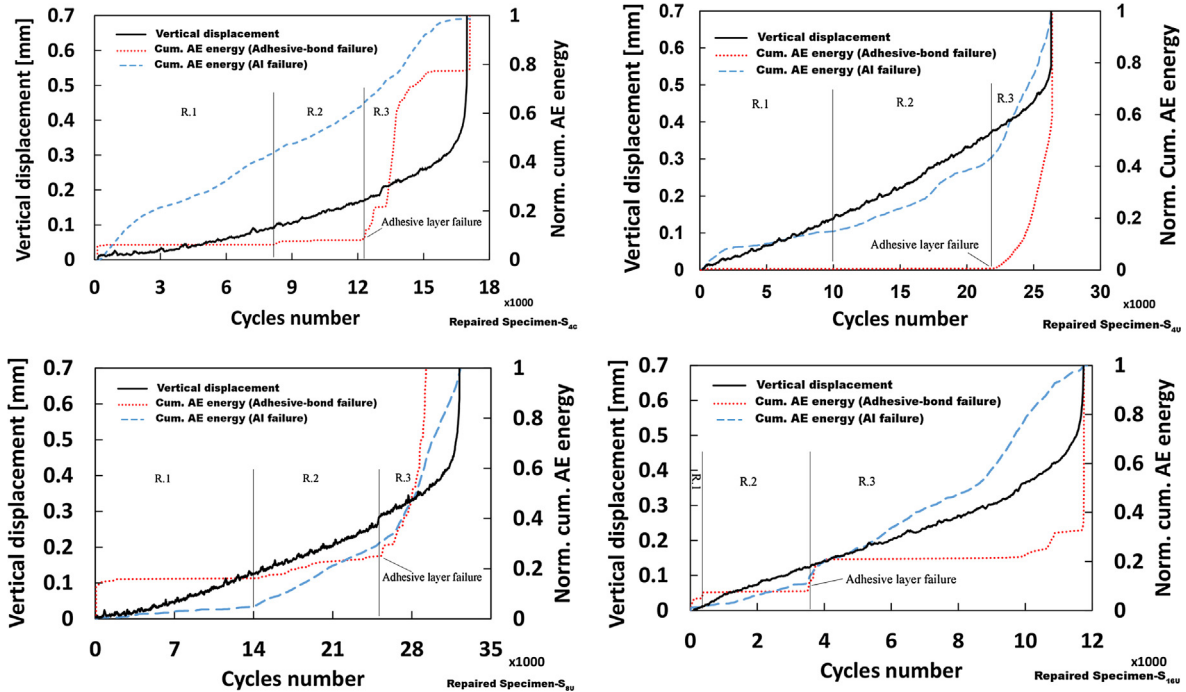
Fig. 10. The normalized cumulative AE energy versus cycles number curves of the AI cracking and adhesive layer failure for the repaired specimens.

The AE signals of the repaired specimens were classified according to their AE energy. The normalized cumulative AE energy versus cycles number curves of the AI cracking and adhesive layer failure for the repaired specimens are shown in Fig. 10. A big jump in the cumulative AE energy curve of adhesive layer failure at the initiation of tests is related to fracture of the little adhesive material which has penetrated to the notch of the aluminum specimen. Besides this jump, all the figures can be divided into three regions. In the first section, almost there are no AE signals of adhesive layer failure. While the AE signals of AI cracking initiate from the beginning of the tests and increase with a low rate. At the end of this region, the adhesive layer failure signals initiate. These signals are referred to some micro damages in the adhesive layer. After some cycles, the energy curve of adhesive layer failure starts to increase with a very high rate. This point corresponds to the significant adhesive layer failure and separation of the patch from the aluminum specimen. In the second region, due to the failure of the adhesive layer, the applied load on the AI specimen increases, and consequently the regime of fracture changes from the brittle fracture to the ductile tearing, therefore the AE signals of AI cracking increases with a higher slope. Thus, the first big jump in the cumulative AE energy curve of adhesive layer failure signals is considered as the point of adhesive layer failure.

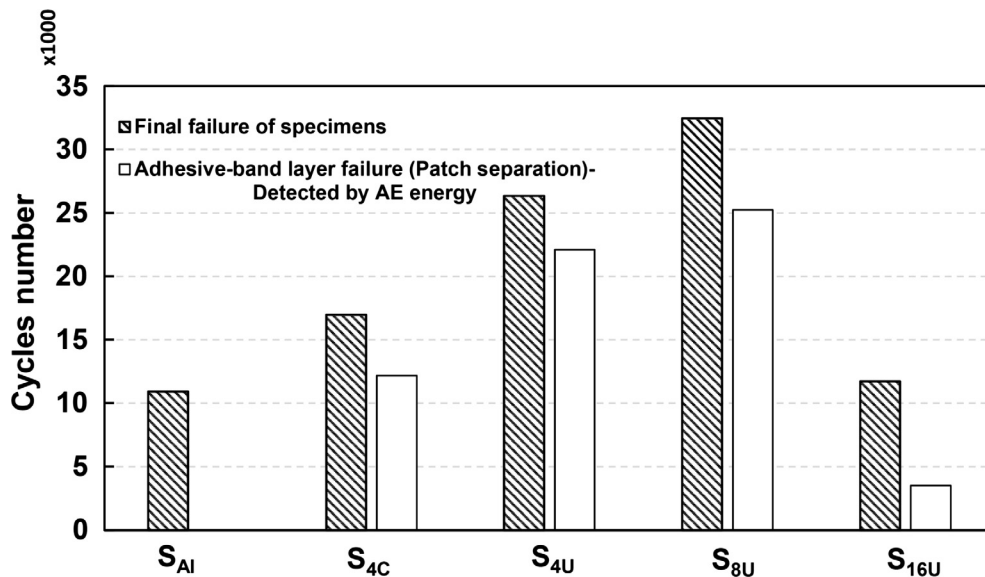
Fig. 11. The cycles number to the final failure of the specimens and the cycles number to the failure of adhesive layer obtained from AE.

Fig. 11 represents the cycles number to the final failure of the specimens and also the cycles number to the failure of the adhesive layer which is detected by the cumulative AE energy curve of adhesive layer failure. It is obvious that at a fixed

patch thickness (4 layers), the unidirectional layup (S_{4U}) has the better performance in comparison with the cross-ply layup (S_{4C}) and it could improve the lifetime of the cracked aluminum with 141% against 55% for the cross-ply layup. However, the remained lifetime after separation of the patch for the S_{4C} is higher than S_{4U} (4790 cycles for S_{4C} against 4223 cycles for S_{4U}). Due to the higher stiffness of the unidirectional patch, it carries more portion of the applied load, thus when it is failed more additional load is applied to the Al specimen. On the other hand, at a fixed layup, the best thickness for the patch is for the 8 layers patch that could improve the fatigue life about 197%. The better functionality of specimen S_{8U} is due to this fact that this specimen has a big stiffness and it does not also induce a big bending moment to the specimen. In contrary, the specimen S_{16U} has the worst functionality. Although the 16 layers patch has a bigger stiffness, but, because of the high thickness of the patch, it induces a big bending moment to the specimen that leads to the separation of the patch from Al at the low cycles number.
