# MASONRY AND EARTHQUAKES

REPAIR WITH GOLD

*Type:* Research paper, Graduation  
*Title:* Masonry and earthquakes: repair with gold  
*Author:* Glazenburg, J.J.

*Faculty:* Faculty of Architecture and the Built Environment  
*Department:* Department of Architecture  
*Degree programme:* Architectural Engineering Graduation Studio

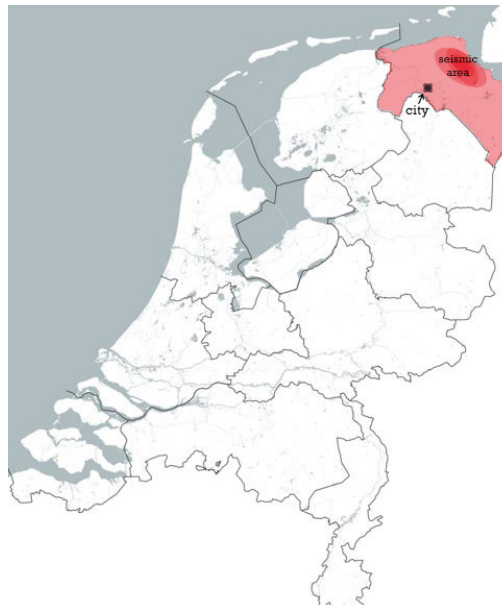
Figure 1: Seismic area in Groningen province

The seismic area is located in Groningen. Groningen is a province located in the North of the Netherlands (Figure 1). The figure shows in red the province and in dark red the seismic area. The capital city of the province is also called Groningen. In this paper I will discuss the seismic area in the province Groningen. The province of Groningen got its present size in 1814. Since the reorganization of the municipality in 1990 the province exists out of 25 municipalities. For the survey, the province is divided into five areas: Gorecht, the Hogeland, Oldambt/Westerwolde, the Veenkoloniën and Westerkwartier. The Hogeland is the area where earthquakes mostly occur. This area consists out of nine municipalities called: Appingedam, Bedum, Delfzijl, Eemsum, Loppersum, De Marne, Slochteren, Ten Boer and Winsum. In all municipalities are earthquakes measured, but the municipality Loppersum is the one most affected.<sup>1</sup>

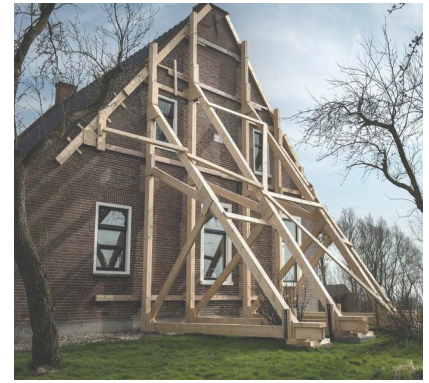
Figure 4:  
Auxiliary construction in Groningen

The typical Dutch building stock is not prepared for earthquakes. Damaged buildings get auxiliary constructions in order to protect against further damage and prevent to collapse. Of course this is a necessary tool right after an earthquake. But so far, there are no permanent solutions. Imagine what this does to the traditional identity of Groningen. A whole province full of auxiliary constructions that stand in front of the original facades. The identity of Groningen will be lost. But what to do with the damaged buildings? Break them down and build an earthquake-proof building on the same place? If so, again the question; what will happen to the identity? Or restore the building and wait what will happen? Until today those questions are still not answered. This is why I think architects should take this problem seriously and start developing ideas how to deal with this situation. How to keep identity and work with the new seismic situation as well. Inhabitants should express their identity. A home is 'a self-made environment, where the inhabitants can shape their own lives in the way they want'. The notion of the home can be extended to the scale of the neighbourhood, because it is part of the living environment.<sup>6</sup>

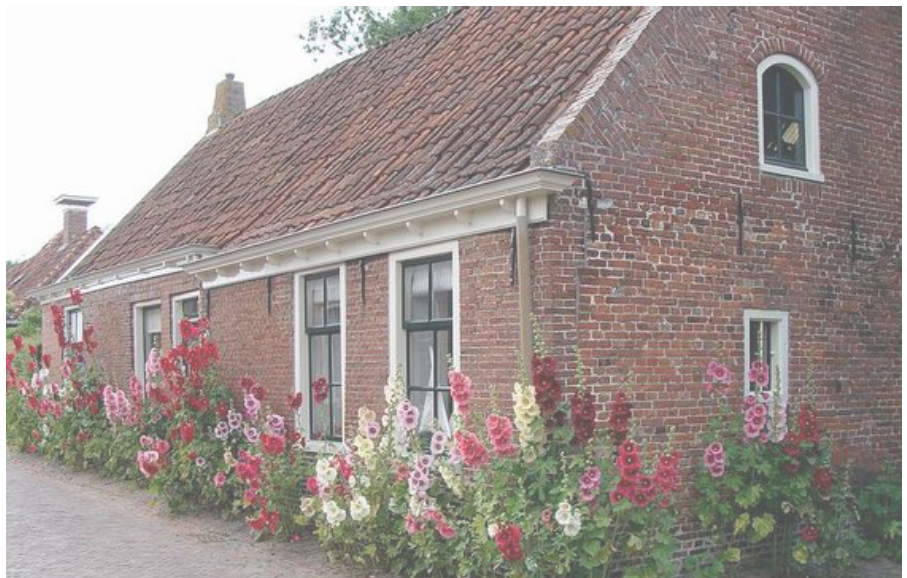
Figure 7: Traditional Brickwork

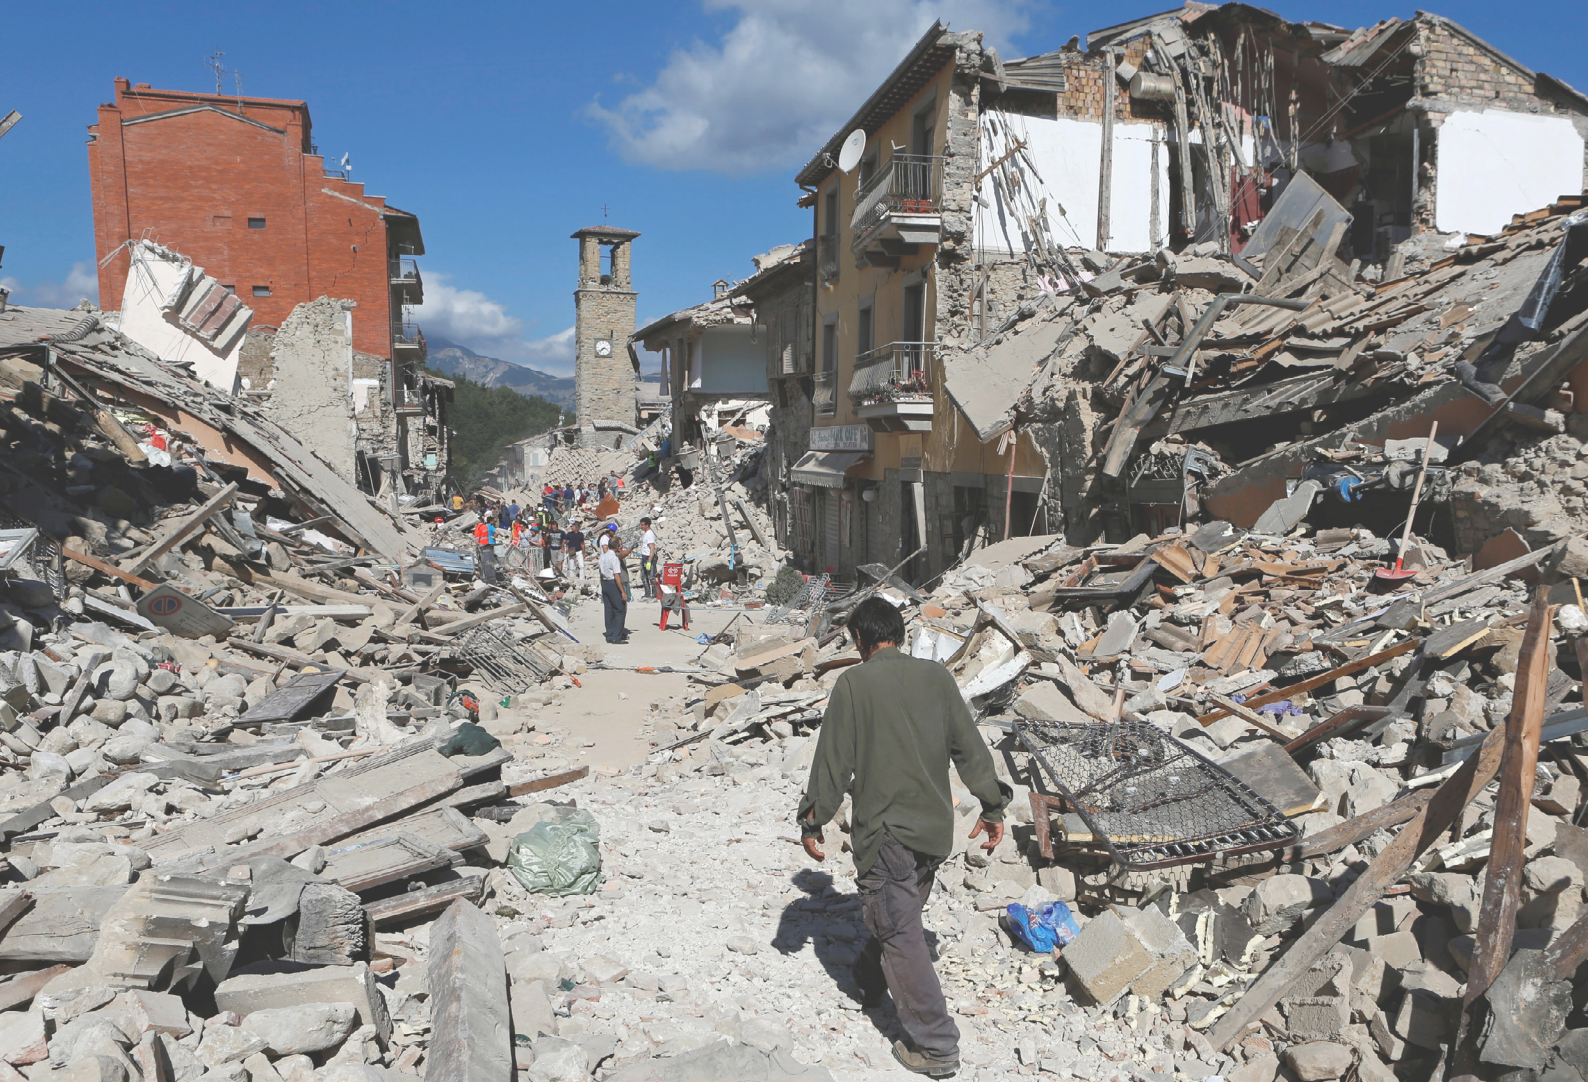
*Figure 19(above): Damage after earthquake in Italy*

*Figure 20(under): Damage after earthquake in Groningen*

In case of Groningen we talk about a different kind of earthquake. So do we talk about different damages as well? For instance earthquakes in Japan or Italy have caused much greater damage due to the much heavier earthquakes. In Groningen the duration of an earthquake is 5-6seconds, while elsewhere in the world it can be much longer. This doesn't mean the earthquakes in Groningen are not a problem. As discussed in the position I take (chapter 1 Problem statement) people should go to Groningen because earthquakes lead to material and emotional damage and, indirectly to depreciation of property and damage of the identity of Groningen.

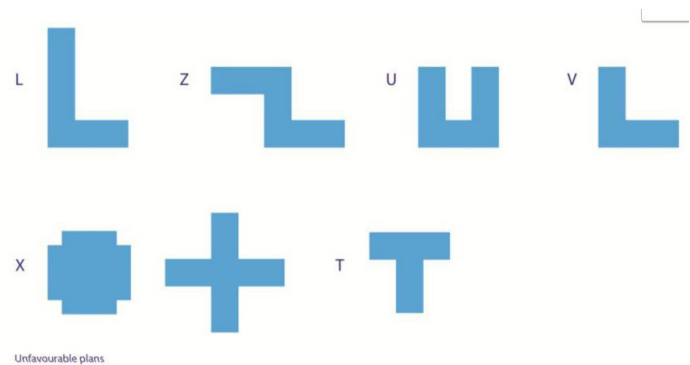
Figure 21: Unfavourable plans

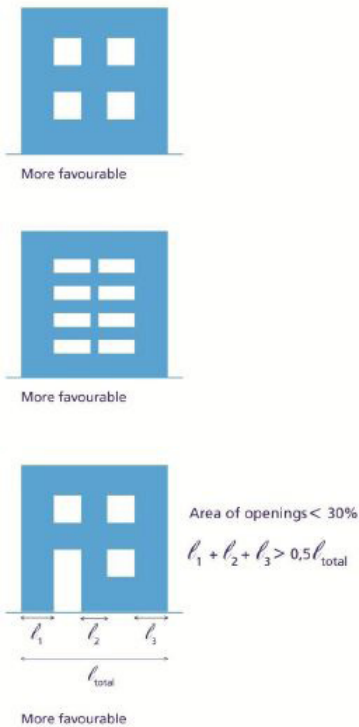
Figure 29: Openings configuration

- *Lack of connections, between wall/wall, walls/roof and wall/floors;*
- *Out-of-plane collapse of walls in direction perpendicular to earthquake direction (especially the outer leaf of cavity walls); and*
- *In-plane wall failure. In-plane failure depends primarily on:*
  - *Load on top;*
  - *Opening configuration*
  - *Length of walls;*
  - *Wall thickness; and*
  - *Material properties.*
