Assessment of Damages in Concrete Parking Structures

MSc Thesis

Delft University of Technology, Department of Engineering Structures

An overview of types of damage in concrete parking structures

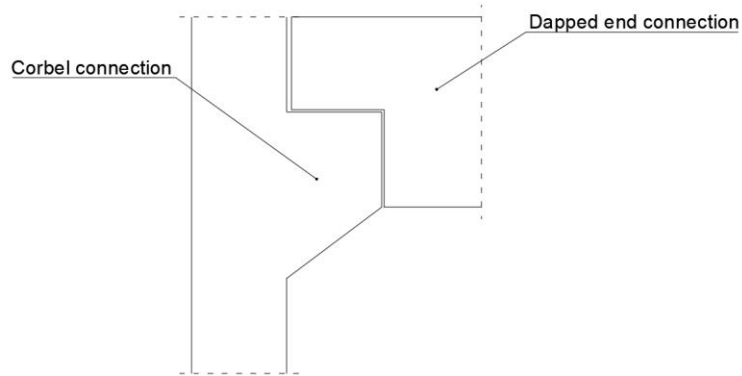
Figure 2.9 Schematisation of connection between corbel and dapped-ended beam.

Three types of support methods are frequently applied for prefabricated connections in parking garages. These systems encompass: corbels, half-joint connections (dapped end), and L- or inverted T- beams (De Boer & Van Haastert, n.d.). Corbel connections are integrated in column elements to support concrete beams. The connection of a beam element on a corbel is commonly achieved by dapped ended connections, as depicted in figures 2.9 and 2.10. To reduce floor height, thus maximize effective height, L-beams or inverted T-beams are used as support for concrete floor elements.

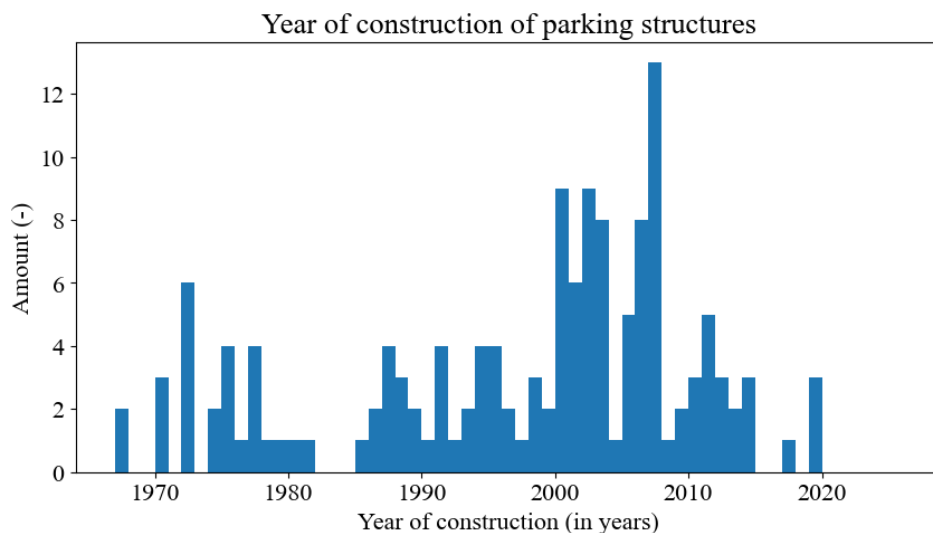
Figure 4.1 Histogram of year of construction of parking structures.

An overview of the year of construction of the structures in the dataset are plotted in Figure 4.1. The histogram represents the year of construction of the parking structures, representing both public- and private parking structures. For context, a public parking garage is seen as a structure accessible to the general public, whereas private parking garages are not. The latter generally being located underneath residential buildings. The results indicate an increase in amount of constructed parking structures between the years 2000 and 2008. After 2008 fewer constructions of parking structures were observed.

The construction years of the parking garages were either retrieved from the archival files or by using the BAG-register. In Figure 4.1 these dates were plotted in a histogram which suggested that a majority of the parking garages were built from the year 2000 up to 2009. As no distinction was made between private or public parking structures it is unknown whether this increase is predominantly found in either one. Although, the increase indicates a desire for more parking amenities. Possibly, this could be related due to it being more common to build a parking structure underneath residential buildings.

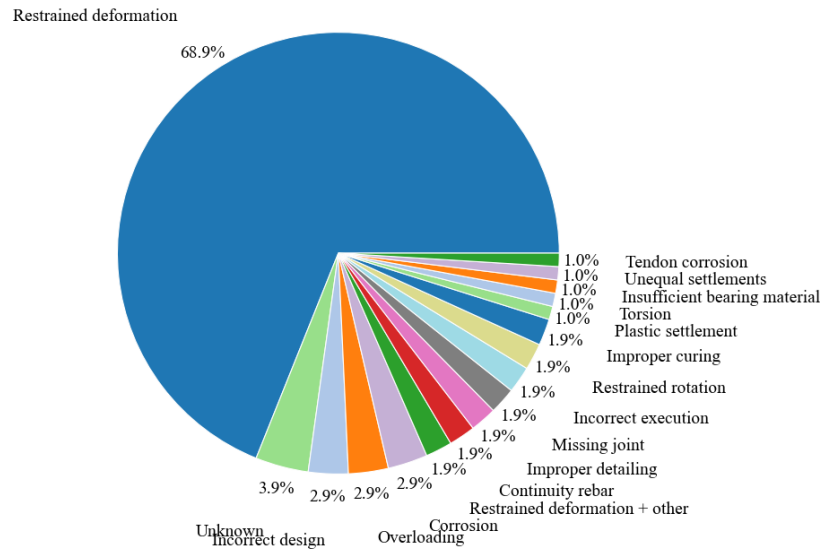
Figure 4.5 Causes of cracks in parking garages.

The general data implied that cracks are the most common form of damage in parking structures. The causes of cracks as collected in the dataset are shown in Figure 4.5.

The results suggest that restrained deformations are the most prevalent cause of cracks. Restrained deformation is an overarching term for deformations either due to shrinkage, thermal influence, or applied load. From the observed data, more than 70% of the cracks in parking garages are caused by restrained deformation, if restrained rotations and a combination of restraints are included. The remaining causes are divided into smaller shares. The amount of degradation induced cracks consists of only 3.9% due to corrosion. In Figure 4.6 the distribution of cracks in elements and sub-elements of the category floors are presented.

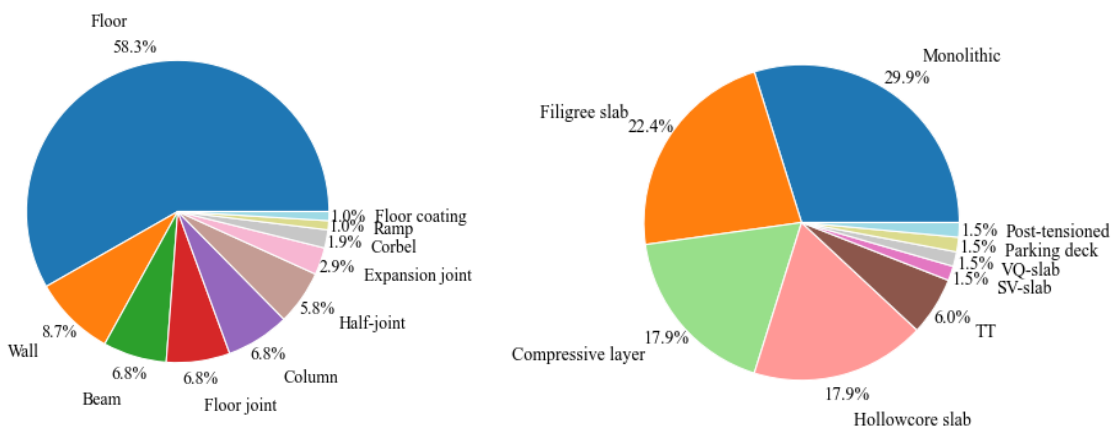
Figure 4.6 Distribution of cracks occurrence in element types (left) and sub-elements of floors (right).

Cracks were significantly more observed in floor elements than other elements. This is expected since floor elements are often designed with large continuous spans as well as many adhering elements, forming constraints. The most affected types of floor elements are in-situ cast floor elements, monolithic (29.9%), filigree slab (22.4%), and a compressive topping layer (17.9%). All of these elements are entirely- or partially casted in-situ. Therefore, it is suggested that a large contribution of restrained deformation is particularly caused by restrained shrinkage.

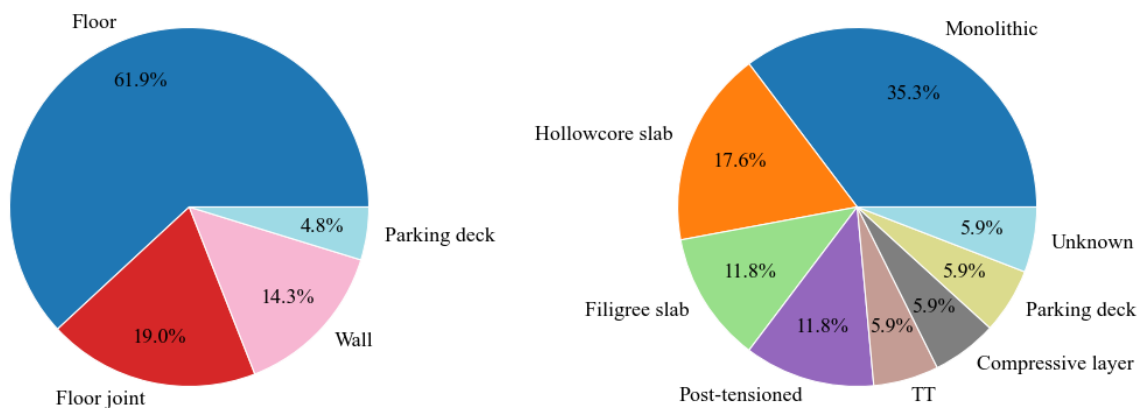
Figure 4.11 Types of elements (left) and floor types (right) subjected to leaking cracks.

The predominant element in which leaking cracks occur in are floors elements (61.9%) and floor joints (19.0%), similar to non-water transferring cracks. From which monolithic floors (35.3%), hollowcore slabs (17.6%), filigree slabs (11.8%), and post-tensioned floors (11.8%) are the most common, reinforcing the claim of large contribution of shrinkage in restrained deformations.

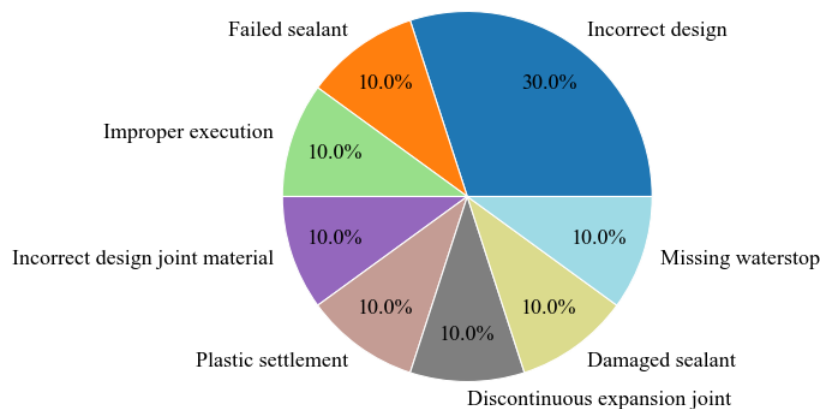
Figure 4.13 Causes of leakage in parking structures.

The causes of leakage in parking structures is displayed in Figure 4.13. The results indicate that the majority of the leakage is due to incorrect design, of both joint (30.0%) and joint material (10.0%). Moreover, damage of the joint sealant (10.0%) and failure of the sealant (10.0%) contribute to a large part of leakage.

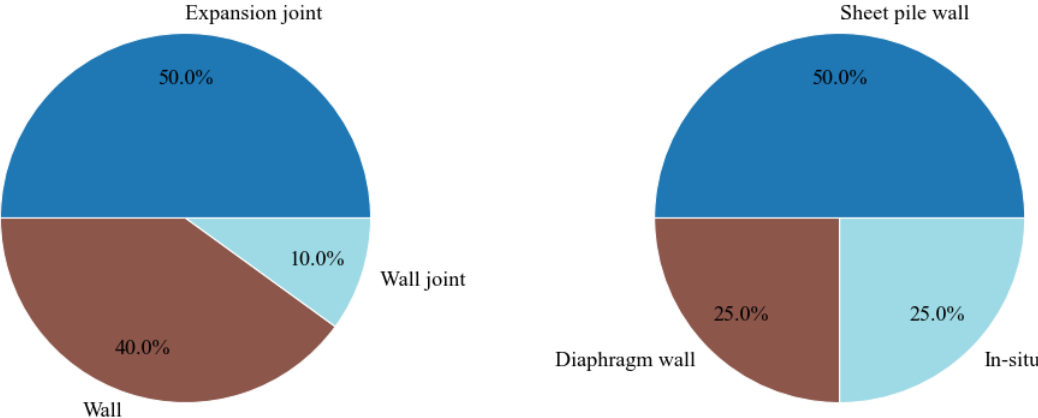
Figure 4.14 Elements (left) and types of wall elements (right) affected by leakage.

The observations of elements and sub-elements of walls affected by leakage are presented in Figure 4.14. The data indicates that leakage occurs most frequently in expansion joints (50.0%) or in wall elements (40.0%). Sheet pile wall elements are the most critical at half of the leakages, followed by diaphragm walls (25.0%), and in-situ casted walls (25.0%).

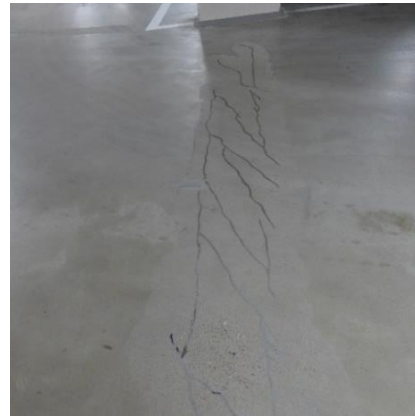
Characteristic cracks in compressive layers of prefab floors span along the floor joints, as shown in figures 5.1 and 5.2. Cracks are to be expected both at the support as well as along the interface between adjacent elements. The cracks along the interface joint for hollowcore slab floor systems are expected at regular intervals of 1.2 m or 2.4 m, which equate to once- or twice the width of a slab.

Figure 5.2: Cracks along the support of slab element (Adviesbureau Hageman).

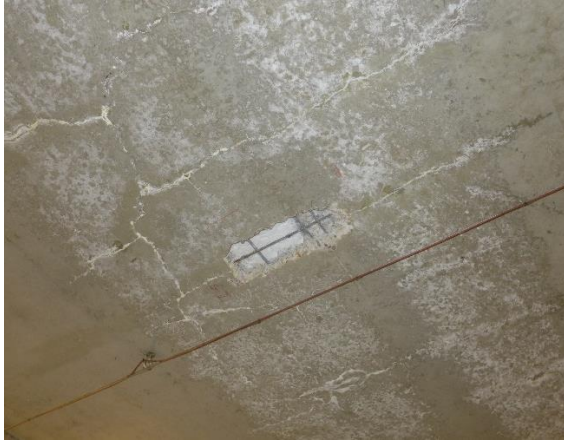
Characteristics of corrosion in compressive layers are cracks, locally spalled concrete, or stained corrosion marks on the floor element, as shown in figures 5.5 and 5.6. Corrosion marks can be expected located directly above the position of the reinforcement mesh or at locations of existing cracks. Furthermore, local reductions of rebar can be expected (Figure 5.8).

Figure 5.5 Cracks as result of corroded rebar (Adviesbureau Hageman).

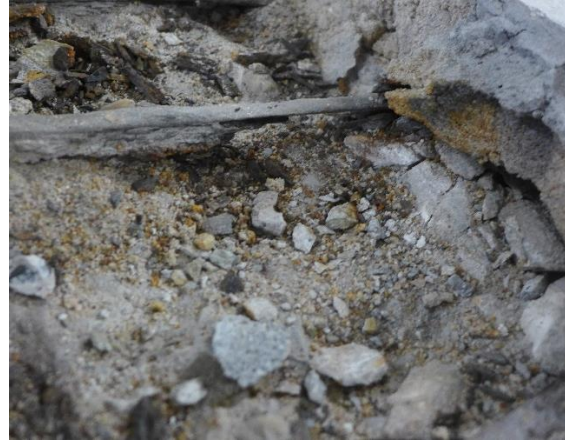
Figure 5.6 Corrosion of reinforcement in compressive layer (Adviesbureau Hageman).

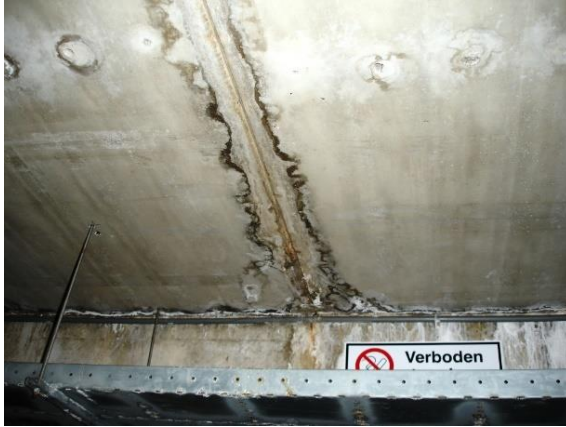
Characteristics for leakage along floor joints are portrayed by visible signs of present or previous occurring water transfer (figures 5.9 and 5.10). Leakage is commonly accompanied by cracks, especially at longitudinal floor joints of prefab floors, and occasionally accompanied by corrosion stains.

Figure 5.9 Leakage at longitudinal joint of hollowcore slab (Adviesbureau Hageman).

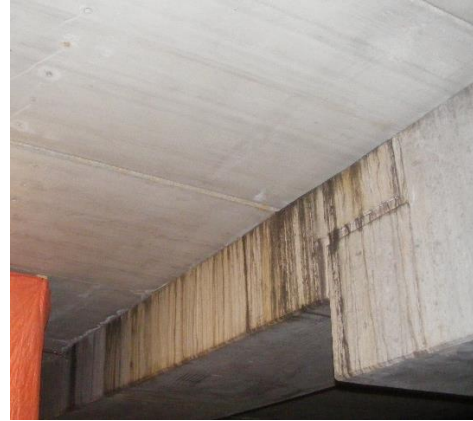
Figure 5.10 Leakage at support joint of hollowcore slab (Adviesbureau Hageman).

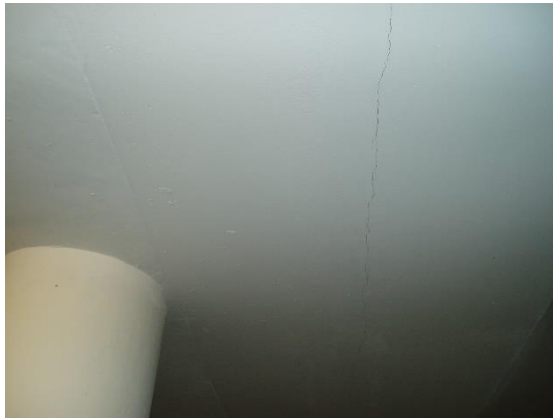
Characteristics for cracks in hollowcore slabs are cracks spanning the entire height of the cross-section. These cracks can occur at any location in a hollowcore slab and are susceptible to leaking. These cracks generally occur in a parking structure at a change of floor layout, corners in floor layouts, or perpendicular to the continuous span. Examples of cracks in hollowcore slabs are shown in figures 5.13 and 5.14.

Figure 5.13 Cracks at the underside of hollowcore slab (Adviesbureau Hageman).

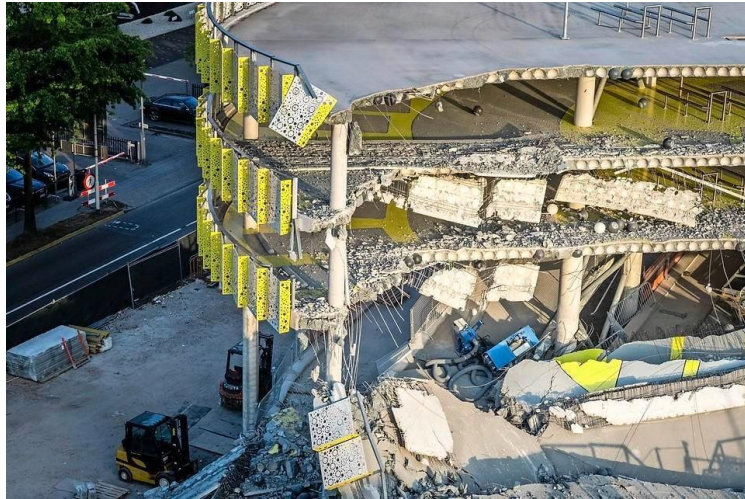
A defect, or incorrect design, of floor joints of filigree slabs was the cause of a collapse in a parking structure (Figure 5.17). Due to ignorance of correct reinforcement detailing of filigree joints, a brittle failure mechanisms occurred (Figure 5.18).

Figure 5.17: Collapse of parking garage using filigree floors (Engelaar, n.d.)

The causes of the collapse was incorrect detailing of the longitudinal joint of the filigree slab. Additionally, due to a smooth surface of the prefab element due to self-compacting concrete a poor cohesion between prefab slab and in-situ concrete was created.

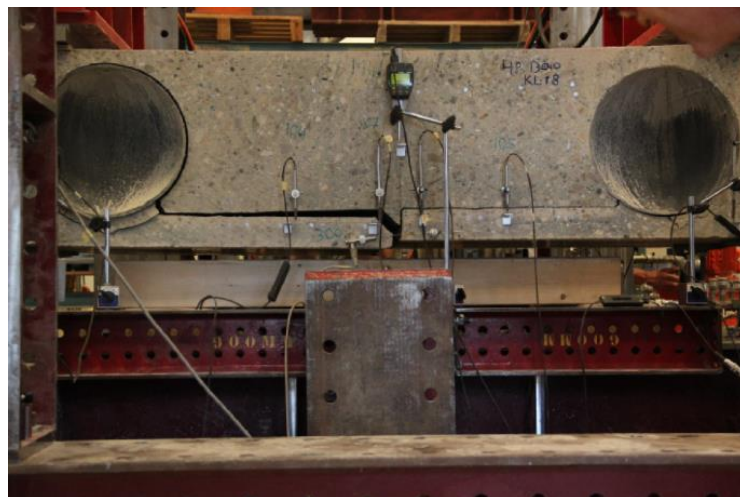
Figure 5.18: Brittle failure mechanism of bubble deck slab joint (Rijksoverheid, 2022)

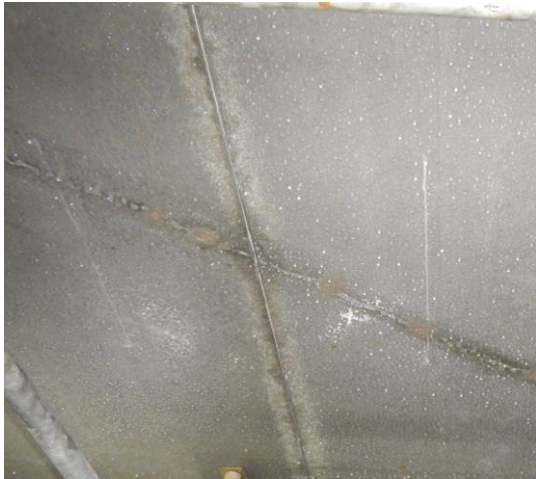
Characteristics crack in filigree slabs are known for two types of cracks. Cracks are commonly located at the bottom prefab slab mid span, or perpendicular to the span direction. These cracks appear shortly after casting the in-situ compressive layer of the concrete. Moreover, cracks often occur through the entire height of the cross-section, at midspan of the largest adjacent span direction. Examples of cracks in filigree slabs are shown in figures 5.19 and 5.20.

Figure 5.19 Cracks running through adjacent filigree slab elements as result of restrained deformations (Adviesbureau Hageman).

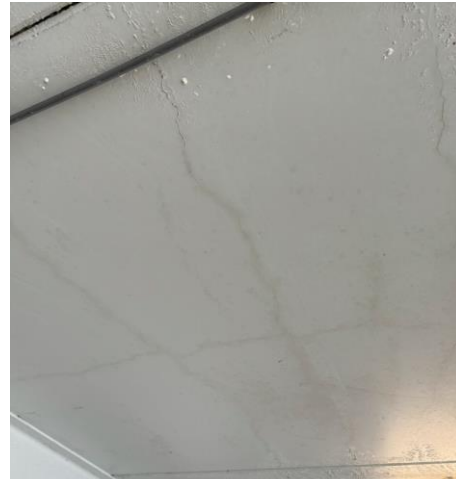
Figure 5.20 Cracking at underside of filigree slab (Adviesbureau Hageman).

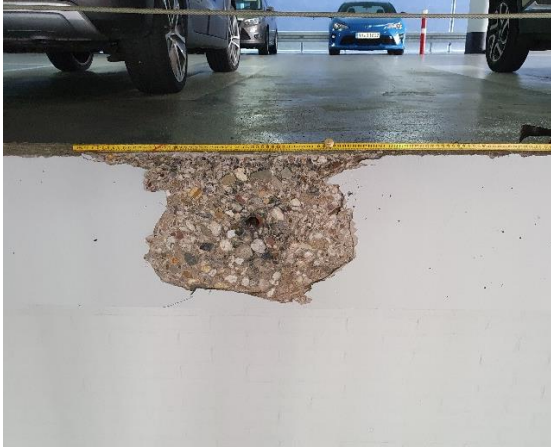
Corrosion of post-tensioned floor tendons can be characterized by leakage of tendon lubricant, exposed tendons at the pavement surface, and formation of cracks, as shown in figures 5.23 and 5.24. This damage only occurs for older post-tensioned floor systems built before 1985.

Figure 5.23 Spalling as result of failure of prestress tendon (Adviesbureau Hageman).

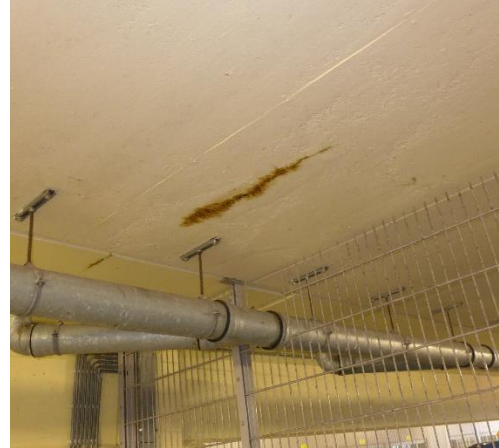
Figure 5.24 Visible exposed tendon lubricant (Adviesbureau Hageman).

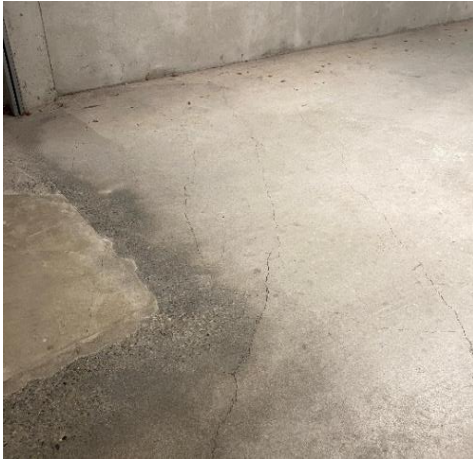
Characteristic cracks within monolithic floor slabs occur frequently at halfway the span length, spanning perpendicular to the span direction. Moreover, common positions of cracks are along the connection between wall elements or at corners of wall elements, as presented in figures 5.25 and 5.26. These cracks generally span the complete height of the cross-section, making them prone to leakage and corrosion induced damage.

Figure 5.25 Cracks in monolithic floor, restraint by adhering walls (Adviesbureau Hageman).

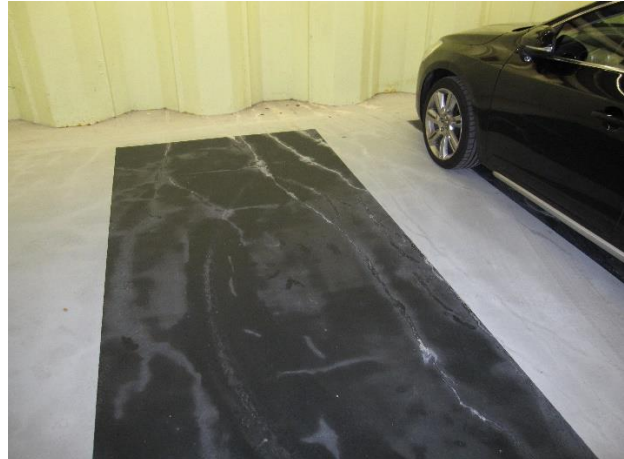
Figure 5.26 Cracks along connection between sheet pile wall (Adviesbureau Hageman).

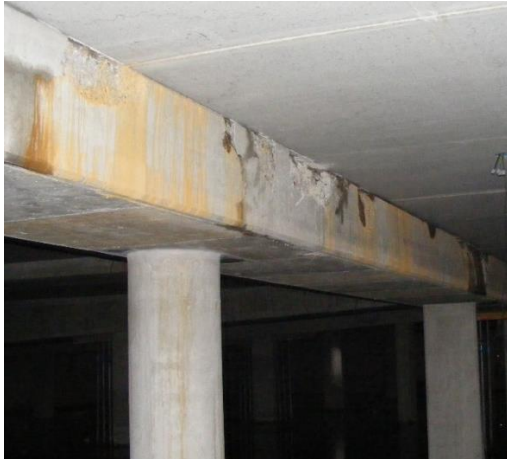
Support end failure is a failure mechanism in which concrete edges or corners are locally cracked or spalled. This phenomenon is found at supporting elements. In parking structures, half-joints, corbels, columns, and support beams are frequently affected. The support end failure mechanism at a support beam and half-joints are shown in figures 5.29 and 5.30, respectively.

Figure 5.29 Local support end failure of concrete support beam (Adviesbureau Hageman).

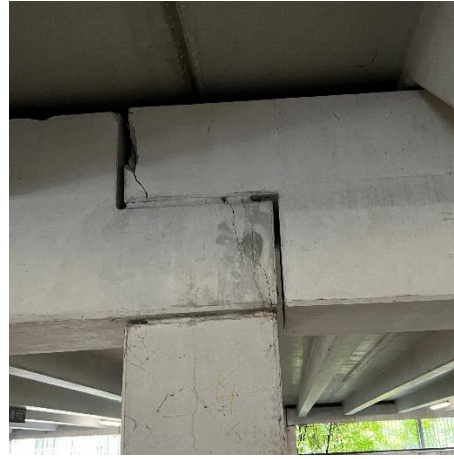
Figure 5.30 Local support end failure of half-joints (Adviesbureau Hageman).

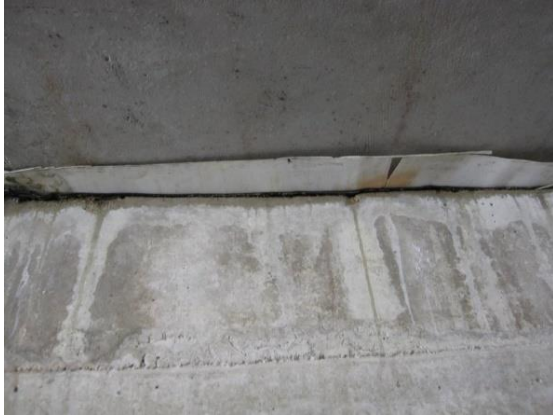
'Walking' bearing pads are characteristically expressed by extruding bearing material from its connection, as presented in figures 5.33 and 5.34. This type of damage occurs at corbels, support beams, or half-joints. The mechanism can occur for various types of bearing materials, elastomeric or steel pads as such.

Figure 5.33 Extruding elastomeric bearing pads at support of slabs (Adviesbureau Hageman).

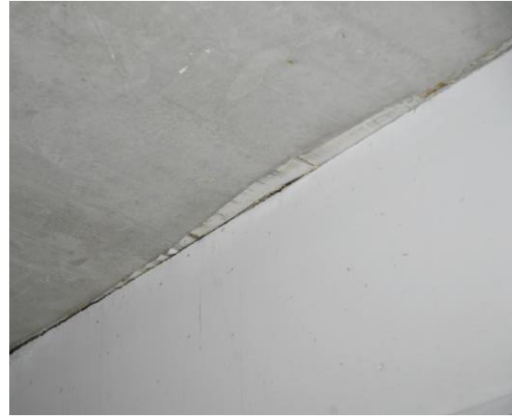
Figure 5.34 Gradual walking of elastomeric bearing pads (Adviesbureau Hageman).

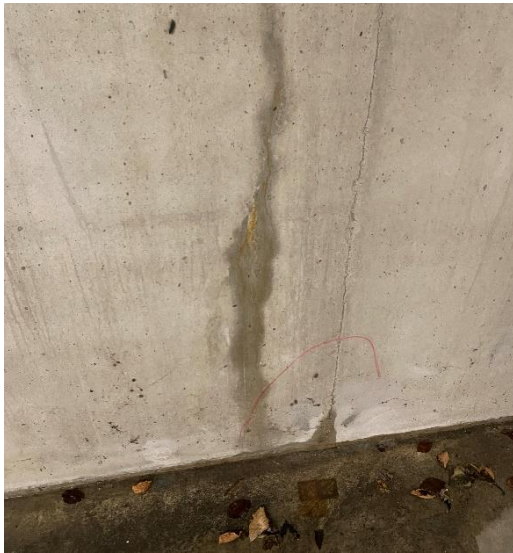
Leaking cracks in cast in-situ walls are notably found at the connection between wall and floor elements. These cracks are vertically oriented, increasing in crack width towards the adhering element, as shown in figures 5.39 and 5.40.

Figure 5.39 Cracks in cast-in situ wall, accommodated by leakage (Adviesbureau Hageman).

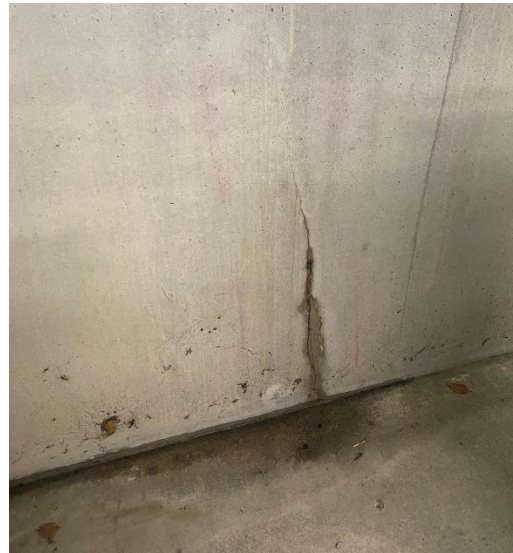
Figure 5.40 Cracking in concrete cast in-situ wall, increasing in crack width towards the floor element (Adviesbureau Hageman).

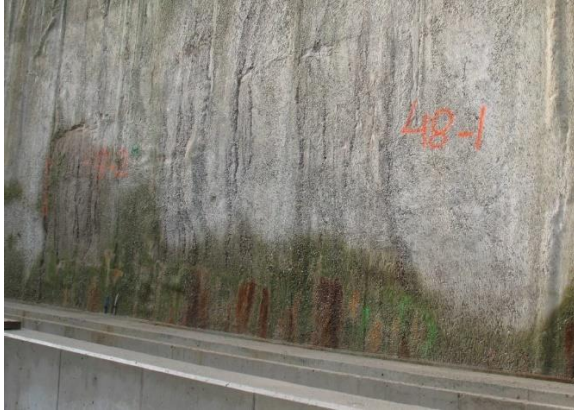
Characteristic locations of leakage in diaphragm walls comprise of wall joints between segments or from protruding bars. The latter being characterized by water transfer through the protruding reinforcement, presented in figures 5.42 and 5.43.

Figure 5.42 Leakage right above concrete beam element (Adviesbureau Hageman).

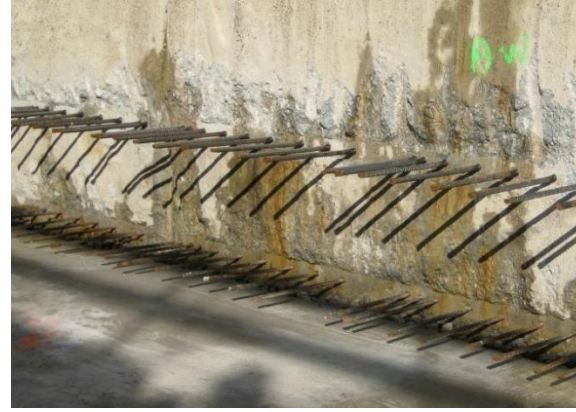
Figure 5.43 Leakage at protruding bars in diaphragm wall (Adviesbureau Hageman).

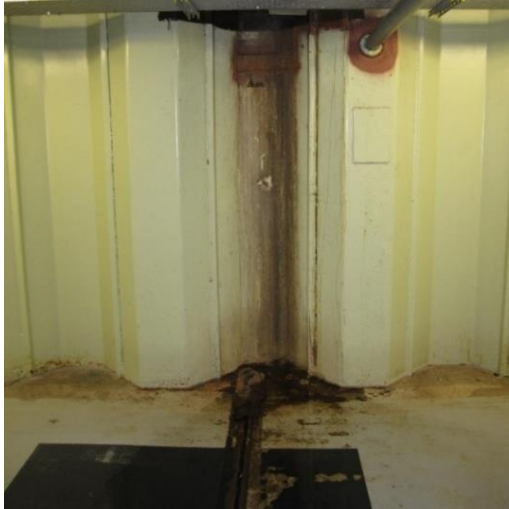
Characteristics of leakage in sheet pile walls are frequently situated at connections between adhering elements, floors or beams as such. Visible indications of leakage are expected to occur at these locations. Moreover, joints of sheet pile elements are susceptible to leakage. Examples of leakage at sheet pile wall elements are given in figures 5.45 and 5.46.

Figure 5.45 Leakage at sheet pile wall located at floor joint (Adviesbureau Hageman).

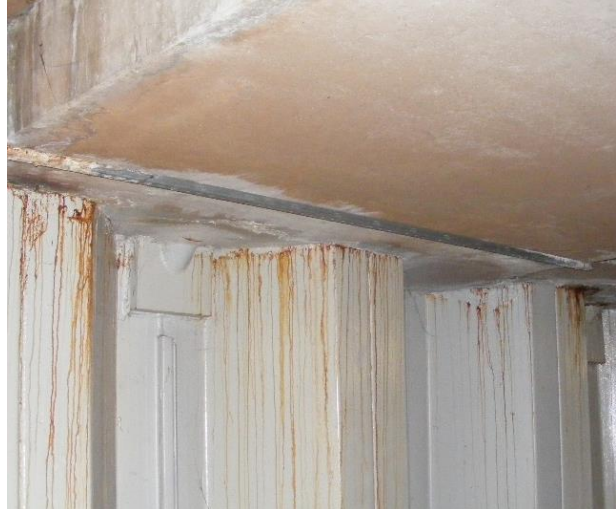
Figure 5.46 Leakage at connection between sheet pile wall and concrete floor (Adviesbureau Hageman).

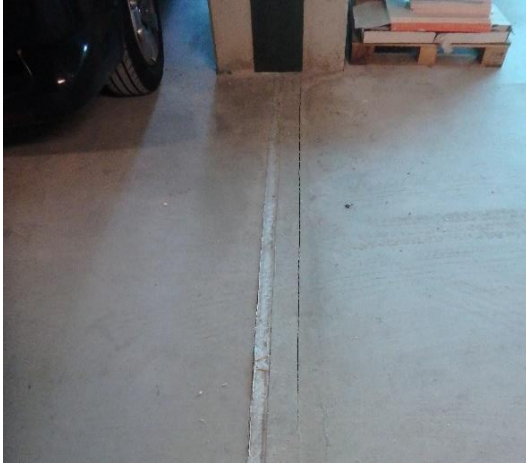
Characteristic cracks in expansion joints are commonly found alongside the direction of the expansion joint, as shown in figures 5.47 and 5.48. Moreover, cracks occur frequently in elements bridging both sides of the expansion joint.

Figure 5.47 Cracking beside expansion joint (Adviesbureau Hageman).

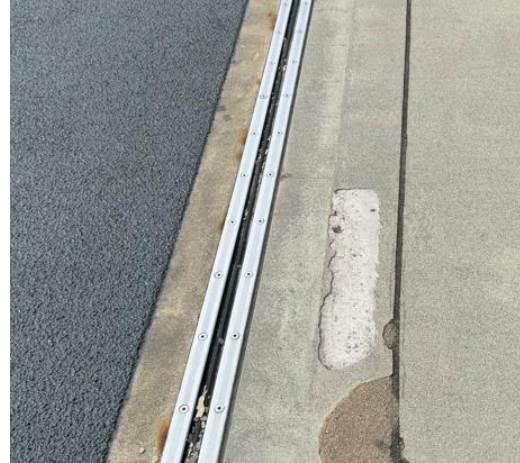
Figure 5.48 Cracking next to expansion joint due to incorrect installation (Adviesbureau Hageman).

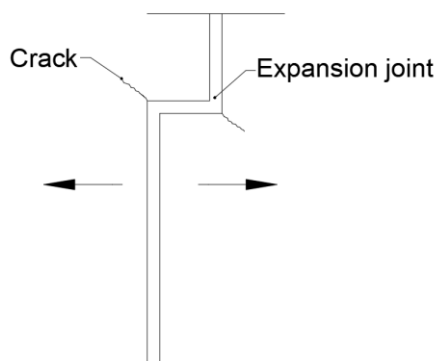
Common causes in expansion joints encompass discontinuity of the expansion joints (Figure 5.49). Moreover, misaligned of expansion joints between connected elements are a potential cause of cracks between the expansion joint, schematised in Figure 5.50.

Figure 5.49 Cracking in expansion joint due to irregularity within the joint.

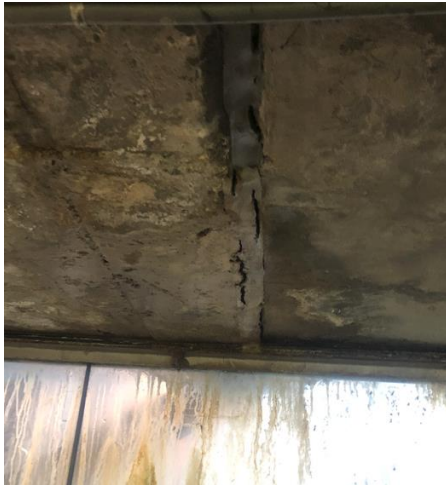
Damage to joint sealants can be comprised by a multitude of factors, encompassing extruding of the sealant, loss of cohesion, or loss of adhesion of the sealant. Extruding sealant can be recognized by compressed and exposed joint from the expansion joint. Cohesion loss of sealant can be recognized by either cracking or tearing of the sealant. This damage occurs in the middle of the sealant, spanning parallel to the joint. Adhesion loss of sealant is known to disconnect the sealant from the adhering joint material, leaving larger gaps between sealant and joint, depicted in figures 5.51 and 5.52. Damaged sealants are often accompanied by leakage of the joint.

Figure 5.51 Failure of adhesion and leakage of joint (Adviesbureau Hageman).

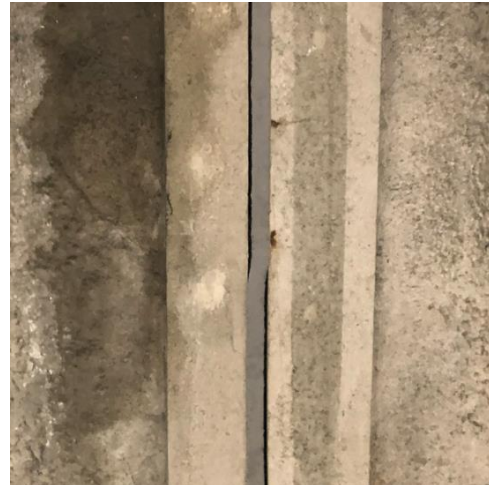
Figure 5.52 Adhesion failure of joint sealant (Adviesbureau Hageman).

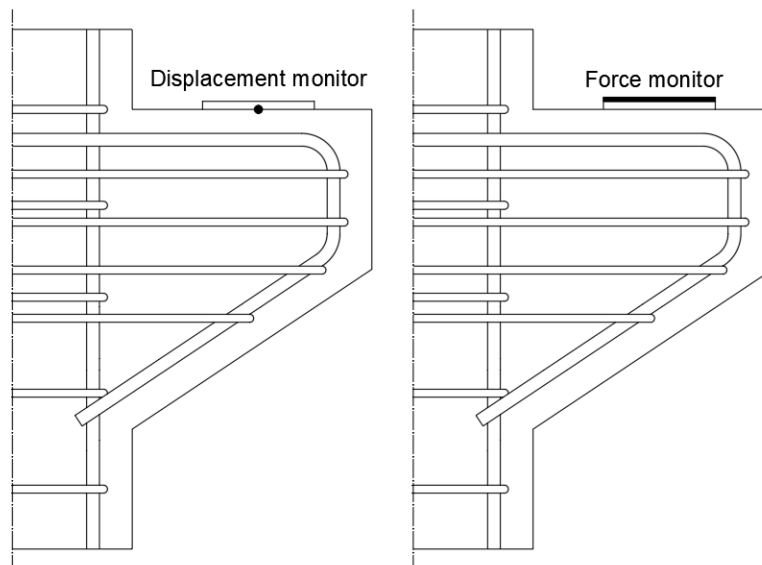
Additionally, monitor points were placed below the middle of the bearing pad to monitor both vertical and horizontal displacements. Moreover, the vertical applied force was monitored by summation of the individual applied displacements on top of the bearing pad.

Figure 11.9 Displacement and force monitors.

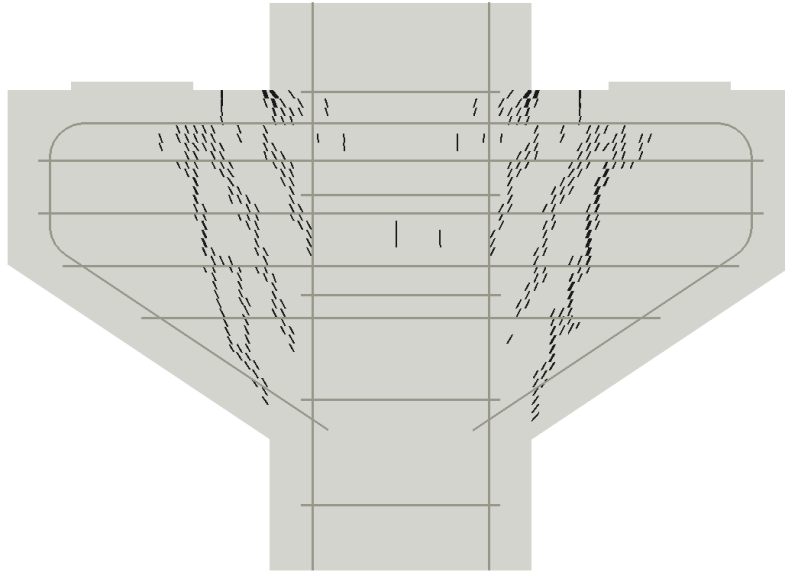
A difference between the load on the left- and right support was observed in the L-D diagram both before- and after the maximum load. The difference starts at a vertical displacement of approximately 0.8 mm, which equates to a vertical load of 730 kN. At displacements larger than 1 mm a greater reduction load is measured on the right corbel compared to the left corbel. It indicates that the corbels behave in an asymmetric manner. A small asymmetric behaviour was also observed in the crack model in Figure 11.11, which displays the cracks with a calculated crack width larger than or equal to 0.05 mm. The asymmetry in the crack model is mainly found in the lower sections of the corbels, in which the left corbel shows three cracks compared to two cracks in the right corbel.

For numerical reasons, a crack does not have to occur exactly at the same instant. As soon as a crack arises on one side, the loading condition for the opposite side is directly different from the loading conditions at the side where the crack came first.

Figure 11.11 Crack model, with a minimum crack width of 0.05 mm, at a vertical load of 815 kN.

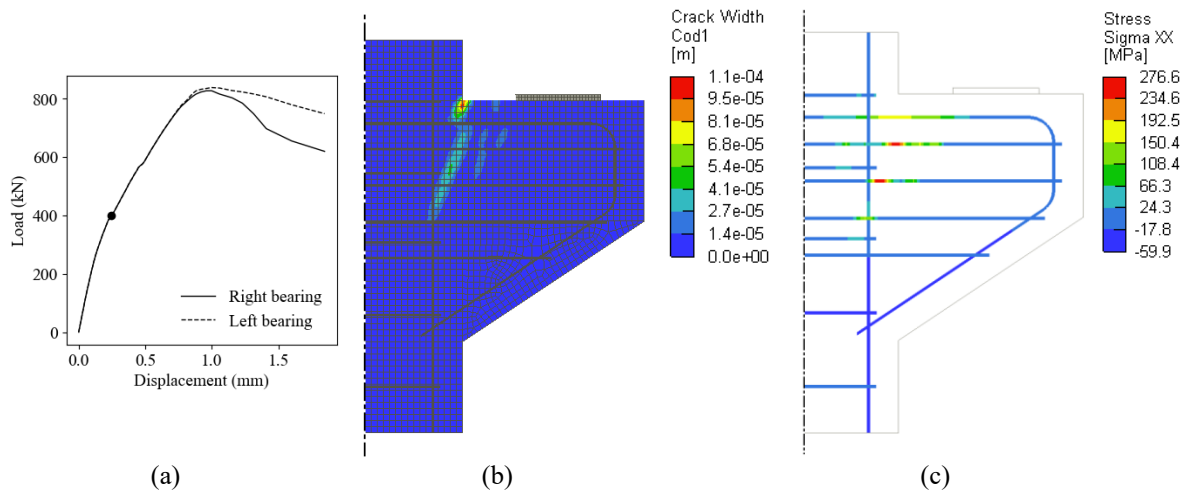
Once the design load of 400 kN was reached, crack 1 had increased in both length and crack width (Figure 11.17). A maximum crack width of 0.11 mm is observed at the re-entrant corner. Therefore, the corbel design meets the crack width limit prescribed by EC2 of 0.2 mm for chlorine environments. As mentioned, crack 1 increased in length intersecting both stirrup 1 and 2, resulting in further rise of the reinforcement stresses. The stresses in the reinforcement reached a maximum of 276 MPa, and thus remained below the yield stress.

Figure 11.17 Load-displacement diagram (a), crack width plot (b), and reinforcement stresses (c) at design load of 400 kN.

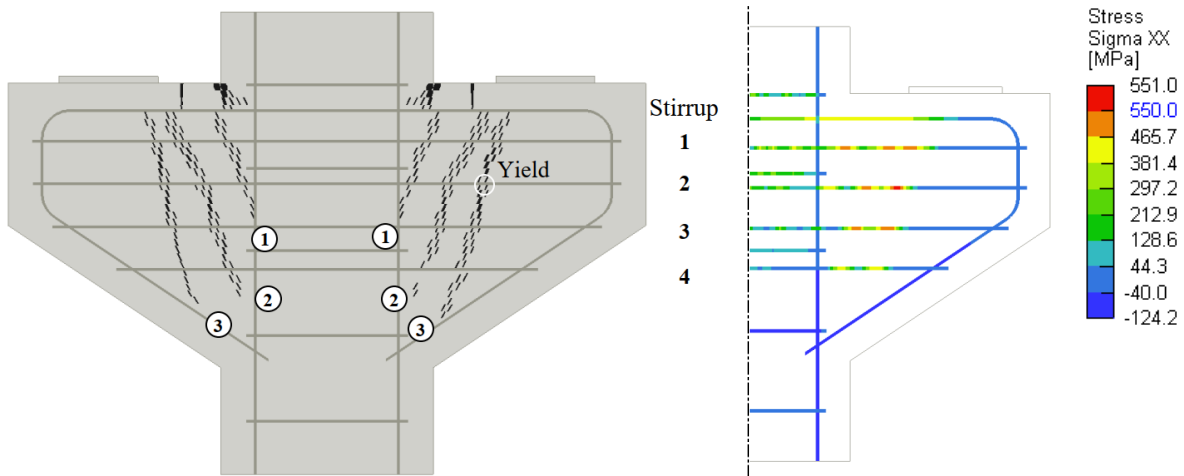
Figure 11.21 Crack model and reinforcement stresses at a vertical load of 745 kN.

In Figure 11.21, the crack model and corresponding reinforcement stresses are displayed for a vertical load of 745 kN. A small difference in crack propagation between the lower half of either corbels can be seen. The maximum crack width has increased to 0.35 mm, positioned at the re-entrant corner. Moreover, crack 3 became the consecutive largest crack with a width of 0.13 mm, situated between stirrups 1 and 3. Consequently, this led to the yielding of stirrup 2.

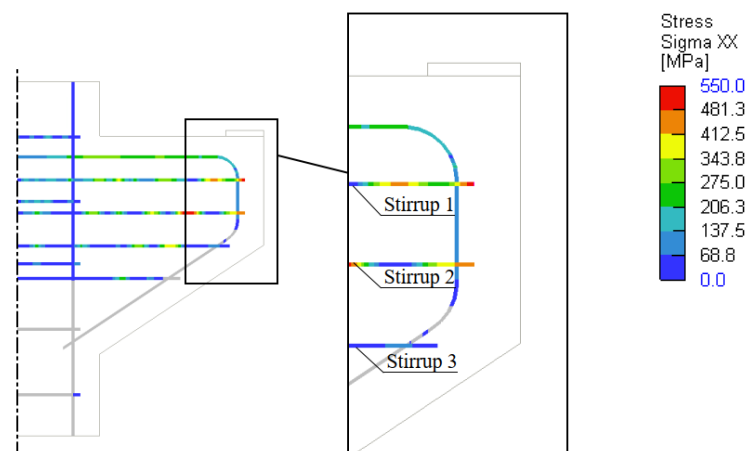
Figure 12.19 Reinforcement stresses at an applied load of 371 kN.

Previously it was observed that the initial support end failure cracks caused an increase in tension in the bend of the main reinforcement. In Figure 12.19, the tensile reinforcement stresses are presented at an applied load of 371 kN. The maximum stresses measured in the reinforcement are just below yield, with the maximum stresses occurring in stirrup 3. Furthermore, tensile stresses increased along the vertical section of the main reinforcement, extending past stirrup 2. Besides, the stresses in the areas of the stirrups nearing the support end failure cracks, increased significantly.

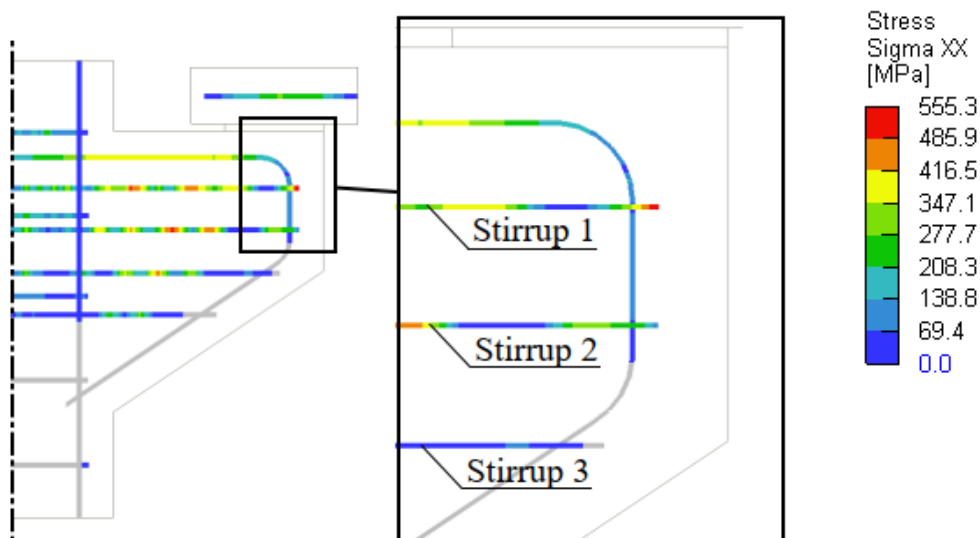
The tensile stresses in the reinforcement as result of the failure cracks are shown in Figure 12.40. The maximum tensile stress has exceeded the yield stress in the reinforcement at the outer edges of stirrup 1. Moreover, the vertical section of the main reinforcement, between its two bends, has increased in stresses along the entire height. Interestingly, the tensile stresses in this section of the main reinforcement are noticeably similar, in both distribution and order of magnitude, as the section at failure of specimen B.

Figure 12.40 Tensile stresses in the reinforcement at 65.4 kN horizontal load.

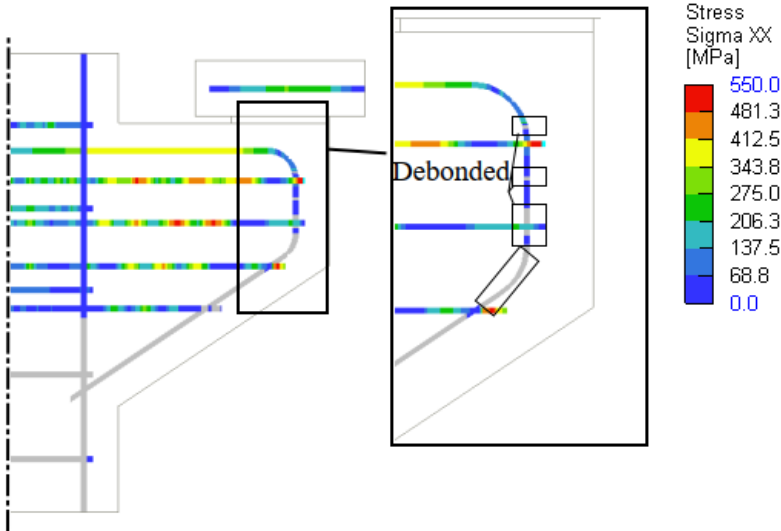
In Figure 12.44, the tensile stresses in the reinforcement are presented. The crack propagation along the main reinforcement affected the tensile stresses within, as the tensile stresses extended up to stirrup 2. Interestingly, the tensile stresses in the vertical section of the main reinforcement had decreased compared to the state at failure. Even more so, several concrete sections had debonded from the from the main reinforcement.

Figure 12.44 Tensile stresses in reinforcement at a horizontal load of 67.4 kN.

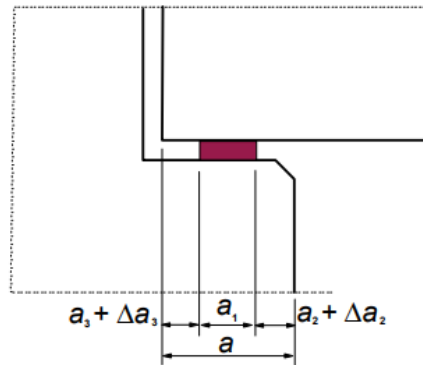
The dimensions of the corbel are calculated based on minimum requirements prescribed based on bearing elements or anchorage of reinforcement by NEN-EN 1992-1-1:2011 (EC2). For bearing elements the dimensions of the corbel comprises of three components: the distance from the edge of the corbel to the bearing pad ($a_2 + \Delta a_2$), the size of the bearing pad (a_1), and the distance between the bearing pad and the end of the supported element ($a_3 + \Delta a_3$), clarified in Figure D- 1.

Figure D- 1 Size parameters of a support based on bearing elements- EC2 art. 10.9.4.7 (Nederlands Normalisatie Instituut, 2011).
