Circularity Overview

Making material use within architecture projects measurable and verifiable in an overview of what contributes to designing architecture for the upcoming Circular Economy

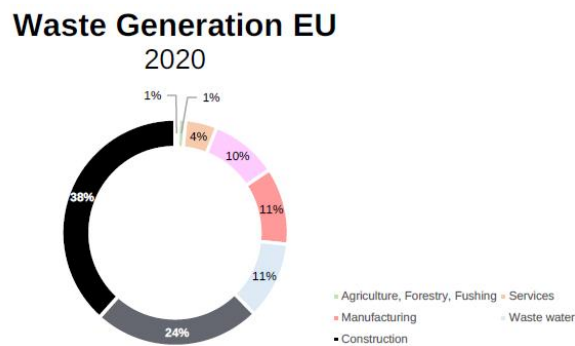
Figure 1: Waste generation, based on Afvalbeheer in De EU: Feiten En Cijfers (2022).

Rau & Oberhuber (2016, p. 38-42) wrote that responsibility over manufactured products is currently organized within the production chain in such a way that no one has to take it in relation to the consequences triggered by production and use. This leads to the mountains of waste being normal. The qualities and potential of the material are lost in large mountains or in the incinerator. According to Stahel, (2019, p. 4) waste coming from industry is a double loss, both for energy and for materials. Energy is needed to use the material to manufacture a product then the product is worth nothing, then new energy is needed to burn the product which means the material is permanently lost. When a consumer buys a product, its responsibility is transferred from the producer to the consumer. The consumer uses the product after which it is eventually thrown away. The current linear economy is therefore known as the 'Take, Make, Waste economy' (Rau & Oberhuber (2016, p. 38-42). This phenomenon mainly occurs in the construction industry, considering the share of construction in total waste production in the year 2021 as visible in Figure 1

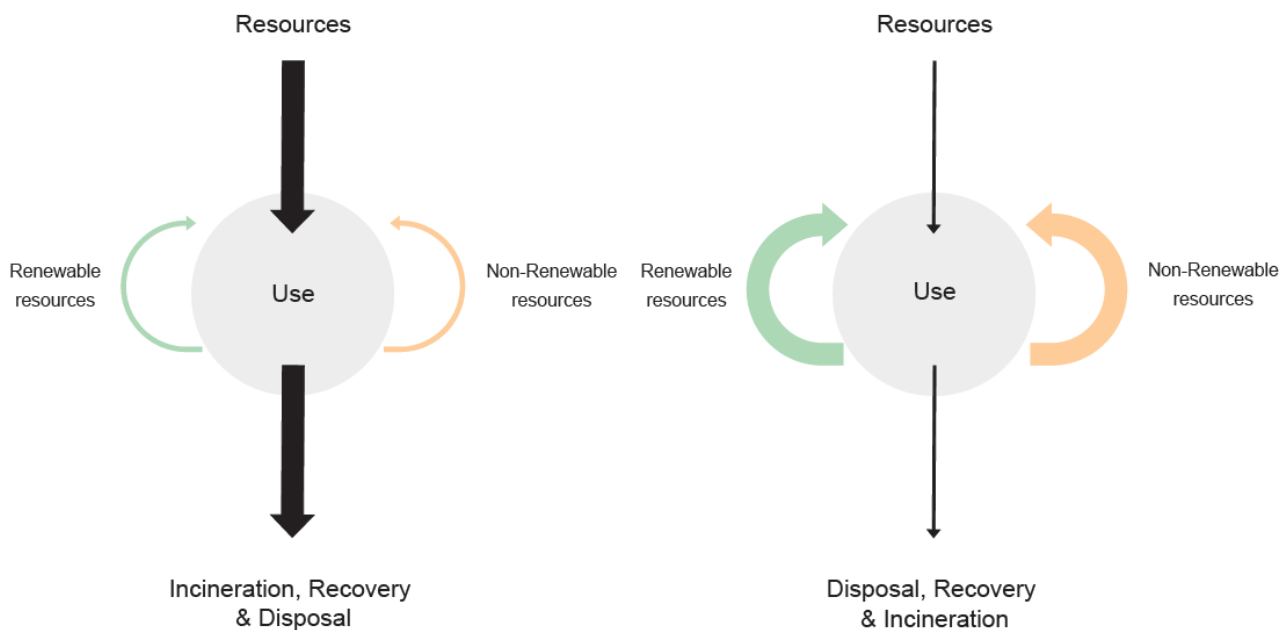
Figure 2: Linear system (left) & and circular system (right), based on Lugt, P., & Harsta, A. (2020).

social cycles. In short, working towards a transition from a linear to a circular system, as illustrated in Figure 3. When the government implements regulations on material use, the cycles of fossil and ecological raw materials can become manageable, through taxes, environmental accounting and market systems. This will then lead to new business models, employment, prosperity and growth in fields such as recycling, repair and collection. Through 'stimuli', or awareness, generated by the government, production sector and finally the consumer, the circular economy can become a reality, by working collectively towards solving issues.

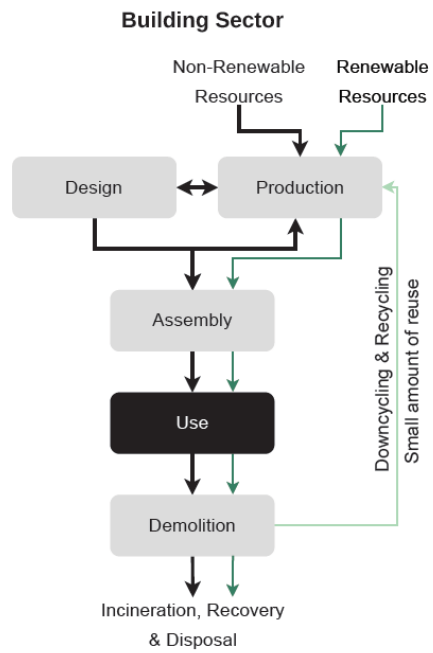
Figure 3: Current system, based on notes made during lecture by Rotor on 16-11-2022.

Within the construction industry, the awareness to apply circularity and solve issues needs to be raised in order to implement it. Currently, there are already circular initiatives such as some case studies covered in this paper, however, there are few actual projects where minimizing waste has become a reality, as researched by Rana Mahanta, N., Samuel, A. K., & Sachan, D. (2021). As mentioned by Schouten (2016), collective collaboration is important for circularity. Currently, the construction industry collaborates in a largely linear manner, see Figure 4, however, this needs to change to a collective system for the circular economy, see Figure 5.

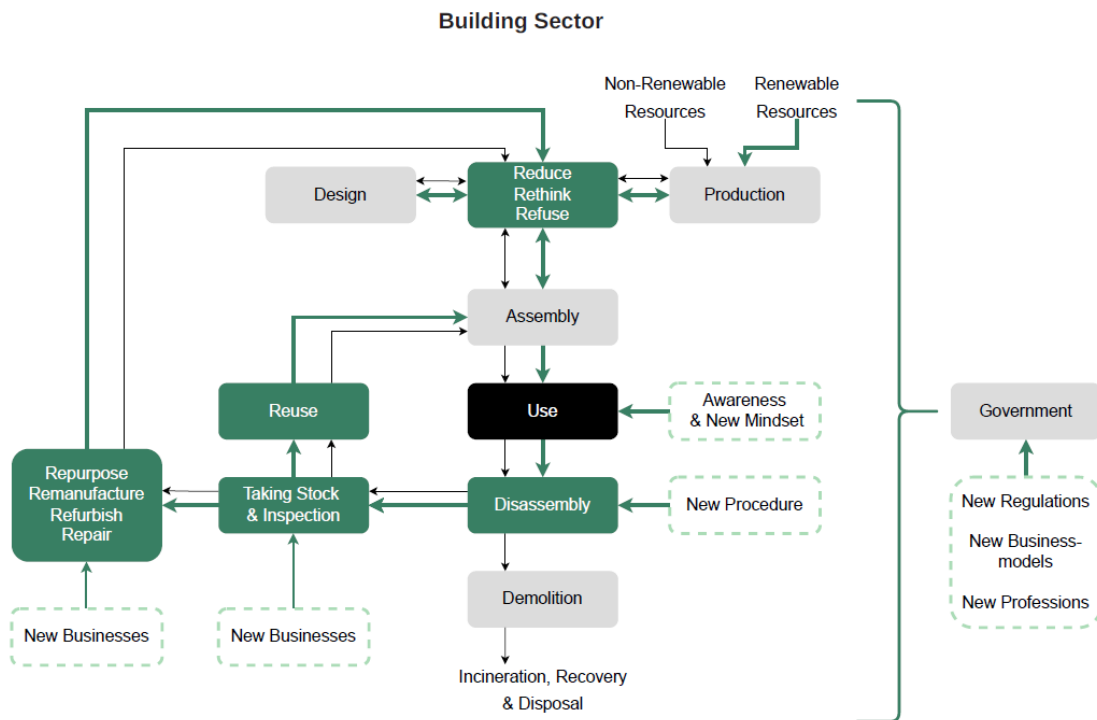
Figure 4: New system, based on notes made during lecture by Rotor on 16-11-2022.

Figure 5 shows that Design and Production will soon have to work and think differently toward circular solutions. Also, new companies are involved and the role of other stakeholders is transforming.

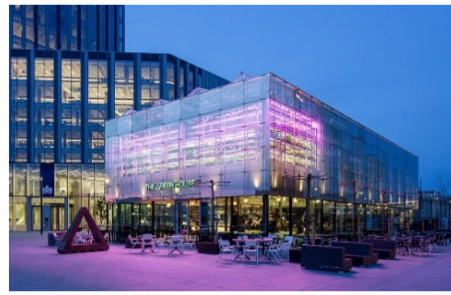
Case Study: **The Green House, Utrecht**
 Architect: cepezed
 Area: 680 m²
 Program: Restaurant, greenhouse & meeting spaces
 Finished: 2018
 Usage period: 15 years
 Assembly: Only dry & mechanical connections

The short 15-year usage results in a very high MPG score of 1,110 for the tested components, which is even higher than the maximum allowed of 1,0. Although many of the materials can be reused, they are largely produced from fossil resources, which also contributes to the high MPG score. If more elements had been made out of renewable or harvested materials, the MPG would be lower with no negative consequence for reusability, the same weight of the structure in timber alone leads to a score of 0.073 as opposed to the 0.235 of steel. In addition, increasing the years of use will contribute to a lower MPG & more efficient usage of the elements since they will be kept longer in their current state. On the other hand, is the MPG score difference between 50 - 100 years very minimal since many materials will not last for 100 years and need to be replaced.

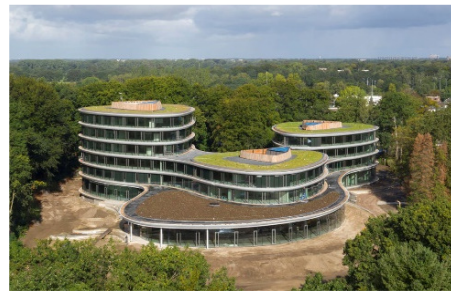
Case Study: **Triodos Bank, Driebergen-Rijsenburg**
 Architect: RAU Architecten
 Area: 12.994 m²
 Program: Offices
 Finished: 2019
 Usage period: 50 years (assumption)
 Assembly: Largely dry & mechanical connections

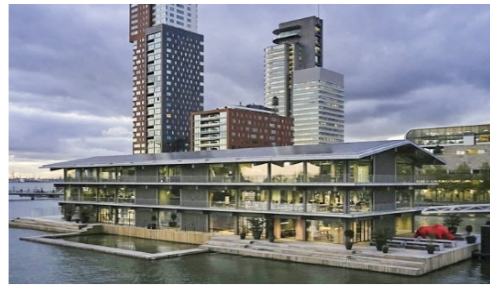
Case Study: **FOR, Rotterdam**
 Architect: Powerhouse Company
 Area: 3564 m²
 Program: Offices & restaurant
 Finished: 2021
 Usage period: 50 years (assumption)
 Assembly: largely dry & mechanical connections

The MPG at an assumed lifespan of 50 years is 1,040 which is higher than the currently permitted score of 1,0, a longer lifespan would be appropriate. Partly due to the amount of concrete and all the PV panels, ventilation units and air conditioning units that need to be replaced during use, the score is so high. Perhaps replacing the air-conditioning ceilings with air heating and cooling, since mechanical ventilation is used anyway, will ensure less replacement of components. Noteworthy are the very low scores of the applied materials in timber, this is due to its renewable raw material and long lifespan. Much of the material is remountable and has a long lifespan, leading to many possibilities for reuse. Without the concrete floating foundation and the PV-panels is the MPG score 0f 0,375, which clearly shows the potential of building with a lot of timber has on the climate impact of this building.

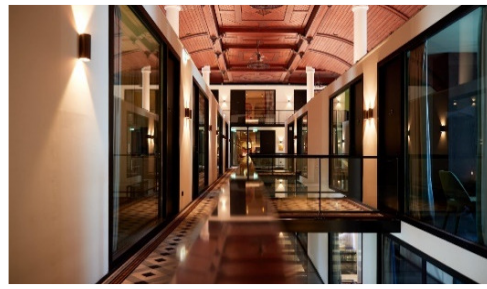
Case Study: **Grote Kerk, Hoorn**
 Architect: Hylkema Erfgoed Advies en Ontwerp
 Area: 2620 m² (+ 2677 m² attic apartments)
 Program: Hotel, restaurant & existing apartments
 Finished: 2020
 Usage period: 50 years (assumption)
 Assembly: largely wet & mechanical connections

The neo-Renaissance P. Grote Kerk was built in: 1883
 Was changed to apartments & store space in: 1983
 A stand alone steel & concrete structure was added for this new program.

The MPG at an assumed lifespan of 50 years is 0,221, which is a beneficial low score. The score is so low because relatively little material has been added to the existing church of which almost everything has been preserved. An important choice is that the inside of the church is not insulated, but rather just the rooms as 'boxes'. Although a lot of maintenance and replacement of elements will be required over the 50-year period of use, the MPG is so low because the relatively few materials provide utility to the large floor area. Using long-lasting natural materials could have made the MPG even lower.

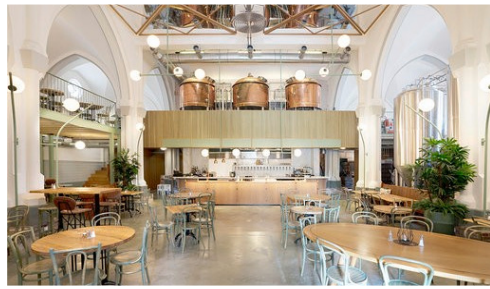
Case Study: **R.K. Laurentiuskerk, Weesp**
 Architect: Stork & Albrecht, arch. en Bouwad.
 Area: 1905 m²
 Program: Offices, brewery, hotelroom, Yoga & app.
 Finished: 2020
 Usage period: 50 years (assumption)
 Assembly: largely wet & mechanical connections

The neo-Gothic R.K. Laurentiuskerk was built in: 1876

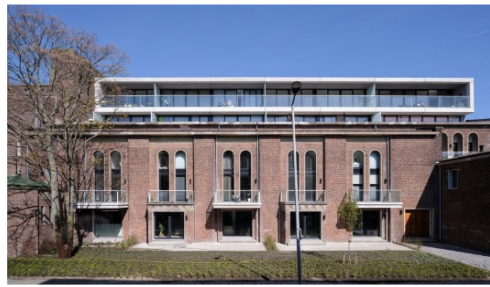
Case Study: **Baumannkerk, Rotterdam**
 Architect: HOYT
 Area: 4205 m² (+ 492 annex)
 Program: Apartments & retail
 Finished: 2020
 Usage period: 50 years (assumption)
 Assembly: largely wet & mechanical connections

Was built in 1953,

Embodied CO2 - 50 years: 175 kg eg/m2
 The MPG at an assumed lifespan of 50 years is 0,422, which is a high score compared to the Grote Kerk but similar to the Laurentiuskerk. The use of a large amount of concrete mainly contributes to this score. Although concrete has a very long lifespan, which can be extended with inspections and maintenance what is sustainable if it remains as it is, the structure cannot be changed or taken apart without demolition. Using long-lasting natural materials could have made the MPG even lower. The structure could have easily be made out of timber to replace the concrete and sand lime stone.
