Non-Destructive Testing for Detection, Localization and Quantification of Damage on Composite Structures for Composite Repair Applications

Proceedings of the 10th International Symposium on NDT in Aerospace

Keywords: automated composite repair, NDT, laser line scanner, thermography.

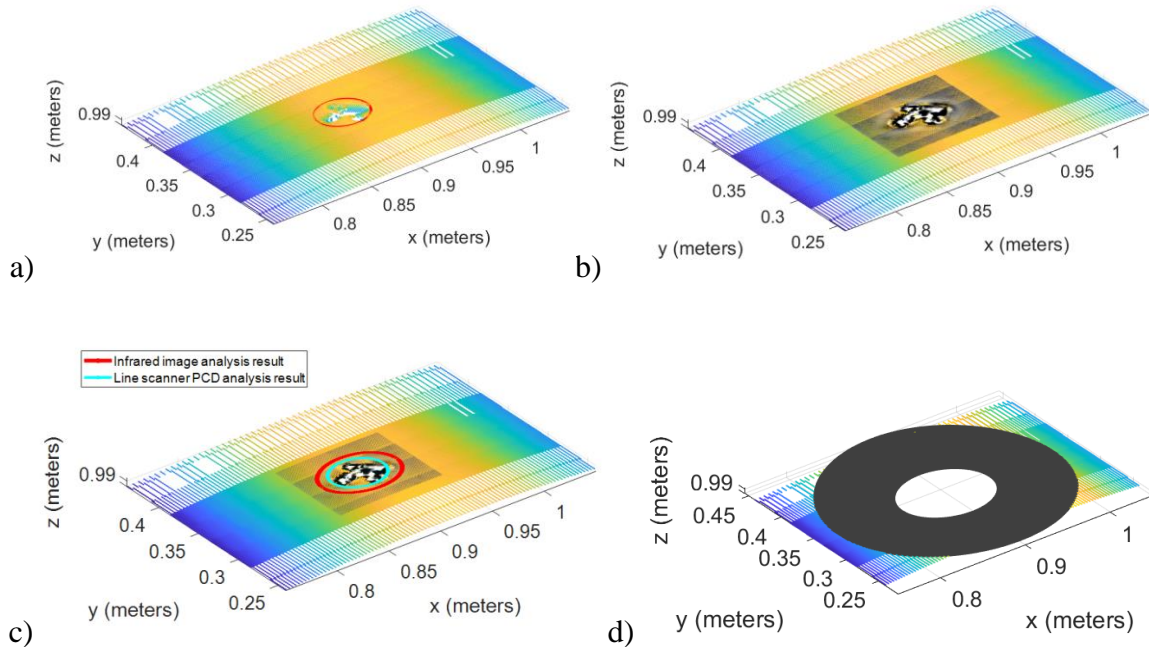
Fig. 8. a) Damage region detected by analyzing the laser line scanner PCD, b) infrared image processed and converted to the laser line scanner PCD coordinate system, c) infrared image and laser line scanner based damage region comparison and d) cut-out profile model generated by the algorithm.

The damage localization algorithm was used to determine the damage location and size by analyzing the laser line scanner data and the infrared image. In case of the laser line scanner, the algorithm analyzed the PCD that lie between x-values of 0.7505 m and 1.049 m, and y-values of 0.24 m and 0.44 m. Whereas, the data range analysis for the infrared image was performed for: x-values between 0.8473 m and 0.9459 m, and y-values between 0.2977 m and 0.3794 m. Fig. 8 (a) shows the damage region, with a maximum x-length of 48.9 mm and a maximum y-length of 41.1 mm, detected by analyzing the PCD obtained

from the laser line scanner. The algorithm then performed the conversion of the pixel information obtained using the thermographic inspection to PCD information with respect to the laser line scanner PCD information, as shown in Fig. 8 (b). In Fig. 8 (c), the damage region detected by analyzing the infrared image is compared with the results obtained by analyzing the laser line scanner data. Moreover, it can be seen that the thermographic inspection detects a larger damage area than the laser line scanner, as the damage detection algorithm determines the damage to be 22.4 mm and 12.3 mm longer in the x and y-directions, respectively.
