TOWARDS AN EVERLASTING ARCHITECTURE

Lorenz Eschke

ABSTRACT

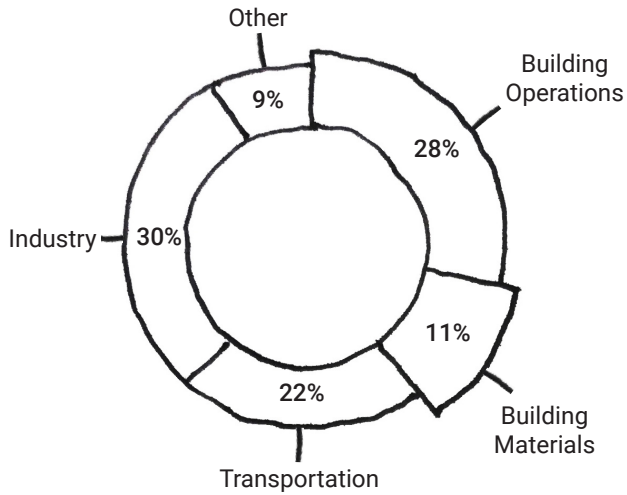
Fig. 1
Emissions by Sector

Global CO² Emissions by Sector

The construction industry plays a significant role in causing the climate crisis, accounting for 39% of global carbon emissions per sector (Fig. 1). Of this, the so-called operational carbon (OC) is the larger part with 28%. The OC is emitted during the service life of buildings through use (e.g. heating, electricity, etc.). With 11%, embodied carbon (EC) is a smaller but no less important share. It describes the carbon footprint of the building materials used. (UNEP & IEA, 2017)

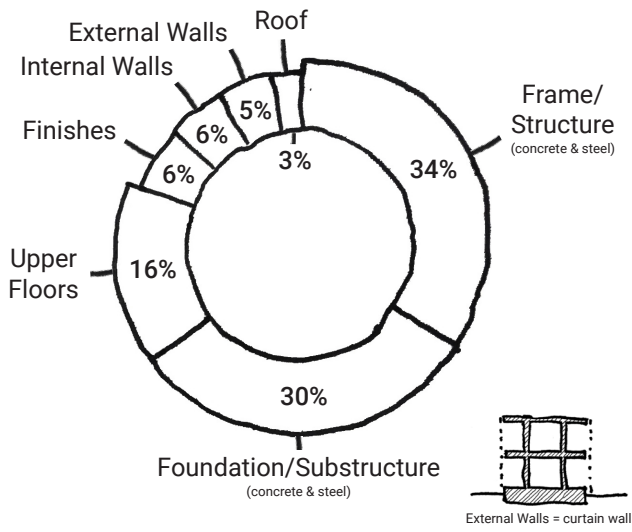
Fig. 4
Case Study Office Building

Case Study 1 - Office Building

In 2018, a residential building complex in the UK was investigated regarding the embodied carbon distribution (Fig. 5) and compared to an earlier case study (Fig. 4). The authors used the division into frame, substructure, external walls, upper floors, finishes, roof and internal walls. These categories are based on the RICS definition of building components. (RICS, 2012) A brief definition is to be found in Table 5. It is important to mention that in Case Study 1 and 2 not 100% of all components could be considered because data was not available or could not be determined. Especially the building services (sanitary-, electrical-, ventilation-, disposal installations etc.) are excluded.

Case Study 1 from 2015 examined an office building. The three largest CO₂ emitters were the categories frame, substructure and upper floors. They accounted for 80% of the total embodied carbon. Case Study 2 of an apartment building looks slightly different. Here, the external walls are added as a carbon hotspot. Frame, substructure, external walls and upper floors contribute to 83% of the EC. (Fernando et al., 2018) The difference in the external walls in both studies can be explained by the fact that Case Study 1 has a curtain wall, while the external walls in Case Study 2 are load bearing. The authors M. Victoria and S. Perera conducted a third study in 2018, based on the initial one in 2015 (Fig. 6). For this, they analysed the EC in 41 office buildings. The number of different buildings makes the study much more representative for office buildings in general. In addition, more data was collected regarding the services. The result is astonishing: the CO₂ emitters from high to low are as follows: substructure, services, frame, upper floors, external walls, finishes, roof, 'rest' (External Windows and Doors, Stairs, Internal Doors, Fittings and Furnishings), internal walls. (Victoria & Perera, 2018)

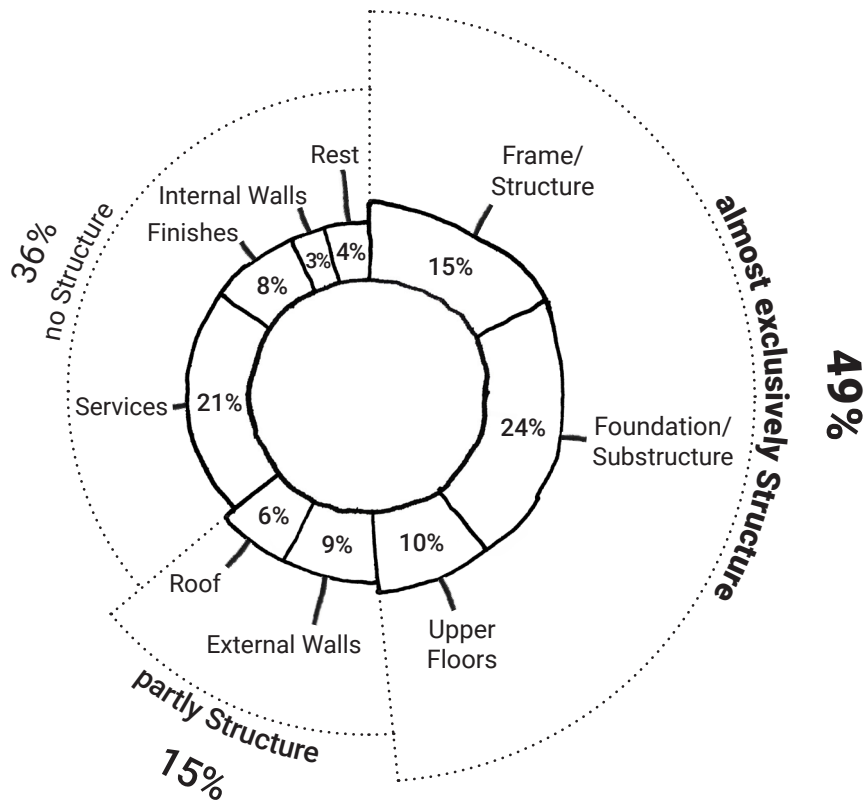
Fig. 6
Case Study Office Buildings

Case Study 3 - 41 Office Buildings

The studies show very well which component categories often have a high EC. Nevertheless, the distribution is of course different from case to case and varies greatly. It is striking that the categories that consist almost exclusively of the load-bearing structure (frame, substructure, upper floors) play a very large role with 49% (Fig. 6). External walls and roofs, which at least partially include structure, are responsible for another 15% EC. The largest part that does not contain any structure is, as mentioned, the services, which are also a large factor in the recurring EC. The biggest potential to save EC in either way lies in these categories.
