Preservation through Adaptation

Revitalising St Barbara church with a focus
on preservation and choice of materials

How can a vacant church be redesigned in a way that it can accommodate different demands for use now and in the future through a Minimal Waste approach?

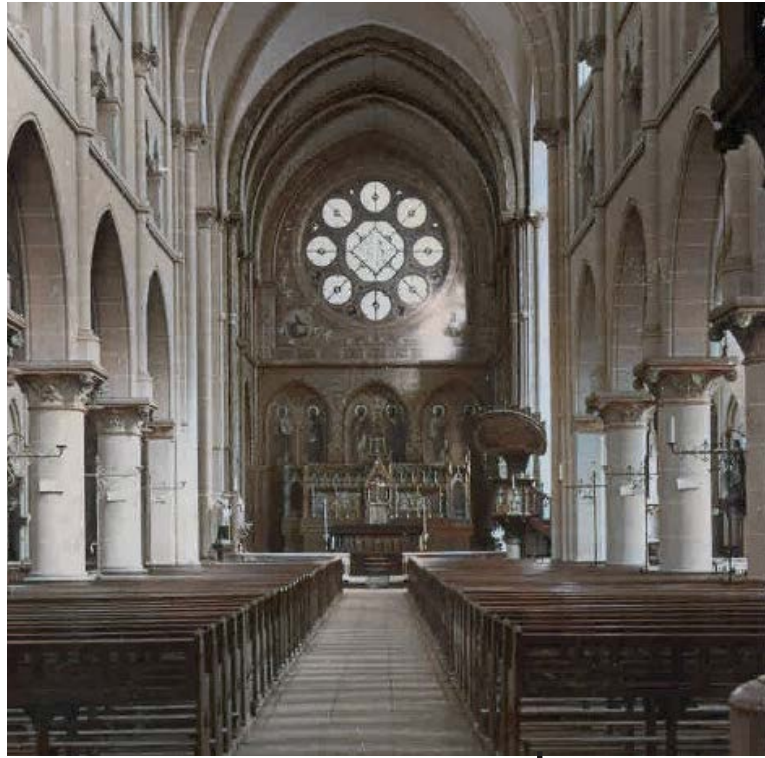
polychromy and beige interior

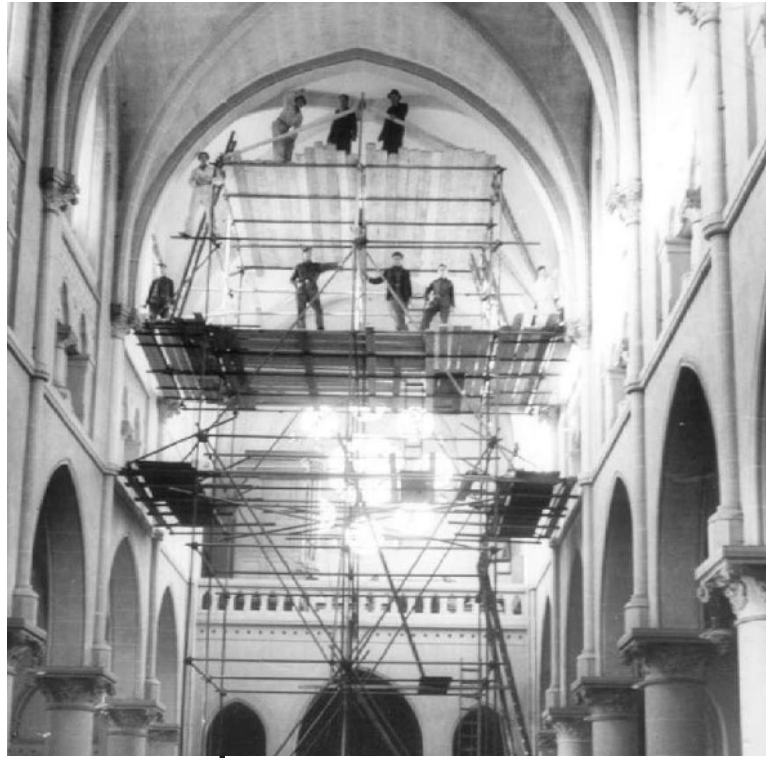
interior is painted over

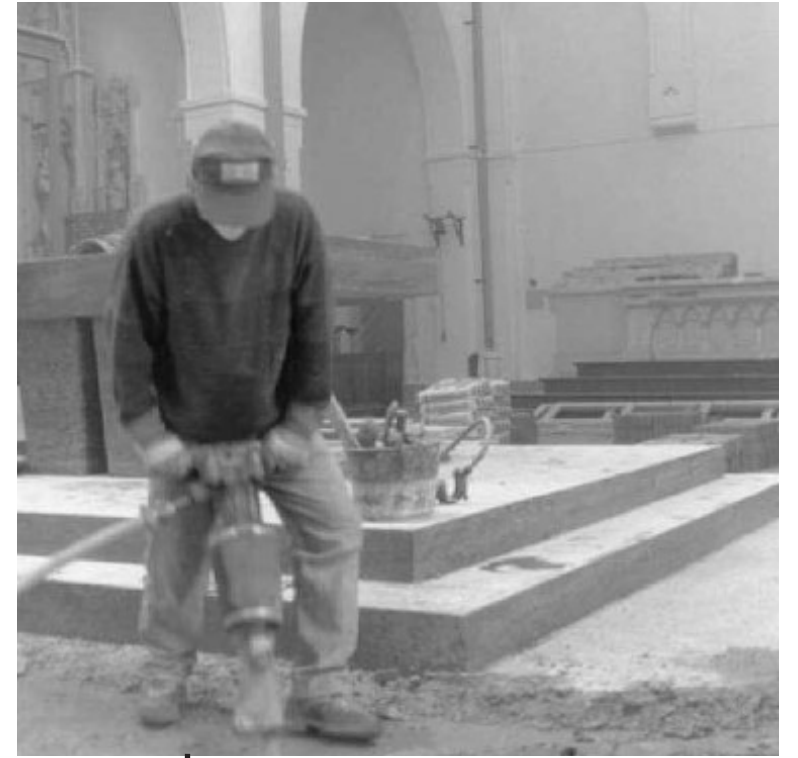
ground floor is replaced

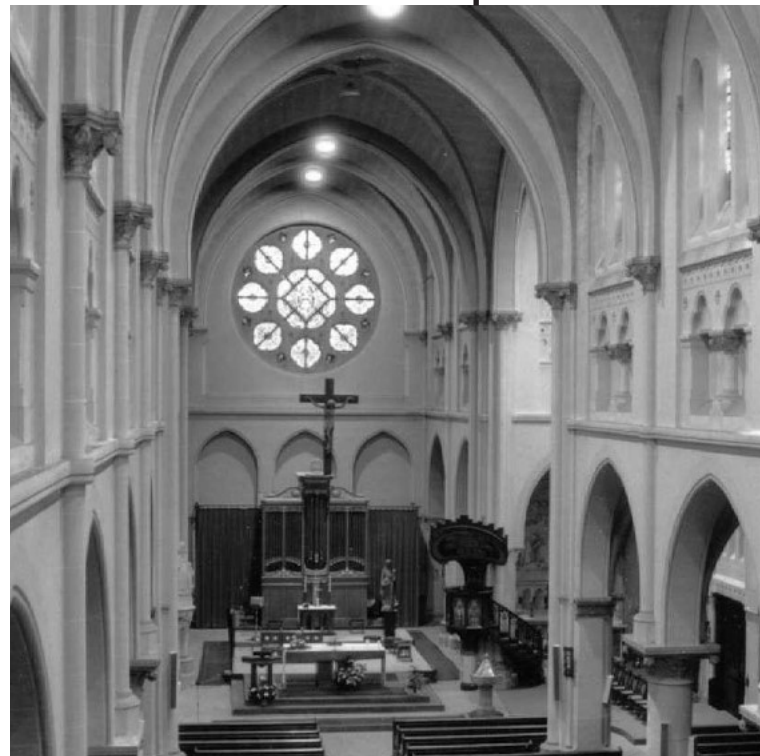
interior is painted over again

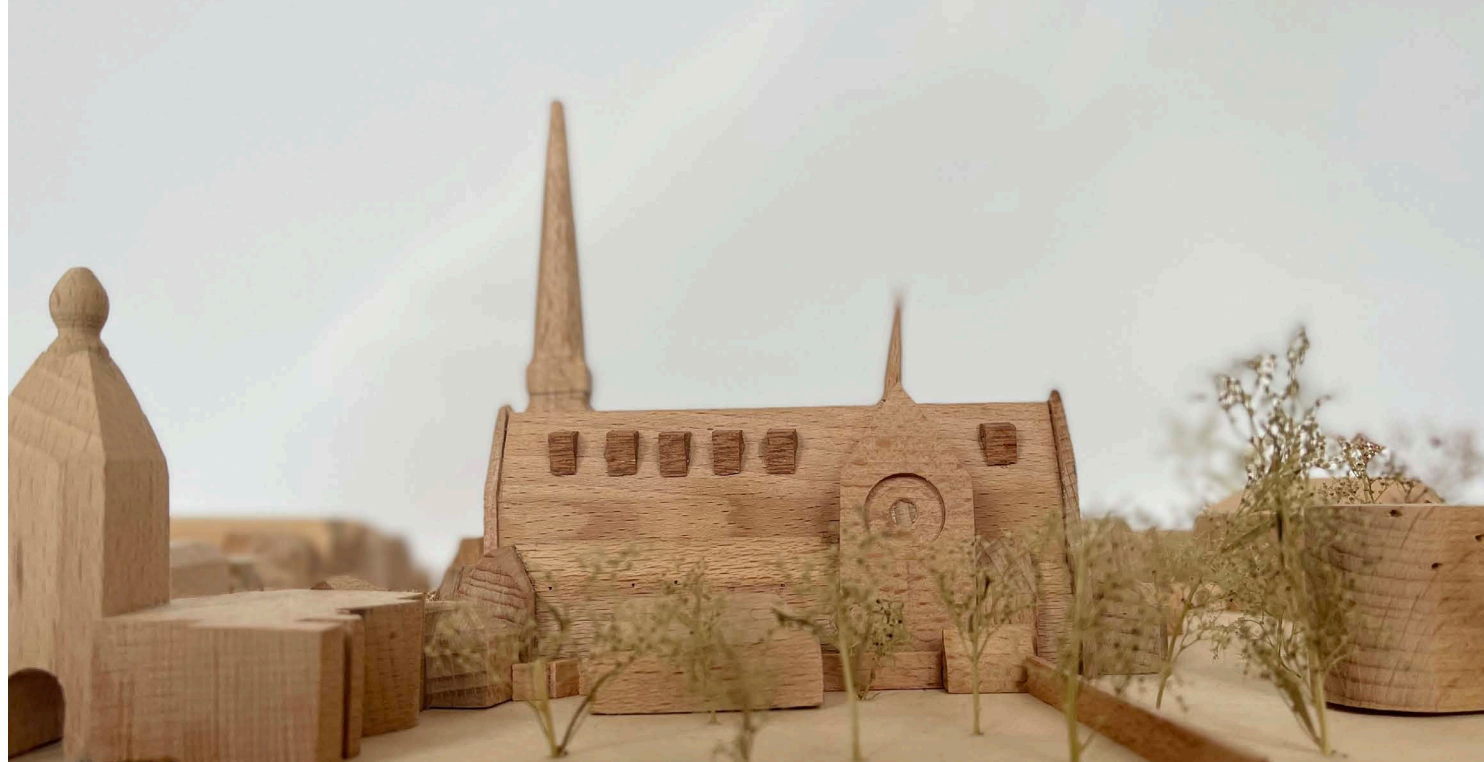
Two Sided Concept

South West Side
preserve & small interventions

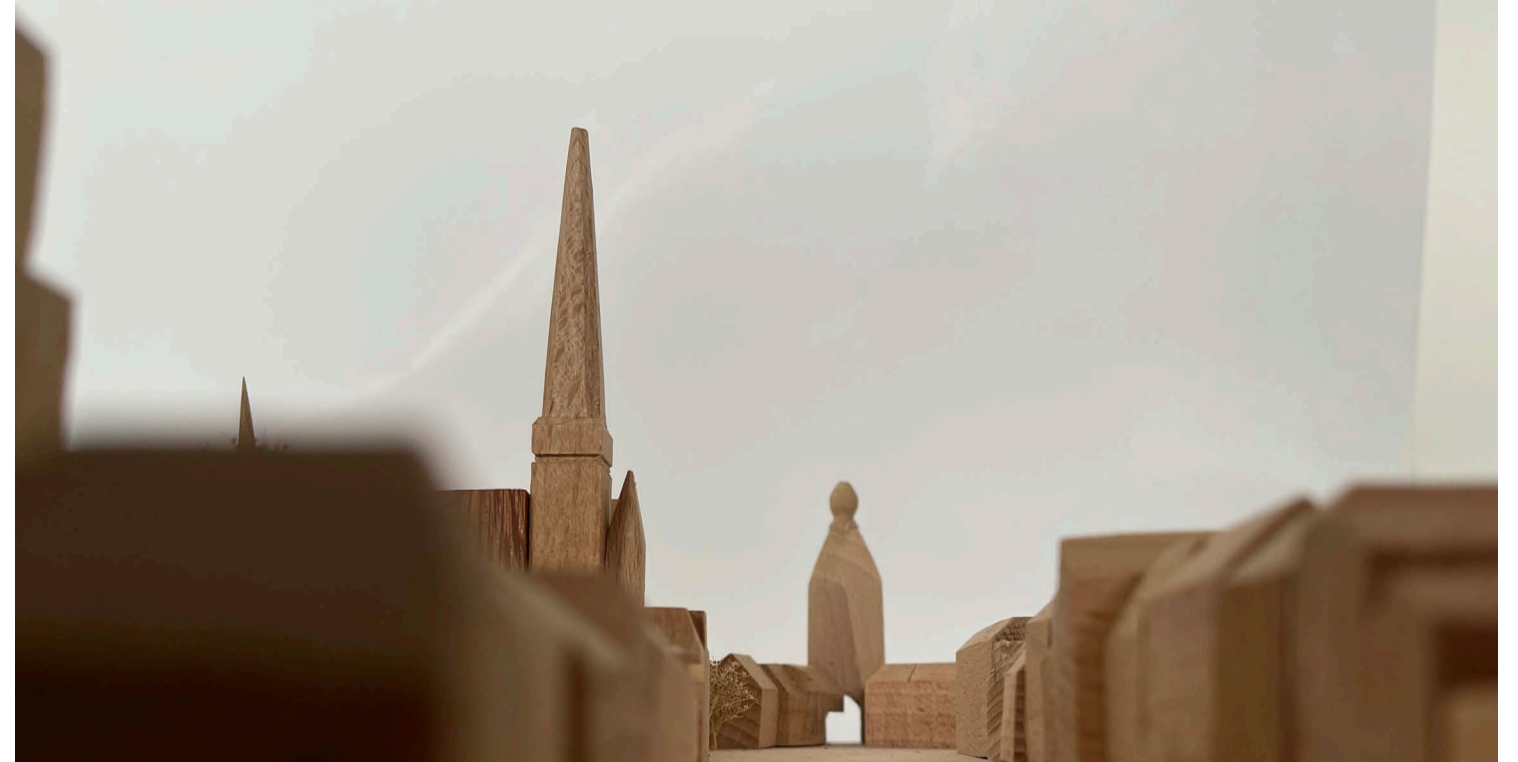
North East Side
space for expansions

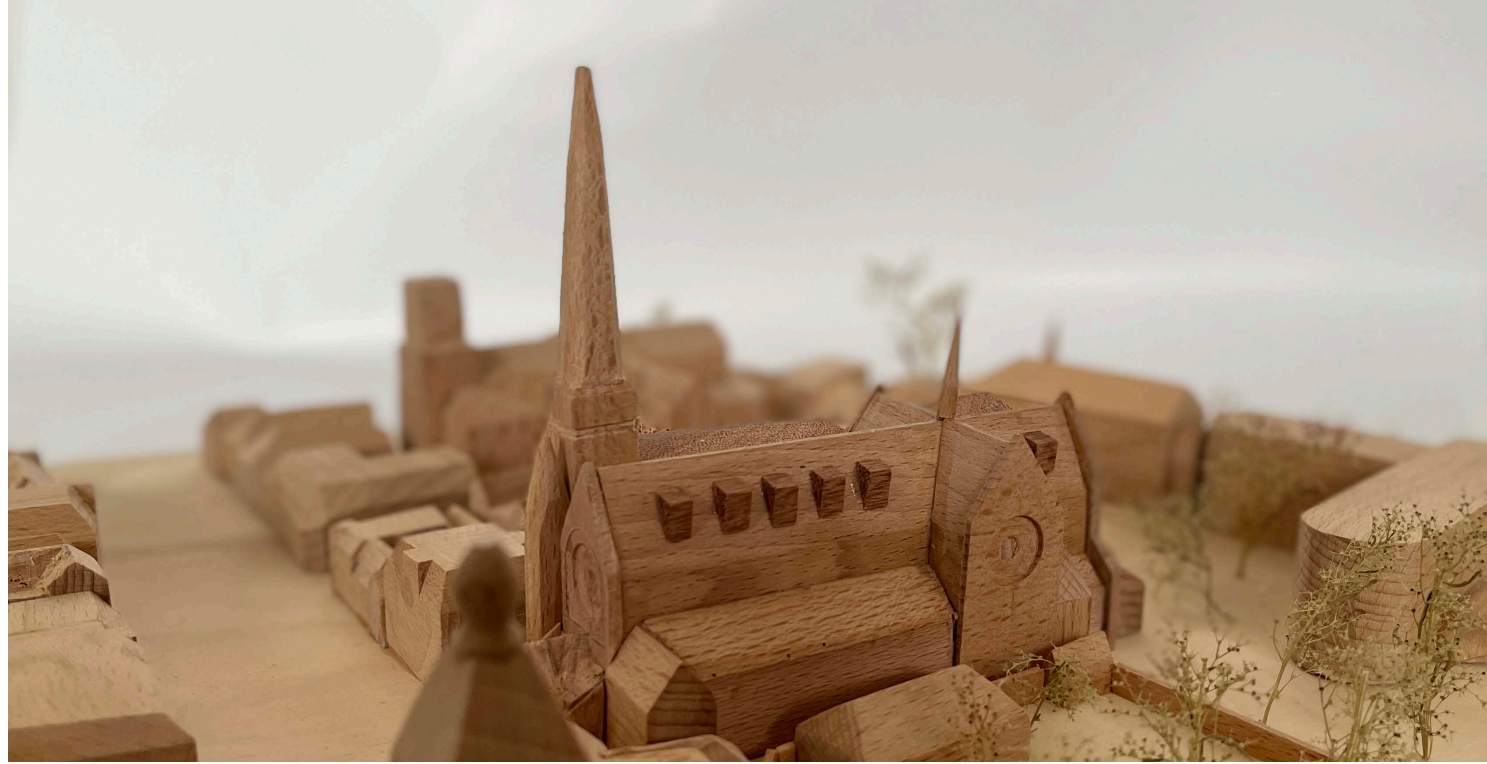
Two Sided Concept

South West Side
preserve & small interventions

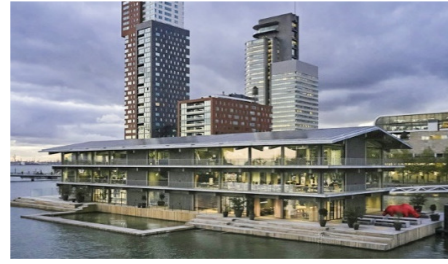
Case Study: **FOR, Rotterdam**
 Architect: Powerhouse Company
 Area: 3564 m²
 Program: Offices & restaurant
 Finished: 2021
 Usage period: 50 years (assumption)
 Assembly: largely dry & mechanical connections

Conclusion
 Embodied CO2 - 50 years: 279 kg eg/m2
 The MPG at an assumed lifespan of 50 years is 1,040 which is higher than the currently permitted score of 1,0, a longer lifespan would be appropriate. Partly due to the amount of concrete and all the PV panels, ventilation units and air conditioning units that need to be replaced during use, the score is so high. Perhaps replacing the air-conditioning ceilings with air heating and cooling, since mechanical ventilation is used anyway, will ensure less replacement of components. Noteworthy are the very low scores of the applied materials in timber, this is due to its renewable raw material and long lifespan. Much of the material is remountable and has a long lifespan, leading to many possibilities for reuse. Without the concrete floating foundation and the PV-panels is the MPG score of 0,375, which clearly shows the potential of building with a lot of

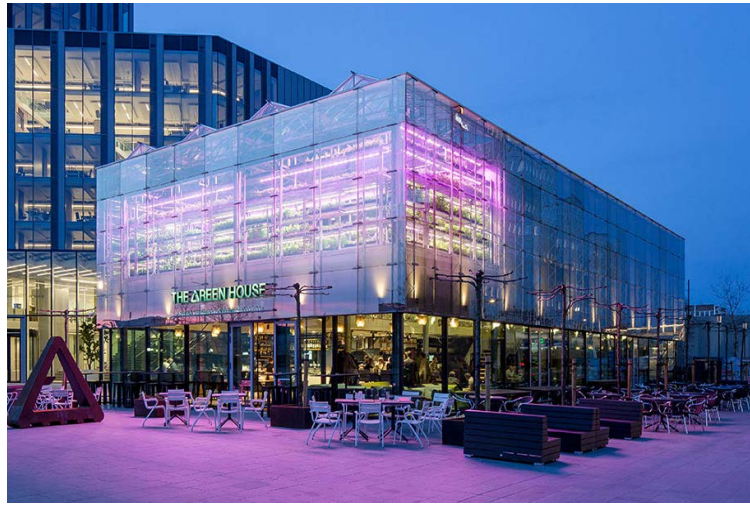
The Green House | 2018

MPG 15 years: **1,110**
Reusable elements: **22/26**
Embodied CO₂: **237** kg eq/m²

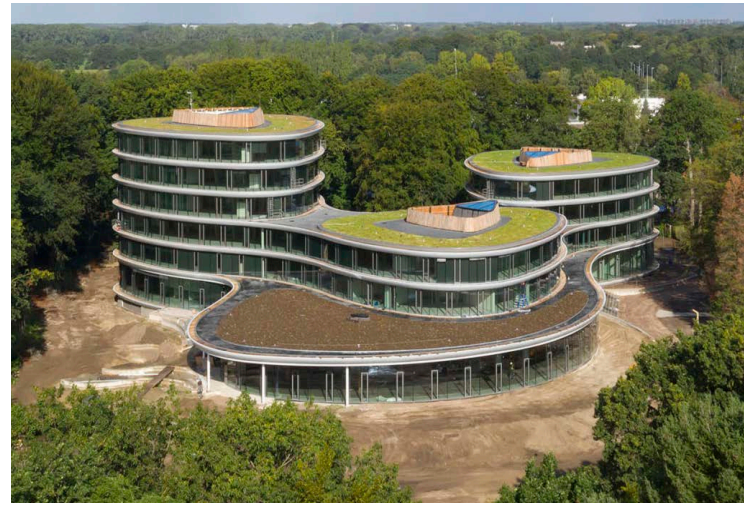
Triodos Bank | 2019

MPG 50 years: **0,567**
Reusable elements: **18/32**
Embodied CO₂: **175** kg eq/m²

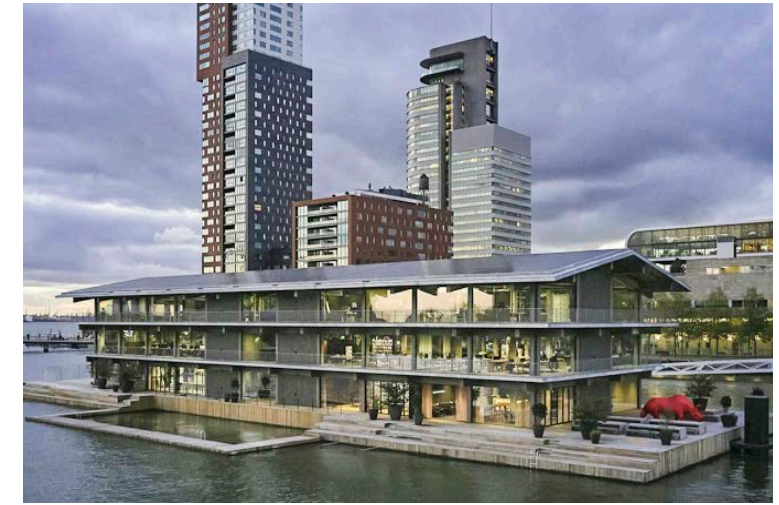
FOR | 2021

MPG 50 years: **1,040**
Reusable elements: **21/27**
Embodied CO₂: **279** kg eq/m²

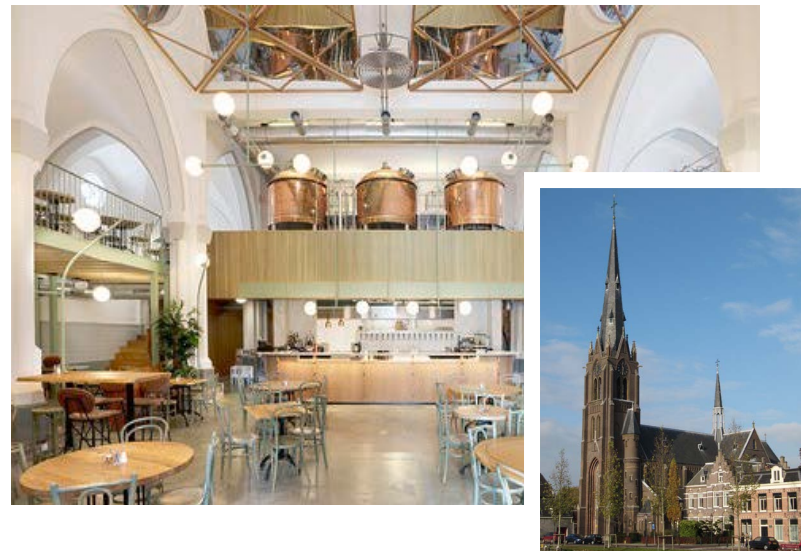
Laurentiuskerk | 2020

MPG 50 years: **0,409**
Reusable elements: **17/26**
Embodied CO₂: **167** kg eq/m²

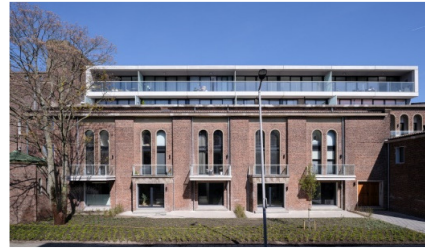
Case Study: **Baumannkerk, Rotterdam**
 Architect: HOYT
 Area: 4205 m² (+ 492 annex)
 Program: Apartments & retail
 Finished: 2020
 Usage period: 50 years (assumption)
 Assembly: largely wet & mechanical connections

The MPG at an assumed lifespan of 50 years is 0,422, which is a high score compared to the Grote Kerk but similar to the Laurentiuskerk. The use of a large amount of concrete mainly contributes to this score. Although concrete has a very long lifespan, which can be extended with inspections and maintenance what is sustainable if it remains as it is, the structure cannot be changed or taken apart without demolition. Using long-lasting natural materials could have made the MPG even lower. The structure could have easily be made out of timber to replace the concrete and sand lime stone.

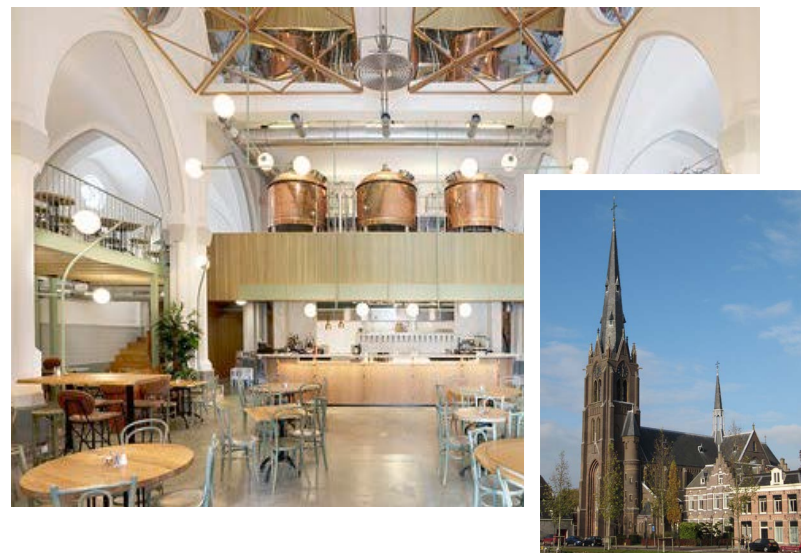
Laurentiuskerk | 2020

hardly any biobased materials have been used
