**Experimental and computational study of the influence of pre-damage patterns in unreinforced masonry crack propagation due to induced, repeated earthquakes**

Proceedings of the Thirteenth North American Masonry Conference

<b>Keywords:</b>	Unreinforced Masonry, Induced Seismicity, Light Damage, Damage Aggravation, Crack Propagation

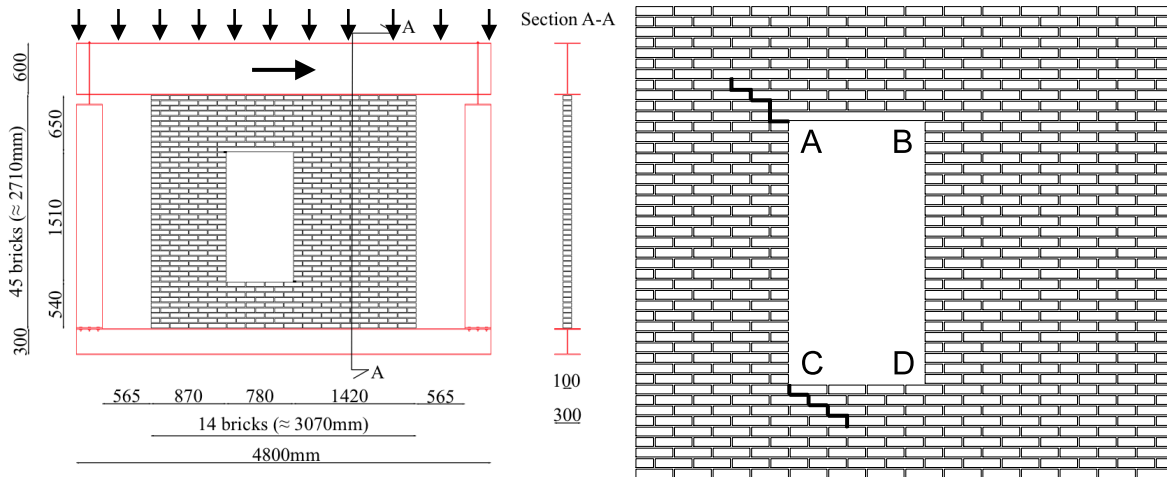
Figure 1. Left, geometry of the masonry wall. Right, position of plastic strips to simulate pre-damage on window corners A and C.

A single-wythe masonry wall built with baked-clay bricks in a running bond and having an asymmetrical window opening is used as the main case of this study, see figure 1. The specimens are built to match four walls of identical geometry and material previously tested that are used as benchmarks against which comparisons are drawn. An elaboration of the selection of the material and geometry of the walls is provided in Korswagen et al. (2019). Briefly, the combination of brick and mortar were chosen to

Two identical specimens of the wall described (designated TUD-Comp45 and Comp46, with ‘Comp’ indicating ‘component’) are experimentally tested in this study. The walls are pre-damaged by means of reduced bond at specific joints. The reduction in bond is accomplished by placing strips of PVC at the moment of construction. The strips run along predefined joints simulating the presence of an open crack. The bond between the mortar and the plastic was determined by a series of bond-wrench tests where the bond area between the bricks was reduced by incorporating different ratios of PVC. From these tests, the bond strength of the plastic to the mortar was keyed at around 0% to 5% of the bond between brick and mortar, hence adequately replicating an open crack. The position of the strips is illustrated in Figure 1 and was chosen to mimic uneven settlement damage on the wall, where the right side of the wall settles more than the left. The precise position of ‘cracks’ was determined by a combination of finite element models and review of damage cases, see Figure 2.

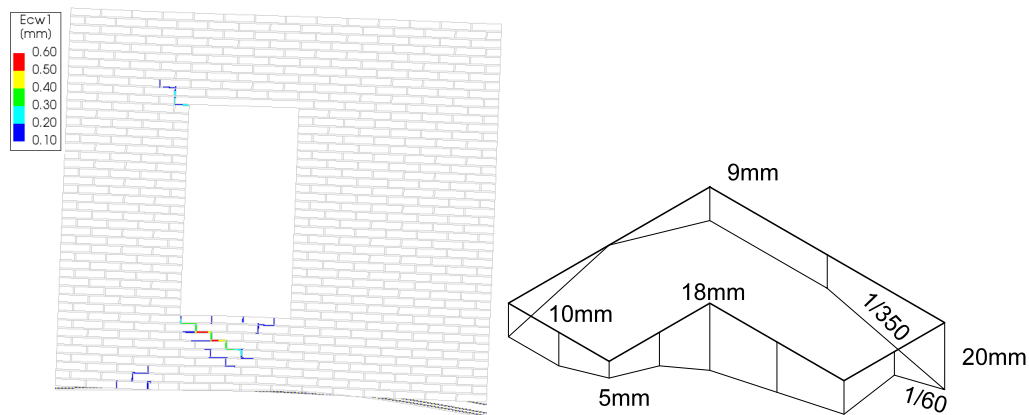
Figure 2. Left, crack width plot of a computational model. Right, example of measurement of bed-joint levelling to determine a settlement configuration which could resemble the employed settlement.

Concrete and steel materials (for lintel and beams respectively) are modelled as linear elastic ( $\rho=2.4 \text{ ton/m}^3$ ,  $E=31\text{GPa}$ ,  $\nu=0.2$ ;  $\rho=7.85 \text{ ton/m}^3$ ,  $E=210\text{GPa}$ ,  $\nu=0.3$ ). Furthermore, to model the reduction in bond of the joints of the two specimens (see Figure 2), weak spots resembling the pre-damage are modelled (dark

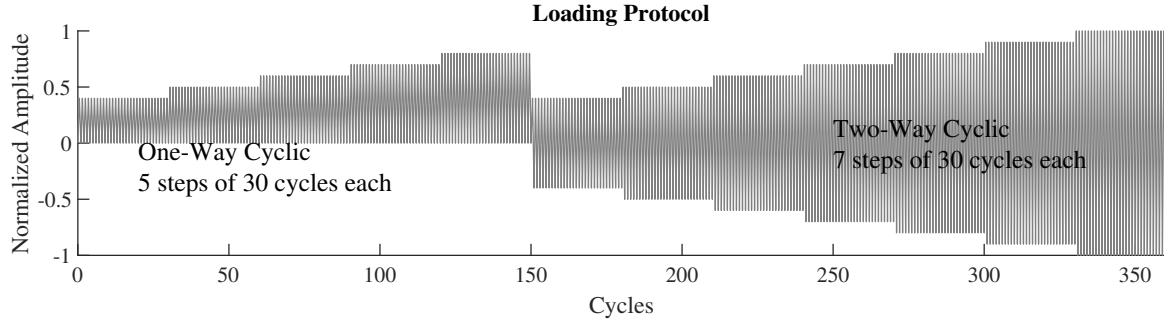
Figure 3. Loading protocol with a high number of small cycles.

The walls were subjected to an overburden of 0.12MPa during the test, representing a moderate gravity load. The specimens were attached to the testing setup at the bottom and fixed to a top steel beam that was free to rotate but whose horizontal displacement (in the plane of the walls) was prescribed. See Messali et al. (2017) for additional details on the test setup. The walls were then subjected to a step-wise increasing top lateral displacement (drift). The loading protocol consisted of five one-way cyclic steps of 30 cycles each and seven two-way cyclic steps also of 30 cycles each for a total of 360 cycles with a maximum drift of 0.75‰; this is illustrated in Figure 3.

Three load cases are applied: dead load, overburden, and in-plane displacement-controlled loading. The displacement protocol is the same as the one employed in the experiment (see Figure 3), albeit with a reduced number of cycles per step, since the material model does not include force degradation for one-way cyclic loading; therefore, only one repetition per step is applied. Efforts to include strength degradation in the composite material model are underway, see Bindiganavile (2018).

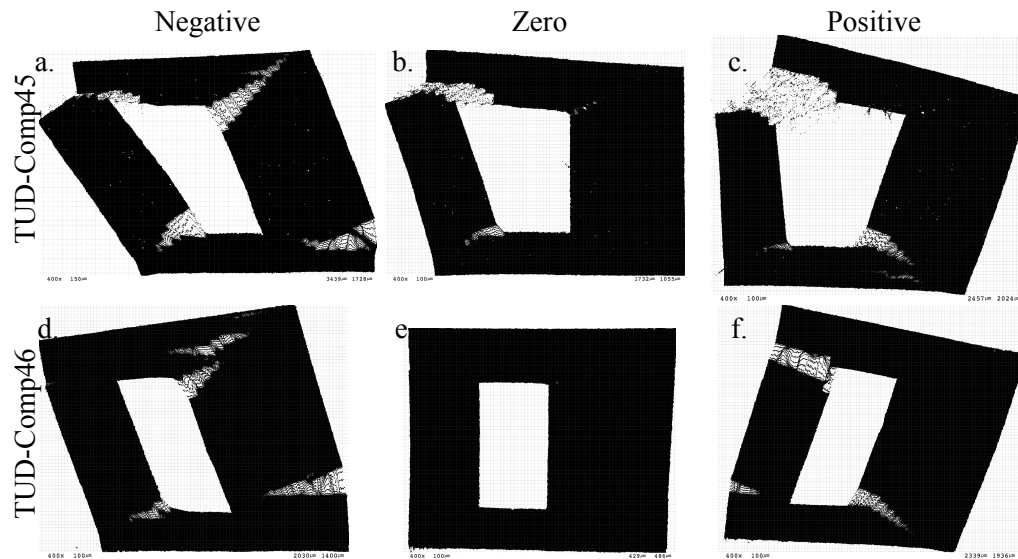
Figure 4. Magnified (400x) deformed shape plots captured using DIC for a negative, zero, and positive drift towards the end of the test (after 300 cycles) for walls Comp45, top, and Comp46, bottom. Note the full detachment of the left pier of Comp45 at this stage.

The behaviour of both pre-damaged walls was partly influenced by the existing crack. While the bottom pre-damaged joints seem to contribute little to the crack development, the weakened joints at the left top corner of the window did influence the crack growth. Especially for the first wall, Comp45, where a full opening and detachment of the left pier was observed with a crack of up to 2mm in width towards the end of the test. See Figure 4c. This also led to reduced hysteresis in comparison to the second wall as evidenced by a more narrow ‘neck’ of the cyclic force-displacement curve presented in Figure 5.

When observing the damage parameter  $\Psi$ , a relationship can be traced between the drift to which the walls are exerted to, and their damage intensity. Figure 7 shows that at larger drift values, increased damage is also expected. A power fit is applied to the data outside of the axes (non-zero damage and non-zero drift). For the walls without pre-damage, the curves appear closer to linear fits, while for the walls with pre-damage, the fits have a stronger curvature. Note that the fits do not consider the fact that damage increases at the same value of drift (strength degradation and damage aggravation), and are thus approximate fits. Nonetheless, it would seem that, walls with pre-damage (Comp45 and Comp46) display more severe damage at lower drift values but equalise with the rest of the walls at higher drift values. Note also that pre-damage walls have a significantly higher number of points on the vertical axis, showing detectable damage at zero drift. Additionally, the case of Comp45 where the left pier detached completely from the top of the wall, displays a clear increase in damage in the positive direction. In the negative direction, the damage decreases between 0.4‰ and 0.5‰ before increasing again; this is likely related to the significant amount of sliding occurring at the top of the left pier which closes the crack at the bottom of the left pier, but later contributes to opening it further as depicted in Figure 4a.

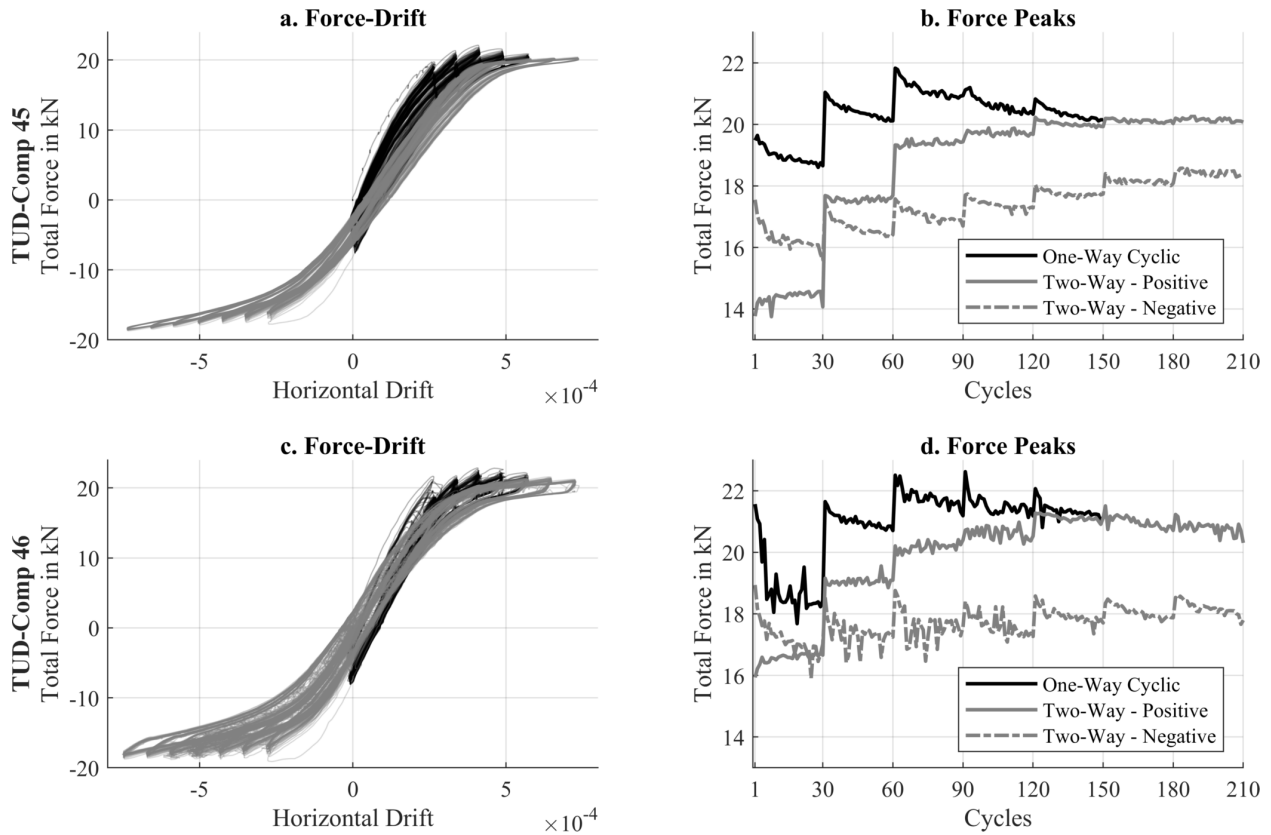
Figure 5. Force-Drift (displacement) plots for pre-damaged walls, including the progression of force peaks during the test. Top, Comp45; bottom, Comp46.

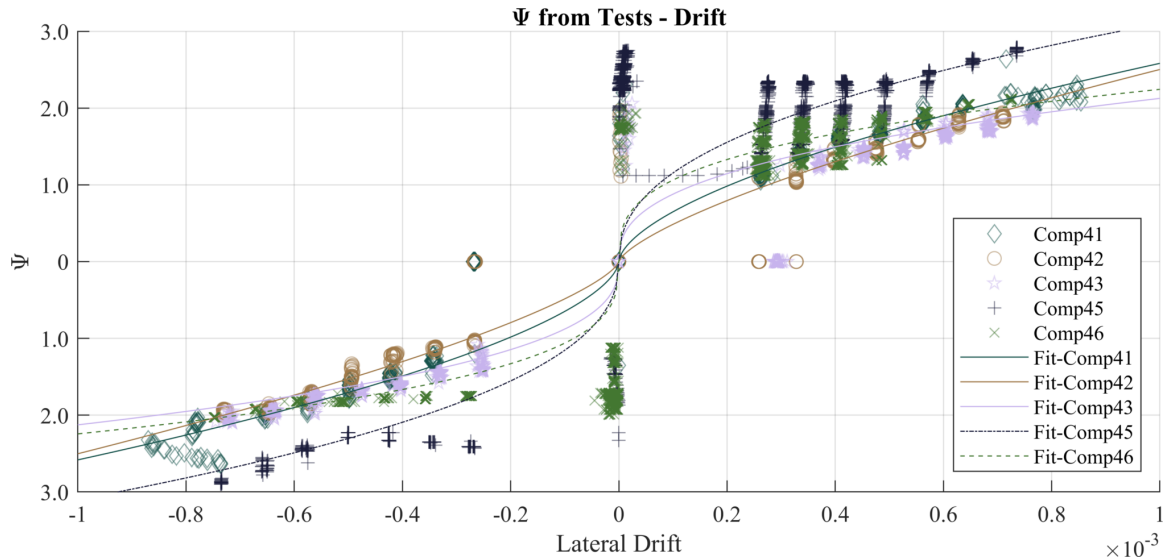
Figure 7. Damage parameter  $\Psi$  against values of drift for five walls, two of which (Comp45 and Comp46) were pre-damaged.

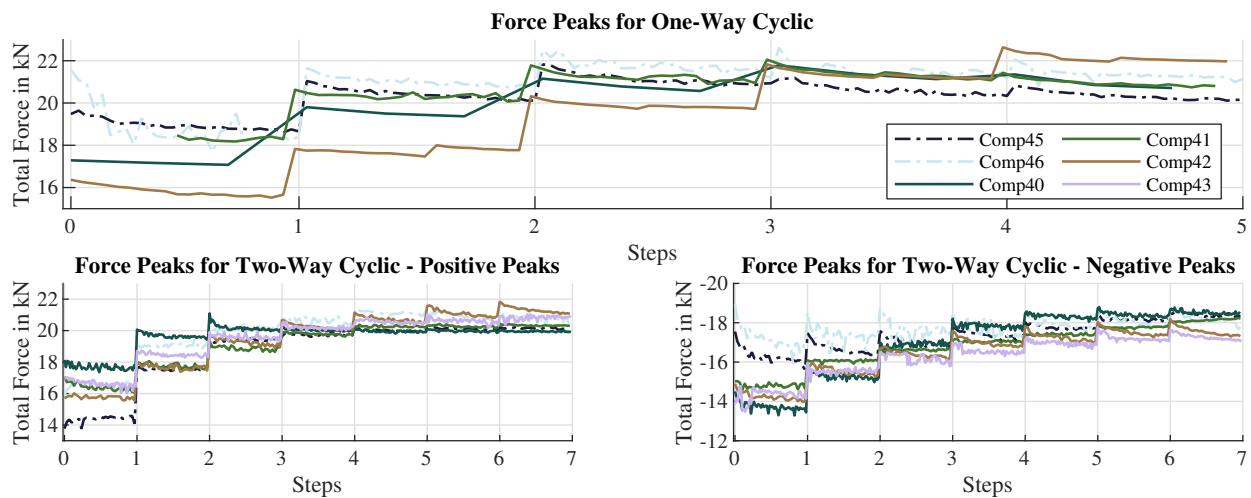
Figure 8. Comparison of force degradation during the tests.

In terms of force degradation, no significant differences can be observed between the virgin and the pre-damaged walls. In Figure 8, the strength degradation during the multiple cycles only reveals that towards the end of the test, the pre-damaged walls do not display much degradation whereas the virgin walls (in particular Comp42) do show a decline in force.

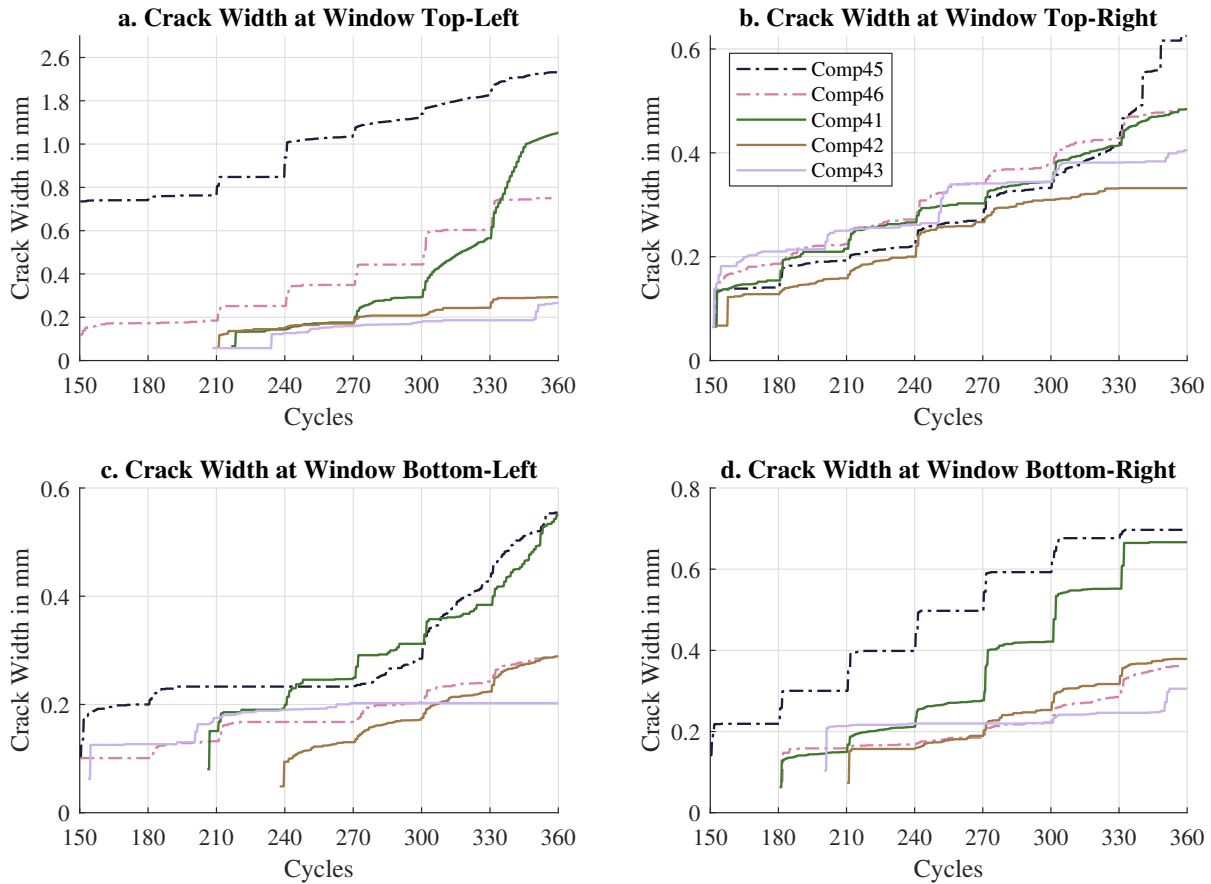
Figure 9. Comparison of crack width as detected by DIC for the two pre-damaged walls (Comp45 and Comp46) and the non-pre-damaged walls, for the four corners of the window during the two-way cyclic portion of the test.

The higher damage of Comp45 is also visible in Figure 9, where the width of the four cracks at the window corners is compared for the two-way cyclic portion of the test. In Figure 9a, the crack for Comp45 is significantly wider than the same crack for the other cases. The second pre-damaged wall, Comp46 also shows increased crack-width, evidencing that for the crack at the top left window corner (from here on, crack a), the pre-damage has had an influential effect. This is reasonable, since this crack was partly pre-damaged (see Figure 2), and the failure mechanism related to the in-plane lateral loading fosters the crack propagation over the pre-damaged joints. Conversely, the crack at the bottom left

window corner (crack c, Figure 9c) does not display unusual width; in this case, the pre-damaged joints trigger the presence of a crack but do not seem to affect its propagation as the crack travels in a different direction (see Figure 9). In fact, the cracks at the left corners of the window (a and c) are not part of the same failure mechanism (see Figure 4) but appear to be related when significant sliding occurs at the top of the pier. Comp41 also shows a large crack width at the top of the left pier (a) which is evidence of a full detachment of the pier towards the end of the test; then, the crack width at the bottom of the pier (c) grows accordingly. Moreover, the crack at the bottom right corner of the window (d), which is related to the mechanism that causes crack a, does mimic the behaviour seen in Figure 9a. Finally, for the crack at the top right corner of the window (b), no influence of the pre-damage is evident.

Figure 9 compares the crack width during the two-way cyclic portion of the tests. This means that all the walls had been partly pre-damaged during the repetitive portion of the test; hence, Figure 10 looks at the one-way cyclic portion of the test. Here, only two cracks are compared as the other window corners are not engaged in the positive drift direction (see Figure 4f). In this figure, both pre-damaged cases develop cracks earlier than the virgin walls. Moreover, the width of crack “a”, a pre-damaged crack, is noticeably higher in the case of the pre-damaged walls, even before the pier detachment of Comp45 takes place.

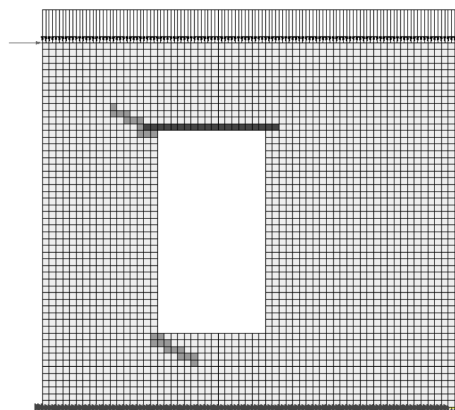
Figure 11. Finite Element Model of TUD-Comp 45 and 46 with 'weakened' elements.

The pre-damaged, in-plane loaded, baked-clay, brick masonry wall with an asymmetric window is modelled with 2D plane stress elements. The wall is 3050mm wide and 2700mm high with a thickness of 100mm. The opening is 800x1500mm and is placed 550mm from the bottom edge and 900mm from the left edge. The concrete beam above the window opening is modelled with a dimension of 1000x50mm. Both wall and lintel are modelled using 8-noded quadratic elements with a mesh size of 50x50mm. The integration scheme is set to 3x3 points per element. The top and bottom steel beams of the set-up are also modelled. One-dimensional beam elements having 3-nodes are employed. The two lines are placed at the top and bottom edge of the wall; as cross-section, HEB-600 and HEB-300 geometries are assigned, respectively. The top boundary condition is cantilever, thus allowing the top of the wall to rotate and displace vertically. Hence, only the bottom beam base is constrained in both horizontal and vertical directions. Before applying the in-plane top displacement to the wall, a vertical uniform load is applied as a line load on the top wall edge to simulate the 0.12MPa overburden. The mesh view of the DIANA model is shown in Figure 11.

grey elements in Figure 11). For these elements, half of the wall elastic properties are used. Moreover, no tensile strength is assigned to the material, since the plastic strips replicate an open crack. A shear resistance that accounts for the brick-PVC interaction is assigned to the weak spots (see Table 2). Accordingly, a non-linear material model is employed for both damage and non-damaged clay masonry. This allows to study the phenomenon of cracking in detail. As constitutive model, the Engineering Masonry Model with the diagonal stair-case option is used. This material model considers the orthotropic behaviour of the masonry, non-linearities in tension, shear and compression, and specific, different unloading/reloading characteristics according to experimental observations. Detailed information about the material model can be found in Schreppers et al. (2017) and Rots et al. (2016). The properties of clay masonry are partly taken from small companion tests and partly calibrated from the in-plane wall experiment results. A summary of the properties for both virgin and pre-damaged material is shown in Table 2. Physical non-linearities are considered in the model. A quasi-Newton (secant) approach is selected as iteration method. Either a force norm, with a tolerance of  $10^{-2}$ , or an energy norm, with a tolerance of  $10^{-4}$ , need to be satisfied for the equilibrium calculation. The Parallel Direct Sparse method is used to solve the system of equations. A tolerance of  $10^{-8}$  is here for employed.

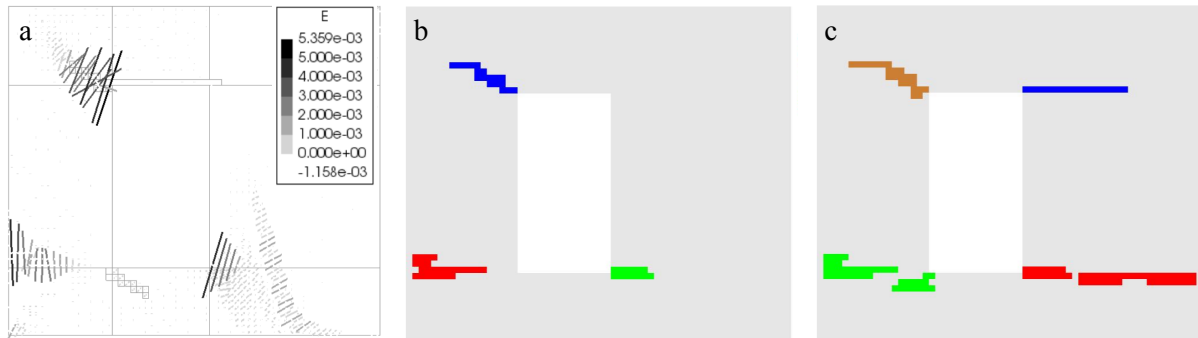
Figure 12. Left (a) Tensor plot of positive principal strain for a drift value of approximately to 0.4%. Right, Crack pattern of the FEM wall model (b) after the one-way cyclic and (c) at the end of the protocol.

When modelling the wall, strains focus at the foreseen crack locations and reveal the intended crack path during positive drift. This is illustrated in Figure 12a where the strain tensors are drawn. The final cracks comprising the crack location, width and length of the pattern produced by the FEM are depicted in Figure 12. As for the experimental results, cracks are evaluated from and to a cutoff width of 0.1mm and span a minimum length of 100mm. After the one-way cyclic protocol (Figure 12.b) three main cracks are detected: a rocking crack starting from the left edge at the height of the window, the opening of the pre-damage wall part at the top left corner of the window, and another rocking crack at the bottom right

corner of the window. At the end of the protocol (Figure 12.c), a rocking crack in the bed joints located in the larger pier at the top (right) window corner also occurs. These cracks are similar to those of the experimental test (Figure 6) differing only by the more pronounced stair-case trajectory of the test against the straighter one of the model, illustrated best by the crack at the top right corner of the window.

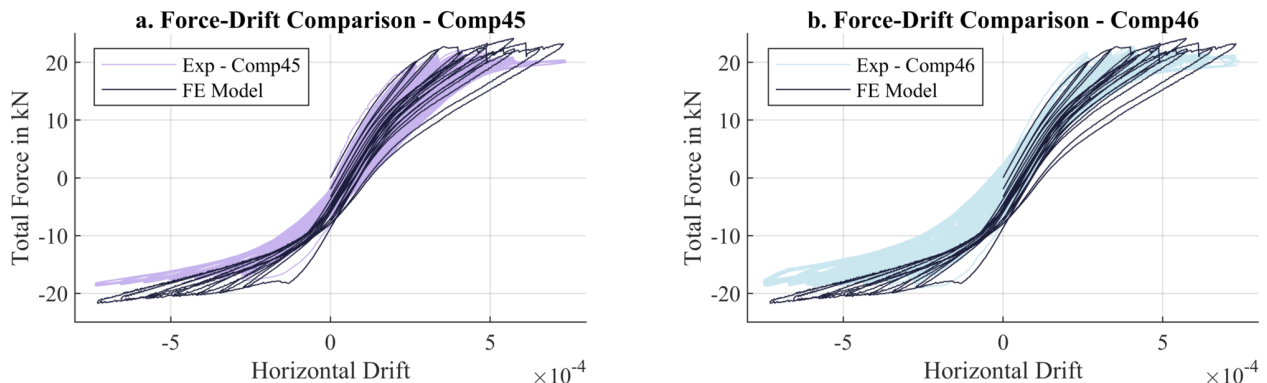
Figure 13. Force-Drift plots comparing the finite element model and the experimental (a) TUD-Comp 45 and (b) TUD-Comp 46 tests.

Next, when plotting the force-drift behaviour (Figure 13), the model looks to be in reasonable agreement with the experiments. Both initial stiffness and positive force are well matched by the model, though the energy dissipation is overestimated in the two last cycles of the positive side. Regarding the negative side of the plots, the force (viewed as absolute value) and the energy dissipation are slightly higher when compared to the wall TUD-Comp 46. For the other specimen (TUD-Comp 45) the experimental hysteretic behaviour is comparable with the FE model.

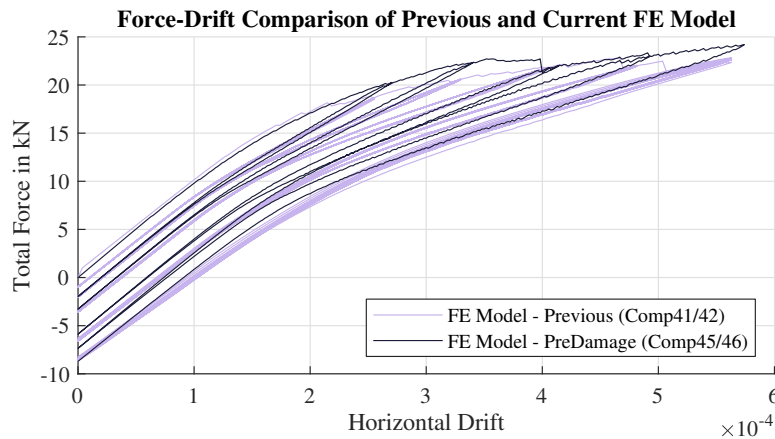
Figure 14. Force-Drift plots comparing the one-way cyclic part of finite element models: TUD-Comp 41/42 vs TUD-Comp 45/46.

Furthermore, the finite element model calibrated only against the virgin walls (as discussed in Korswagen et al., 2019) does not differ significantly from the improved model (Figure 14). The difference between these two models can be found mainly in the modelling of the boundaries and in the material parameters. In the virgin walls only the top stiff beam was modelled using plane stress quadratic elements. A dummy stiffness and cross section was adopted for these elements. In the updated FE model, line beam elements are used to reproduce the rigid beams of the experiment (see Figure 1). Realistic values of stiffness, cross section and eccentricity are given to both bottom and top beam elements. In addition, the converge norm is switched from force or displacement (virgin wall) to force or energy (pre-damaged wall) since the analysis is run under displacement control. From these adjustments, the analysis duration and stability are improved. Ultimately, the material properties of the pre-damaged wall are updated based on the new small scale companion tests. Elastic, tensile and shear properties are slightly higher than the ones found in the

previous campaign (see Korswagen et al., 2019 for a collection of values). Hence, a minor increment in force and global stiffness is detected in the force-drift graph of Figure 14.

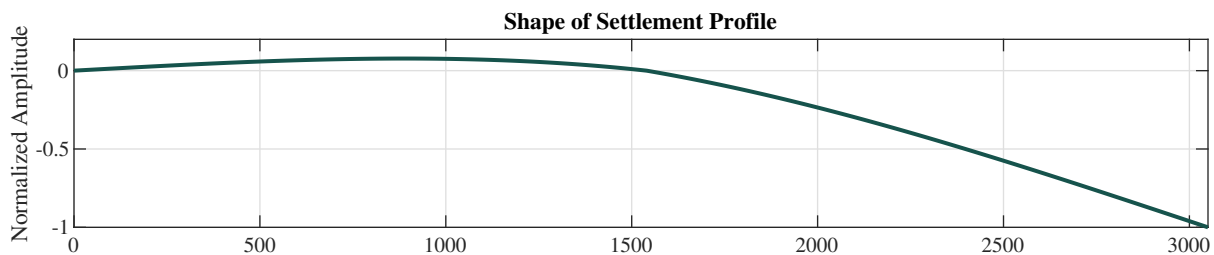
Figure 15. Settlement shape applied to the wall model.

The calibrated model described in the previous section (5.1) is adopted for NLTHAs. The scope of the study is to compare the effect of specific initial conditions on the increase of the wall damage generated by a given earthquake excitation. Three different initial conditions are considered: no pre-damage, a virgin wall is considered; pre-damage via weak spots where the wall is weakened through weaker elements resulting in the same approach as in the previous section (5.1); and, pre-damage via settlement loading. For the latter, the wall is subjected to a settlement deflection case before applying the motion. The shape of such deformation, representing a right-side hogging settlement, is shown in Figure 15 (see also Figure 2).

The non-linear analysis procedure is subdivided in three phases. In the first phase, the gravitational load and an overburden of  $0.12 \text{ MPa}$  are applied. The second phase is used only for the case with pre-damage via settlement deflection. Here, the settlement shape, pictured in Figure 15, is assigned as displacement to the bottom side of the interface. The hogging deformation is applied at a rate of  $0.01 \text{ mm}$  per step, up to  $4 \text{ mm}$  of vertical displacement on the right edge of the wall. The third phase is related to the application of the dynamic motion. Horizontal and vertical accelerations are added to the bottom edge of the wall. The entire duration of the signal amounts to  $12.5 \text{ s}$  at steps of  $0.001 \text{ s}$  each.

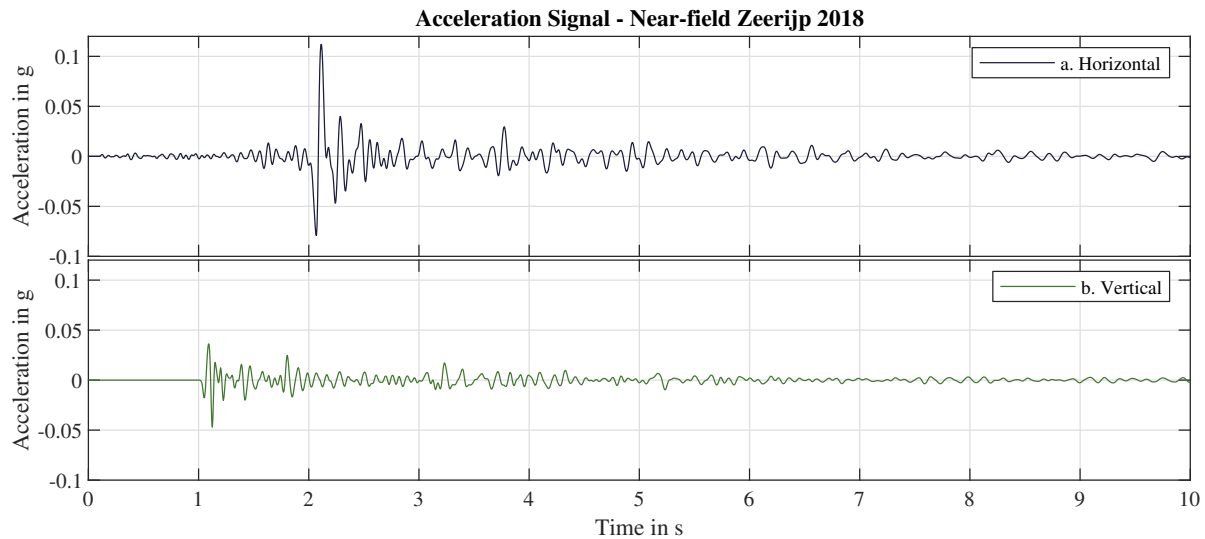
Figure 16. Near-field Zeerijp (2018 ) earthquake signal, (a) horizontal and (b) vertical acceleration plot.

As input for the base motion, a set of horizontal and vertical components of the recent Zeerijp earthquake (8th of January of 2018) is chosen and applied at the base of the wall. This signal was recorded at the Garsthuizen station close to the epicentre and was selected mainly to be representative of a ‘near-field’ record of the ground motion in the Groningen region. The amplitude of the original signal is taken unmodified from its original peak ground acceleration (PGA) of  $0.11 \text{ g}$  in the maximum rotated horizontal direction and applied at the base of the model. This PGA is equivalent to a peak ground velocity (PGV) of approximately  $32 \text{ mm/s}$  for this record. Additionally, the effect of amplification factors with values of 2 and 3 are also investigated. These are arbitrary values selected to produce reasonable light damage within the interval defined as DS1. A representation of the set of records is given in Figure 16.
