Effect of salt spray ageing on the fracture of composite-to-metal bonded joints

Arouche, M.M.; Saleh, M.N.; Freitas, S. Teixeira de; Barros, S. de

International Journal of Adhesion and Adhesives

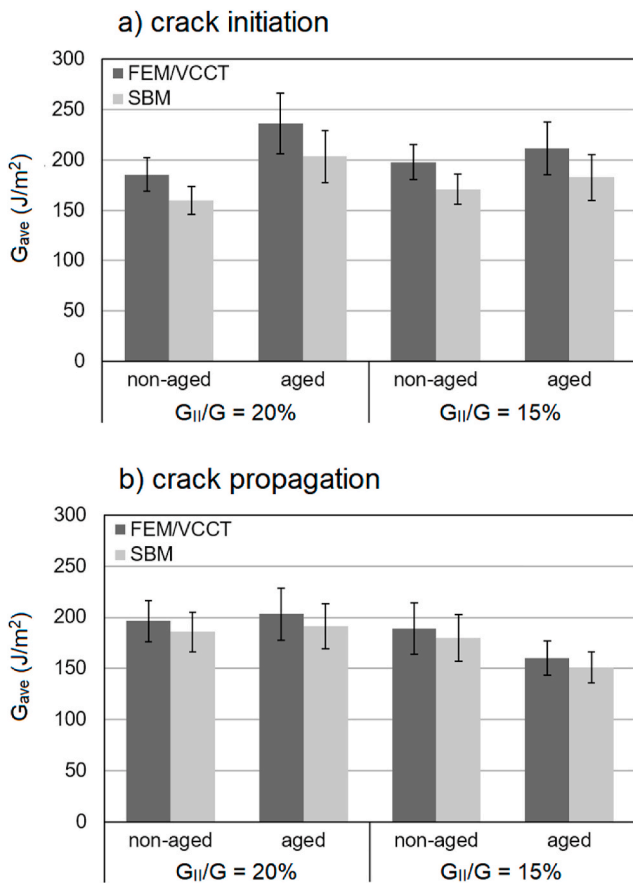
Fig. 12. Average fracture energy at (a) crack initiation and (b) propagation.

The average fracture energy (G_{ave}), presented in Fig. 12, provides a comparable data for the evaluation of the ageing effect on the fracture performance of the tested specimens. Fig. 12a shows the mean fracture energy at crack initiation of the 4 repeats of each configuration. It reveals a significant increase of 27% of the fracture energy at crack initiation when tested in 20% mode II. In the case of specimens tested in 15% mode II, the fracture energy showed a slight increase of 7% at crack initiation. The region of crack initiation is directly affected by the moisture across the whole width and resulted in an increase of the fracture toughness. This seems to be related to the shear behavior of the adhesive and is attributed to the effect of plasticization [19,21].

Fig. 12b shows the mean fracture energy at crack propagation points (from 35 to 65 mm crack length) of the 4 repeats of each configuration. A negligible variation is observed of 3% of the fracture energy at 20% mode II during crack propagation, while a reduction 15% of the fracture

energy is noted at 15% mode II. As expected, the SBM showed good agreement with the numerical results. Moreover, the average fracture energy obtained from the SBM deviated by 15% from the FEM/VCCT at crack initiation (Figs. 12a) and 6% during propagation (Fig. 12b), as observed in Fig. 10.
