# Repair Methods for CFRP Aircraft Structures with Functional Inserts

Master of Science Thesis

For obtaining the degree of Master of Science in Aerospace Engineering  
at Delft University of Technology

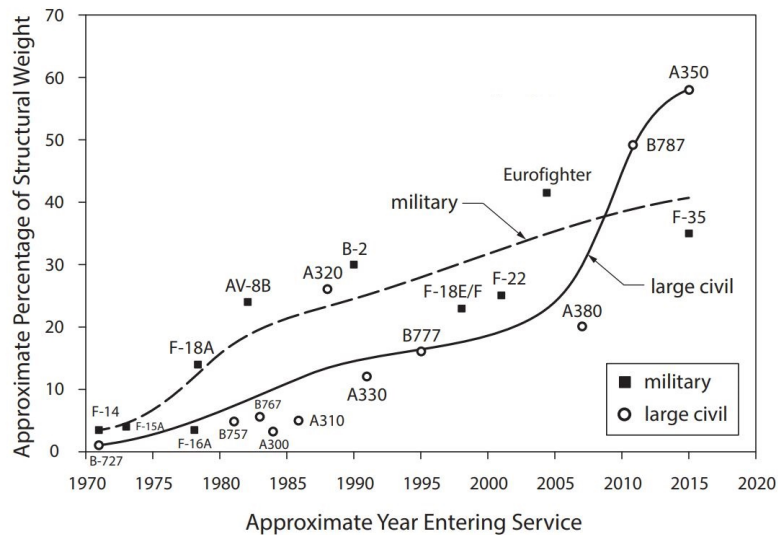
**Figure 1.1:** Percentage of composites in terms of weight adopted in various military and large civil aircraft over time (edited chart from [3])

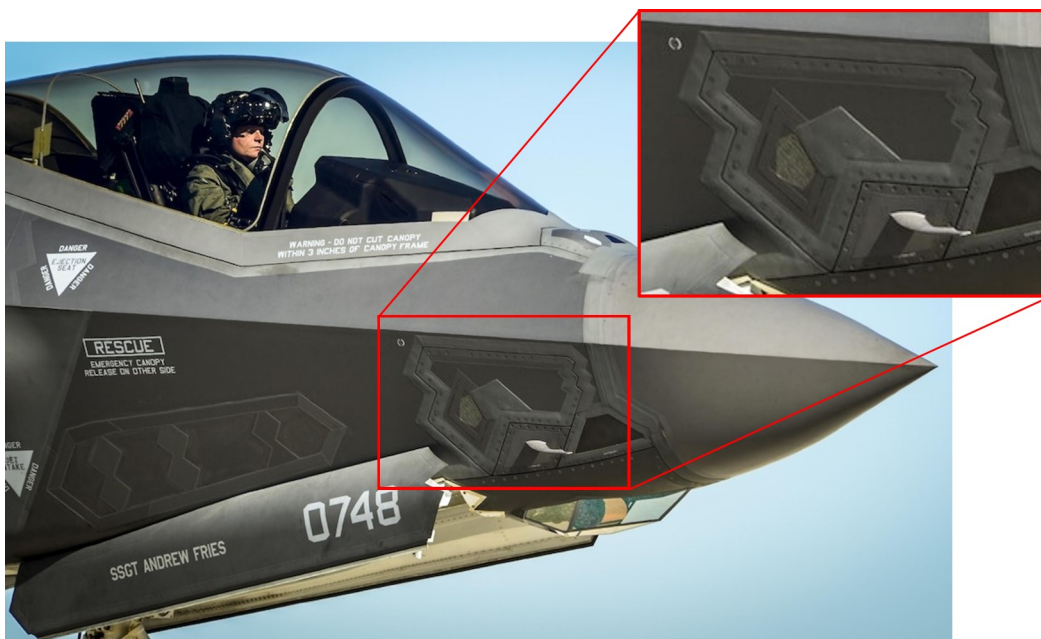
**Figure 1.2:** Nose of the Lockheed-Martin F-35A, showcasing composite panels with functional material inserts on their edges

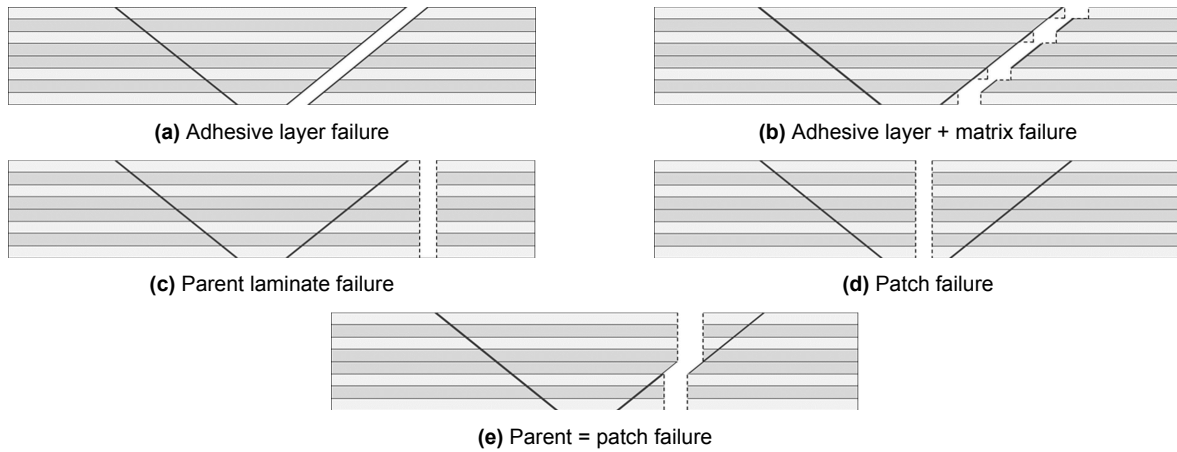
**Figure 3.6:** Schematic representation of common tensile failure modes for scarf repairs [41]

Being effectively adhesive bonded joints, scarf repairs fail according to the modes presented in subsection 2.5.2 — and primarily as a combination of such mechanisms. Some common failure modes typical of scarf repairs are depicted in Figure 3.6. As summarised by Orsatelli *et al.* [41], the scarf angle has an influence on the failure mode.

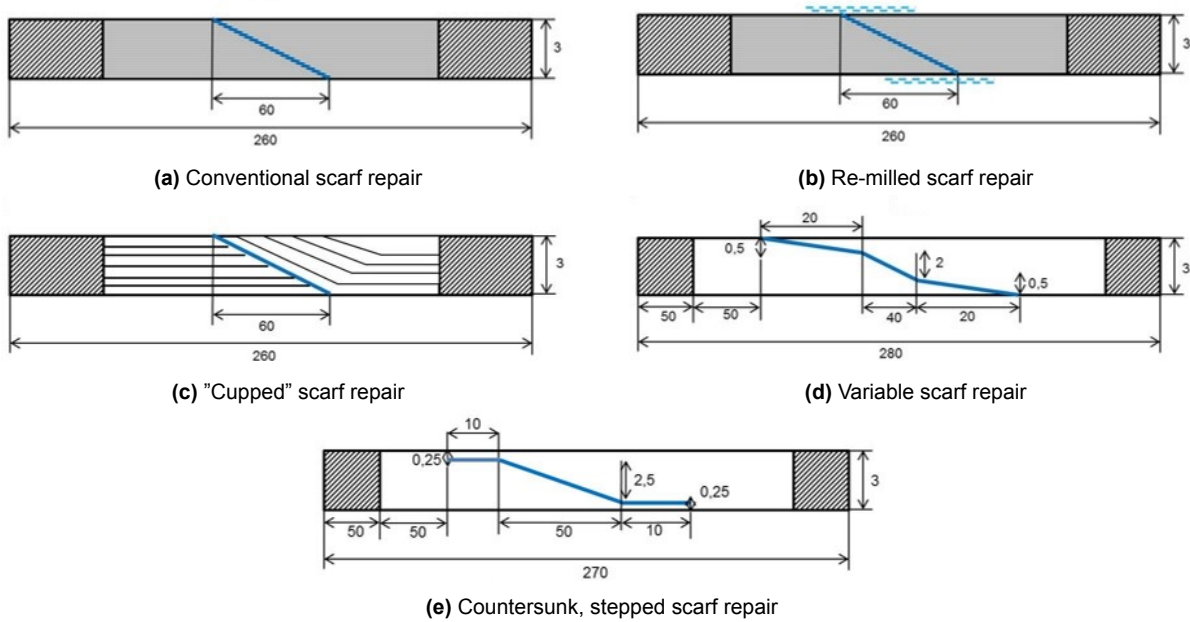
**Figure 6.1:** Flush scarf repair geometries previously tested at Airbus (dimensions in mm) [5]

and compared to the conventional one (Figure 6.1a) are shown in Figure 6.1b, 6.1c, 6.1d and 6.1e. A key aspect that was investigated in this work for the first time is the post-processing of the repaired surface via CNC milling, in order to eliminate the thickness offset generated by the repair. This investigation concluded that — among the considered options — the re-milled variant (Figure 6.1b) is the optimal one, due to the relative simplicity in terms of manufacturing and good mechanical performance (i.e. comparable to the original, undamaged material). Nonetheless, it was highlighted how the re-milling procedure — despite being promising — needs to be further investigated and refined. Indeed, a fully flush surface could not be achieved after milling, which still left a thickness difference quantifiable at around 0.2 mm.

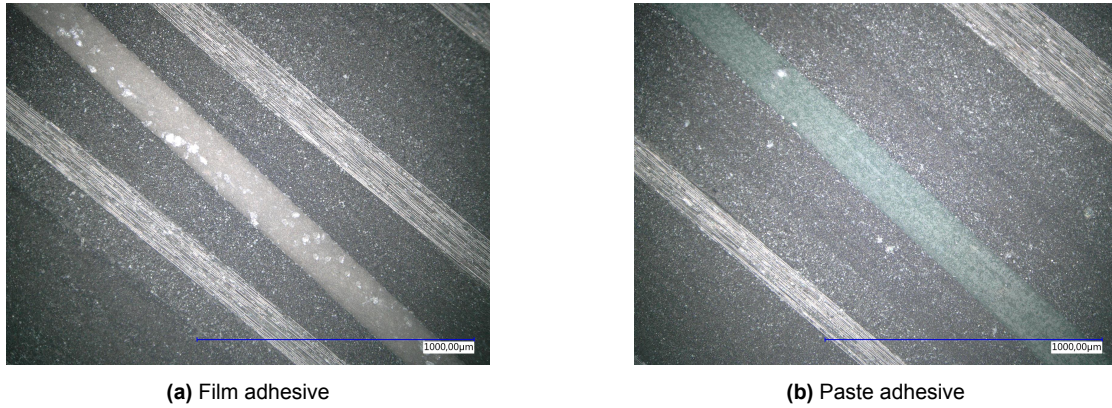
The bondline thickness was measured in three different locations (shown in Figure 7.7) along the scarf for all the specimens, via analysis of images taken with a digital microscope (two examples of such images are depicted in Figure 7.5). The measurements are listed in Table 7.4 and graphically shown in Figure 7.6. Do note that the specimen MCLS\_FA\_1, due to manufacturing complications, did not meet the dimensional specifications and was therefore discarded.

**Figure 7.5:** Micrographs showing the bondline of the MCLS specimens

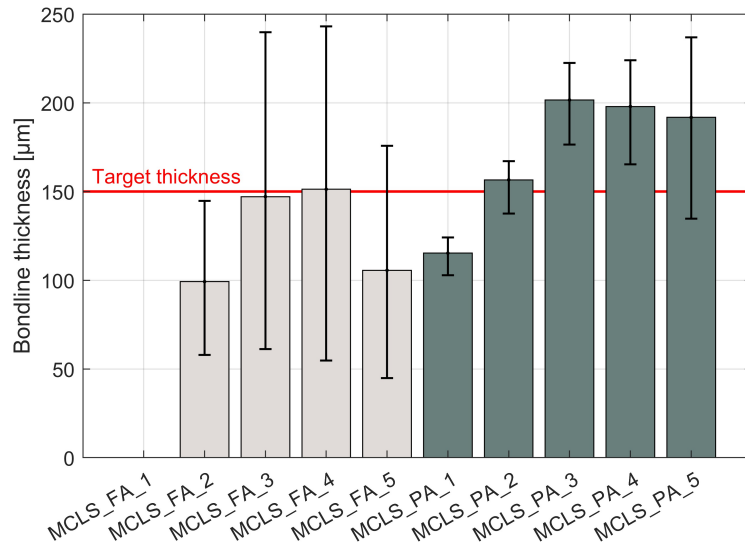
In Figure 7.6, the bars represent the average of the measurements, while the error bars the minimum and maximum measured values. As one can notice, the bondline thickness is generally lower for the film adhesive specimens compared to the paste adhesive ones, although there is more variation along its length.

**Figure 7.6:** Adhesive bondline thickness of the MCLS specimens, both with film and paste adhesive

influence on the results, despite none of these seem capable on its own — or even combined — to justify the major discrepancy. First, as shown in Figure 7.6, the paste adhesive bondline was generally thicker in all the specimens, albeit more consistent along its length. Second, a higher number of voids/imperfections was observed in the paste adhesive specimens while analysing their sides with the optical microscope (few sample images are shown in Figure 7.12). The void content was not properly estimated, and the bond areas were not inspected in their entirety. Nonetheless — based on what was observed on the sides — it is reasonable to assume that the paste adhesive specimens had a higher void content than the film adhesive ones. Third, the tabs were glued to the specimens with an adhesive that was cured at 121°C, which happens to be right below the glass transition temperature of the paste adhesive (122°C – 124°C). This means that the paste adhesive is likely to have entered its glass transition phase while the tabs were being bonded. Since the paste adhesive was not subjected to any mechanical load during this phase, this most likely did not have any consequence. Nevertheless, a deeper analysis should be performed in order to confirm this assumption.

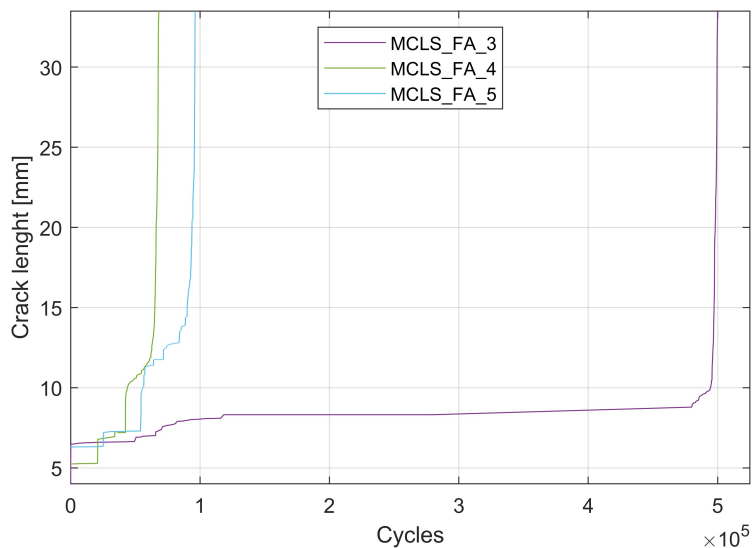
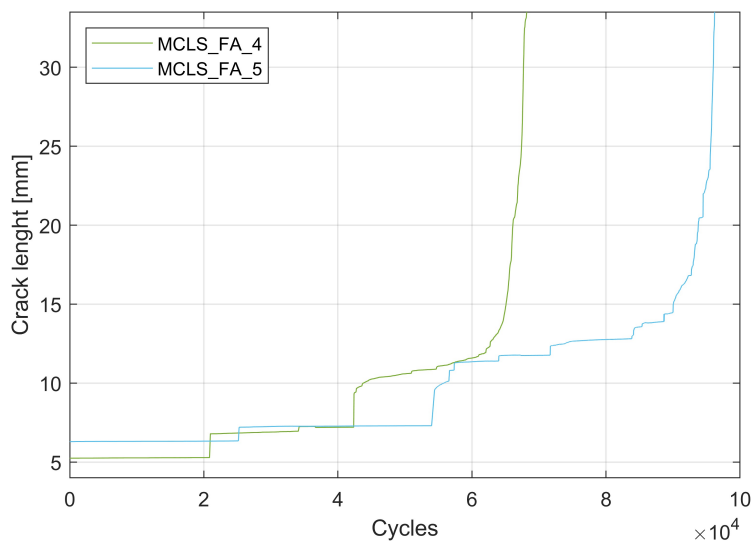
Figure 7.9 plots the crack growth over time (expressed as number of cycles) for the specimens with the film adhesive. In more detail, Figure 7.9a shows all the specimens at once, while Figure 7.9b only depicts the two specimens with a more similar timescale. The results for the specimen with the paste adhesive are plotted in Figure 7.10. Do note the difference in order of magnitude between the specimens with the film adhesive and the one with the paste one.

(a) Overview of all the specimens with the film adhesive

(b) Focus on the two specimens with similar performance

**Figure 7.9:** Crack growth as function of the number of cycles for the MCLS specimens with the film adhesive

Considering the results presented in subsection 7.4.1, it is evident that the film adhesive demonstrated a superior performance, allowing for a significantly slower crack propagation. When tested at a maximum load of 10 kN, the film adhesive specimens hardly showed any crack propagation (even after hundreds of thousands of cycles), while the paste adhesive specimens allowed cracks to propagate and lead to failure in a rather limited time frame. Additionally, when tested at 13.1 kN, the film adhesive specimens showed a steady crack propagation behaviour (at least below  $\approx 60000$  cycles), while the paste adhesive specimen quickly failed — in an abrupt manner, without allowing to observe any steady crack propagation — after a few thousands of cycles. Do note that MCLS\_FA\_5 and MCLS\_PA\_3 had a comparable end-of-life. However, the film adhesive specimens were fully tested at 13.1 kN; whereas, for the paste adhesive specimens, the maximum load was  $\approx 30\%$  lower for roughly half of the testing time.

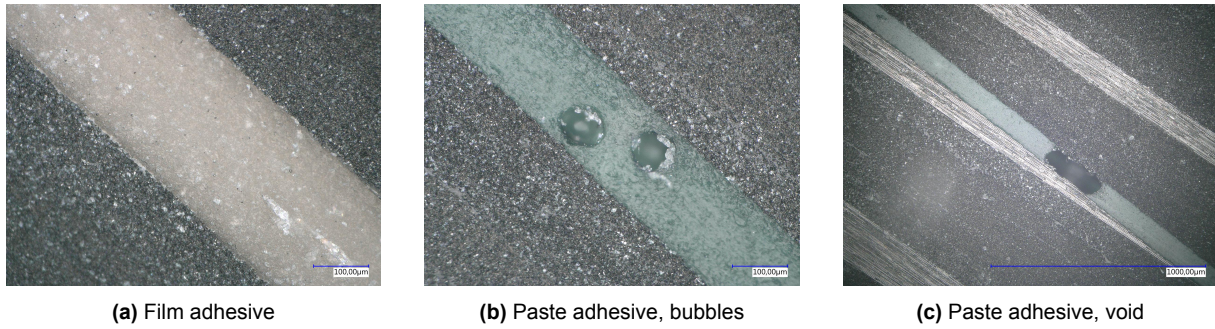
**Figure 7.12:** Micrographs depicting imperfections — or the lack of — in the bondline of the MCLS specimens

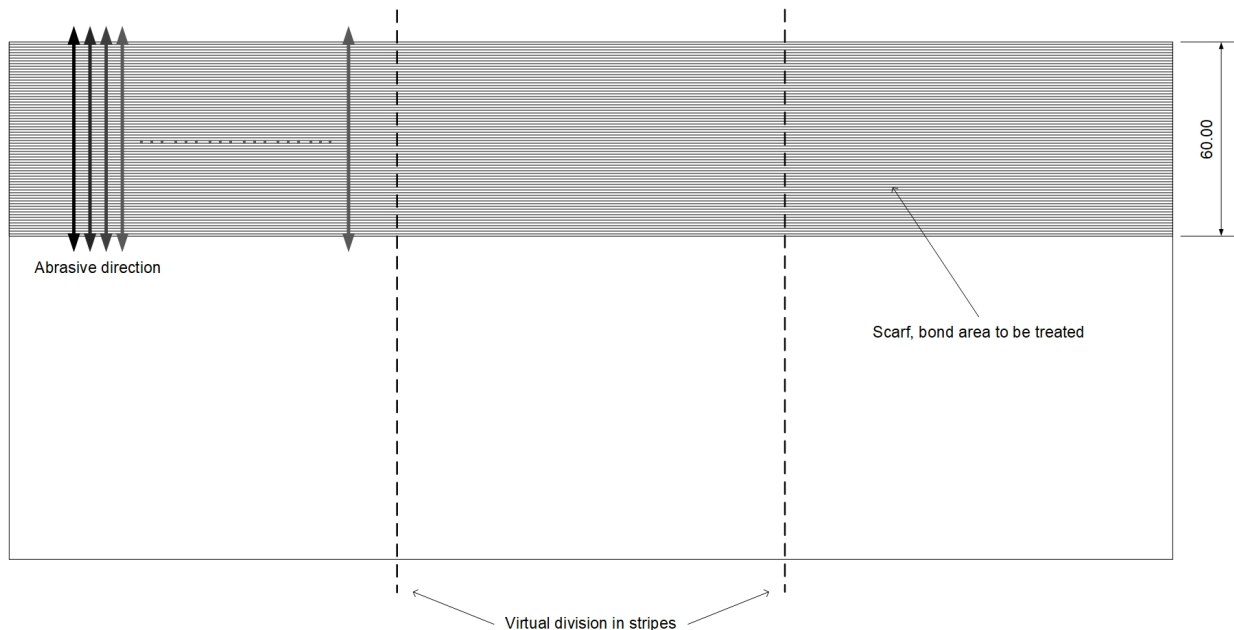
The scarf surfaces were treated according to the following steps. First, they were thoroughly cleaned with acetone and virtually divided into strips with an approximate width of 10 cm, as shown in Figure 8.5. Then, ensuring that both the surface and the abrasive pad were constantly

wet with deionized water, each stripe was abraded moving the pad 15 times back and forth — without lifting it from the surface and without applying pressure — and then rinsed with deionized water. Next, in the same fashion, the total area was abraded moving the pad 30 times back and forth. These steps were performed in four different directions; the first one ( $0^\circ$ ) is shown in Figure 8.5, the remaining ones are  $90^\circ$  and  $\pm 45^\circ$ . The surface was then cleaned with isopropanol, deionized water and then left to dry for 45 minutes before applying the adhesive.

**Figure 8.5:** Division into strips and first sanding direction for the surface treatment (dimensions in mm)

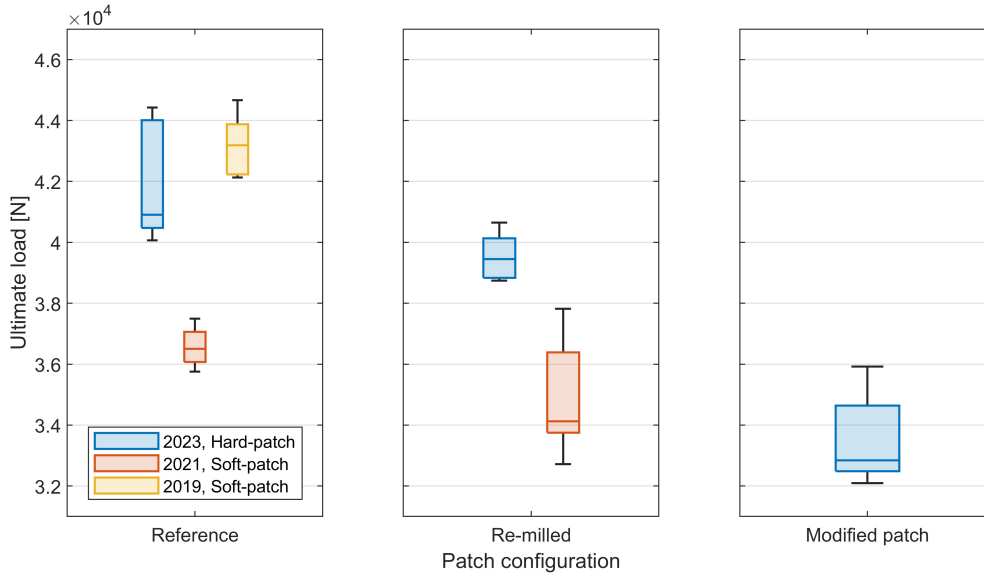
Figure 9.1 shows the ultimate failure load achieved by the various specimens under static, tensile testing conditions. The data are grouped by repair type (i.e. reference, re-milled and modified patch), and further separated based on the type of patch (secondary bonded hard patch or

Generally, the reference specimens failed later than the re-milled specimens, which in turn proved superior to the modified patch specimens. This is most likely due to the different cross-sectional areas in the bond region of the various configurations.

**Figure 9.1:** Ultimate tensile load reached by the different patch configurations during static testing

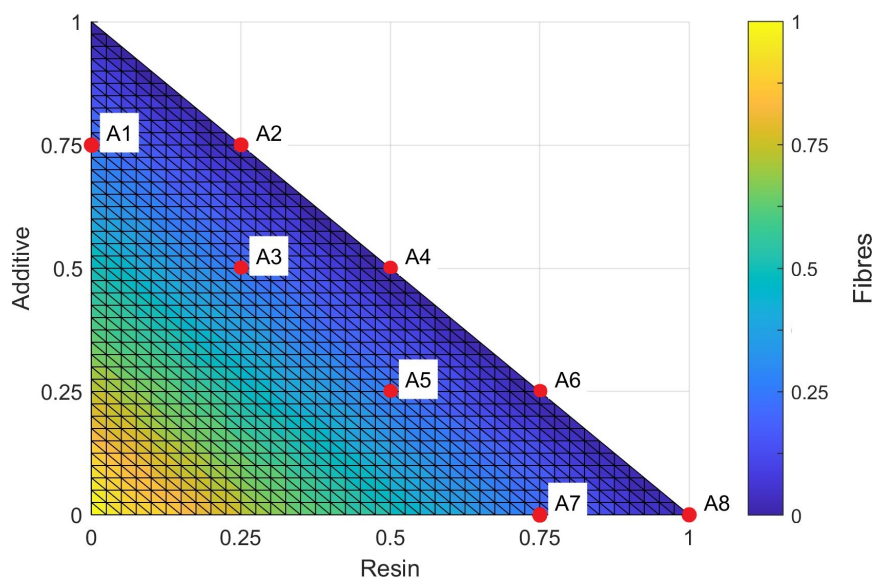
**Figure 12.1:** Range of all the possible repair compounds for the functional material

Among all these possible options, eight combinations — depicted in Figure 12.1 — were selected and mixed. No compounds located in the lower-left corner of the chart were selected, given that preliminary trials highlighted their unfeasibility. These repair compounds are listed in Table 12.1, which qualitatively shows the content of their constituents ("0" represents no content, while an increasing number of "+" represents an increasingly higher content). Additionally, the feasibility of achieving a uniformly homogeneous compound is also mentioned. All the doable compounds were then compared, as detailed in the next section.

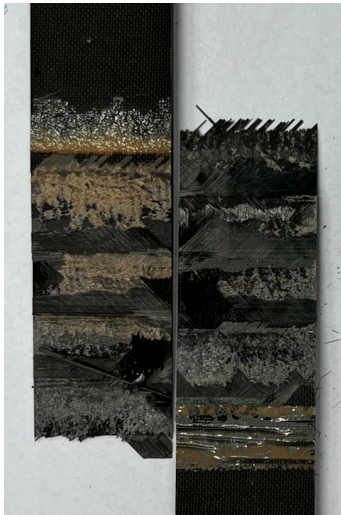
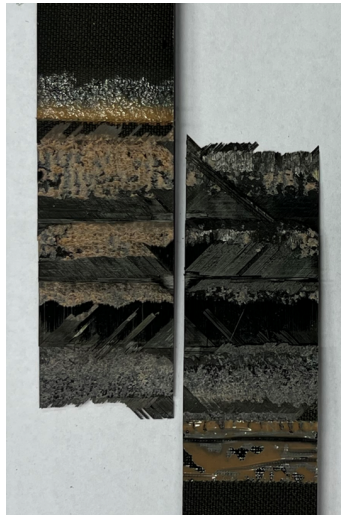
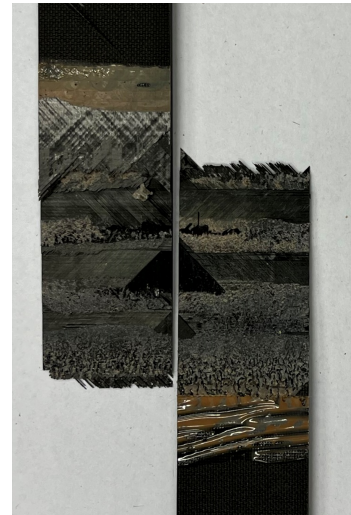
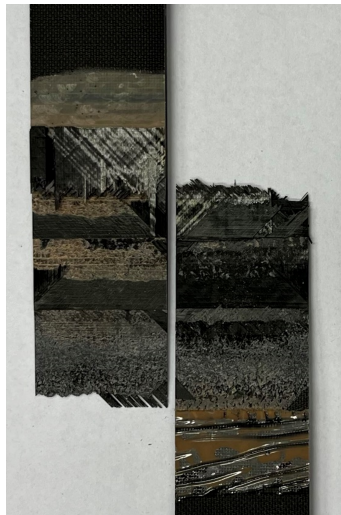
**Figure A.2:** Fracture surfaces of the EN6066 specimens, static tests (in every picture: parent laminate on the LHS, repair patch on the RHS)

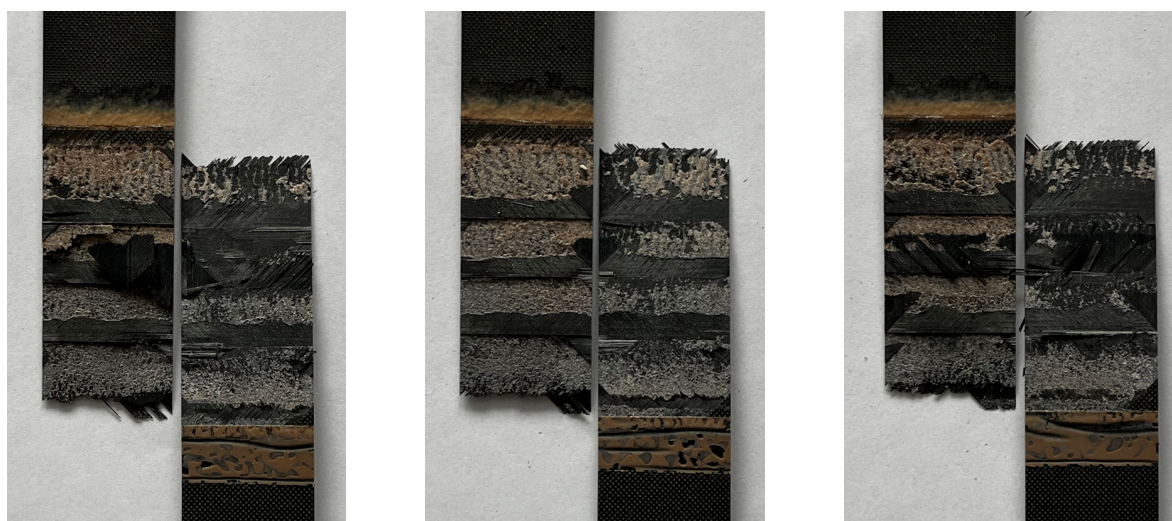
**Figure C.2:** Fracture surfaces of the EN6066 specimens, residual strength tests (in every picture: parent laminate on the LHS, repair patch on the RHS)
