# Cracking of the cover layer leading to backward erosion piping

**KEYWORDS:** Uplift, backward erosion piping, exit point, cover layer, cracking, levees.

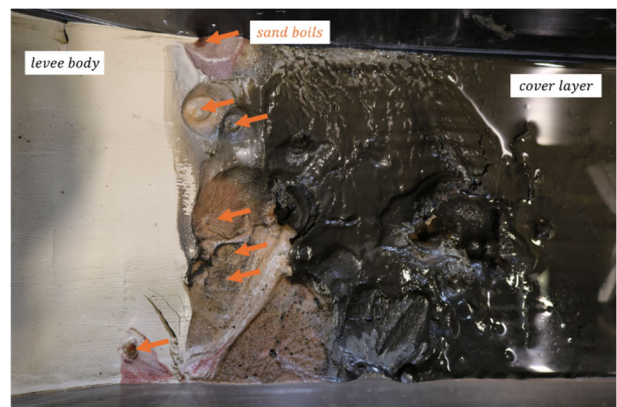
Figure 8. Geocentrifuge model (top view) with sand boils (indicated by orange arrows) located at the toe of the levee.

The diagonal crack was present over the entire (in plane) length of the model. It is located at the toe of the levee, and the crack was observed to start at the bottom of the cover layer, propagating upwards. The diagonal crack consistently formed at an angle of approximately 60–65° from the horizontal direction. The length of the uplift zone was 15–45 m (187–559 mm on model scale). At the top of the cover layer, sand boils were observed at the location of the toe (Figure 8). Furthermore, in six of the tests, lateral cracks were observed, and in four of the tests, these sand boils occurred at the location of these lateral cracks.

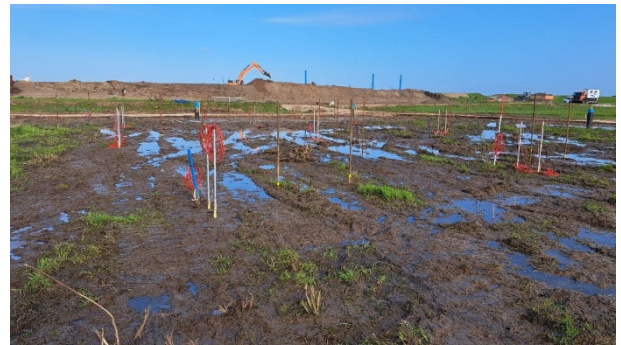
In the two full-scale tests, uplift conditions were reached over a period of several days, and the deformation of the cover layer was measured. The subsoil of the tests consisted of a cover layer of 3-3.5m of sandy clay and peat overlaying an aquifer. A comprehensive publication detailing the full setup, methodology and results of this field experiment, is currently in preparation.

Figure 11. Photo of full-scale test with pore water pressure meters at the front.

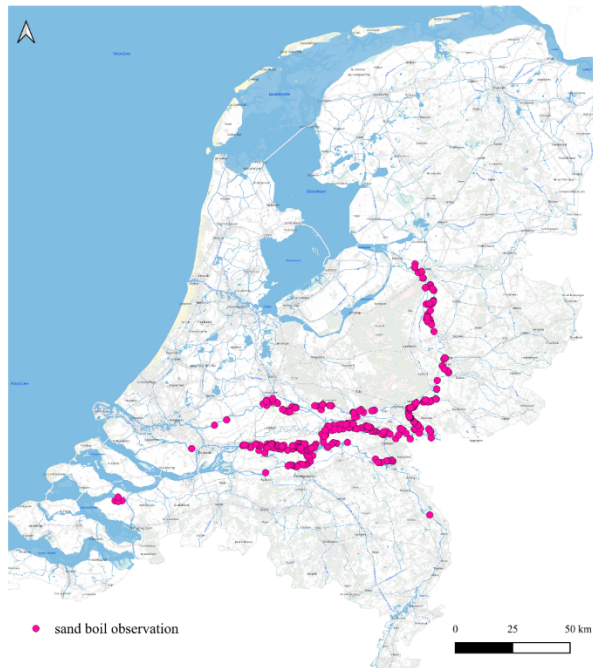
The distribution of sand boils in the Netherlands

Figure 14. Sand boil locations in the Dutch national dataset.

Field observations of sand boils connect to the physical description in the sense that both uplift and heave have occurred. Previous analysis of the Dutch national dataset (Figure 14), comprising over 800 recorded sand boils, showed a trend of fewer occurrences in areas with thicker cover layers (Figure 15).
