# Assessment of consequence class two (CC2) buildings

Exploration to an effective and efficient assessment method for existing consequence class two buildings

Master thesis by M.L. Weijer

15-11-2023

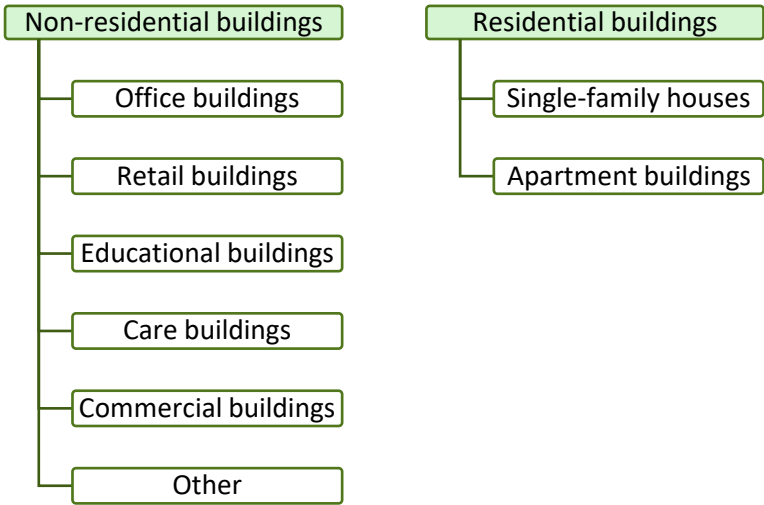
Figure 3.4: Building types used in the study (EIB, 2015)

The Economic Institute for the Building Sector (EIB) has devised a categorisation for the building stock in the Netherlands. Initially, buildings are classified as either residential or non-residential. Residential buildings are further divided into single-family houses and apartment buildings. Non-residential buildings are further subdivided based on their functional purpose. The EIB building categorisation, which is used in this document, is shown in figure 3.4. It is important to note that the EIB provides only a limited number of categories for non-residential buildings, with the remaining structures grouped under the 'other' category.

Chapter 3 and appendix C treat this sub-question by examining the building stock in the Netherlands. The building typologies present in the Netherlands are depicted in figure 3.4. The category of 'other buildings' includes functions such as restaurants, cafés, hotels and other forms of lodging, day care, sports facilities, swimming pools and congregation areas. The latter is often also found within other building typologies like offices. Furthermore, the Netherlands also features hybrid building typologies, which consist of a combination of the typologies mentioned below.

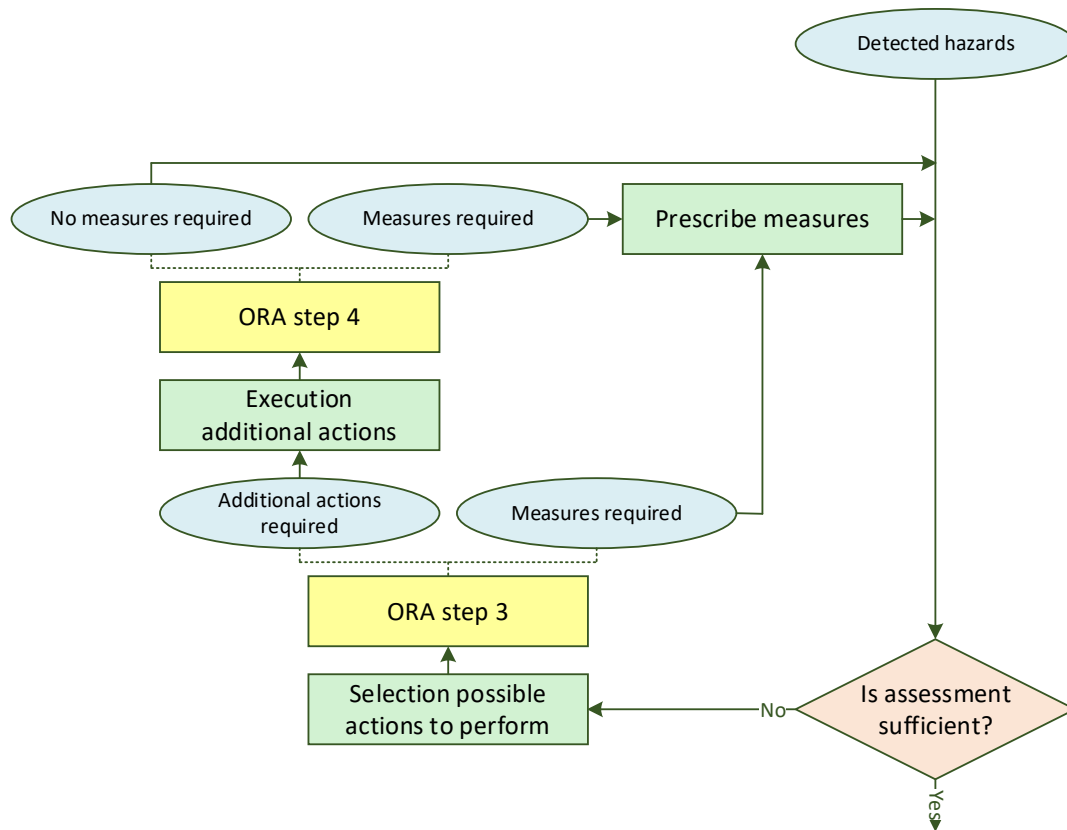
Figure 6.4: Iterative loop for additional actions and measures

Figure 6.4 presents the iterative loop for additional actions or advice on measures. The detected hazards, based on the previously described input, are evaluated for acceptability and sufficiency of information. If neither criterion is met, the loop is entered. The process conducted within this loop is discussed in this subsection. Even within the loop, the assessor(s) should first attempt to perform more abstract actions and then progress to finer details if required.

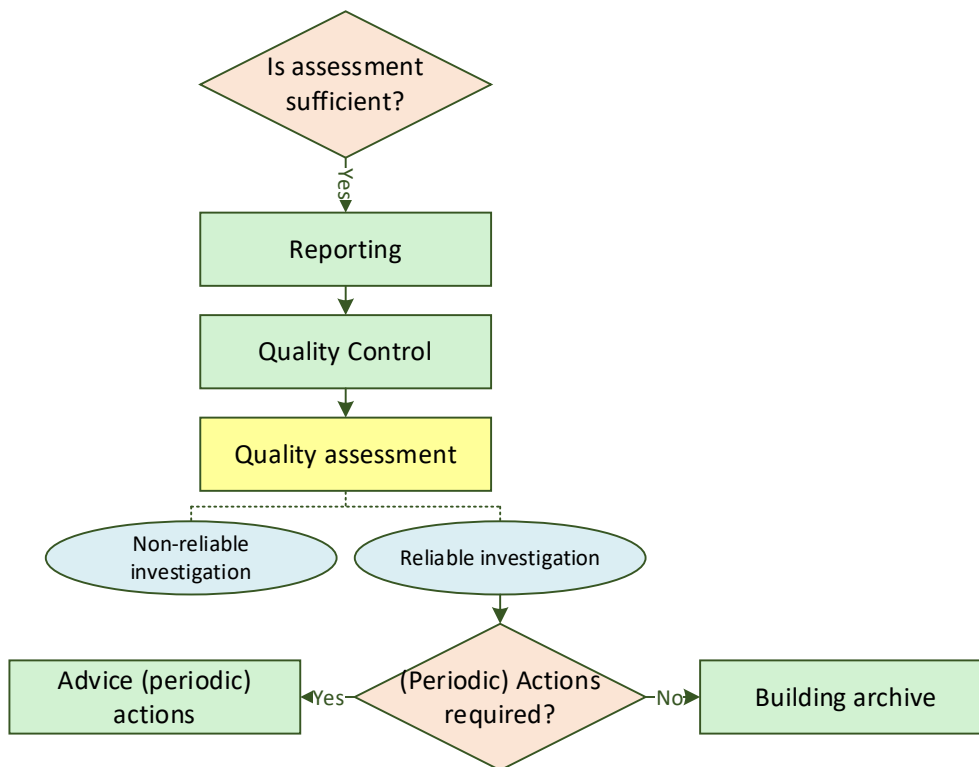
Figure 6.5: final steps assessment

When the assessment is deemed sufficient, the final steps of the initial assessment can be accessed. These final steps are captured in stage three and shown in the figure below.

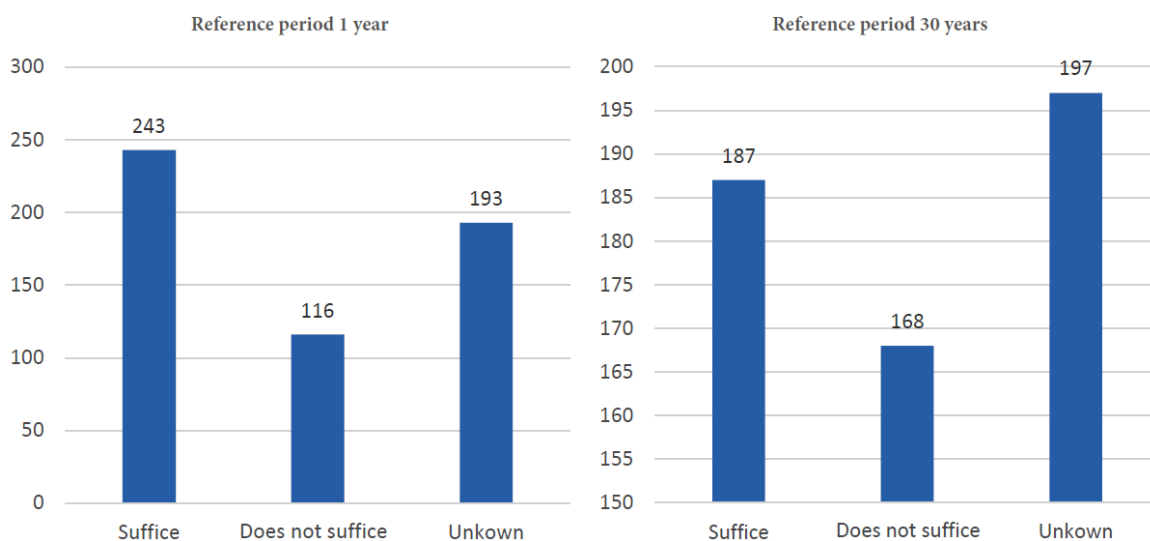
Figure D.4: Study to apartment buildings for short (left) and long term (right) (van den Berg et al., 2021)

There are two articles by the journal Cement used in this subsection. The first article discusses the insufficient load resistance and the lower position of the reinforcement in the cantilevering gallery and balcony floors. It also considers chloride damage to these floors. An inventory was conducted on 552 monolithically connected cantilevering floors that were inspected. Out of these 552 cases, 158 were gallery floors, 229 were balcony floors and in 165 cases both type of floors were inspected (van den Berg et al., 2021). The figure below illustrates that a significant number of floors did not meet both short-term as long-term standards. Furthermore, in 176 cases elevated chloride content was detected and in 46 cases actual corrosion of the reinforcement was discovered.

The article also provides data to demonstrate that balcony floors pose a problem. In total, 46 floors did not meet short-term standards and 61 failed to meet long-term standards (van den Berg et al., 2021). In addition, 38 of these floors exhibited elevated chloride content.

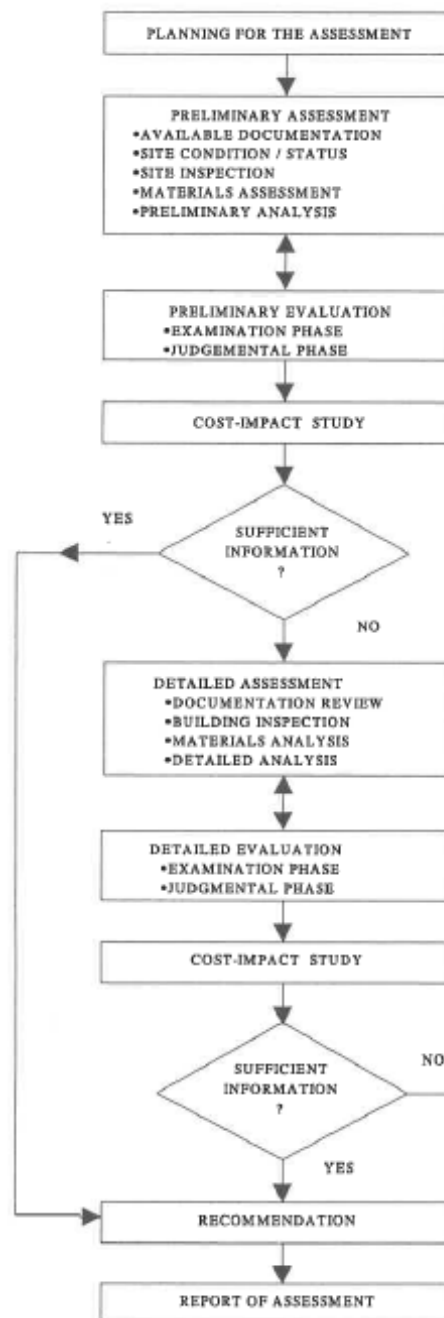
Figure G.1: Workflow ASCE Standard (ASCE, 2000)

This assessment is similar to the preliminary assessment, except for the greater detail and higher accuracy, which increase the reliability of the recommendations made. As such, the detailed assessment considers the entire structural system.

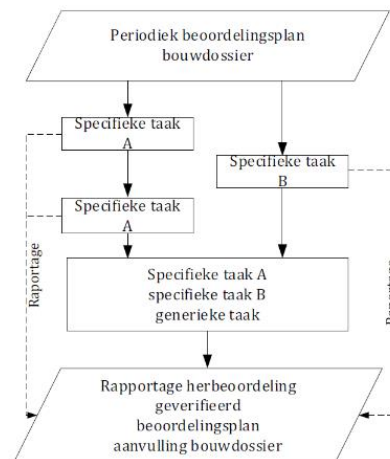
Figure G.6: Periodic assessment scheme (NEN, 2023)

The periodic assessment is based on the risk classification, the frequency of the tasks is given in ... Despite these frequencies, once in ten years a general task must be performed to check if the assessment plan is still valid, see figure g.6.
