water research laboratory

Report No. 104

SCOUR RESISTANCE OF FARM DAM SPILLWAYS WITH GRASS DORMANT

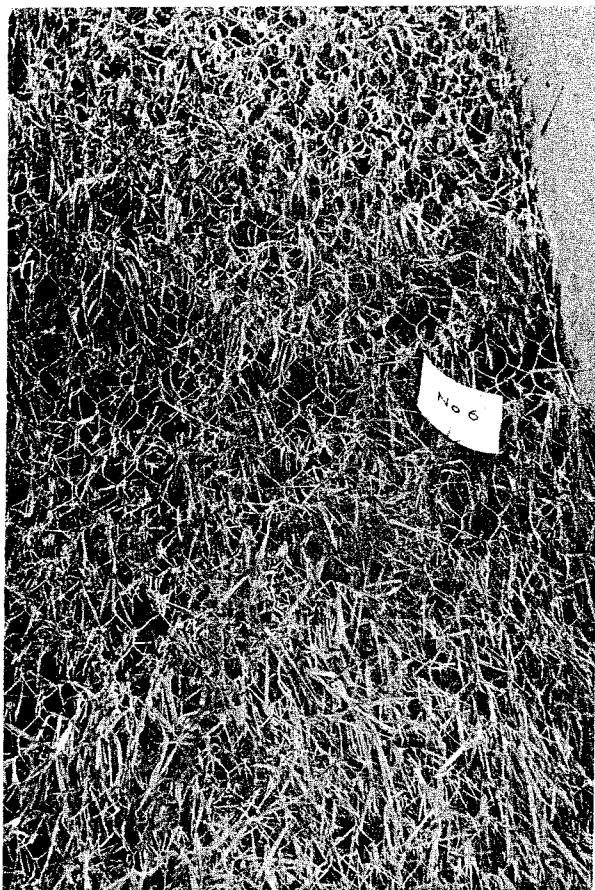
Kikuyu Grass

Testing of Kikuyu grass in channels Nos. 4 and 5 had to be discontinued after 4 hours and $7\frac{1}{2}$ hours respectively, not because of failure of the surface but because of increasing danger to adjacent channels caused by leakage under the brick dividing walls. The grass itself withstood the flow with no appreciable deterioration.
