Combined Impact and Fatigue Loading in CFRP

Effects of the timing of an impact event during
cyclic loading of composite aircraft structures

**Effects of the timing of an impact event during
cyclic loading of composite aircraft structures**

to obtain the degree of Master of Science

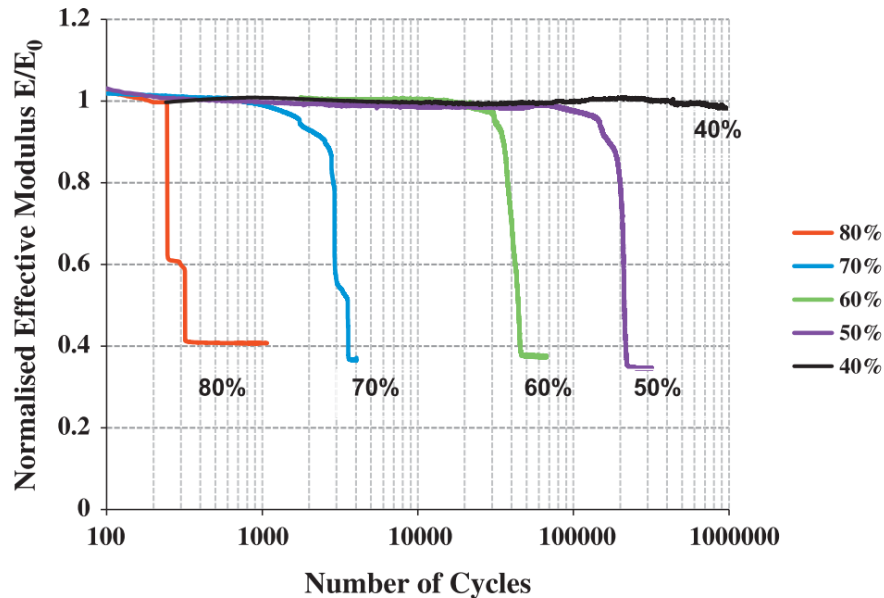
Figure 2.4: Normalised stiffness degradation at different severity percentages [6]

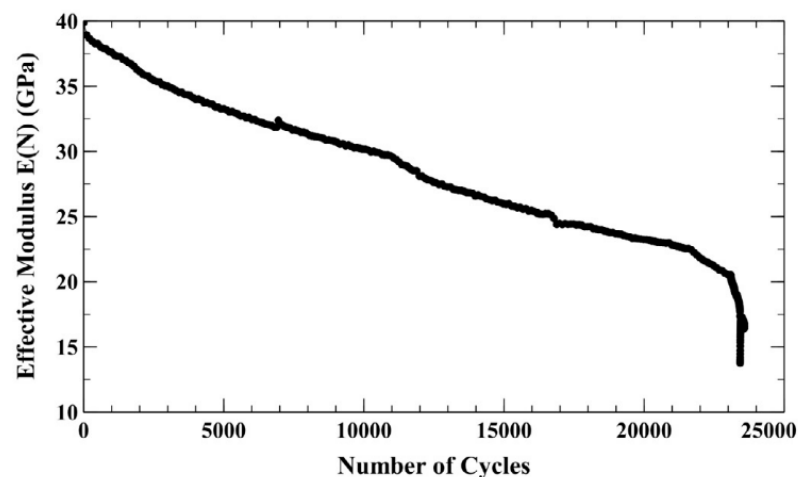
Figure 2.5: Typical reduction in effective modulus over fatigue lifetime [16]

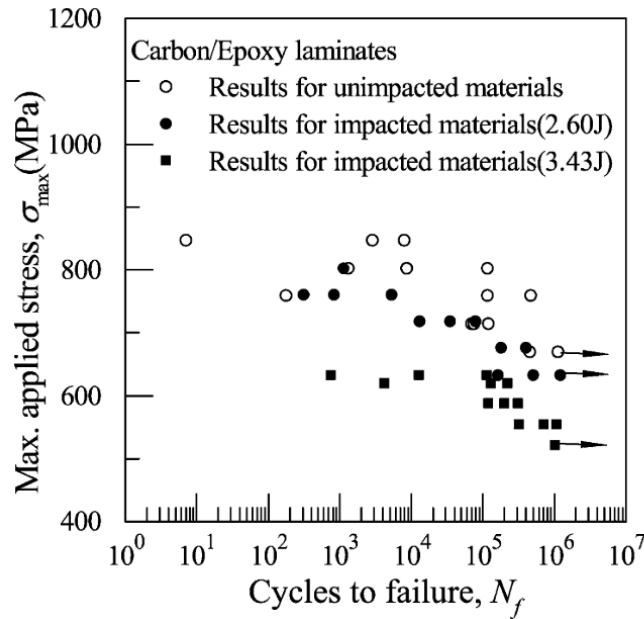
Figure 2.10: Effect of impact energy on tension-tension fatigue performance [32]

The combined effects of impact and other loadings have been studied by tension after impact (TAI), compression after impact (CAI) and fatigue after impact (FAI). Quasistatic CAI and compression-compression or compression-tension FAI have been studied the most, due to the propensity of composite materials to form delaminations during an impact event, which typically reduces the compression strength significantly. While fibre damage is critical for the residual tensile strength of a laminate, matrix toughness is the main driver behind residual compression strength of a quasi-isotropic laminate [20]. According to Vlot, tension-tension fatigue is much less critical than types of fatigue involving compression, and the splitting caused by T-T fatigue tends to remove stress concentrations from the initial damage [3]. This removal of stress concentration may even increase the static tensile stress again. Because of the higher severity of compression loading after impact, tension loading is less researched and therefore less well understood. Researchers like Kang and Kim have shown that impact indeed also has a detrimental effect on tension-tension fatigue [32]. Figure 2.10 shows the results of their experimental campaign.

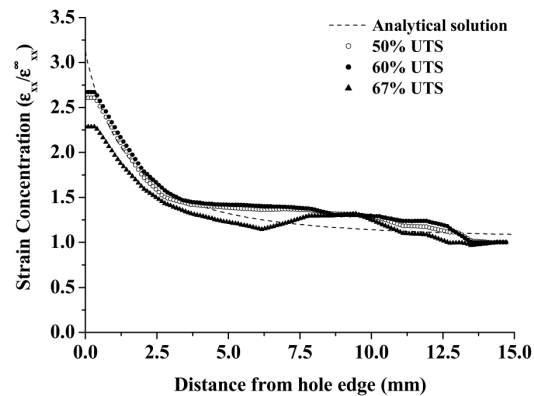
Figure 3.3: Strain concentration next to hole edge measured with DIC [43]

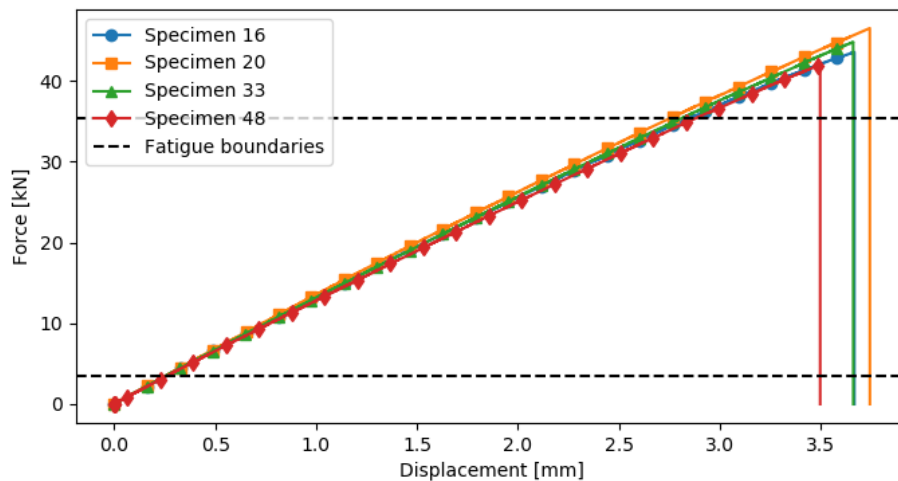
Figure 4.7: Load-displacement curves of the static tests

All tests were performed on a servo-hydraulic fatigue machine from the company MTS. The machine has a force capacity of 100 kN, which was ample for these tests. First some quasi-static tests were performed on four different samples, with the ultimate tensile strength (UTS) and global failure strains shown in Table 4.4. These tests were displacement controlled, with a speed of 1 mm/min. The force-displacement curves are shown in Figure 4.7. While some non-linearity is observed which is to be expected, there are no significant load drops before final fracture. This is important as it shows that no

significant load carrying plies are likely to fail within the first fatigue loading cycle of the dynamic tests. However, small load drops are seen when zooming in and cracking sounds were heard well before ultimate failure. The black dashed lines indicate the upper and lower force limit of the fatigue tests.

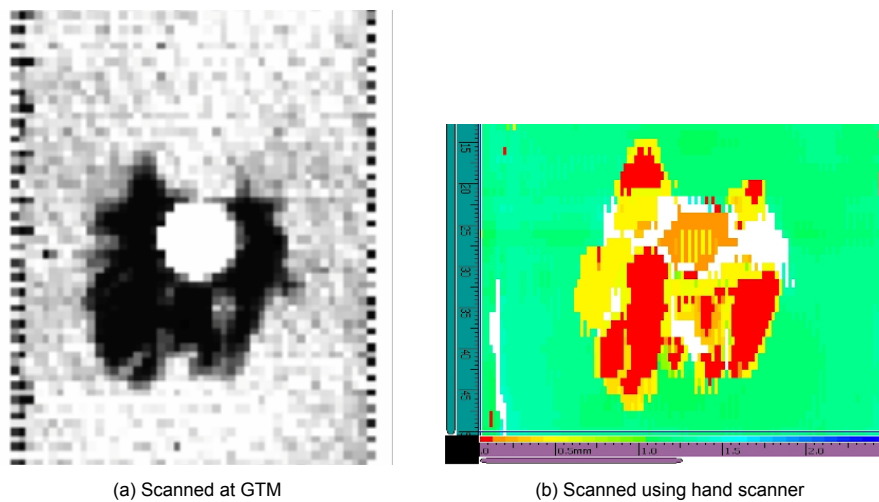
Figure 4.17: Examples of C-scans (both specimen 28)

In addition to the specimens that were tested to failure, ten samples were tested up to a certain point, after which they were C-scanned. This was performed at GTM Advanced Structures in The Hague. The images produces are black and white, without differentiation between the various plies. While the resolution is not great (about 0.55 mm per pixel), the contrast is good, and a clear boundary between the delaminated and intact area is seen.

In addition, a hand scanner was used obtain information about the positions of the delaminated areas through the thickness. An Olympus RollerFORM phased array wheel probe was used in combination with an Olympus OmniScan SX acquisition and display device. While coloured images with depth differentiation were produced, high quality was not achieved after trying a range of settings. An example of the area around the hole as scanned by both methods is provided in Figure 4.17. Section 5.1 further discusses the use and implications of the C-scan results.

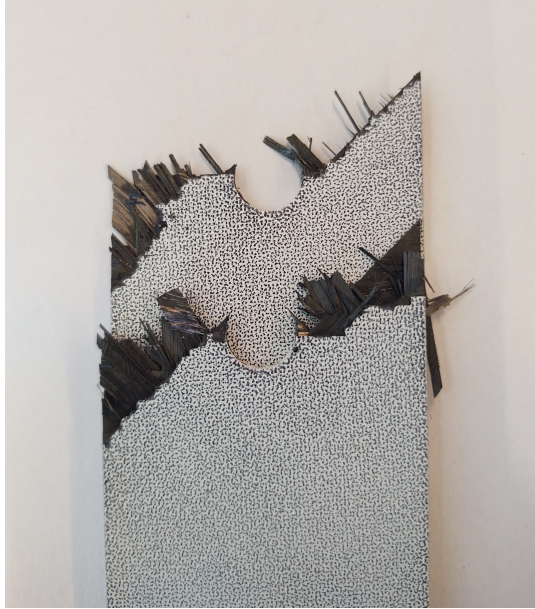
Figure 5.1: Typical static failure (sample 16)

All the tested specimens failed in very similar ways. As expected, damage initiated left and right of the central hole which propagated until fracture. Figure 5.1 shows an example of what a static failure looks like. The material fails at a 45 degree angle, with some fibre pull out. Figure 5.2 shows what a typical fatigue specimen looks like after failure. Much more delamination damage and fibre pull out is seen here. The fracture still mostly follows a ± 45 degree angle, with long 0 degree fibres completely pulled out. The delaminations typically ran along the full length, up to the hydraulic grips in which the sample was clamped.
