IMPACT OF NOURISHMENTS ON NEARSHORE CURRENTS AND SWIMMER SAFETY ON THE DUTCH COAST

Roeland C. de Zeeuw¹, Matthieu A. de Schipper¹, Dano Roelvink², Sierd de Vries¹ and Marcel J. F. Stive¹

Assessing swimmer safety along the Dutch coast entails more than only assessing the risk of rip currents. Seven criteria have been formulated to make a comprehensive assessment of swimmer safety along the Dutch coast. These are based on interviews with lifeguards, rescue report statistics and detailed lagrangian measurements of the current patterns and bathymetry in the shallow nearshore, at three different field sites along the South-Holland coast.

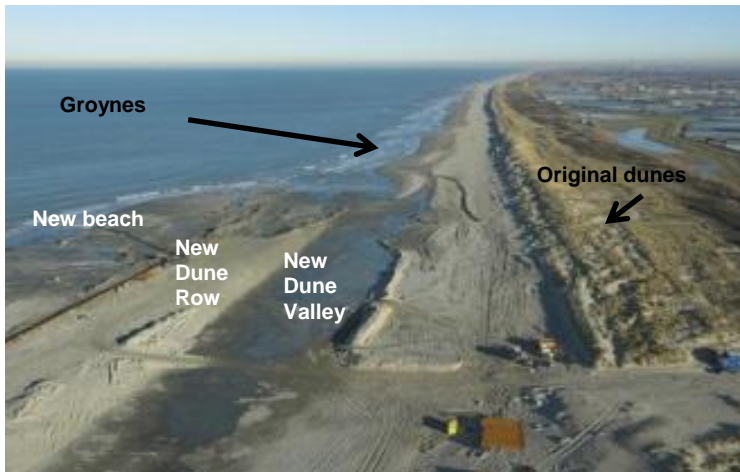
Figure 2: Aerial photograph of the Vlughtenburg field site during construction of the nourishment in 2009. Original beach and vegetated dunes visible on the left. (source: www.delflandsekust.nl)

Vlughtenburg beach was characterized by groynes until 2008. Extensive beach and foreshore nourishments in 2008 and 2009 created a new beach configuration. An entire new dune row and valley were constructed. Figure 2 shows the execution of the nourishment and the original dune, beach and coastline with groynes. Figure 3 shows the northern part of the construction, showing the groynes more clearly. After construction, the coastline was shifted several hundreds of meters seawards covering all groynes with sand.

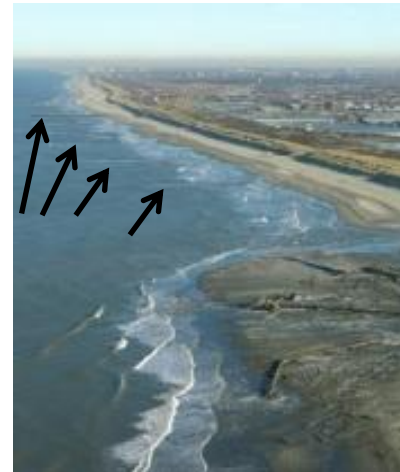
Figure 3: Aerial photograph of the northern end of the Vlughtenburg field site during construction. Groynes at the southern end are already covered with sand. (source: www.delflandsekust.nl)

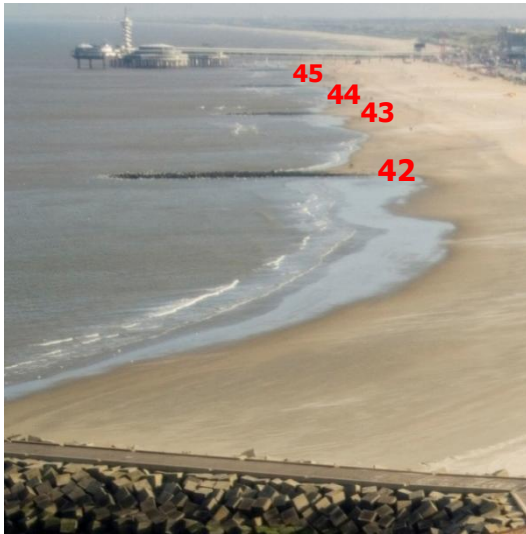
Figure 4: Beach of Scheveningen prior to the nourishment in 2009. Numbers correspond to individual groynes. (source: www.kustfoto.nl)

Scheveningen beach is the main tourist beach of the city of the Hague, located just north of the harbour moles. Figures 4 and 5 show the beach of Scheveningen before and after the nourishment of 2010 respectively. The nourishment covered the groynes completely with sand. The alongshore (lateral) boundaries of the nourishment initially resulted in sharp alongshore gradients in the coastline.

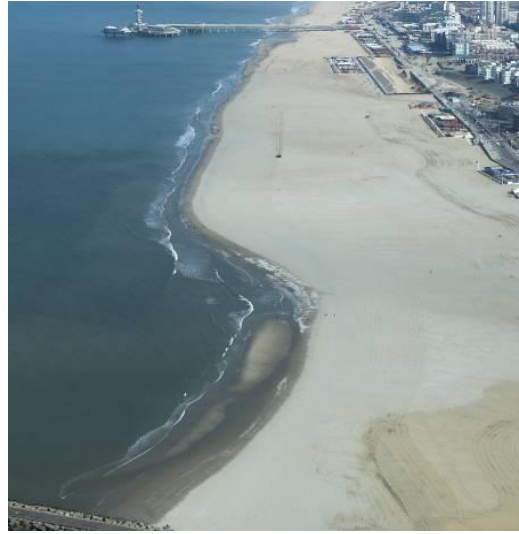
Figure 5: Nourished beach of Scheveningen in 2010. Groynes 42 to 44 are covered by the nourishment, 45 still present. (source: projectbureau Combinatie Delftlandse Kust)

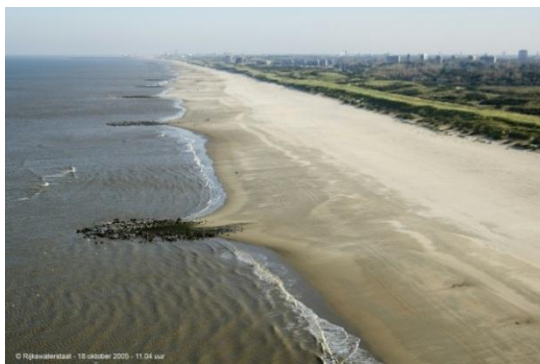
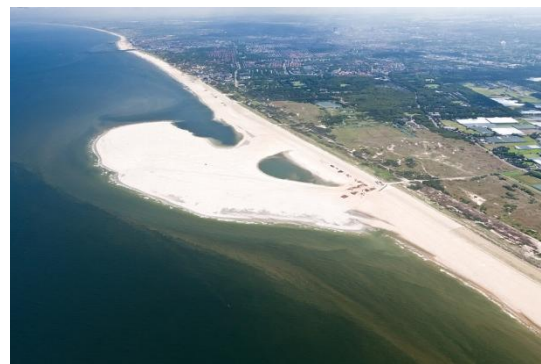
Figure 6 and 7: Coastline between The Hague and Ter Heijde before and after the mega scale nourishment 'The Sandengine'.

The third field site is the mega scale nourishment just north of Ter Heijde and south of The Hague (HVRB post 1), called the Sandengine (see Fig. 1). Approximately 19 Mm^3 sand has been nourished along a 2.5 km stretch of coast. The nourishment is designed as sediment supplier for the adjacent coast and provider of extra natural and recreational area. Like the other field sites, existing groynes were covered with sand as a result of the nourishment and an entirely new coastline and beach configuration was created (Figures 6 and 7).

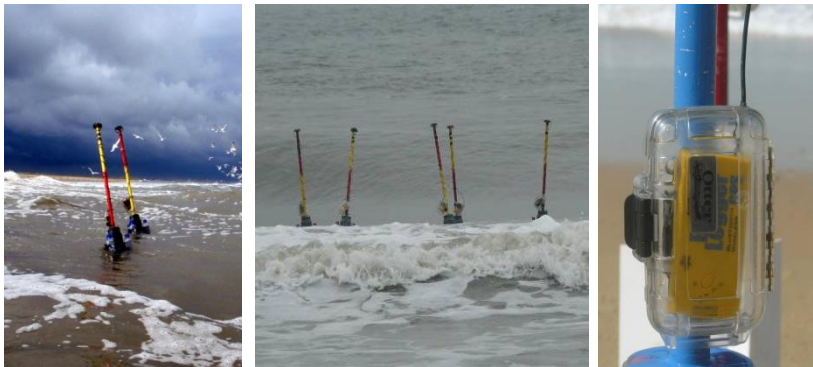
Figures 8, 9 and 10: GPS data loggers attached to PVC buoys. (GPS drifters)

The GPS drifters are free-floating devices used to derive the velocities of the top layer of the watercolumn. The GPS records the position of the drifter with high accuracy enabling to calculate the velocities and to make a coupling of drifter trajectories with the bottom contours. The GPS drifters (Figures 8 to 10) are built similar to the design described by MacMahan et al. (2009). They consist of a buoyant 0.1 m by 0.3 m PVC body on which a 0.7 m by 0.03 m PVC mast is attached. The GPS antenna is mounted on top of the drifter on a metal disk with a diameter of 0.05 m. Three fins along the shaft of the body are attached for sail area under water. The drifters are designed to minimise surfing back to the beach on the roller of a breaking wave, as they tilt on wave impact. A flat plate attached to the bottom reduces surfing and ballast weights attached to the bottom increase stability of the drifters. The drifters were shown to closely follow simultaneous dye release and passive swimmers.

The GPS data loggers are housed in a waterproof box attached to the mast, see Figure 10. The loggers internally record carrier phase information on one frequency at a sampling frequency of 0.5Hz. The capacity of the loggers allows for measurements up to three hours. Position accuracy is in the order

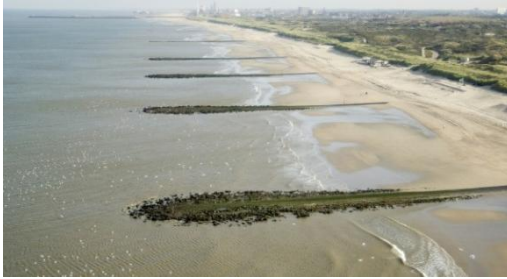
Figure 11: Picture of groynes beach around low tide. (source: www.kustfoto.nl)

Prior to the nourishments, the typical beach configuration along the South-Holland coast is a groyne beach, see Figure 11. It consists of a row of dunes, a fairly wide upper beach (O (100 m)) and a dissipative, mildly sloping inter- and sub tidal beach face (1:50 – 1:100). The groynes are separated 250 – 500 m in alongshore direction, are 100-200 m long with crest levels around MSL. The predictable morphology (in space and time) in between the groynes is gently sloping in both along and cross shore direction. Often one or two bars are present between the groynes, incised with a shallow rip channel (O (10 - 50 cm) relative to the bar top) and a deep channel adjacent to the groynes (Fig 12.). The predictable character of the morphology in between the groynes was perceived to be beneficial to swimmer safety by the lifeguards.

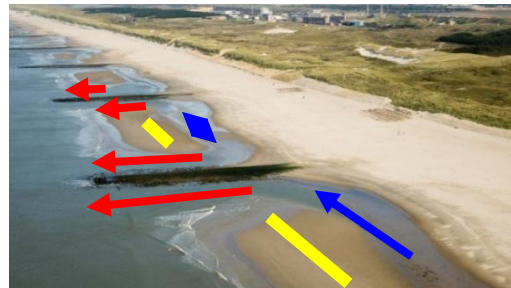
Figure 12: Schematic of permanent rips (red arrows) next to groynes. Breaker bars (yellow lines) and trough/feeder current (blue arrows) are clearly visible in the intertidal bathymetry. (source: www.kustfoto.nl)

Due to the characteristic predictable morphology, the nearshore current pattern was also predictable and well-known amongst lifeguards (due to decades of experience). The groynes with a crest level at approximately MSL deflect wave and tidal alongshore currents in the low tide period and invoke a strong outward flowing current. The current pattern on a beach with emerged groynes shows permanent rips at the upstream side of the groyne due to any longshore current and possibly eddies in the lee side of the groynes, see Fig. 13. The reduced longshore current in between the groynes (indicated as A in Fig. 13) compared to offshore (B, Fig 13) is perceived as a positive effect of the groynes on swimmer safety. On the other hand, the deflected offshore flowing current along the sides of the groynes poses a hazard for swimmers and therefore a negative effect on swimmer safety.

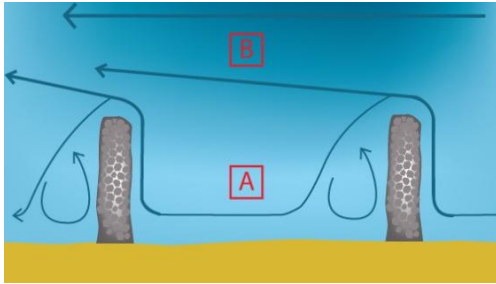
Figure 13: Schematised current pattern under oblique wave incidence or a tidal longshore current. Rip currents on the upstream side, possible eddies in the lee side of the groynes. The thickness of the lines indicates the relative current velocity and the reduction of the longshore current due to the groynes.

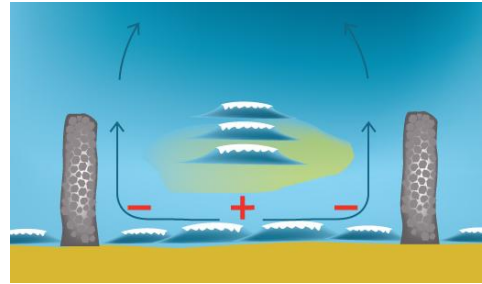
Figure 14: Schematised current pattern under normally incident waves. Shallow submerged bar in between groynes results in water level setup gradients at the shoreline indicated by + and - signs.

Besides rip currents invoked by alongshore currents, near shore-normal wave breaking can also induce rip currents in between the groynes. The associated current pattern due to normal incident wave breaking over the (submerged) bar is schematically indicated in Figure 14. In case of normally incident waves there is some wave breaking directly on top of the groyne, almost no wave breaking in the deep areas next to the groyne and intense wave breaking over the submerged bar(s). The set up in water level increases with increasing wave breaking. Consequently, there is a gradient in water level between the area behind the bar(s) and channels. This causes a current towards the channel: the feeder current. The rip currents are stronger with increasing wave breaking over the bar. Besides the gradient in water level, mass flux by and breaking of waves causes a net onshore directed flow over the bar, which flows back offshore through the feeder en rip current channel, enhancing the rip circulation. Generally, a combination of both current patterns will develop, depending on the conditions.

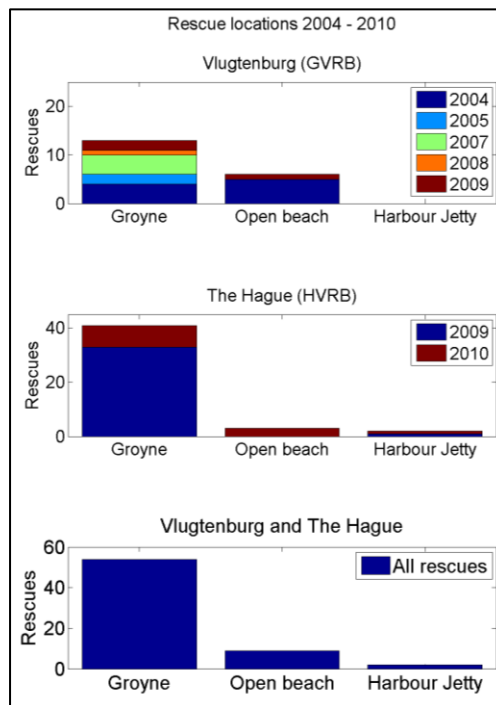
Figure 15: Rescue reports sorted to the location of the rescues, categorized as near groyne, open beach and harbour jetty for the years 2004 – 2010 at Vlugtenburg site (top), Scheveningen site (middle) and both sites combined (bottom).

Interviews with lifeguards and statistics of the rescue reports revealed that rips near emerged groynes form the biggest threat to swimmers. Figure 15 shows the amount of rescues performed near groynes and on open (nourished) beaches. Figure 16 shows the amount of rescues plotted against wind directions (and tidal phase (both vertical and horizontal tide). The beaches are facing NW, so clearly the majority of the problems for swimmers are related to longshore current invoked rip currents along the emerged groynes. A smaller part of the rescues is related to shore-normal wave breaking and thus rip currents in conventional sense. Amongst others, Lushine (1991) and Lascody (1998) performed similar research in the US to reveal a higher risk on rips for shore-normal conditions.

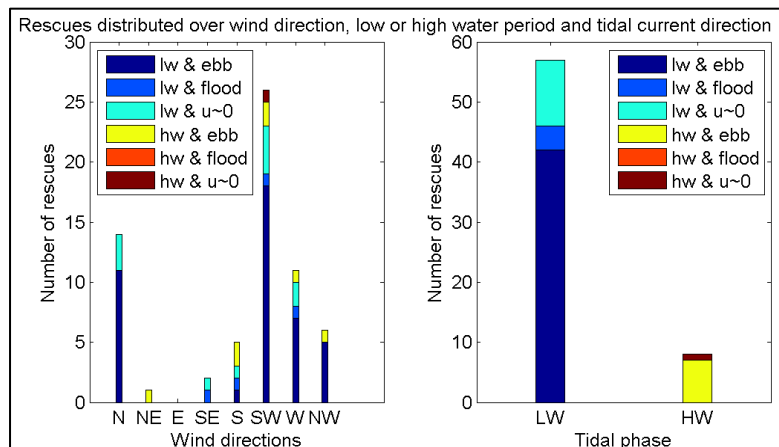
Figure 16: Rescue reports sorted to meteorological conditions and the tidal phase. Left: Rescues distributed over wind direction at times of the rescue. The colours of the bars indicate water level and approximate tidal current direction. Right: Low tide or high tide period at times of rescues.

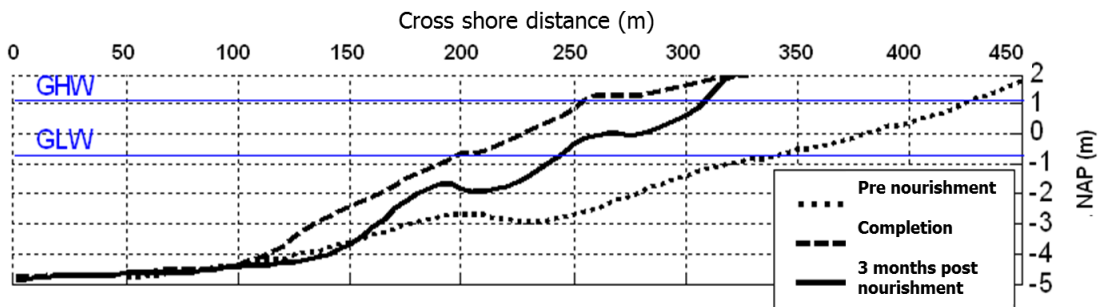
Figure 19: A beach profile at Scheveningen pre-nourishment (dotted), at completion of the nourishment (dashed) and 3 months post-nourishment (solid).

Measurements on the open nourished beach (area indicated by dotted black arrow in Figure 18) revealed strong alongshore currents close to the waterline for most measurements and no rip currents for obliquely incident waves, see Fig. 18. This is almost the opposite situation compared to the groyned beach. The strong longshore current close to the waterline could be explained by the steep beach profile post nourishment, see Fig. 19, and the absence of groynes.

Generally an alongshore (oblique) trough and bar system developed, see also Fig. 19. Combined with a strong longshore current, several hazardous situations were reported. Bathers were drawn to the

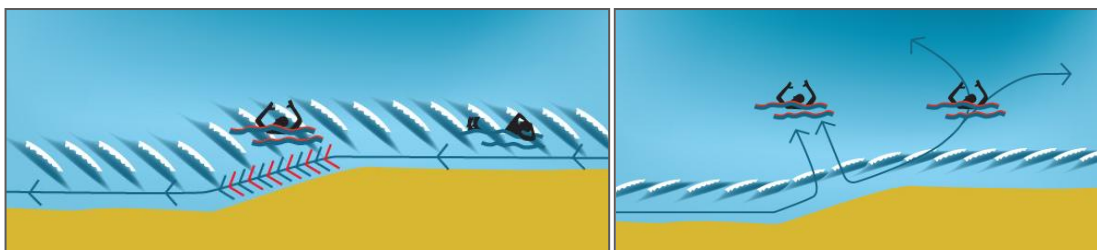
Figure 21: Schematics of hazardous situations near the lateral boundaries of the nourishment. Alongshore coastline gradients can cause alongshore flow acceleration (left) or rip currents depending on wave direction and shoreline orientation.

The lateral boundaries of nourishments often introduce gradients in the coastline. The smoother these gradients are, the less the local hydrodynamics and morphology differ from the rest of the beach. However, these gradients are often clearly visible and not very smooth. At these gradients accelerations of the longshore wave driven current and variations in beach profiles are observed, see Fig. 21.

When wave angle of incidence and the shore-normal at the gradient are parallel rip currents can also form. The lifeguards of Vlughtenburg have reported serious incidents with swimmers at similar locations as shown in Figure 21.
