FROM DETERIORATION TO REVIVAL

Approaches to the Conservation of Plastic Buildings

Ashal Tyurkay, Uta Pottgiesser

KEYWORDS: Futuro, deterioration, Conservation Management Plan (CMP), comparative analysis, plastics

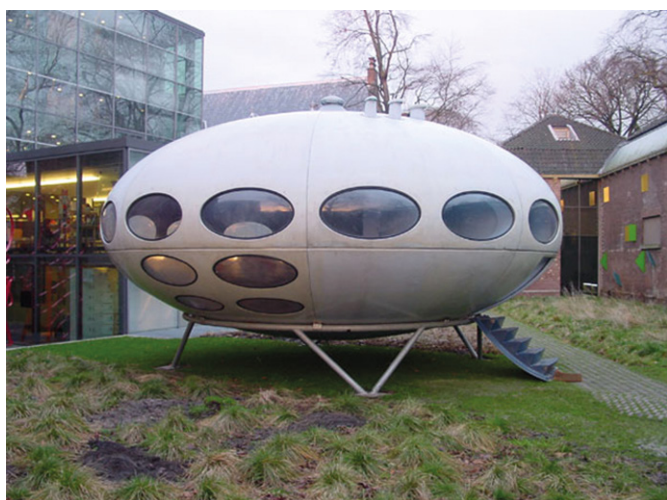
01 *Futuro No. 000* (prototype) before conservation in 2003 exhibited outside in the Centraal Museum in Utrecht. © K. Vermaas, 2003

expression and of experimental construction from post-WWII [FIGURES 01 - 04]. They witness an iterative construction process using innovative forms, materials or joints in connection with traditional building methods and techniques.²

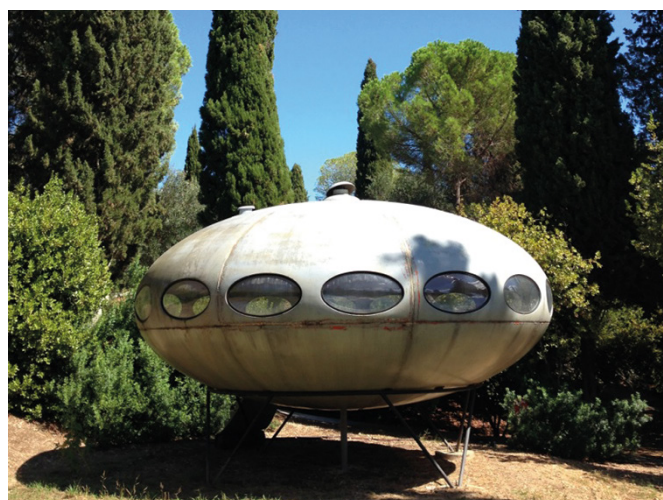
02 The *Corfu-Futuro* house installed in Limni, Corfu island. © D. Joannou, 2014

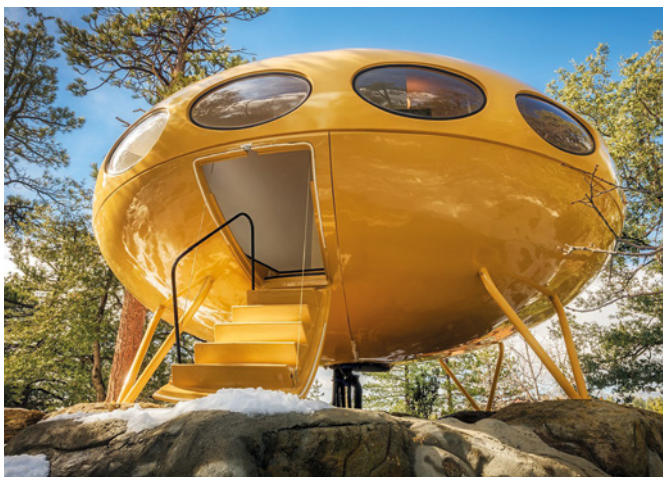
03 The *Donaldson-Futuro* is placed outside and serves as a private guest house. © P. Kozal, 2018

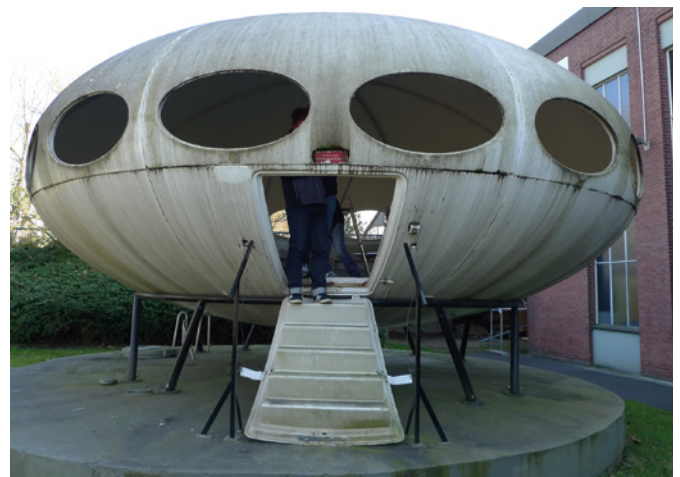
04 The *Munich-Futuro* in Witten (Germany) before transportation to Munich. © BAKU, P. Voigt, 2016.

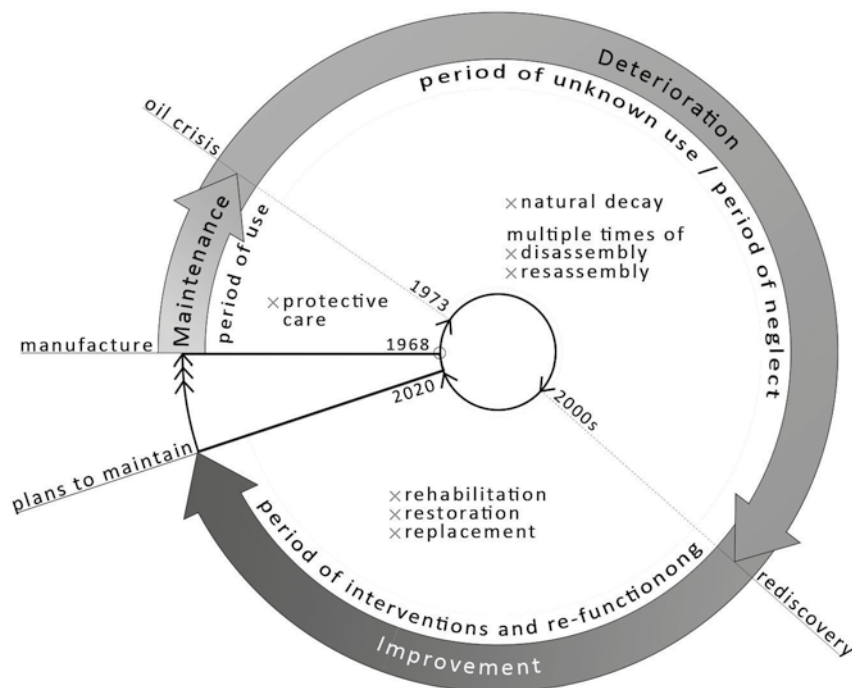
06 The Life-time Change Curve can be transformed into a life-cycle concept through conservation. © Authors
