Interlaminar adhesion assessment of carbon-epoxy laminates under salt water ageing using peel tests

Moreira Arouche, Marcio; Budhe, Sandip; Banea, Mariana D.; Teixeira De Freitas, Sofia; de Barros, Silvio

Institution of Mechanical Engineers. Proceedings. Part L: Journal of Materials: Design and Applications

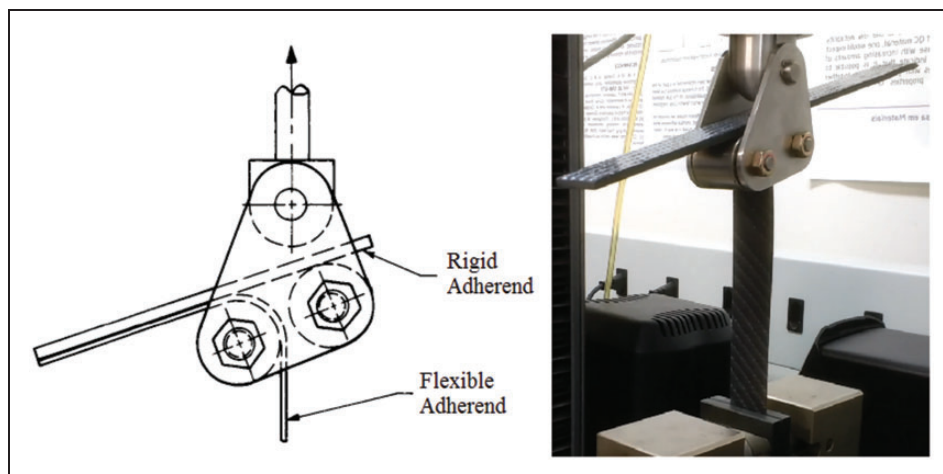
Figure 3. Floating roller peel test setup.

Figure 3 shows the test set up. The initial crack of the specimens was too short for clamping on the machine grips and had to be manually increased by pre-loading to enable testing. Load–displacement curves were recorded during testing. Three specimens were tested for each condition.

The floating roller peel test allows determining the peel strength between a rigid and a flexible adherend. Tests were performed on the specimens at room conditions, by means of an electro mechanic Instron machine (Series 5966) with a maximum capacity of 20 kN, coupled with a load cell of 1 kN. The testing speed was 125 mm/min, in accordance with the Composite Peel Test.²⁸ During the test, the flexible adherend is peeled off from the rigid adherend.
