# Modelling of damage in historical masonry façades subjected to a combination of ground settlement and vibrations

**Abstract.** Historical masonry façades are sensitive to various damaging processes. A recent study, looking at the initiation and progression of cracks in masonry, in the range of 0.1 to 5 mm in width and thus corresponding to light damage [1], has allowed for the calibration of finite-element models that include a material model capable of accurately replicating this damage and which is populated with material properties corresponding to existing structures [6]. The models, which also include a soil-structure interaction boundary designed to account for the effect of the soil during earthquake vibrations [7], have been used to determine the fragility of masonry buildings via the proxy of 2D walls [2]. In the study presented herein, the finite element models are employed to replicate the geometry of (historical) masonry facades to determine their sensitivity to light damage as a consequence of the two damaging processes observed to be most common for this type of façade, namely (differential) settlements and (earthquake) vibrations [3].

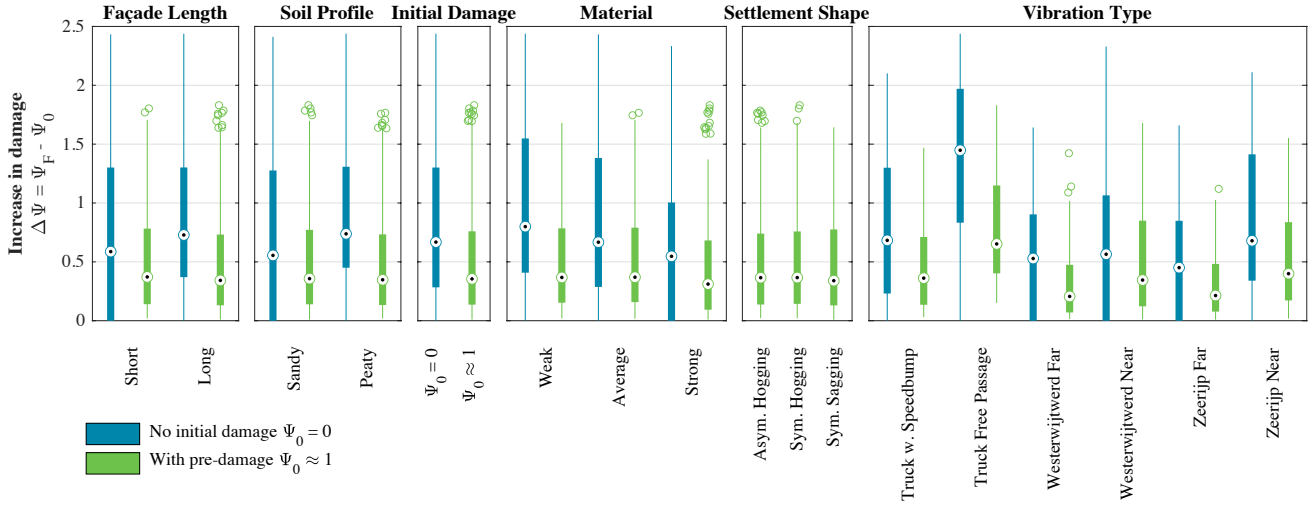
**Fig. 8.** Comparison of pooled results segregated only by the indicated parameters and, where applicable, the initial damage.

In contrast, the façade length and soil profile did not lead to large damage differences between the cases; however, the shorter façade and the sandy soil, when no initial damage had been applied, displayed less damage by the vibrations. The damage increase of the pre-damaged cases is lower than that of the virgin cases, except for very low PGVs when undamaged cases remain undamaged after the motion; this is recurrent in all the categories and summarised in the third box. However, the final damage of the pre-damaged façade is larger. It seems that pre-damage made the façades more flexible which allowed them to withstand the vibrations better; moreover, the existing damage already occupied the vulnerable spots in the façades and thus there were fewer locations for additional damage to develop. The stronger façades showed slightly less damage than the weak and average material masonry which is expected; however, this difference is less marked when the façades had sustained prior settlement damage. This is coherent with the hypothesis of damage making the façades more tolerant to additional damage. Finally, the shape of the applied soil distortion that caused pre-damage seems slightly influential when looking at the latter damage aggravation by the vibrations. For sagging shapes, a larger variation is observed, while asymmetric hogging displays the most outliers.
