**Interface adhesion assessment of composite-to-metal bonded joints under salt spray conditions using peel tests**

Teixeira de Freitas, S.; Banea, M.D.; Budhe, S.; de Barros, S.

Composite Structures

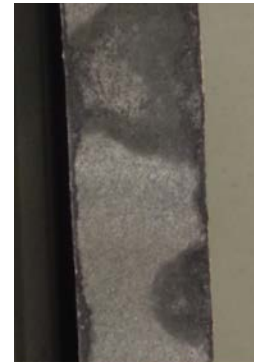
(a) non-aged

(b) 30 days in Salt Spray

(c) 90 days in Salt Spray

Figure 4. Examples of fracture surfaces of the flexible adherend (steel) after peel test.

Figure 4 shows a typical fracture surface of the steel substrate after testing. It can be seen that the cohesive failure was the dominant failure mode for the non-ageing condition – see Fig. 4(a). This indicates a good adhesion quality of the bonded joints. Cohesive failure was also the dominant failure mode after 30 days in salt spray condition, but small adhesive failure areas (less than 5%) were observed at the edges of the specimens – see Fig. 4(b). This implies

that after 30 days in SS the interface is marginally affected by the ingress of moisture. After 90 days of exposure, the adhesive failure areas increase significantly, which is also shown by the decrease in peel load. The pattern of the adhesive failure is also mainly at the edges of the specimens, but in some area crosses the complete width of the specimen, as shown in Fig 4 (c). The fracture surface of the ageing specimens shows that the moisture ingress is through the edges to the center of the specimen and it is not always affecting the complete adhesion surface. Increasing exposure times increases the moisture ingress and consequently adhesive failure areas and decreases the peel loads.

The 90 days salt spray aged specimen presented in Figure 4 (c) was selected to conduct a fractographic analysis of the different failure surfaces present along the peel length. The analysis consisted in, firstly, visually observe the exposed fracture surfaces, secondly, select areas of interest using optical microscopy and finally characterize the selected areas using Scanning Electron Microscope (SEM).
