Lifetime Prediction of PVC Push-fit Joints

Proefschrift

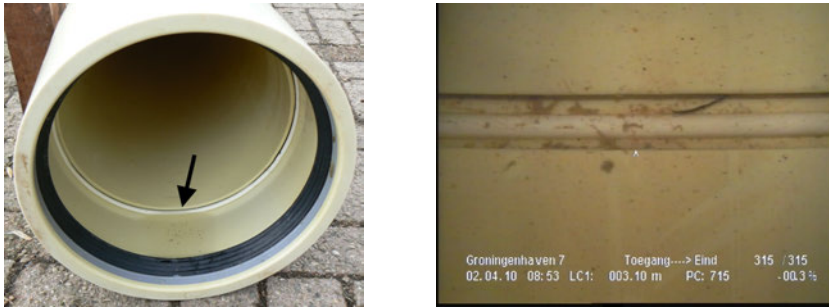
Figure 3.1: Left: image of the interior of a 315 mm PVC joint. The gap is signaled with an arrow. Right: underwater image of the interior of the same PVC joint obtained with CCTV. Please note the difference between this joint and the one presented in Figure 2.2: in this situation the ring separating both joints (white) was molded with the joint and is not a stand-alone piece.

Most of the failure modes presented in Chapter 2 can be detected by analyzing the alignment of the pipes inside of a joint. Other failure mechanisms (e.g. slow crack growth) cannot be detected when employing this approach. Inside of a joint, there is a gap (Figure 3.1). For double-socket PVC joints, the gap is the separation between the two pipes connected inside a joint. Different alignments of the pipes will correspond to different shapes of the gap.

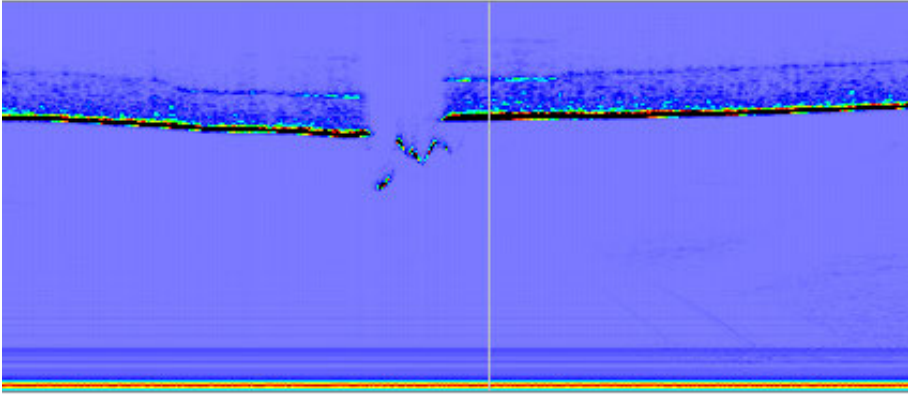
Figure 3.4: B-scan data. The x-axis represents an in-pipe axial position. The y-axis represents sound travel time (or travel distance). In the middle of the image, a discontinuity in the horizontal lines between the two vertical black lines is seen - the gap. Courtesy of Applus RTD.

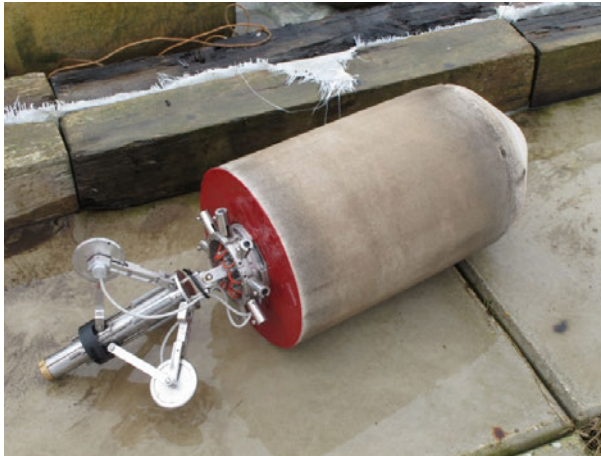
Figure 3.8: Photograph of the ultrasound tool used in the tests attached to a foam pig. Courtesy of Applus RTD.

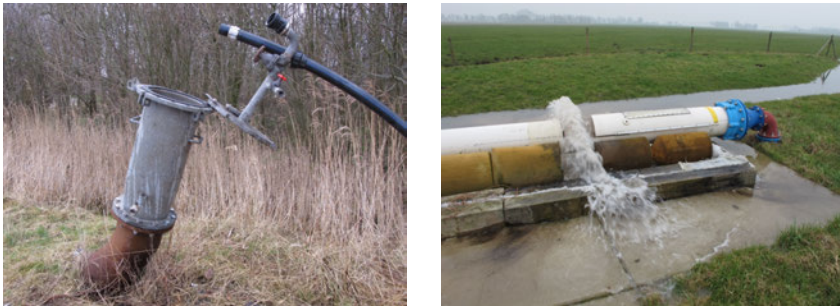
Figure 3.11: Entry point with flange and hose (left). Exit point with sliding door above ground level (right).

A DN300 620 m long AC pipe was used. The first 20 m of pipe were PVC. This pipe was selected for the following reasons. First, it possessed all of the adaptations necessary to perform an ultrasound inspection using a foam pig - an entry and an exit point. The entry point was a flange connected to the network through a hose (Figure 3.11, left). The exit was a sliding door above ground level (Figure 3.11, right). Second, the barrels of this AC pipe were also connected with push-fit double-socket joints. Finally, an inspection of another pipe material proves that this assessment procedure can be applied to any pipe material connected with push-fit joints.

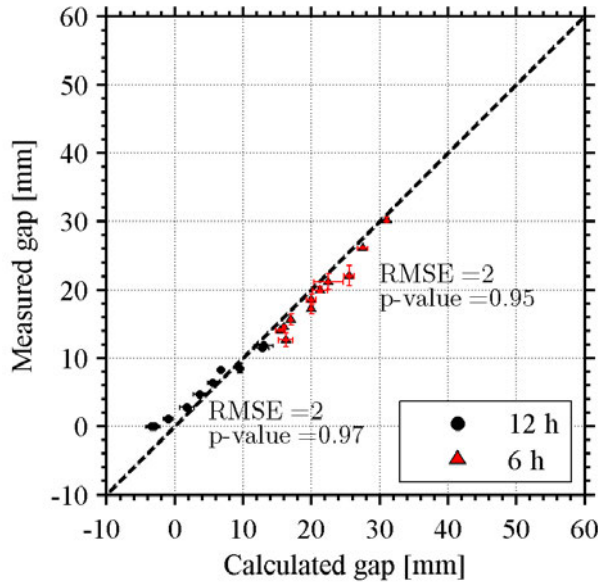
Figure 3.13: Results of the NDE inspection with the CCTV. The measured gap with CCTV is plotted against the gap that is calculated using the marks on the pipe's outer wall. For the 12 h data points, the support height increases from left (0 cm support) to right (10 cm support). For the 6 h data points, the support height increases from right (0 cm support) to left (10 cm support).

The gaps measured at the top and at the bottom with each one of the three tools are plotted together with the calculated gaps employing the marks on the pipe exterior. The results for the ultrasound, CCTV and Panoramo[®] are respectively presented in Figure 3.12, Figure 3.13, and Figure 3.14. In these figures, certain calculated gap values are negative because, at a maximum bending angle, the pipes overlap inside the joint. The error-bars are representations of the standard deviation of the measurements. The results of the RMSE and of Wilcoxon Rank Sum Tests are depicted in Table 3.5.

From Figures 3.12, 3.13, and 3.14, it is also evident that all three tools fail to size negative gaps (overlapping pipes), which was expected given their characteristics. Nevertheless, this is the reason why all three tools seem more accurate for wider gaps.

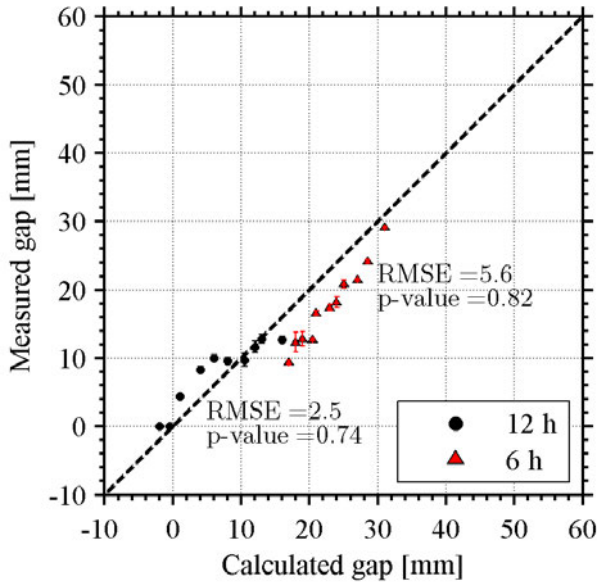
Figure 3.14: Results of the NDE inspection with the Panoramo[®]. The measured gap with Panoramo[®] is plotted against the gap calculated using the marks on the pipe's outer wall. For the 12 h data points, the support height increases from left (0 cm support) to right (10 cm support). For the 6 h data points, the support height increases from right (0 cm support) to left (10 cm support).

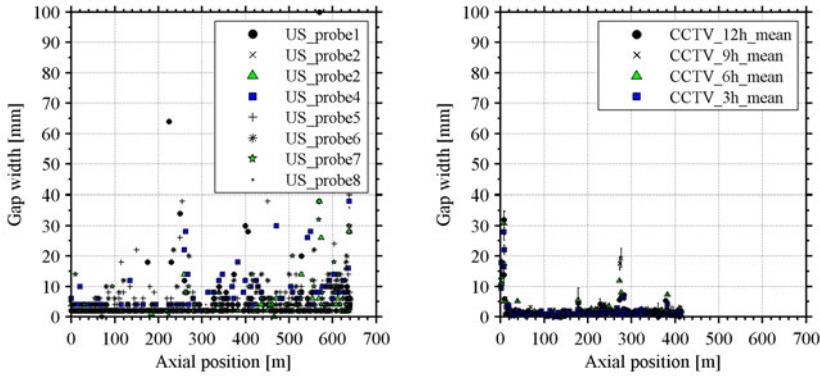
Figure 3.15: Results of the NDE inspection with the ultrasound (left) and CCTV (right). The gap measured with both the ultrasound and the CCTV is plotted against the in-pipe axial position.

The gaps measured by the eight ultrasound probes are provided in Figure 3.15 (left). The gaps measured by the CCTV at 3 h, 6 h, 9 h and 12 h are depicted in Figure 3.15 (right). In Figure 3.15 (right), the error bars represent the standard deviation of the measurements. The results of the Wilcoxon Rank Sum Tests are presented in Table 3.6.

For the AC sections of the pipe, several gaps appear to be wider than 20 mm with many reaching 30 mm to 40 mm.

be explained with the debris (mostly sand and iron) discovered at the bottom of the pipe (6 h) during this inspection. For some joints, the beginning and the end of the gap was not visible, and the operator, in order to size the gap, had to estimate these boundaries.

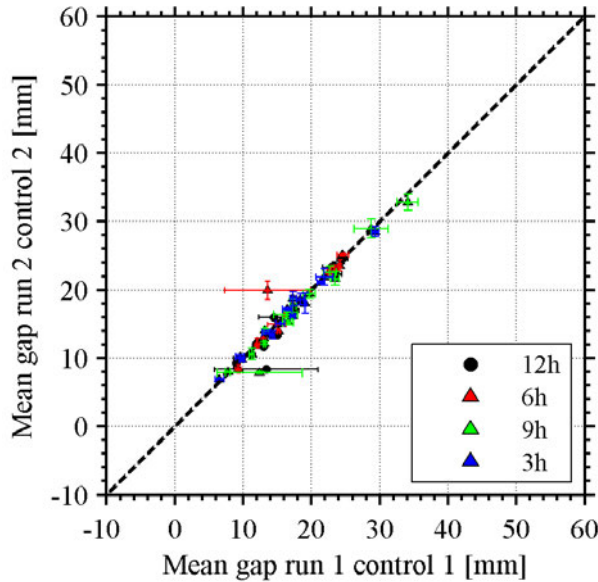
Figure 3.18: CCTV results of inspection three. The mean gap calculated for run 2 and control 2 is plotted against the mean gap calculated for run 1 and control 1. The line $x=y$ is also presented.

The results of inspections one, two, and three are illustrated in Figure 3.16, Figure 3.17, and Figure 3.18, respectively. In these figures, the error bars represent the standard deviation of the measurements. The results of the Wilcoxon Rank Sum Tests are provided in Table 3.7.

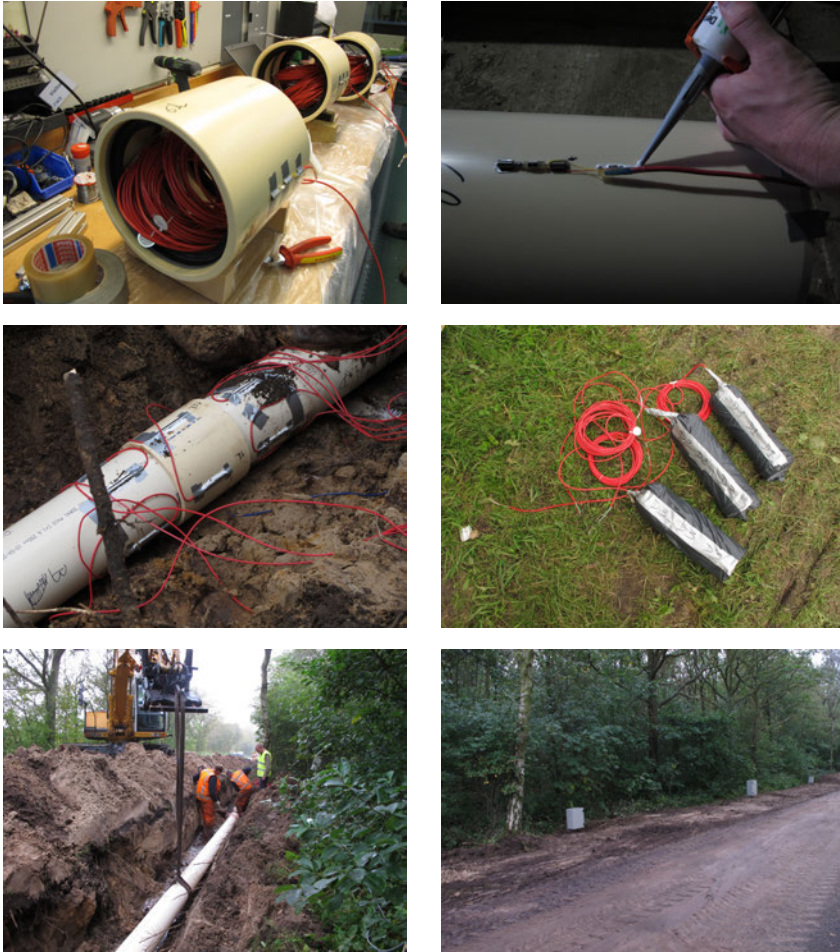
Figure 4.2: Photos taken during the installation of the sensors. Top left: the strain gauges fixed on the joints. Top right: a strain gauge being fixed on a pipe. Middle left: the dummy strain gauges inside sealed PVC canisters. Middle right: the installation of the pipe. Bottom left: the strain gauges fixed to a joint and two pipes. Bottom right: following the installation, the three cabinets are visible above ground.

To monitor strain on pipes and joints, strain gauges were used (Figure 4.2, top and middle-left). Three monitoring locations were created:

strain dummy strain gauges were also used. To prepare the dummies, strain gauges were glued to small rectangular coupons (10 cm×4 cm) made of PVC similar to the installed pipe. These coupons were then sealed in water proof-canisters to isolate them from the surrounding soil and water (Figure 4.2, middle-right). The PVC canisters were 50 cm sections of 110 mm PVC pipes. These dimensions minimized the friction between the PVC coupons and the inside of the PVC canisters. Therefore, the dummy strain gauges, while being responsive to temperature changes comparable to those experienced by the gauges installed on the pipe and joints, are isolated from all other factors (e.g. traffic).

For this work, a newly installed 250 mm PVC pipe that serves approximately 1,250 customers in the region of North Holland, in the Netherlands, was selected. The installation of the sensors was performed on the 27th of September 2011 (Figure 4.2,

Pipes and joints are monitored with strain gauges and, adjacent to each joint, a thermistor and a dummy were installed. Three cabinets were placed above ground 1 m away from the pipe (Figure 4.2, bottom right). A complete list of the installed sensors (per monitoring location) is provided in Table 4.1. All sensors were first checked in the laboratory.

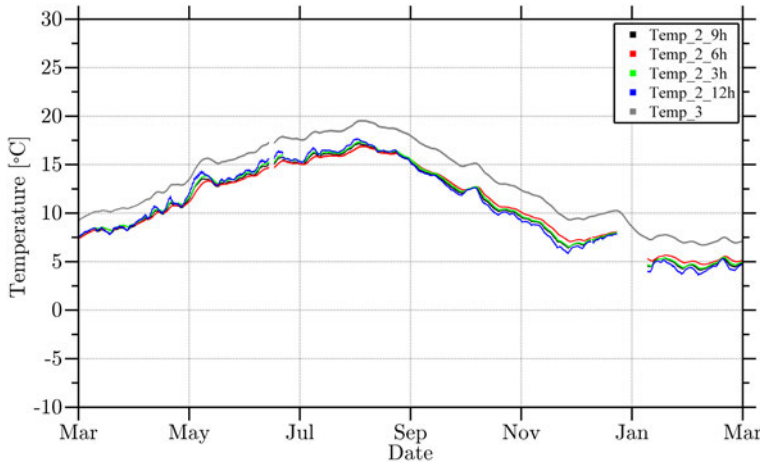
Figure 4.8: The temperature recorded by Thermistor 3 ($Temp_3$) is plotted together with the temperatures recorded at joint 2 (3h, 6h, 9h and 12h).

In Figure 4.7, the temperatures recorded by Thermistor 3 (Temp_3) are plotted collectively with the temperatures recorded at point D (3h, 6h, 9h and 12h)[¶]. The temperatures recorded at joint 2 are depicted in Figure 4.8.

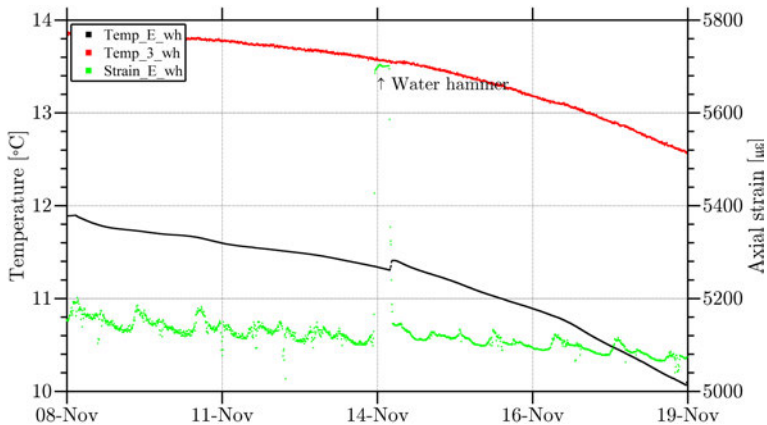
Figure 4.12: One of the water hammer episodes recorded around the 14th November of 2011. The increase in strain is indicated with a black arrow. The water utility confirmed having closed the valves on this day. Please notice the change in scale from Figures 4.11 and 4.9.

In late 2011 and beginning of 2012, two episodes of water-hammer were registered by the set-up (Arsénio et al., 2012c). Both episodes occurred before the period of analysis covered in this thesis. Nevertheless, to support the present data-analysis, the first episode is presented in Figure 4.12 (annotated). In this figure, the average strain calculated at point E is plotted together with the average temperature at point E and the temperature recorded by Thermistor 3 ($Temp_3$). It is obvious that the transient detected by the strain gauges (positive variation of more than $500 \mu\epsilon$, or 5 mm in 10 m) was not induced by changes in the soil/pipe temperature. According to the utility, a valve was closed when the water-hammer episode was detected.

From the analysis of Figure 4.12, it is also visible that the water temperature (Temp_E_wh) increased after the water-hammer. It can be hypothesized that the origin of the water flowing inside the pipe changed once the valve was closed, and that the water from the new source was warmer than previously.

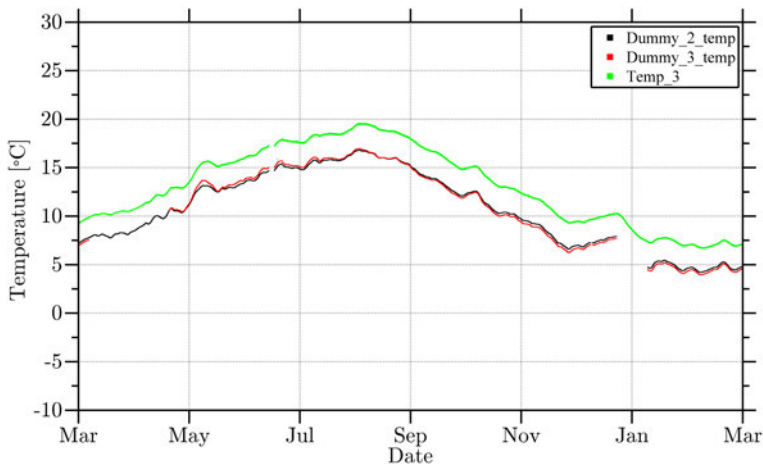
Figure 4.14: The temperature recorded by Thermistor 3 (Temp_3) is plotted together with the temperature recorded at Dummies 2 and 3.

In Figure 4.14, the temperatures recorded by temperature Thermistor 3 (Temp_3) are plotted collectively with the temperature recorded by Dummies 2 and 3**. As before, the soil temperature is higher than the temperatures registered by the dummies.

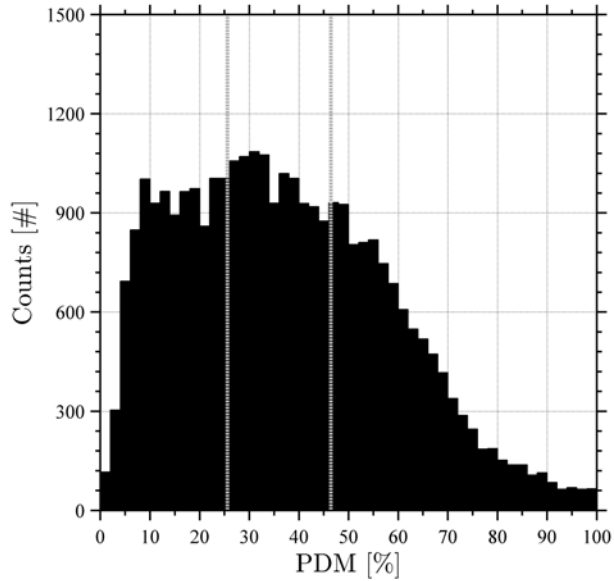
Figure 7.3: Histogram PDM. The two grey dashed vertical-lines represent the boundaries for ground movement: percentiles 33rd (PDM=25.6%) and 67th (PDM=46.4%). While LM is for PDM<25.6%, HM is for PDM>46.4%.

A histogram of PDM per cell is illustrated in Figure 7.3. The boundaries between the bins are percentiles 33rd ($PDM=25.6\%$) and the 67th ($PDM=46.4\%$) percentiles. While LM is below $PDM=25.6\%$, HM is above $PDM=46.4\%$. The boundaries are represented in Figure 7.3 by dashed vertical-lines. These boundaries were selected to allow having an equal number of counts in each bin.

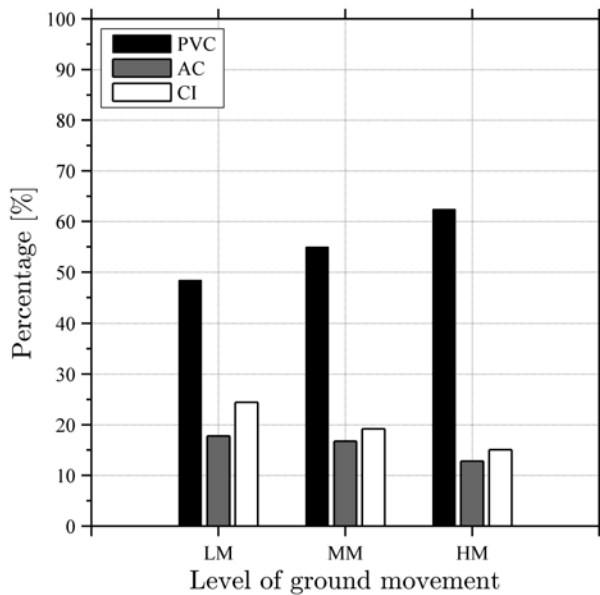
Figure 7.5: Distribution of pipe lengths per level of ground movement.

Areas with increased ground movement also have a higher percentage of PVC and lower percentages of AC and CI (Figure 7.5).

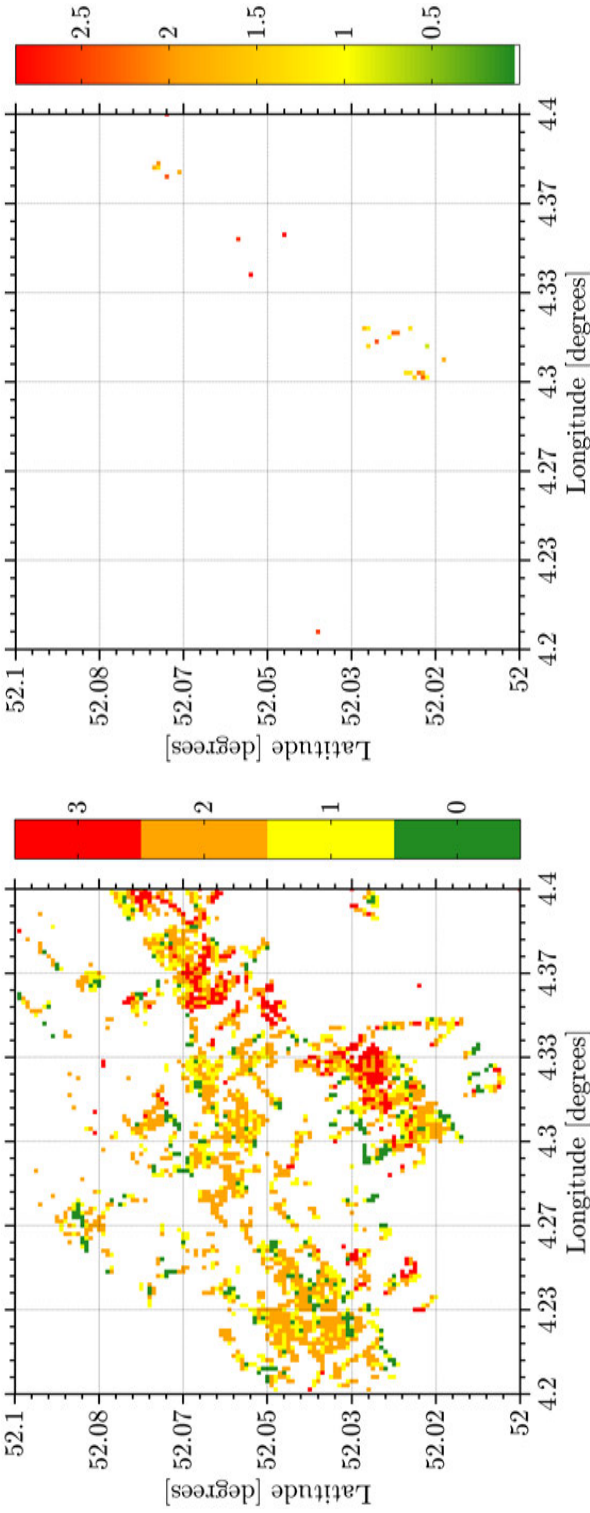
Figure 7.10: Left: risk map for AC for part of the study-area (10×10 km). The risk varies from low (green) to high (red). Right: failure rate distribution in the same area, the scale ($\# \cdot \text{km}^{-1} \cdot \text{year}^{-1}$) varies from green for cells with low failure rate until red for cells with higher failure rate. In both plots, a colored dot represents a cell (100×100 m) in which there is pipe network and for which ground movement data was available. A white dot indicates a cell without AC network and/or failures.

Using the impact matrix, the risk map was produced for AC pipes (Figure 7.10, left). To validate the assumptions of the risk-map, the distribution of failure rate in the study-area for AC pipes is depicted in Figure 7.10 (right). While, in Figure 7.10 (left), white indicates the nonexistence of pipe network and/or soil ground movement data, in Figure 7.10 (right), white indicates the absence of failures and of pipe network.

The cells that contain older pipes (Figure 7.8 in red) are also cells of higher-risk (Figure 7.10, left in red). Furthermore, the most number of failures (Figure 7.10, right) were registered inside or close to the cells of higher risk. It should be noted that there are high-risk cells without failures inside or in the vicinity. This indicates that not all high-risk areas lead to failures, but that all failures are located inside or in the vicinity of high-risk cells. Therefore, despite needing further validation, this work suggests that the areas that are presented in Figure 7.10 (left) in red, could be selected by the water utility to be inspected as discussed in Chapter 3 as they represent a greater risk for the pipes installed inside or in their vicinity.
