Looking at glass from a different angle: new insights into fracture patterns through transmitted light microscopy

Abstract

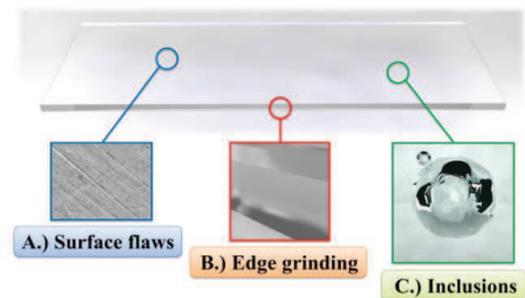
Figure 1: Flaws categorised by location (Molnár et al. 2012)

In the last decades there has been an increase of the use of glass as a building construction material. Next to window panes, glass can also be used to build columns, walls and beams. However, a true glass revolution is impeded by its uncertainty in strength. Strength tests performed on glass can yield values as high as 150 MPa and as low as 20 MPa (Veer, 2007). Mostly the lowest value is assumed to be the strength of glass in structural design. This is a waste of material when the true strength of the glass is actually much higher. Therefore, more research in the strength of glass is desirable. Glass researchers generally agree that these lower strengths are caused by flaws that weaken the glass (Bourhis, 2014, Quinn, 2007, Veer, 2007, Wurm, 2007). The types of flaws that occur in glass can be categorised by their location, see Figure 1. This paper follows this classification (Molnár et al. 2012):

- Surface, such as scratches from mishandling or pits from weathering
- Edge, such as grinding or polishing damage
- Volume, such as air bubbles or inclusion formed in the glass during its manufacturing process.

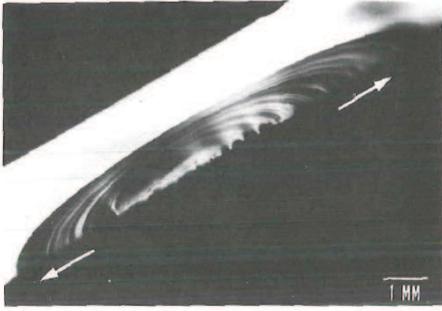
Figure 2: Wallner lines (Shinkai, 1994)

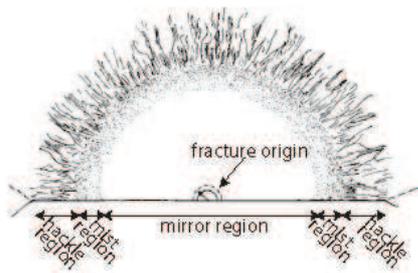
Figure 3: Regions marking the origin of fracture (Quinn, 2007)

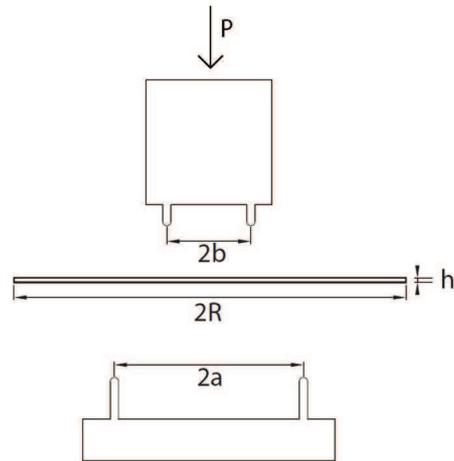
Figure 5: Ring on ring test values

The strength values of the glass in this research were determined by a Ring-on-Ring (RoR) test. It was chosen because the fracture stress is not influenced by the flaw orientation and because it introduces a large area in the glass under constant bending stress. This stress can be calculated by the formula below (Morrel, 1998). Also see Figure 5.

$$\sigma_b = \frac{3P}{2\pi h^2} \left\{ (1 - \nu) \frac{a^2 - b^2}{2R^2} + (1 + \nu) \ln \frac{a}{b} \right\} \quad (1)$$

The dimensions used are $a = 45$ mm, $b = 20$ mm, $R = 141$ mm, $h = 3.9$ mm, $\nu = 0.22$. P is the load at failure. The dimensions are based on recommended ratios (Fessler and Fricker, 1984, Morrel, 1998). 52 soda lime silica glass plates were RoR tested in an Instron 8874 loading device. The specimen dimensions are shown in Figure 6. The cruciform shape was chosen to be able to introduce compressive stresses in a later stage of the total research. The specimens were taped with transparent foil, so that the fracture pattern could be studied after failure. Friction is known to be an issue in RoR tests. Various precautions were tried to minimise this. A full description and evaluation of them can be found in this research's corresponding thesis (van der Velde, in preparation).

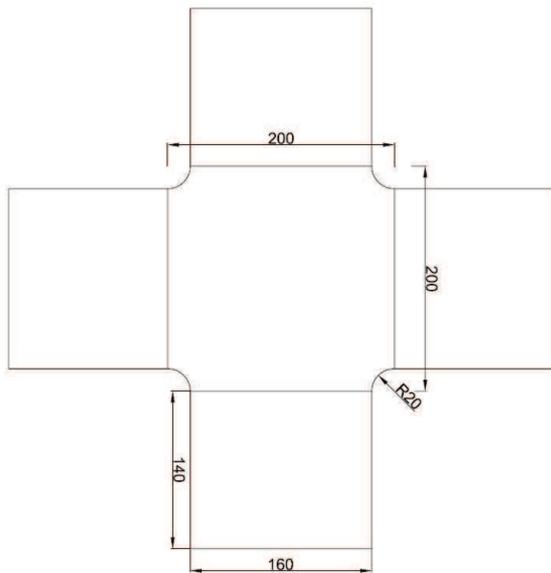
Figure 6: Dimensions of the glass specimen

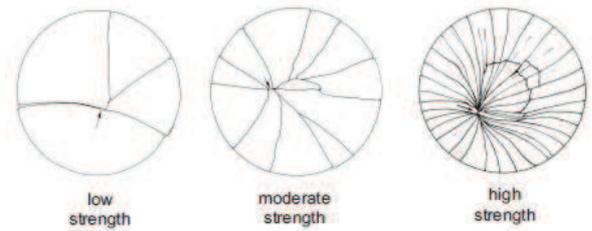
Figure 7: At high failure stress the pattern can include circumferential cracking at the loading ring (Quinn, 2007)

ranging from 42 MPa to 143 MPa. What was notable is that there was a difference in fracture pattern among the results. Some plates had the expected pattern: fracture origin inside the loading ring (category I) or at or just outside the loading ring (category R). Some of these were accompanied by a circumferential cracking pattern at the loading ring, as is reported in literature (?), see Figure 7. However some also showed such a pattern at the support ring, which is not mentioned in literature (noted by an additional S). This might have two explanations: either the cracking pattern is created by a punching shear mechanism caused by friction between the glass and rings or the pattern is created by shock waves brought along by unstable crack growth interacting with the branching cracks. Fractographical analysis might conclude this. Lastly, a few plates had a line-shaped fracture origin which is an indicator for a line-shaped flaw, such as a scratch on the surface (noted by an additional L). The plates that were examined with the microscope are depicted in the pictures on the next pages. The white circles mark the contact of the loading and support ring. The red arrows mark the likely origin crack. TT3, TT40 and TT10 were chosen because they had the smallest failure stress: 41.79 MPa, 56.16 MPa and 57.59 MPa, respectively. This is thought to be the case due to a line defect. Microscopical examination might prove this. The other three plates form a good representation of the fracture pattern categories.

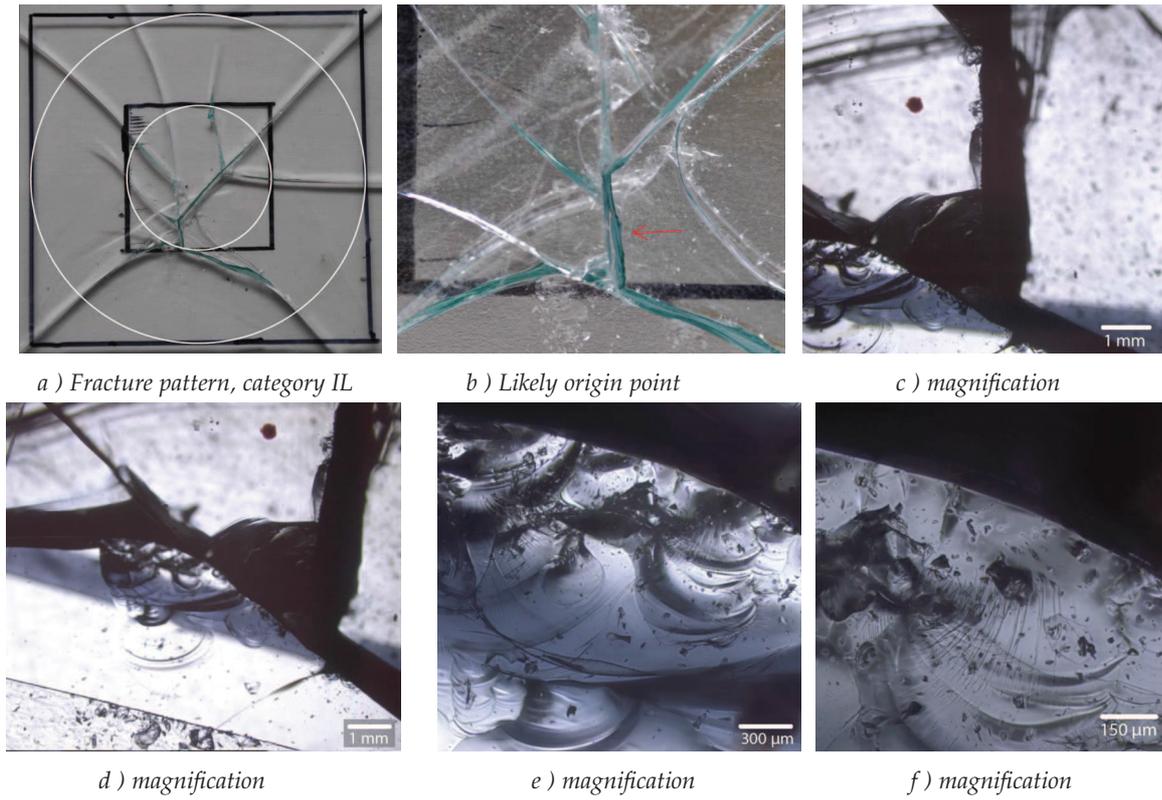
Figure 8: Fractographical analysis of TT3

TT3: At this magnification of the likely origin nothing much is seen. However looking at the left bottom, a lot of fracture marks are seen, see Figure 8c and 8d. Quinn states that the greater the failure stress at fracture, the more the stored energy and the richer the fracture marks (Quinn, 2007). Therefore it is concluded that on this line the actual origin point lies. Apparently the branching of the cracks was interpreted wrongly. In Figure 8e several origin like marks are observed.

Which is the actual first one cannot be said from this image, but it does show multiple cracking processes followed up on one another. The last figure zooms in on one of them.

It is the opinion of the authors that this technique works best in combination with fracture surface analysis, but definitely is a valuable addition. For TT3 and TT16 it seems the wrong origin crack was concluded from the visual fracture pattern analysis. In a fracture surface analysis this would have been discovered by following the Wallner lines at the fracture surface to the right origin point. However, by looking at the fracture pattern by transmitted light microscopy this can be seen in one glance and immediately gives a direction at which point to look in the fracture surface analysis. Therefore it is recommended to use these Z-axis scanned images as an overview to contemplate during the fracture surface analysis. For example for TT10 a very clear spot is marked where the fracture origin can probably be found. When having found the fracture origin at the fracture surface the researcher then can use the Z-axis scanned image to gain an understanding of the rest of the cracking process. This process cannot be deduced in one view by examining only the fracture surface. And interpreting the fracture pattern by eye can lead to wrong assumptions. This is nicely seen in the case of TT8 where twist hackle marks the crack propagation at several location in the glass in one image.

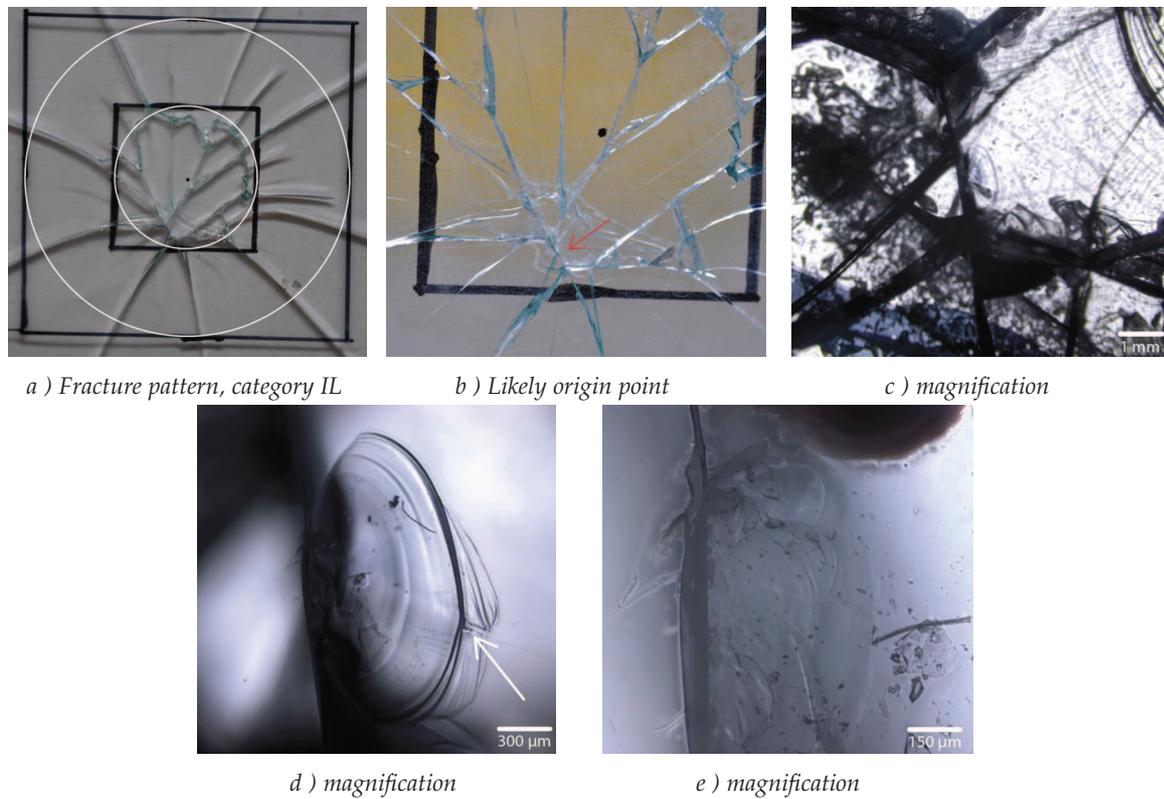
Figure 9: Fractographical analysis of TT10

TT10: This specimen gave quite a straightforward analysis. At the first crack a clear shell-shaped mark can be seen in Figure 9c. In Figure 9d stable crack growth is observed. Interestingly at the arrow a point where unstable crack growth commences is marked. Figure 9e zooms in at a magnification at the centre of shell shape where the cracking process started. Analysis of the fracture surface will have to conclude whether it is the actual point of origin.

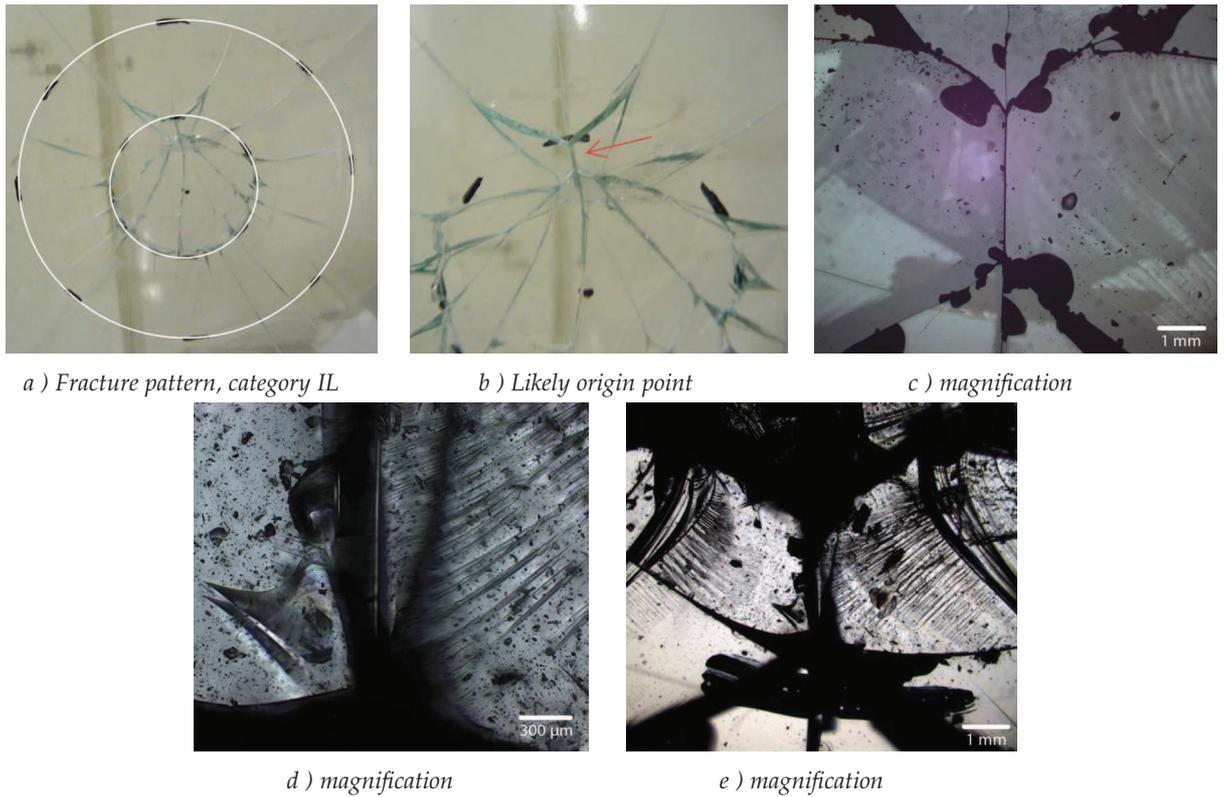
Figure 10: Fractographical analysis of TT40

TT40: In Figure 10c, made with reflected light instead of transmitted light, the crack branching is clearly seen which suggests this is the origin crack. In transmitted light in Figure 10d no starting point can be marked, but it could be blocked from view by the shadows. Looking at Figure 10e in transmitted light something interesting is going on. Twist hackle marks are observed at the sides, both with their propagation direction (marked by arrows) towards the origin crack. This is special because mostly crack propagation runs away from the origin point. Whether this is a coincidence or the origin point is actually located somewhere else cannot be concluded from this analysis alone.

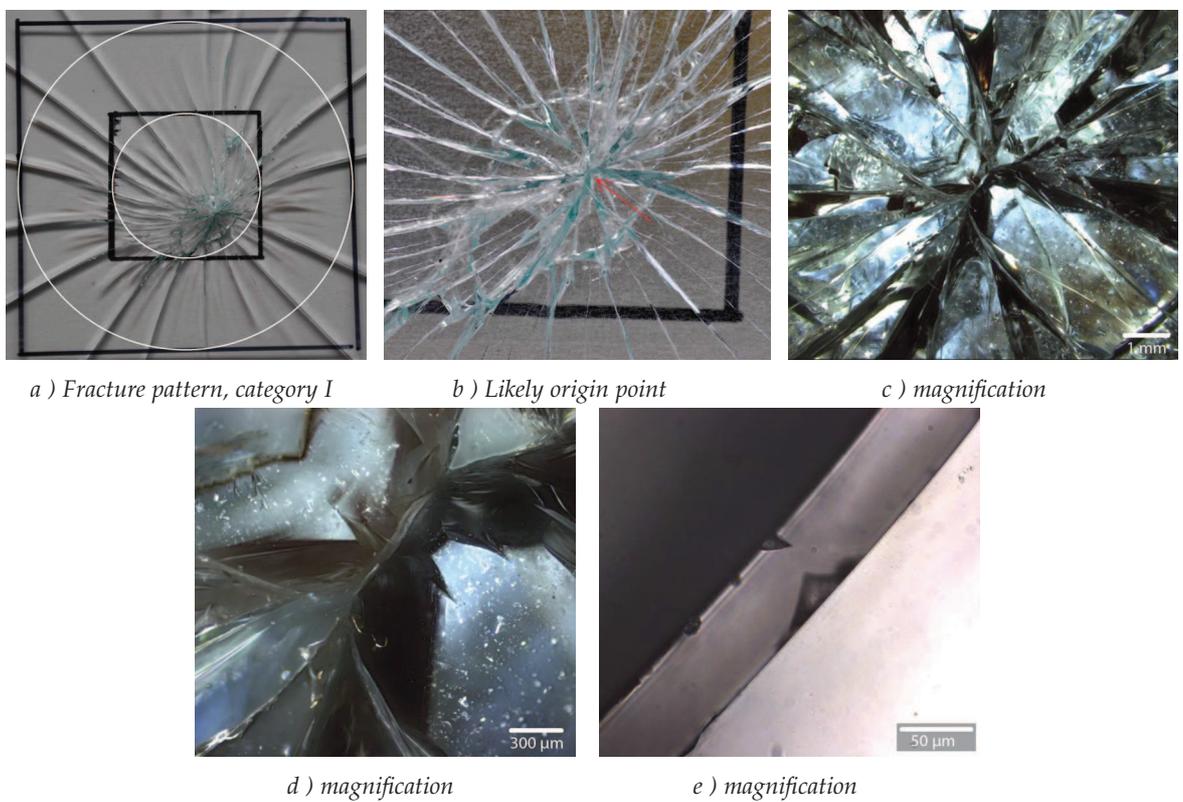
Figure 11: Fractographical analysis of TT6

TT6: The location of the fracture origin is clearly visible in this specimen. However, under the microscope so much light was coming through a gap at the crack of interest that the image was too bright. Therefore Figure 11c was taken in crossed polarised light. Despite giving a spectacular picture, in this light it is harder to distinguish the fracture marks, so it is less suitable to draw conclusions about the fracture pattern. On a sidenote, crossed polarised light can be useful in determining the composition of a material's components.

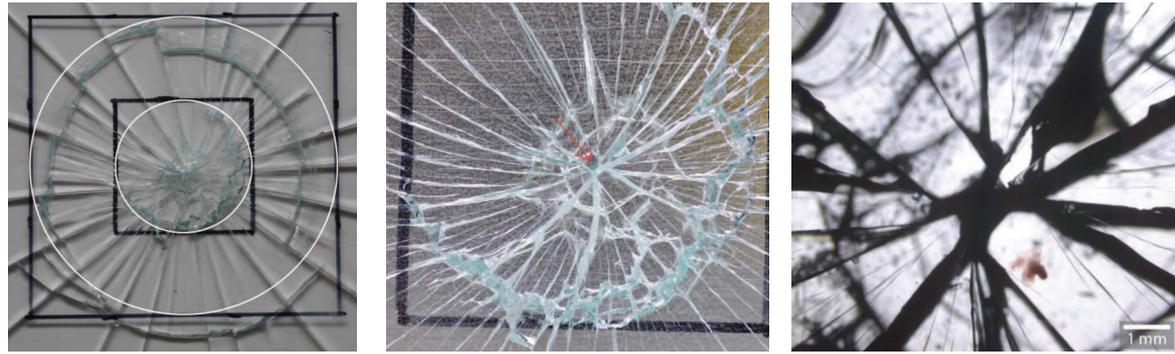
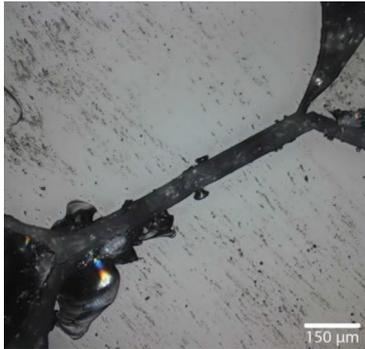
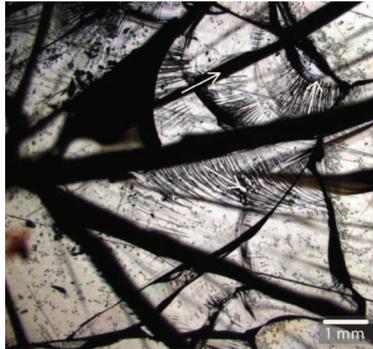
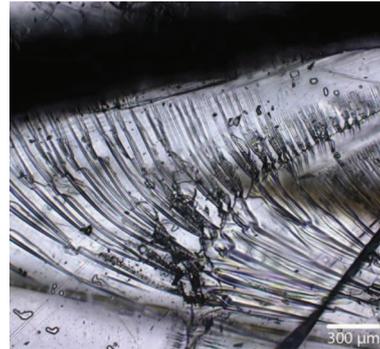
a) Fracture pattern, category IS

b) Likely origin point

c) magnification

d) magnification

e) magnification

f) magnification

Figure 12: Fractographical analysis of TT8

TT8: In this specimen the transmitted light was blocked at the crack of interest. Therefore Figure 12d was taken with reflected light only. Especially to the left, crack growth marks are observed. The origin of fracture might be found there. Figure 12e is taken to the right from the origin crack (the red dot can be used as a reference). Here twist hackle is captured that gives an indication of the ongoing crack propagation

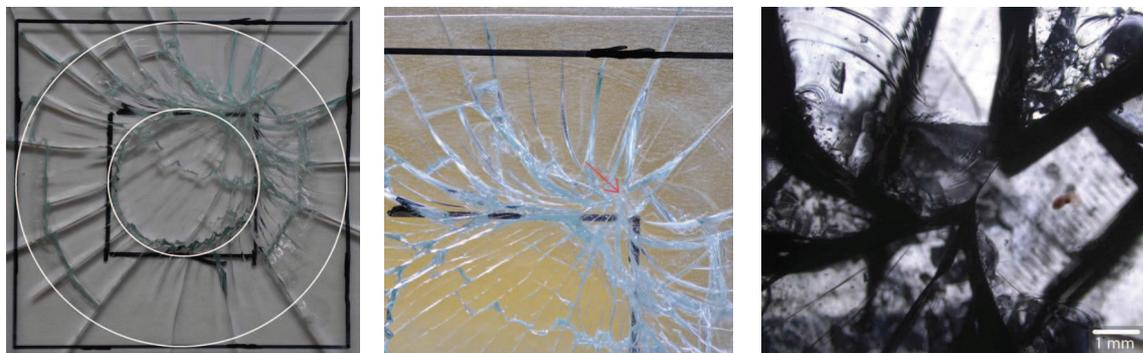
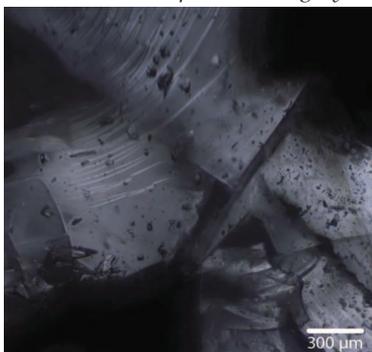
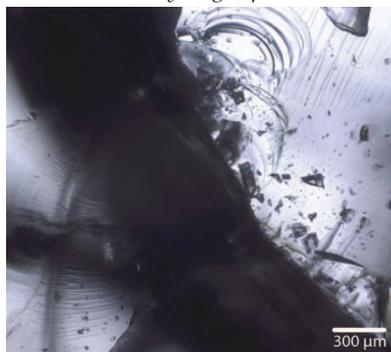
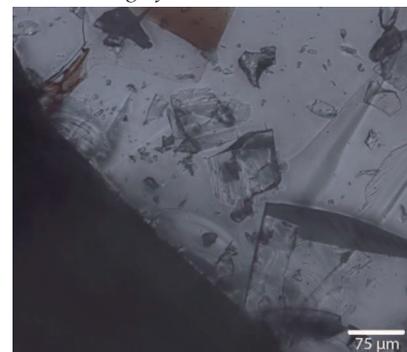
a) Fracture pattern, category RS

b) Likely origin point

c) magnification

d) magnification

e) magnification

f) magnification

Figure 13: Fractographical analysis of TT16

TT16: The origin crack seemed to have been found but under the microscope hardly any fracture marks were observed, nor in Figure 13d. Looking back at Figure 13c a lot more marks are observed to the left, which are shown in Figure 13e. Interestingly, stable crack growth is seen in the form of beach marks but they seem to be taken over by unstable crack growth in the form of hackle.

At the centre of this hackle, next to the crack more stable crack growth marks were captured in Figure 13f. The fracture may have originated there instead.
