Duró, G., Crosato, A., Kleinhans, M., & Uijttewaal, W. (2018). On the morphological evolution of restored banks: Case study of the Meuse river. *E3S Web of Conferences*, 40, Article 02021. <https://doi.org/10.1051/e3sconf/20184002021>

## 1. Introduction

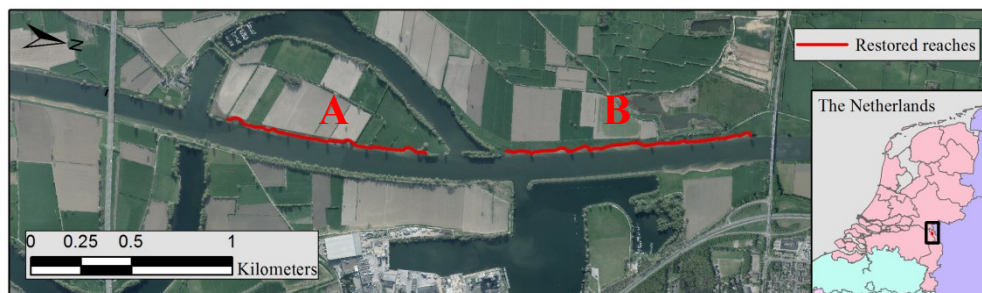
**Fig. 1.** Location of restored reaches under analysis

The Meuse River is a highly regulated river, with a series of weirs that keep minimum water levels, bend cut-offs, and protections that prevented banks from eroding. During the first phase of restorations after the WFD, 750 m of reach A (Figure 1) had the left-bank rip-rap removed in 2008. In 2010, the remaining 250 m of reach A and 1.2 km of reach B followed the same path (Figure 1).
