Regeneration of Value: Journey of a Waterfront Industrial Heritage from Abandoned to Alive

Water Sports Center Design in Gorinchem ©Xiaoling Wei (2025)

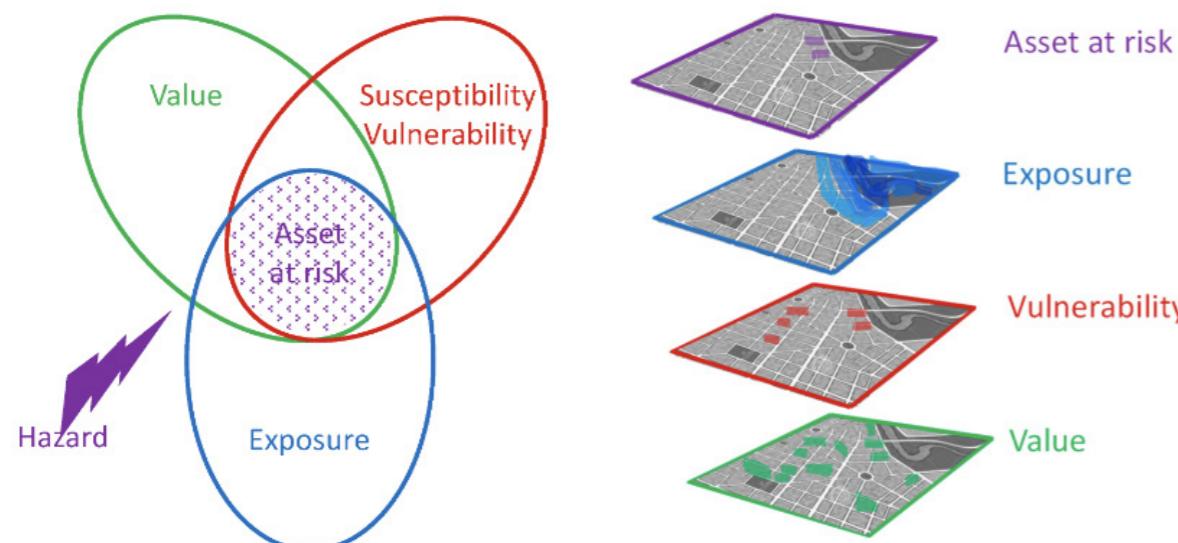
Fig. 2.1.1. Principle of the Quick Flood Risk Scan Method. ©Brokerhof et al.

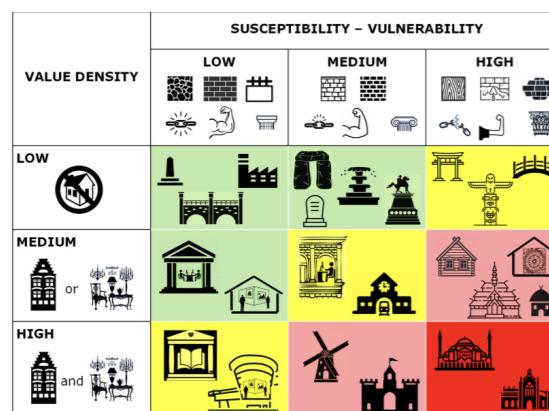
Fig. 2.1.2. Vulnerability-Value Matrix. ©Brokerhof et al.

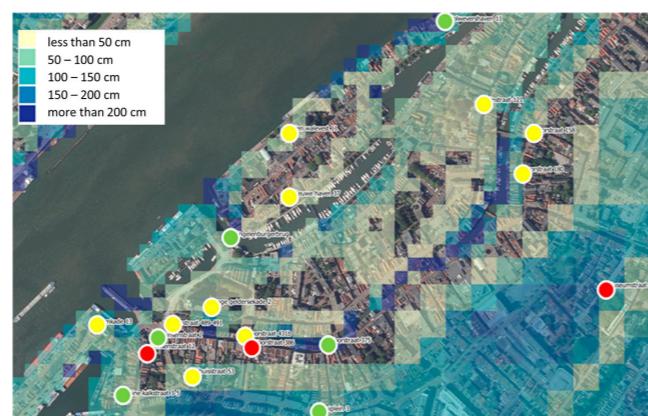
Fig. 2.1.3. Mapping of Research Objects on Hazard Map. ©Brokerhof et al.

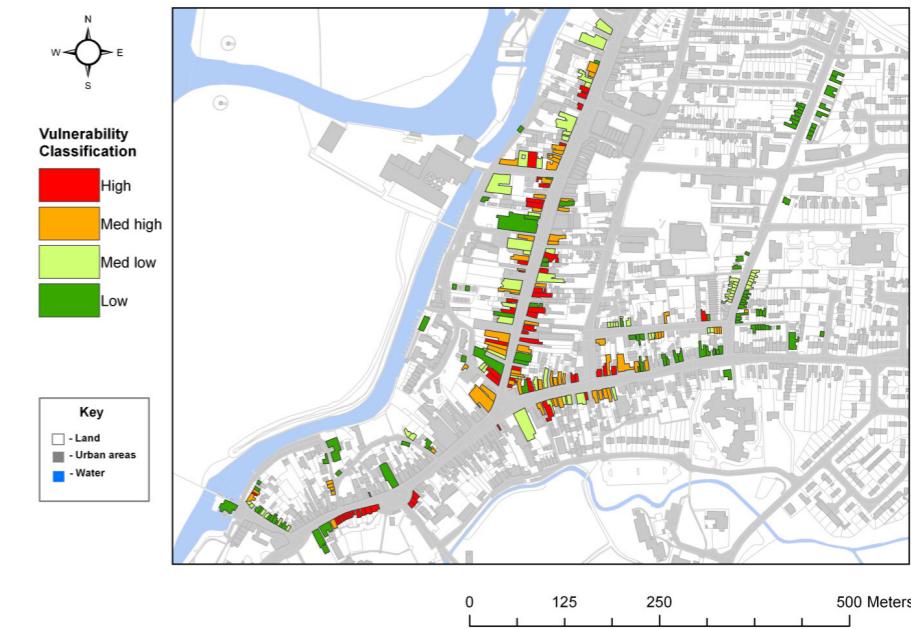
Fig. 2.2. Vulnerability Map of Tewkesbury. ©V. Stephenson and D. D'Ayala

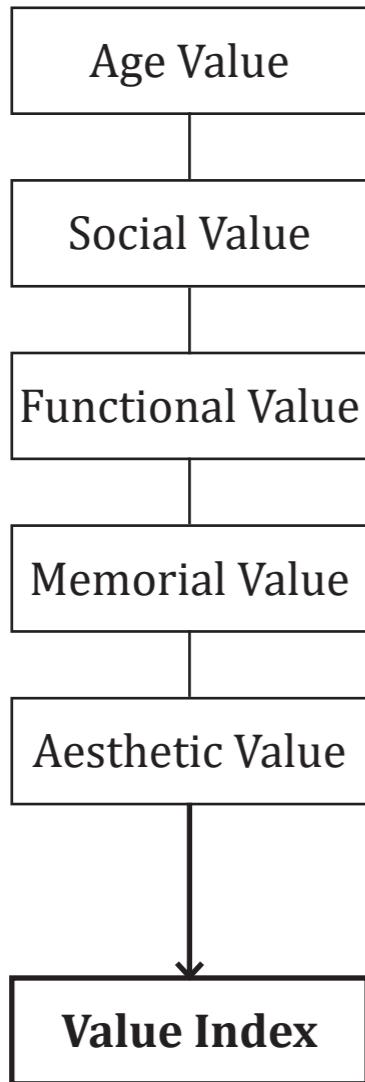
Reference Number	Value Assessment					Value Index (VI)
	Age Value	Social Value	Functional Value	Memorial Value	Aesthetic Value	
1	o	o	+	+	++	4
2	+	o	-	++	+	3
3	o	++	++	+	+	6
4	o	++	++	+	+	6
5	++	++	++	++	++	10
6	+	++	++	+	o	6
7	o	++	++	o	+	5
8	++	+	o	++	+	6
9	++	+	-	++	++	6
10	++	+	-	++	++	6
11	+	+	-	++	++	5
12	+	+	-	++	++	5
13	+	++	++	o	+	6
14	+	o	-	+	++	3
15	+	o	-	o	++	2
16	o	+	+	o	+	3
17	+	o	++	++	o	5
18	o	++	++	+	o	5
19	+	+	++	+	++	7
20	+	o	++	+	+	5
21	+	++	+	o	o	4
22	+	++	+	o	o	4
23	+	+	-	o	+	2
24	+	-	o	+	+	2
25	+	-	o	+	o	1
26	+	-	+	o	+	2
27	+	-	o	+	+	2
28	+	-	+	o	+	2
29	+	+	++	o	+	5
30	+	o	+	+	o	3

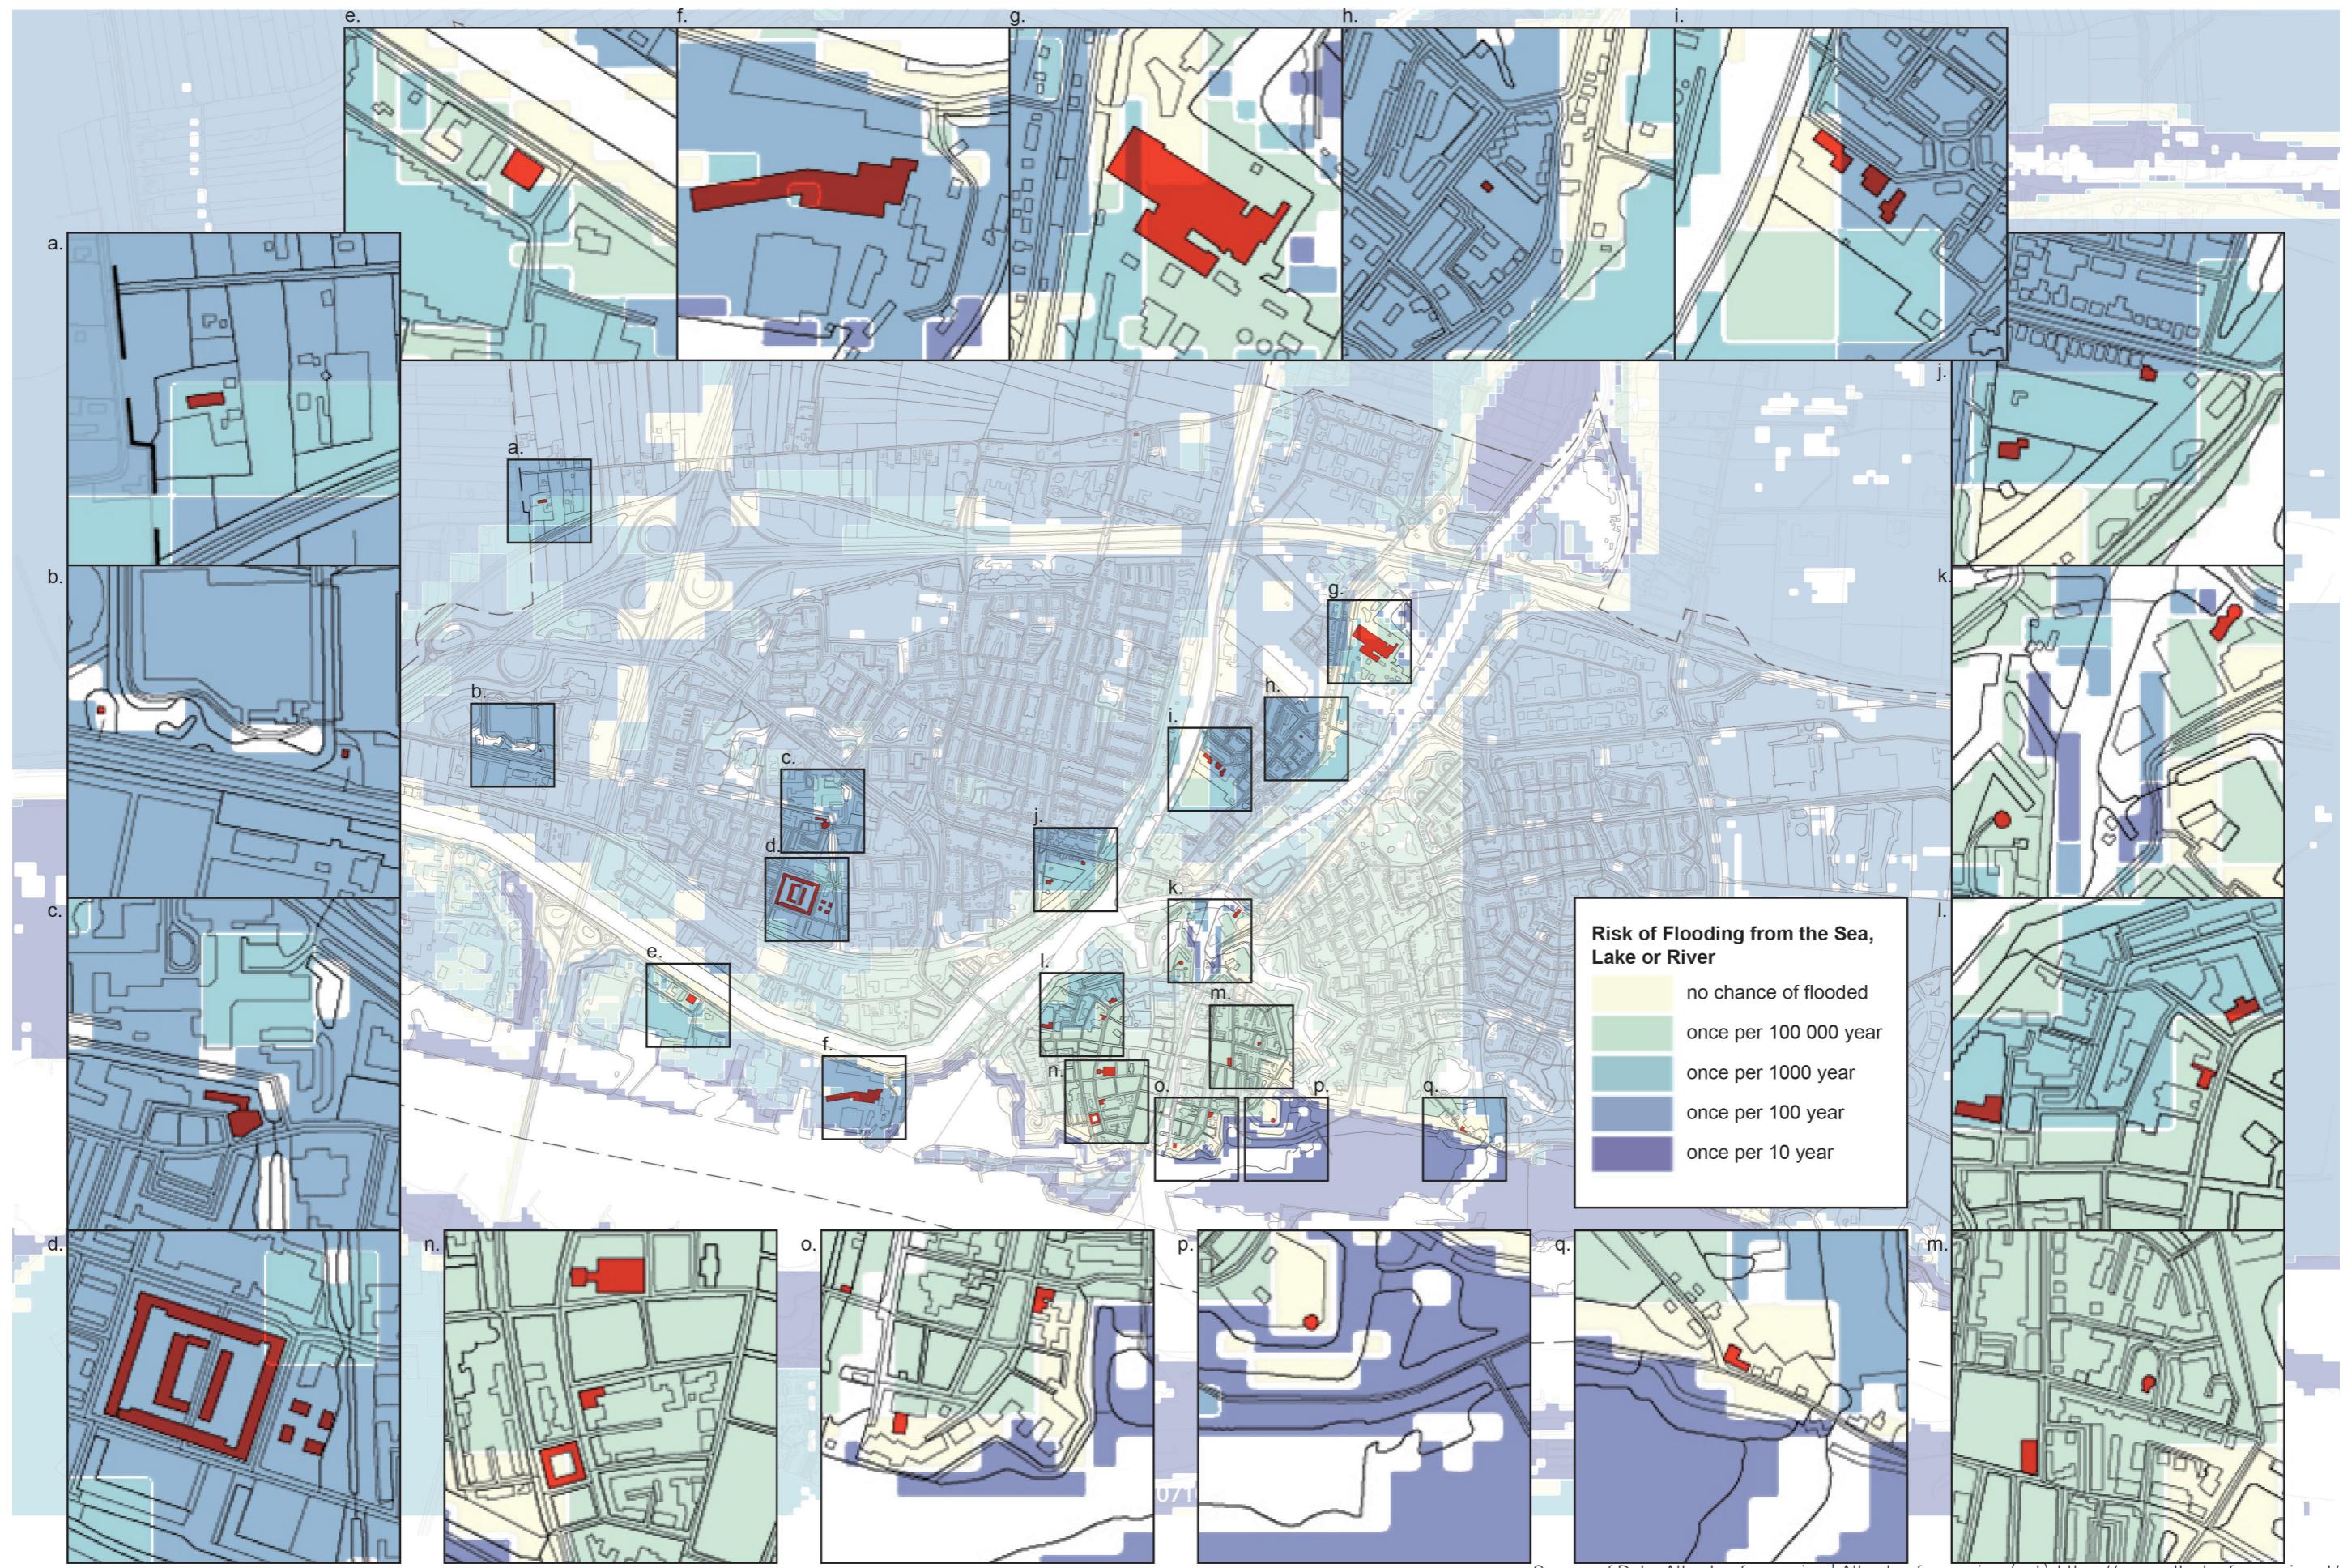
1. Risk of Flooding from the Sea, Lake or River

Source of Data: Atlas Leefomgeving | Atlas Leefomgeving. (n.d.). <https://www.atlasleefomgeving.nl/>

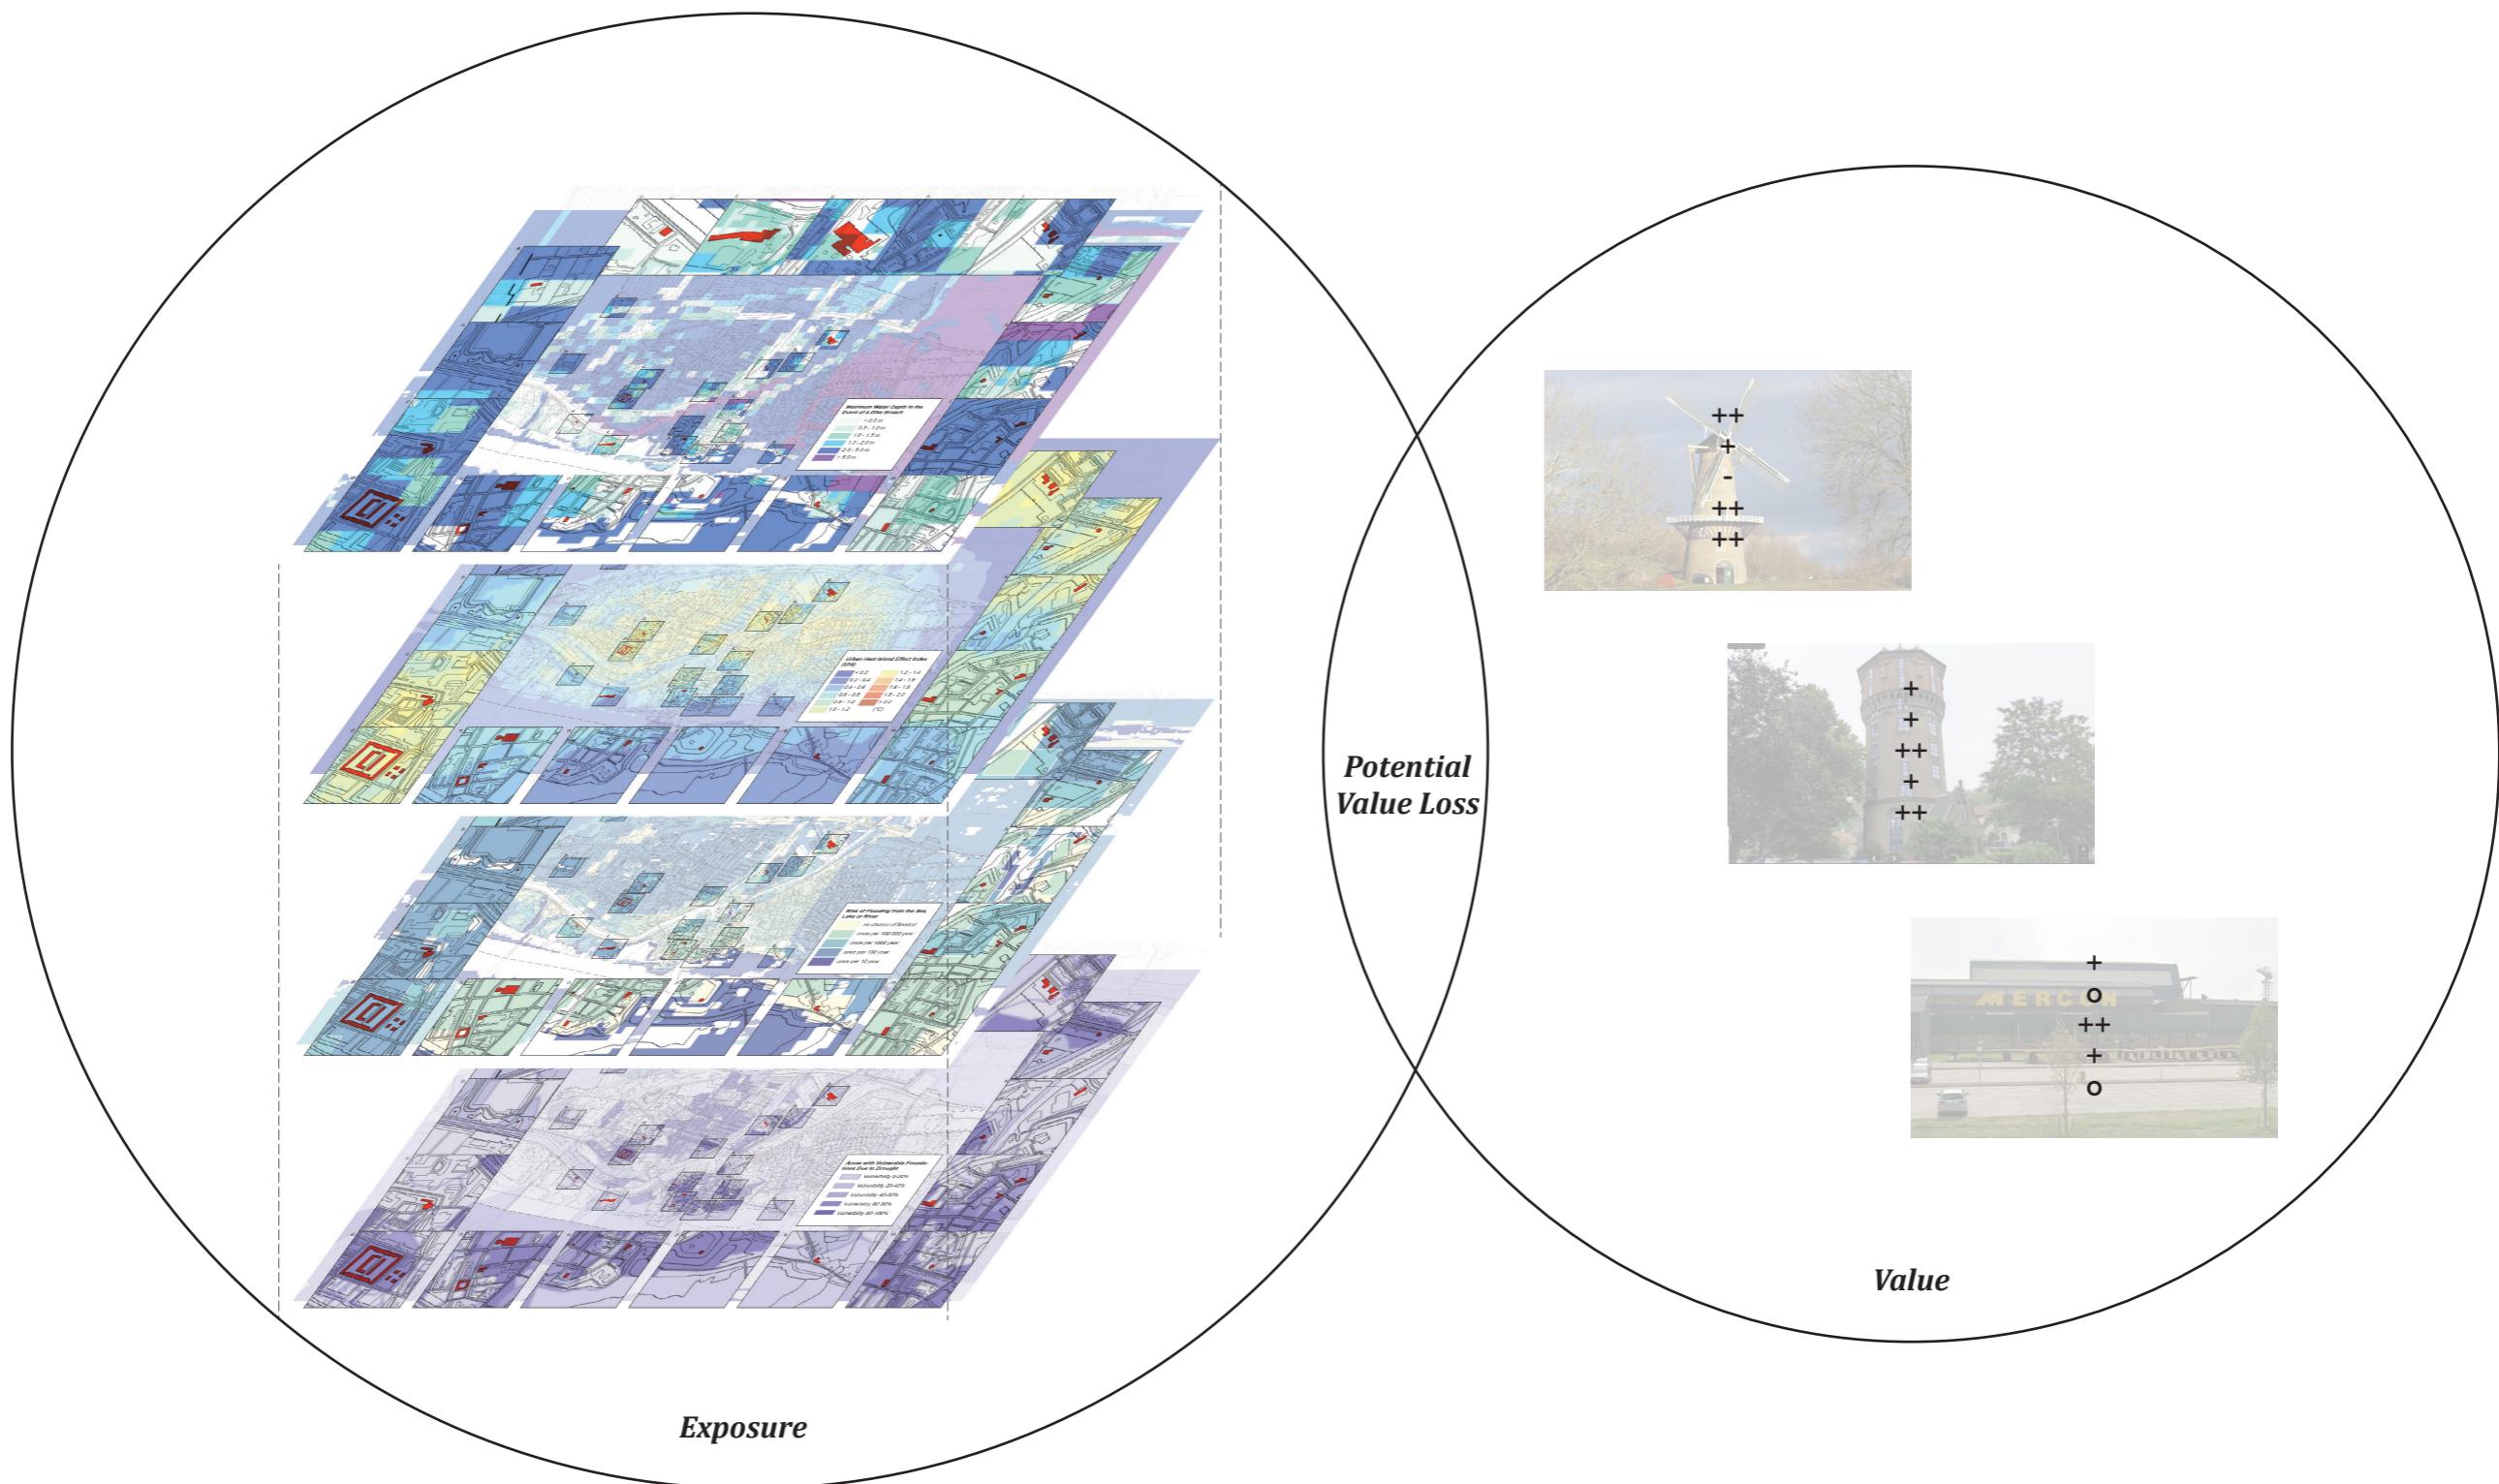
Vulnerability Assessment Results

Reference Number	Climate Vulnerability Assessment				Overall Vulnerability (OV)
	Flooding		Drought	Heat	
	1. Risk ... *	2. Maximum ... *	3. Areas ... *	4. ... UHI *	
1	low	high	low	medium	moderate
2	low	low	low	low	low
3	high	high	high	medium	high
4	low	high	medium	low	moderate
5	low	high	medium	low	moderate
6	low	low	low	low	low
7	low	high	high	low	high
8	low	high	medium	low	moderate
9	low	low	high	low	moderate
10	low	low	high	low	moderate
11	high	high	low	low	high
12	high	high	low	low	high
13	medium	high	medium	medium	moderate
14	low	medium	medium	low	moderate
15	low	medium	medium	low	moderate
16	low	low	low	low	low
17	medium	low	low	low	low
18	medium	high	low	high	high
19	low	medium	low	low	low
20	medium	high	low	medium	moderate
21	medium	high	low	high	high
22	medium	high	low	high	high
23	high	medium	low	high	high
24	low	low	low	low	low
25	high	medium	low	low	moderate
26	low	low	high	low	moderate
27	low	low	high	low	moderate

28	medium	medium	low	low	moderate
29	medium	medium	high	high	high
30	low	high	medium	medium	moderate

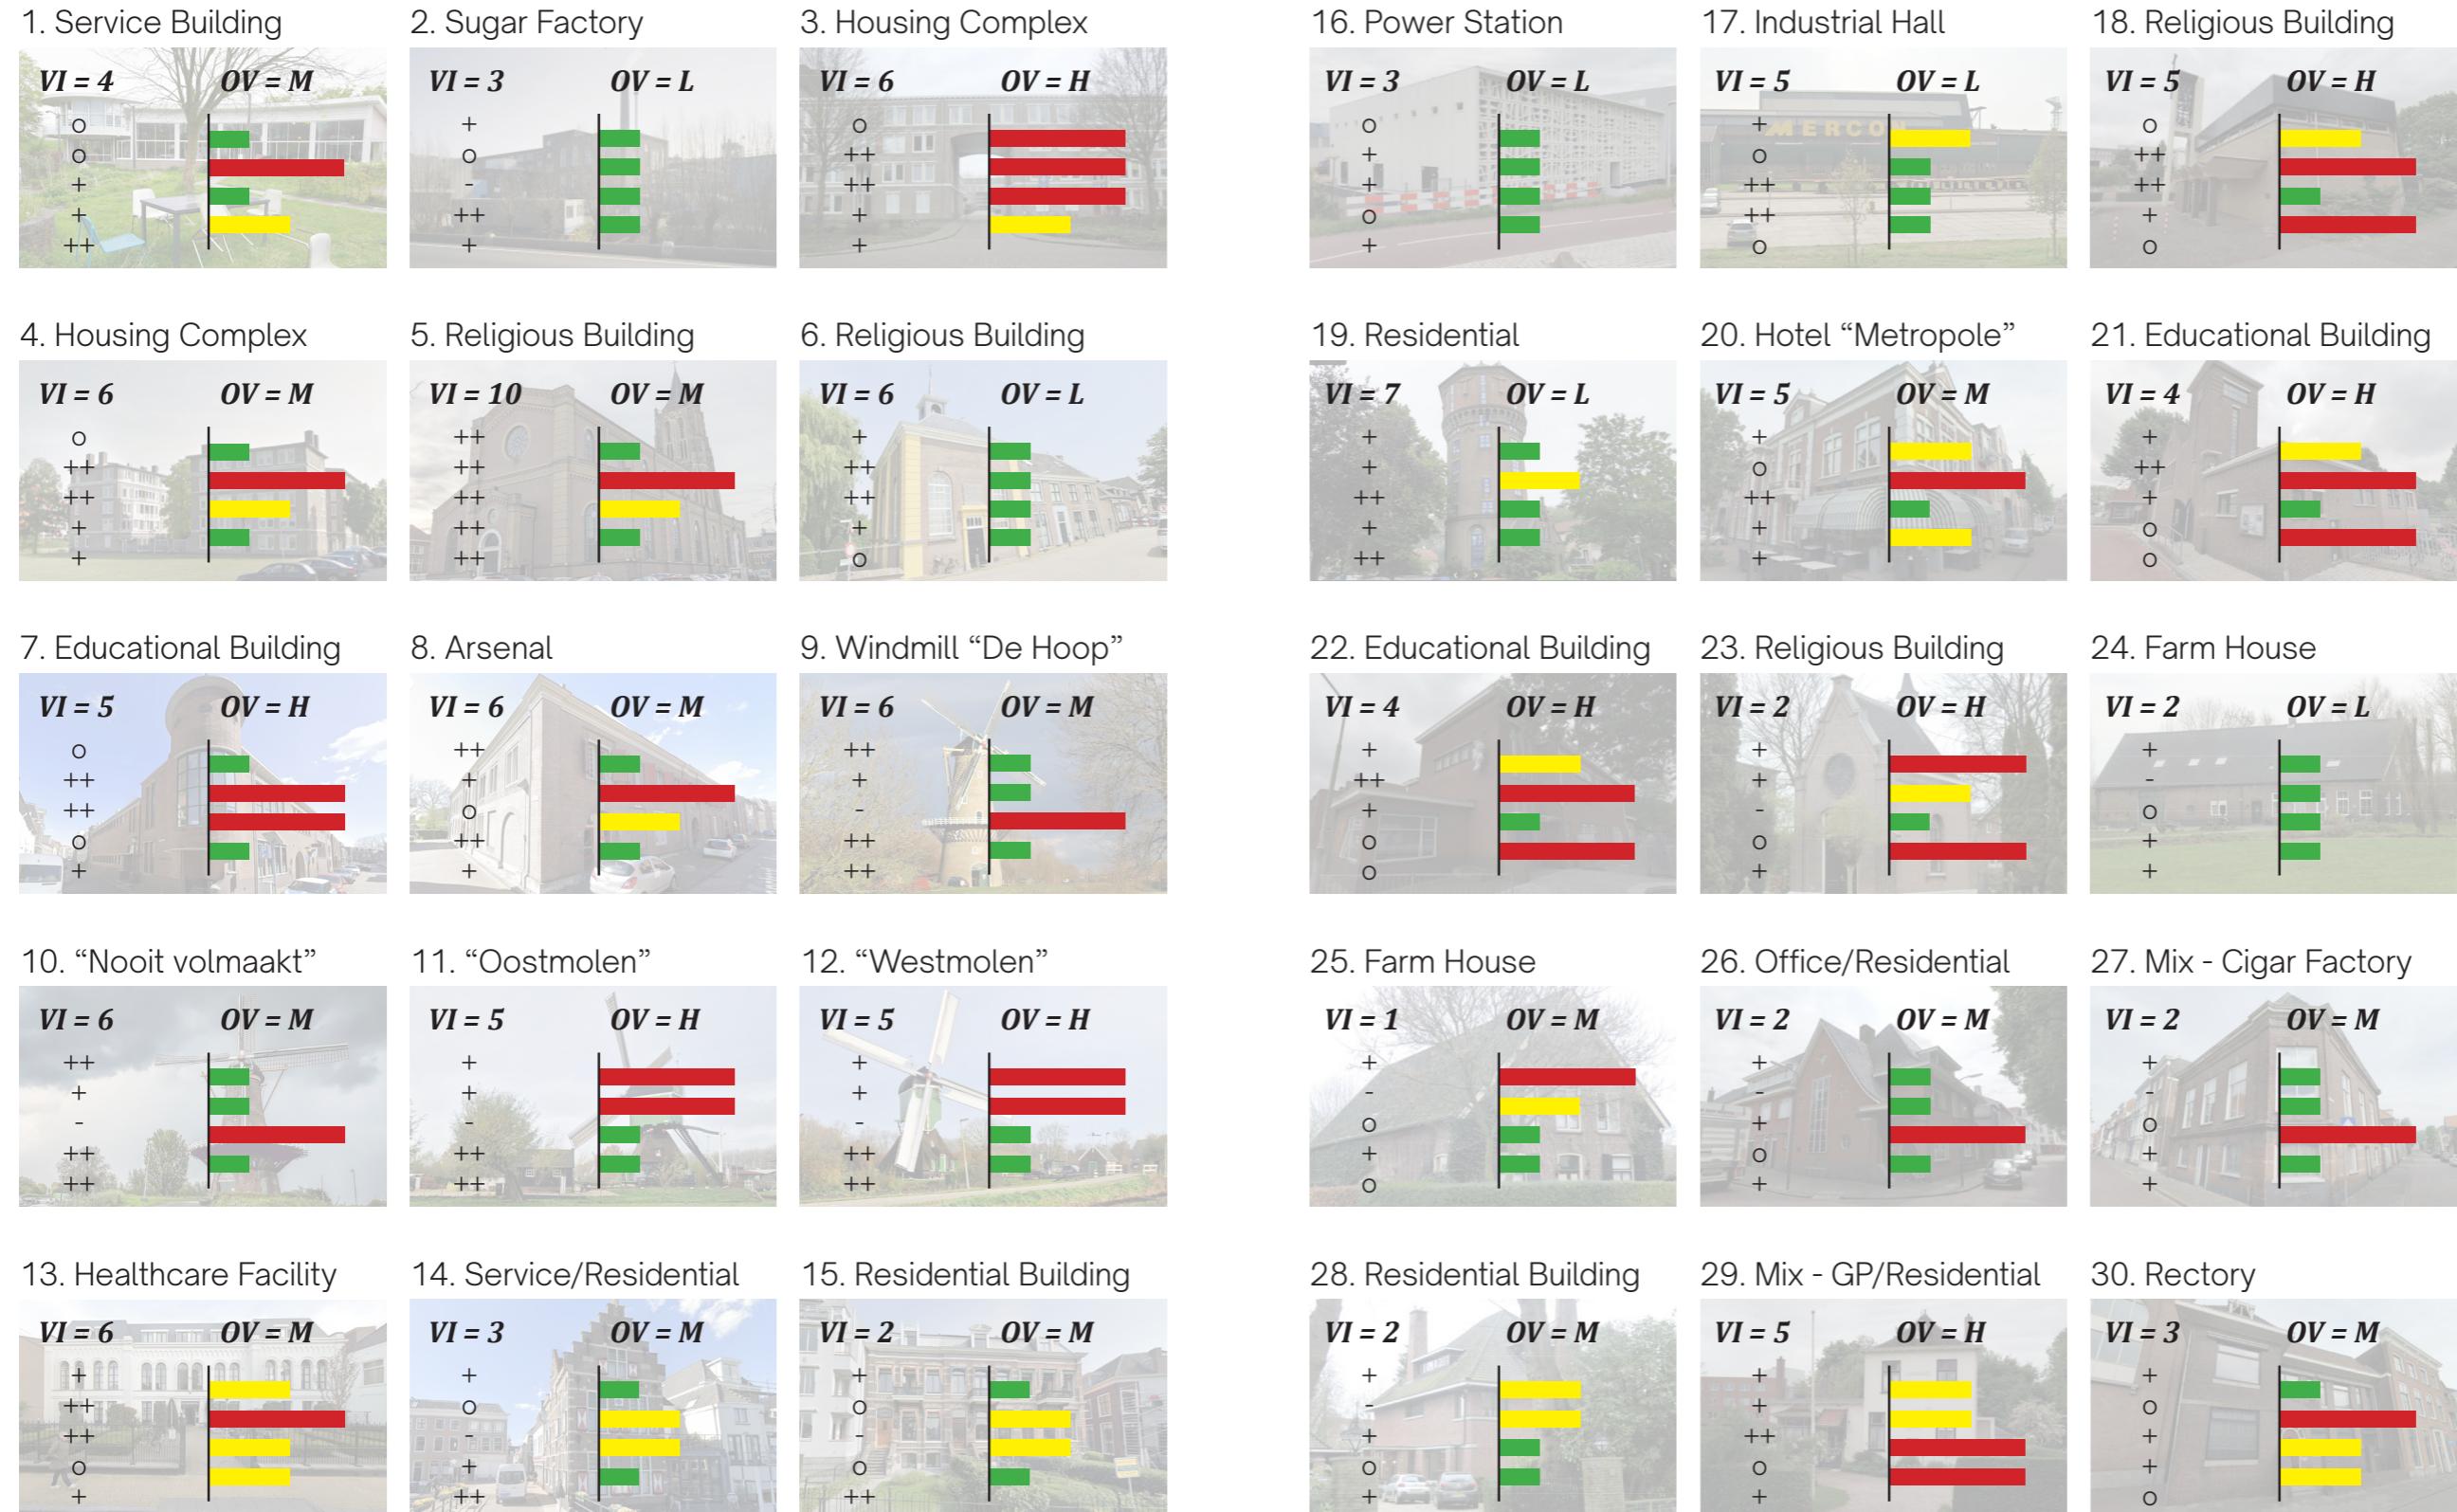
Results

Value Index (VI)

Value Dimentions

Age Value ++/+/o/-
 Social Value ++/+/o/-
 Functional Value ++/+/o/-
 Memorial Value ++/+/o/-
 Aesthetic Value ++/+/o/-

Overall Vulnerability (OV)

Risks

Flooding |
 Water depth |
 Drought |
 UHI |

Rating

high |
 middle |
 low |

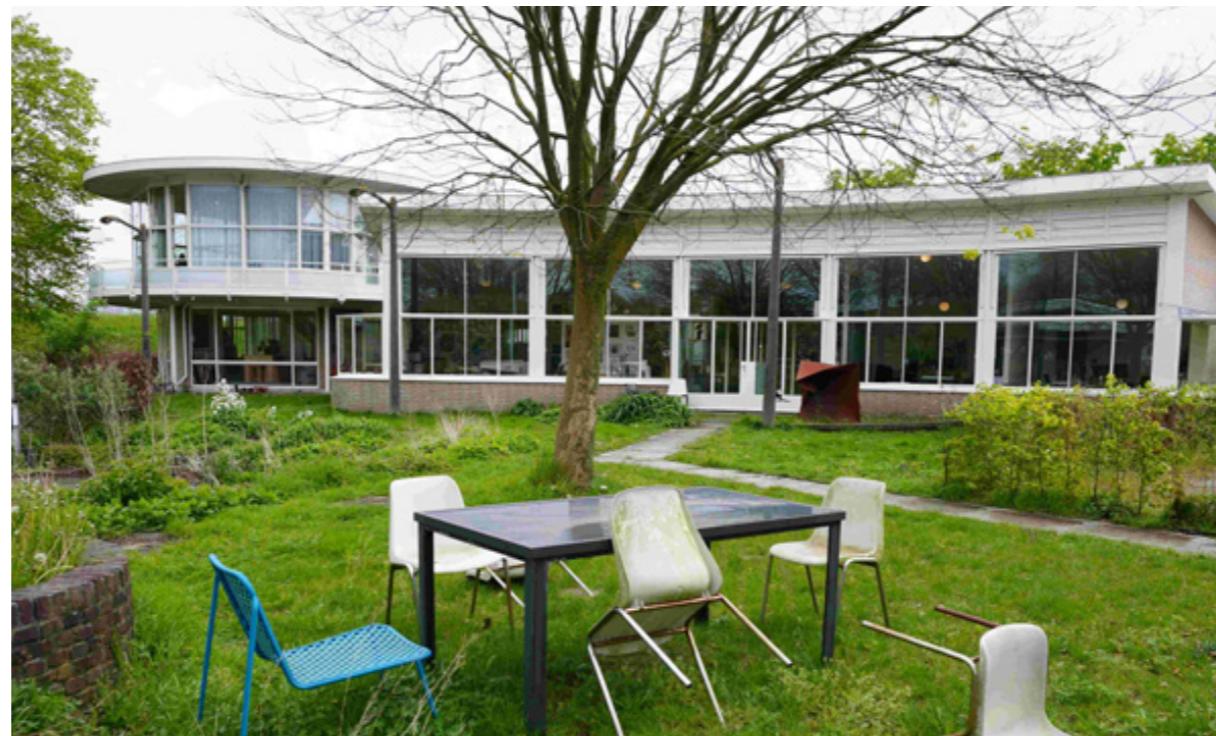
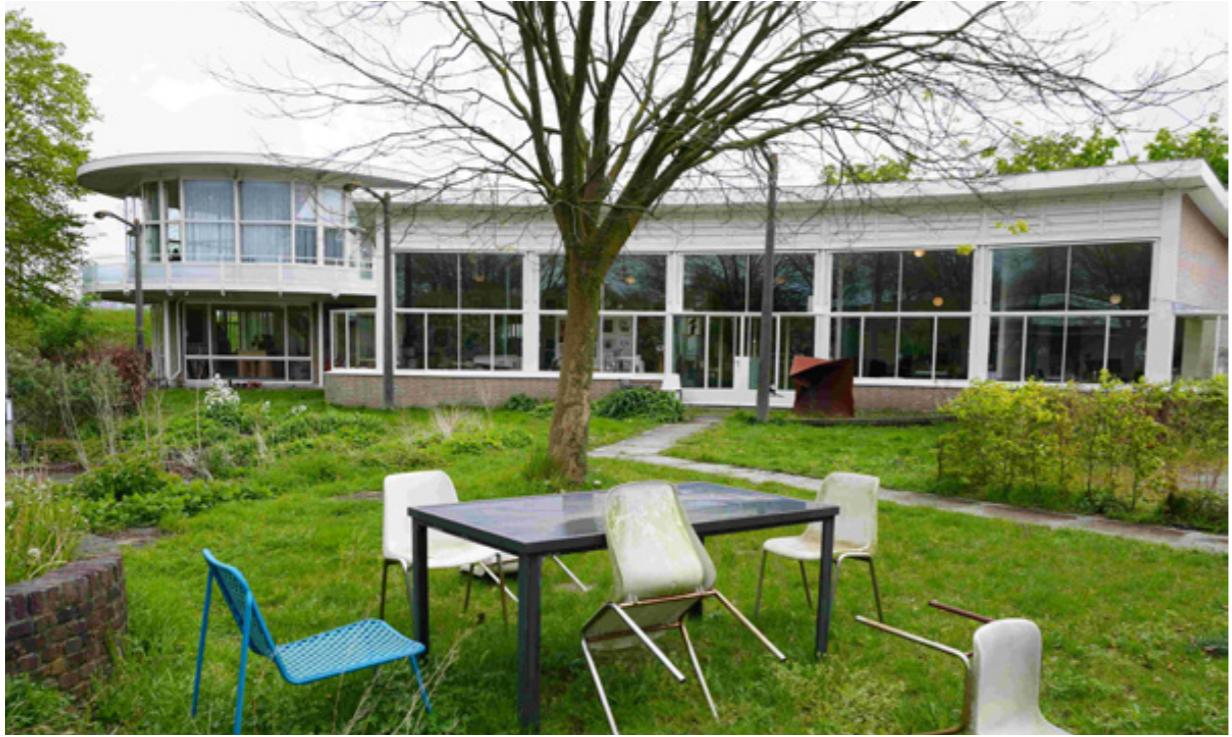
De Vries Robbé Building, De Rotonde

Construction Year: 1940

Original Function: Factory Reception

Year of Important Intervention: 1996, moved to and reconstructed in mirrored way on the other side of the Linge River

Current Position: Gallery, Office

Status: National Monument

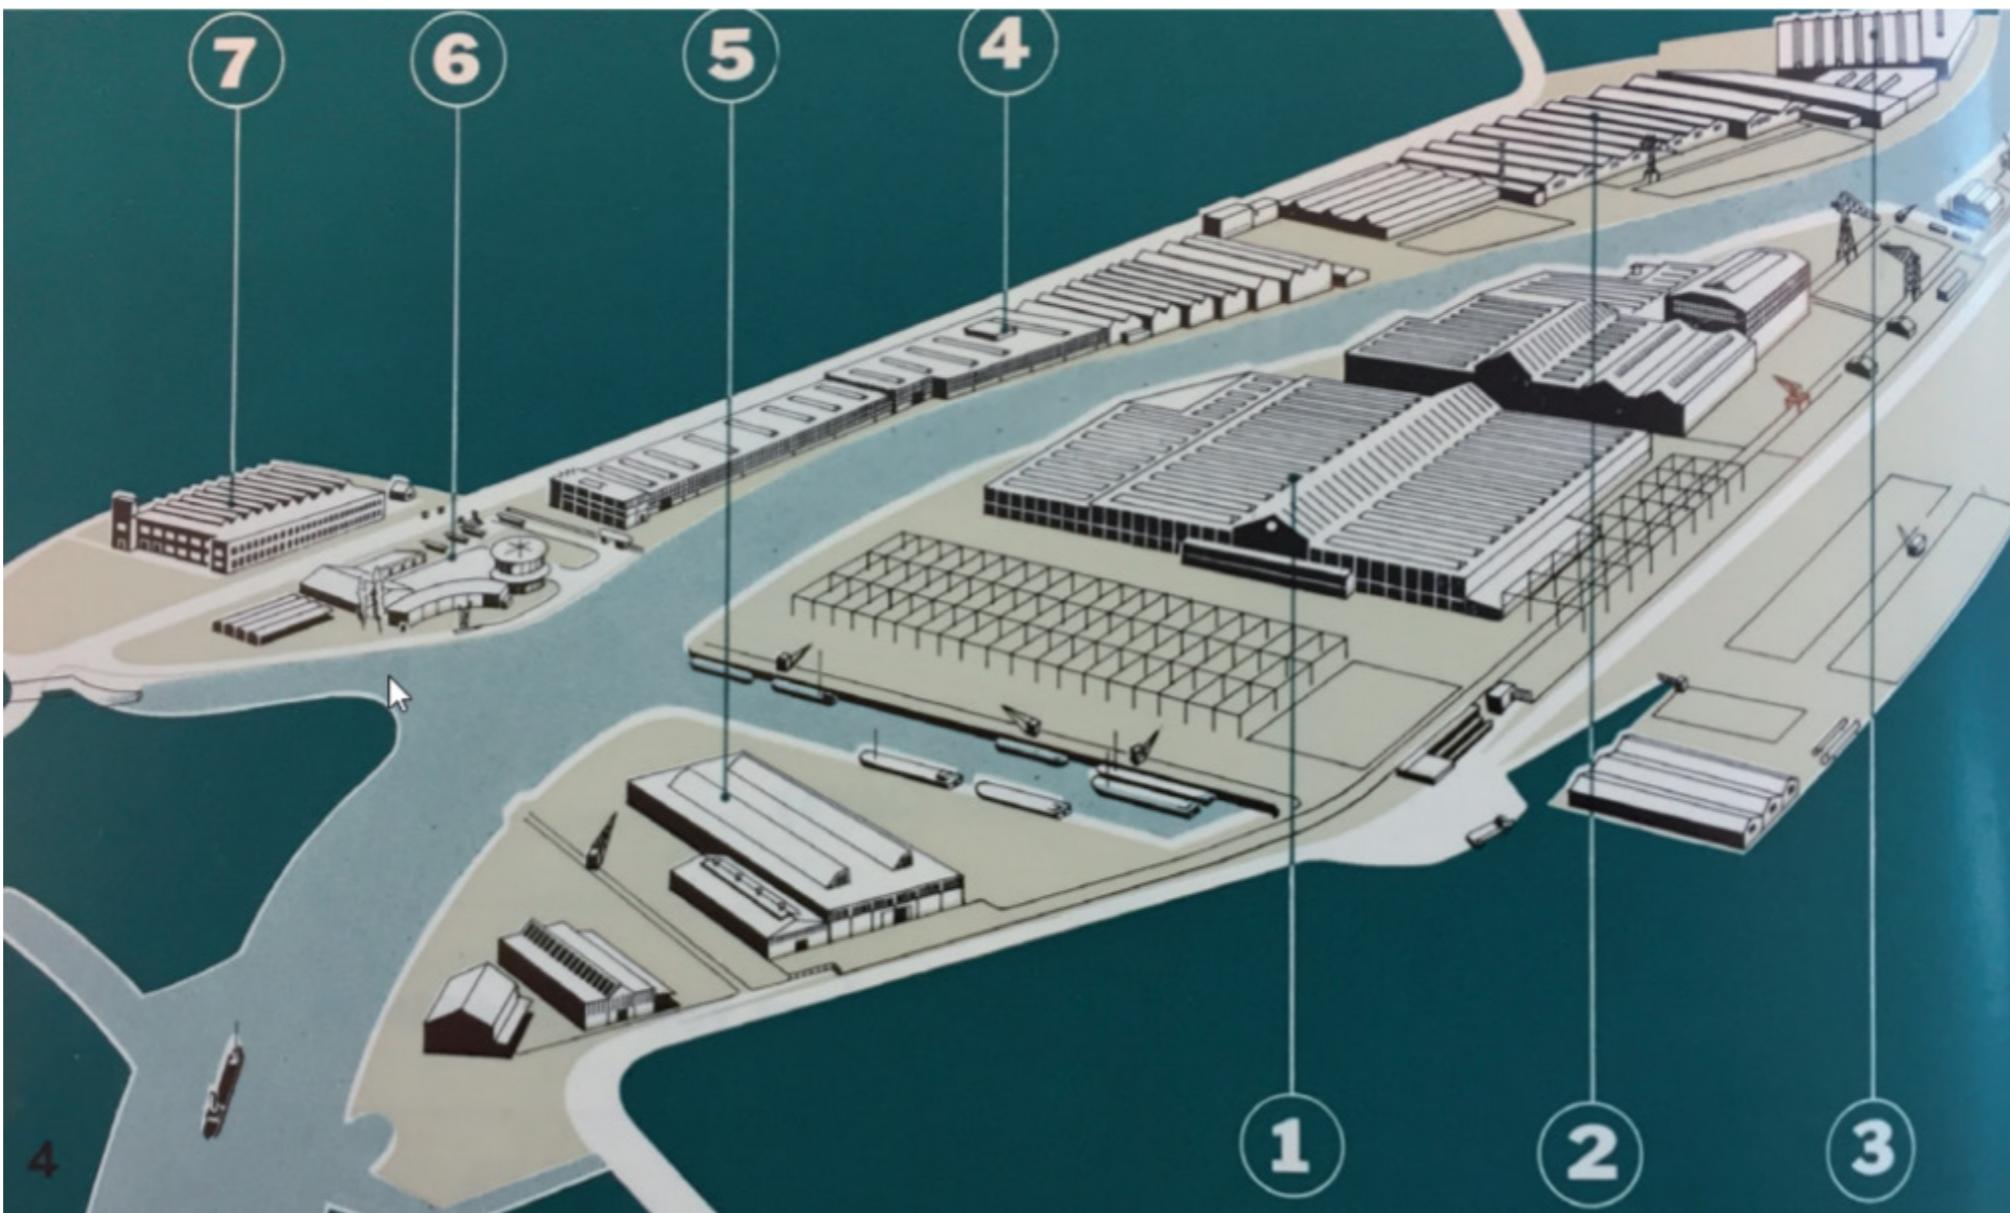
Map of De Vries Robbé site at its peak

- 1) Construction workshops, welding shop and assembly site. → already demolished
- 2) Steel window and door factory. → Plan Arkelsedijk, will disappear
- 3) Aluminum window and door factory. → Plan Arkelsedijk, will disappear
- 4) Radiator factory. → Plan Arkelsedijk, will disappear
- 5) Central warehouse. → can still be saved!**
- 6) Reception building (De Rotonde) and canteen. → Moved to the other side of the Linge (national monument)
- 7) Head office (1928) De Vries Robbé → already demolished

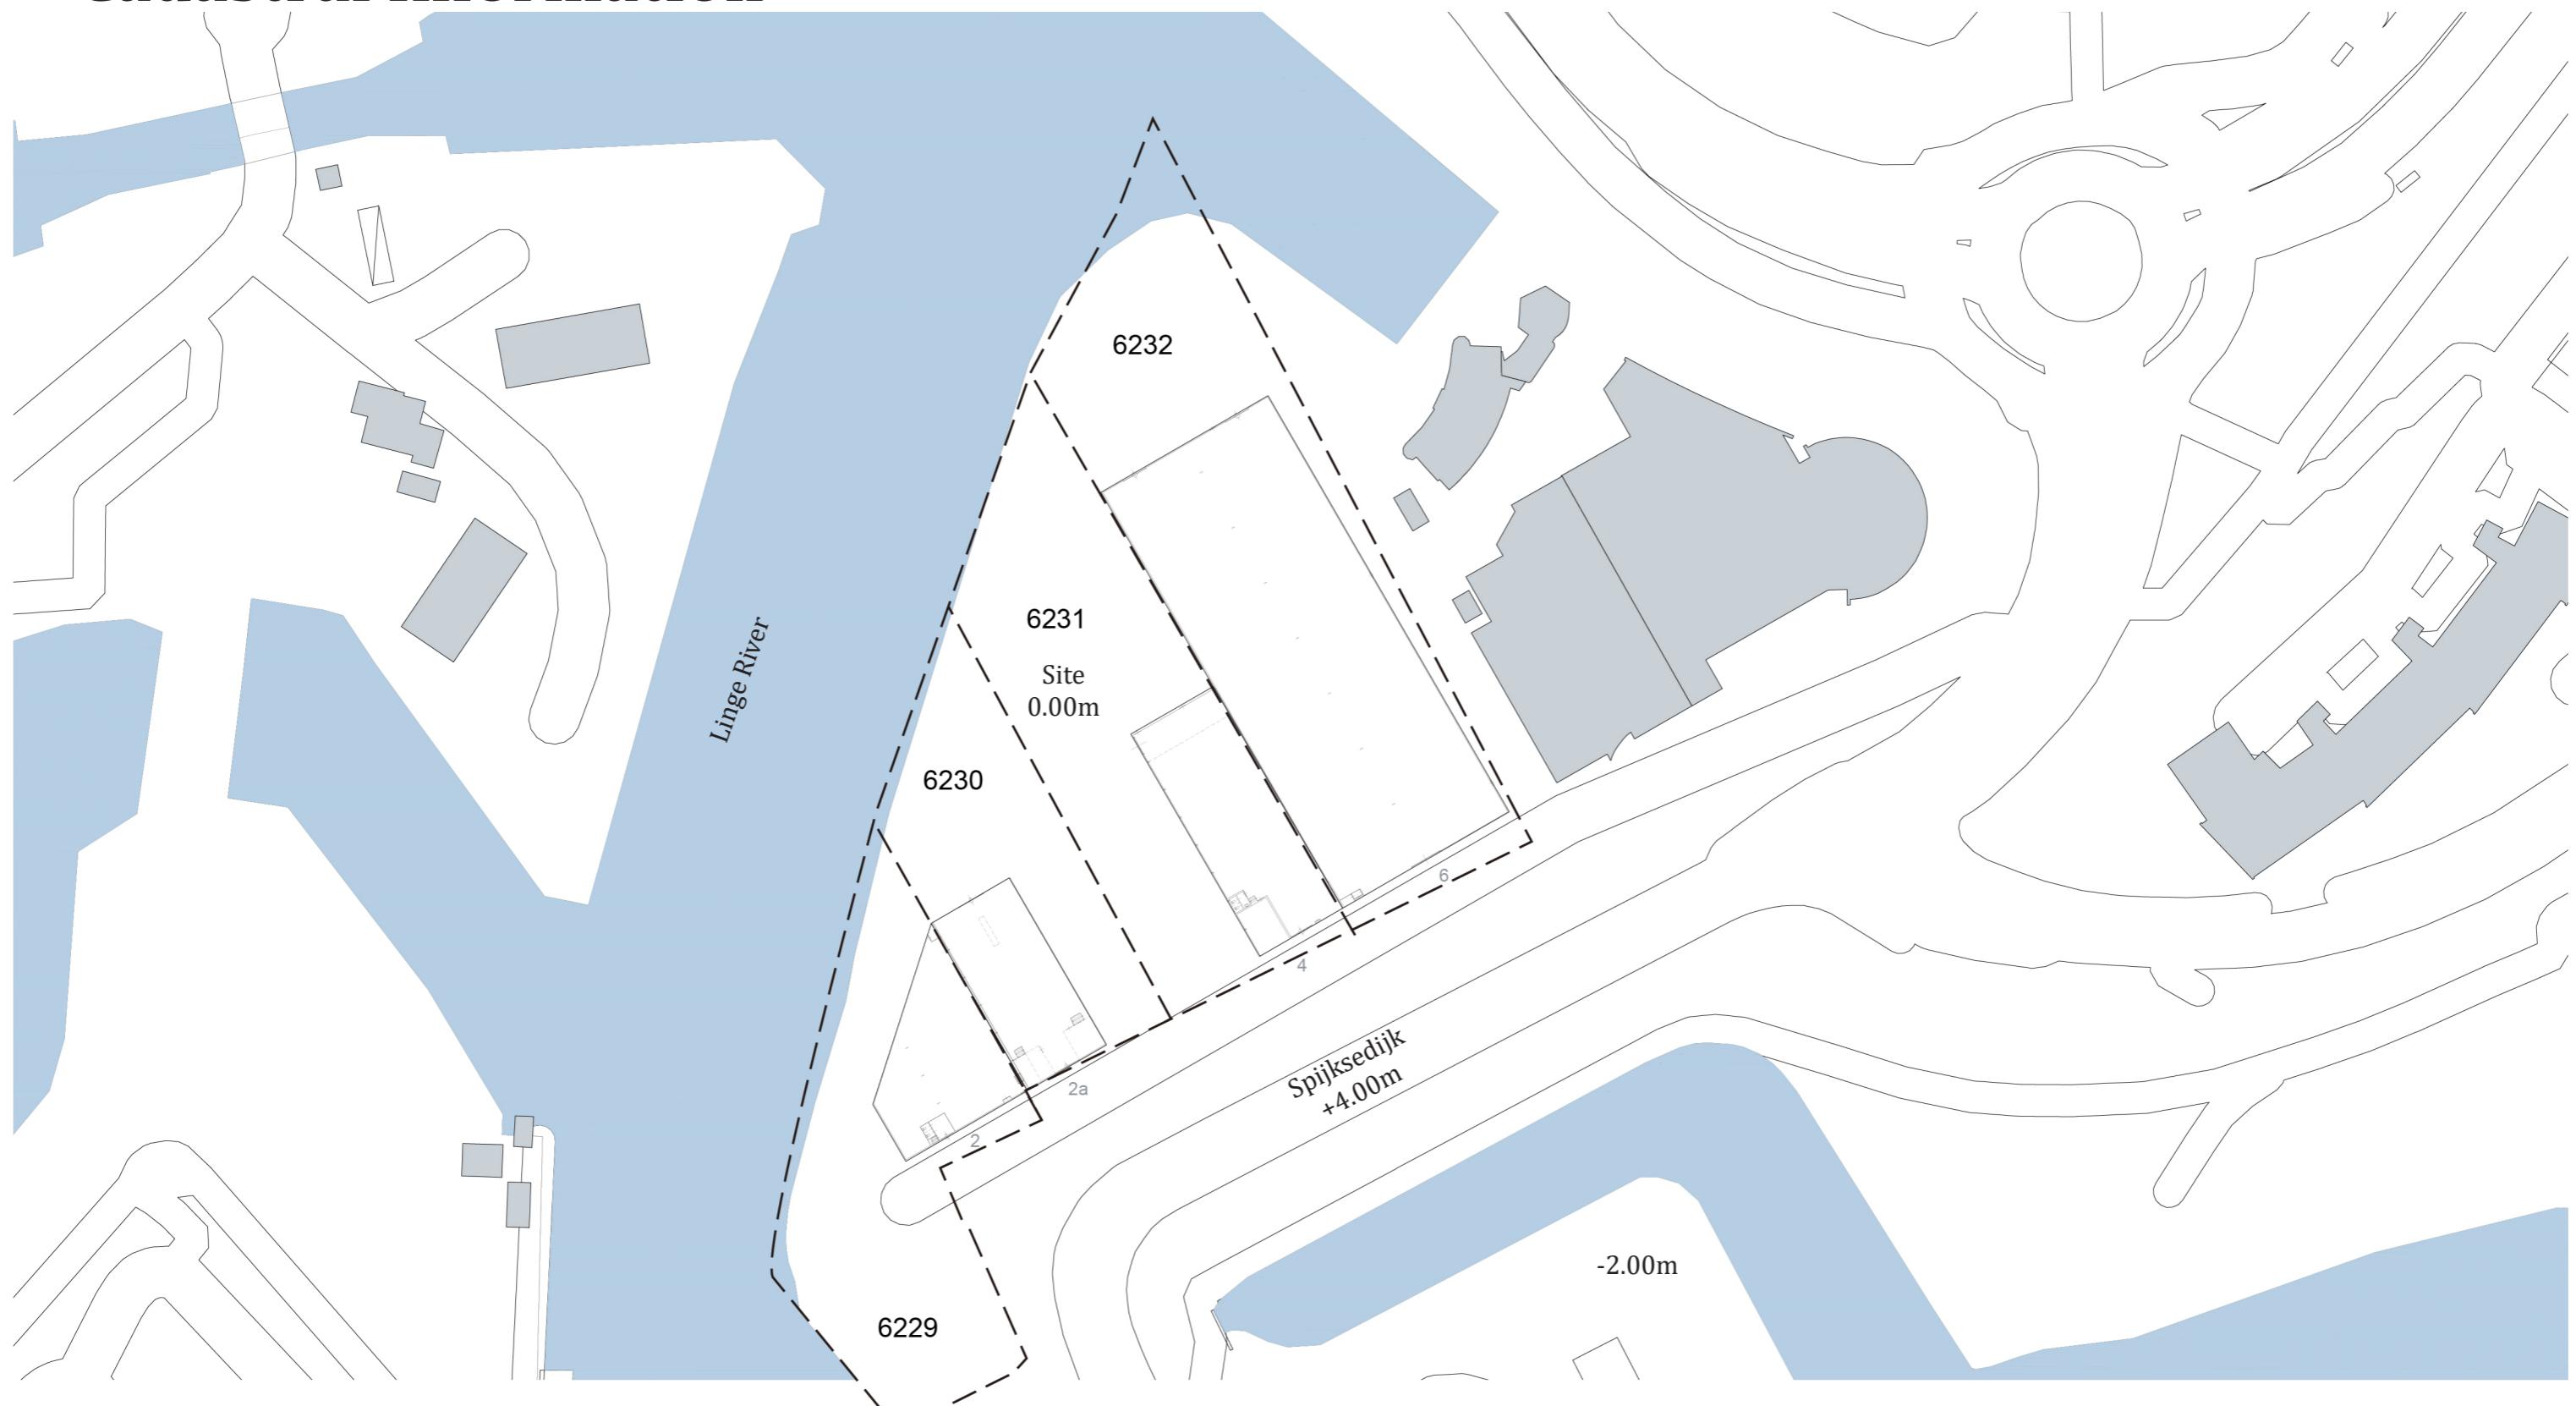
Cadastral Information

Cadastral Information:
 n.6229 (2,170 m²); n.6230 (1,640 m²); n.6231(2,705 m²); n.6232(3,670 m²). Total Area = 10,185m²

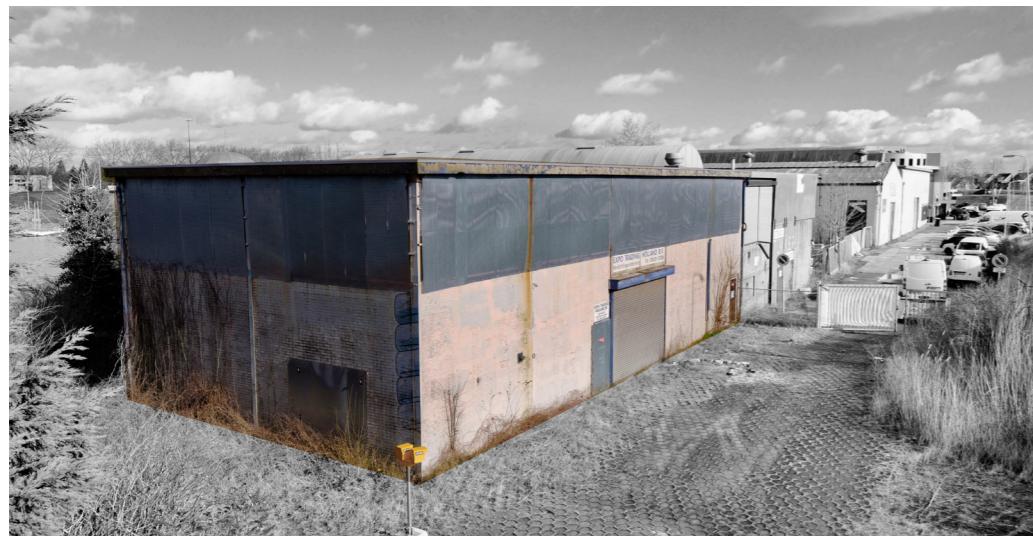
Spiksedijk 2

Built Year: 1928-05 (First Constructed), 1966-03 (Renewed)

Dimension: 10.3 m, 22 m, 29.7 m, 30.2 m (trapezoid plan)

Height: 6.7 m, 2 floors

Gross floor area (GFA): 910.52 m²

Original Function: De Vries Robbé & Co. N.V. Factory Storage
