Regeneration of Value: Journey of a Waterfront Industrial Heritage from Abandoned to Alive

Water Sports Center Design in Gorinchem ©Xiaoling Wei (2025)

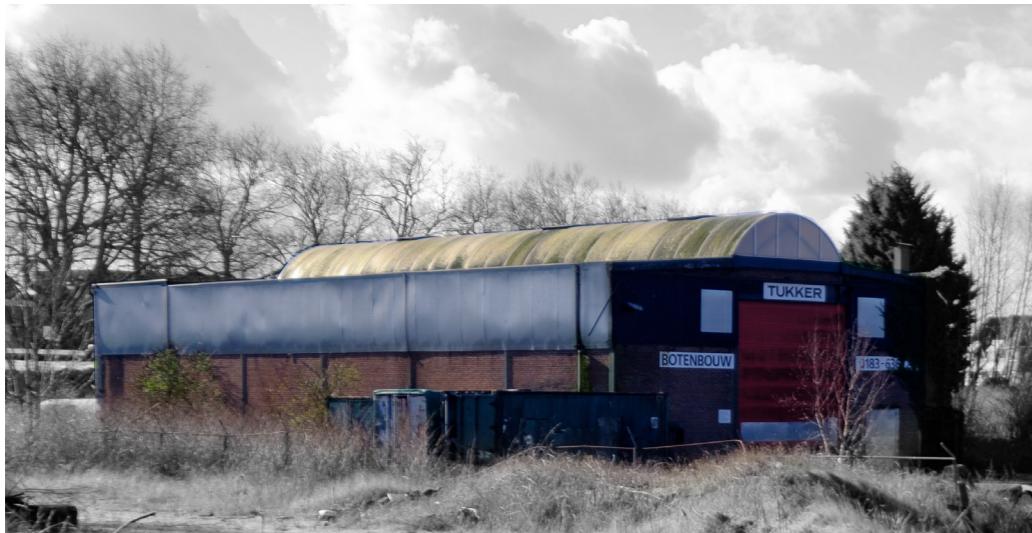
Spiksedijk 2a

Built Year: 1928-05 (First Constructed), 1966-03 (Renewed)
 Dimension: 14.3 m * 30.2 m
 Height: 6.7 m (flat roof); 8.4 m (skylight), 1 floor with 2 mezzanines
 Gross floor area (GFA): 489.22 m²
 Original Function: De Vries Robbé & Co. N.V. Factory Storage

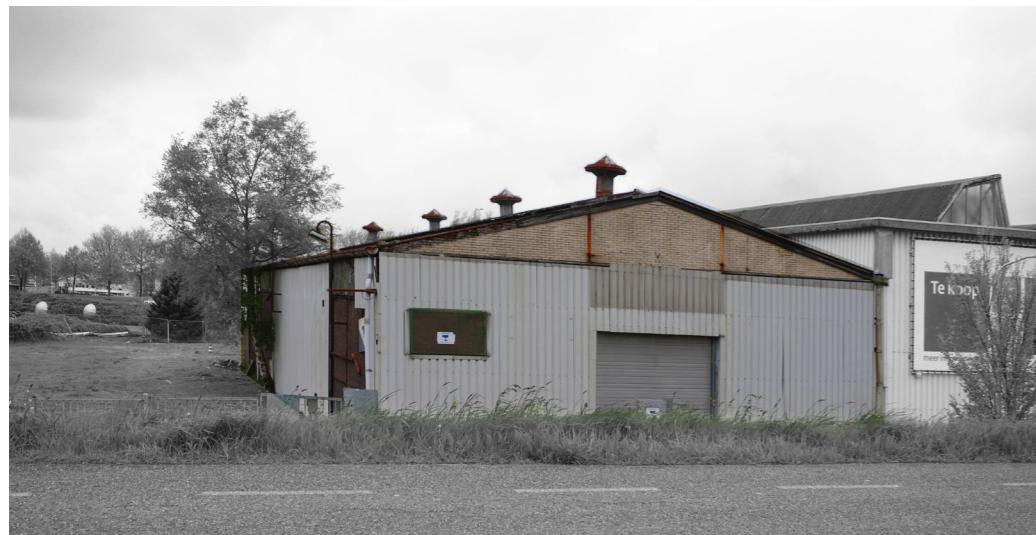
Spiksedijk 4

Built Year: 1950-01 (First Constructed), 1983-04 (Renewed)

Dimension: 15 m * 40.2 m

Height: 8 m, 1 floor with 1 mezzanine

Gross floor area (GFA): 659.71 m²

Original Function: De Vries Robbé & Co. N.V. Factory Storage

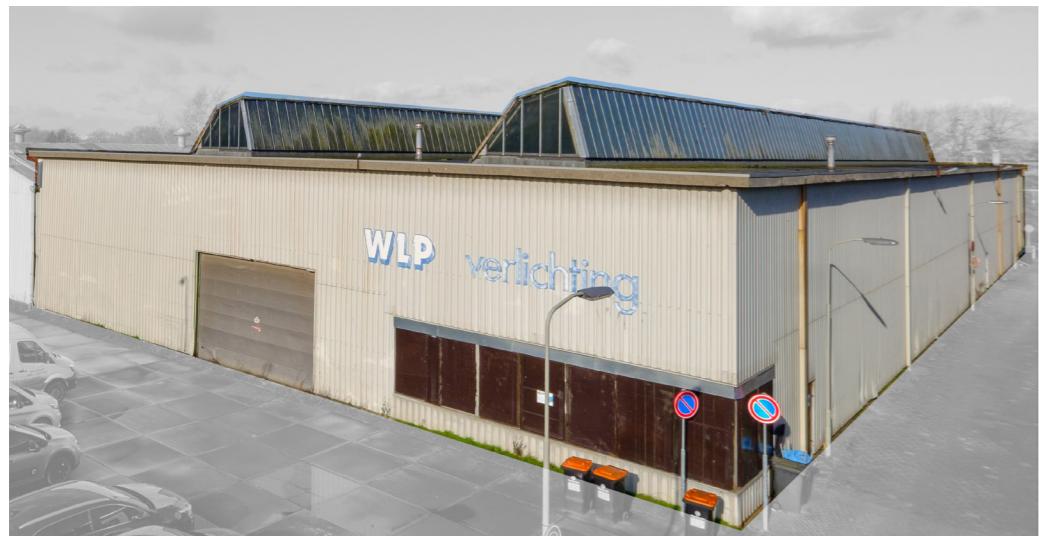
Spiksedijk 6

Built Year: 1950-12 (First Constructed), 1995-03 (Renewed)

Dimension: 30.1 m * 75.2 m

Height: 7.7 m (flat roof); 10.7 m (skylight)

Gross floor area (GFA): 2,271.86 m²

Original Function: De Vries Robbé & Co. N.V. Factory Storage

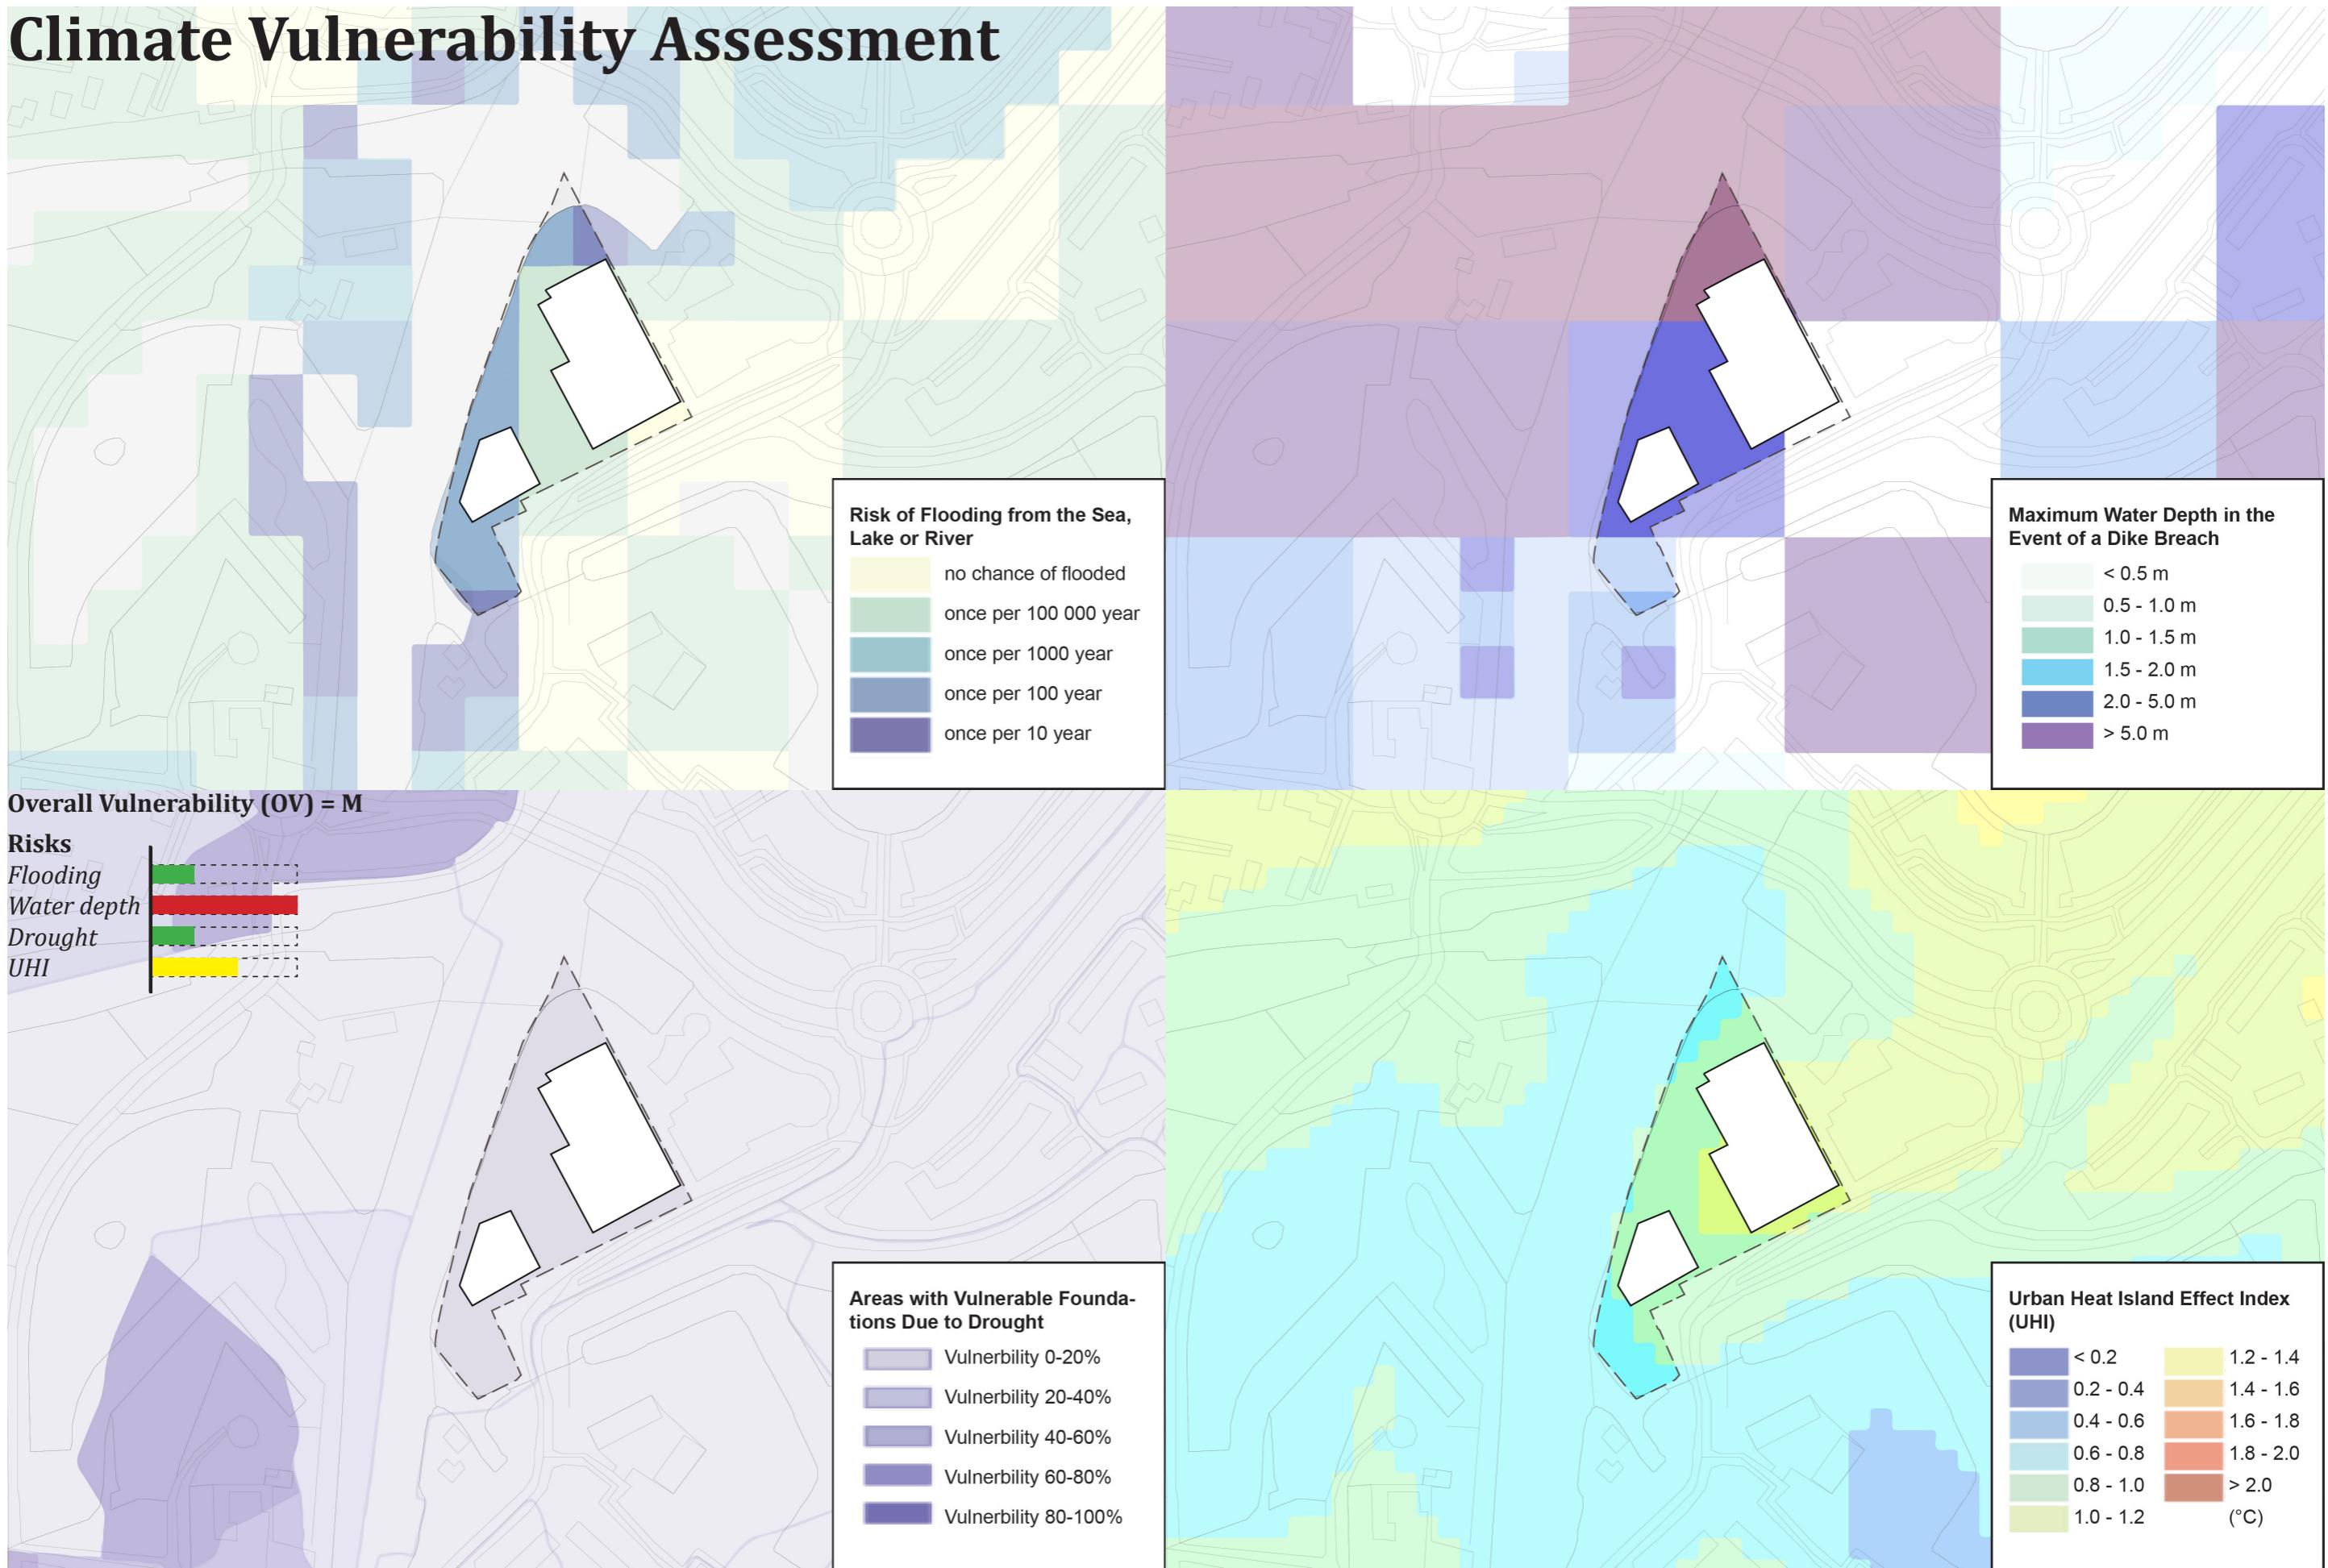
Climate Vulnerability Assessment

Source of Data: Atlas Leefomgeving | Atlas Leefomgeving. (n.d.). <https://www.atlasleefomgeving.nl/>

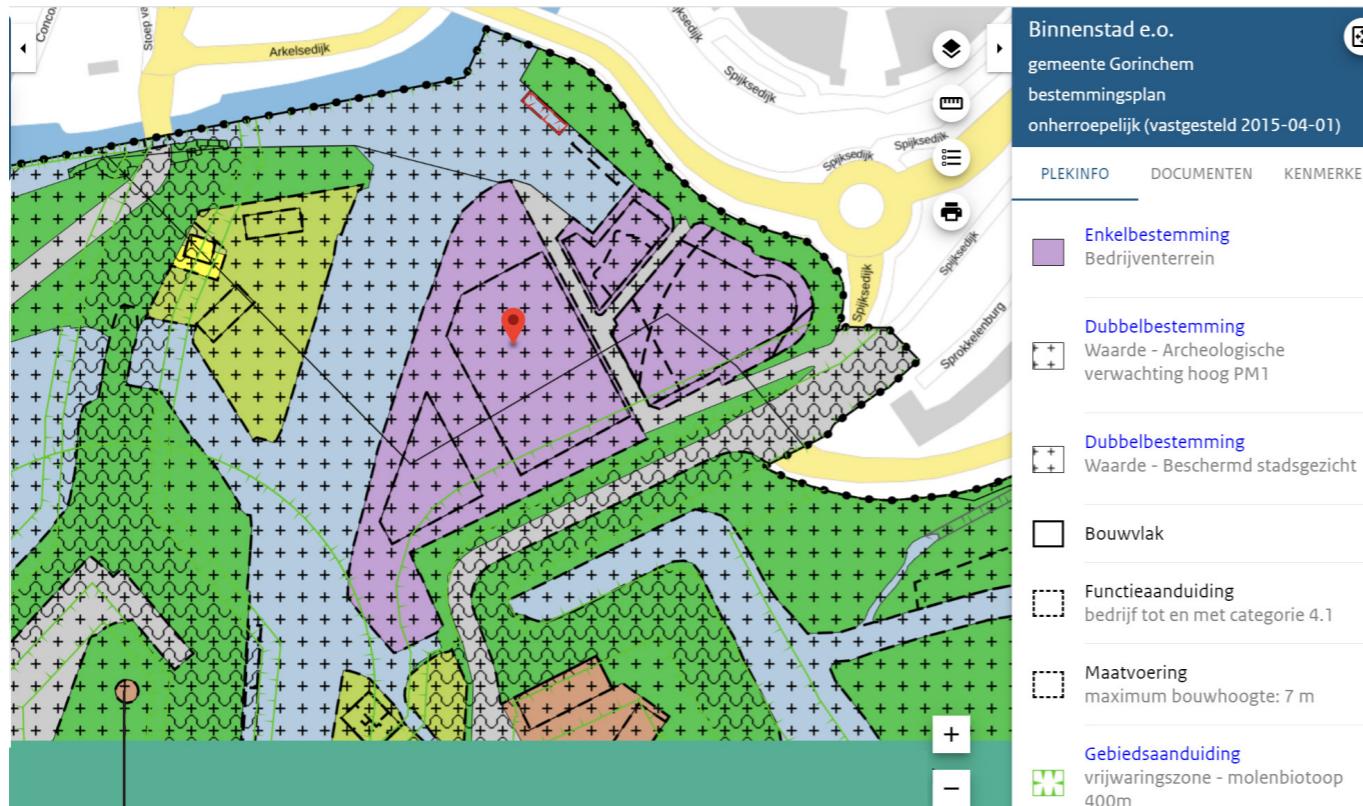
Municipality Zoning Plan

This plot of land is single-destination for business use, featuring high archaeological significance, a protected cityscape, and it is within a 400m safeguarded mill biotope. The zoning allowances for industrial activities is up to category 4.1.

- Single Destination: Business Park
- Dual Destination Value: High archaeological potential (PM 1)
- Dual Destination Value: Protected Cityscape
- Function Designation: Company operations permitted up to and including Category 4.1
- Regional Designated Conservation Area: Mill Biome 400m, the building height should be 1/50 of the distance between the building and the height of the lowest point of the vertical mill wing.

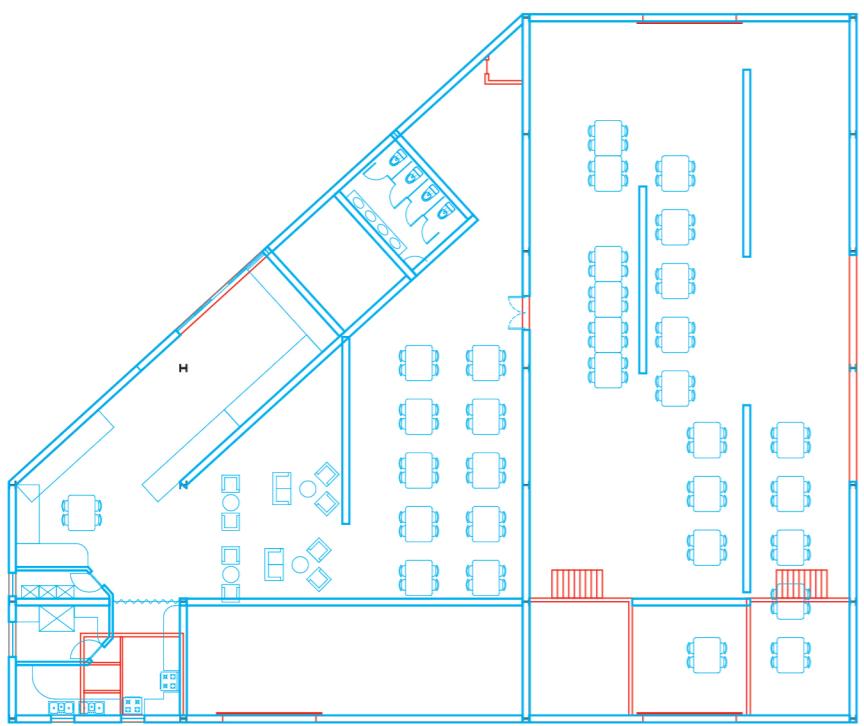
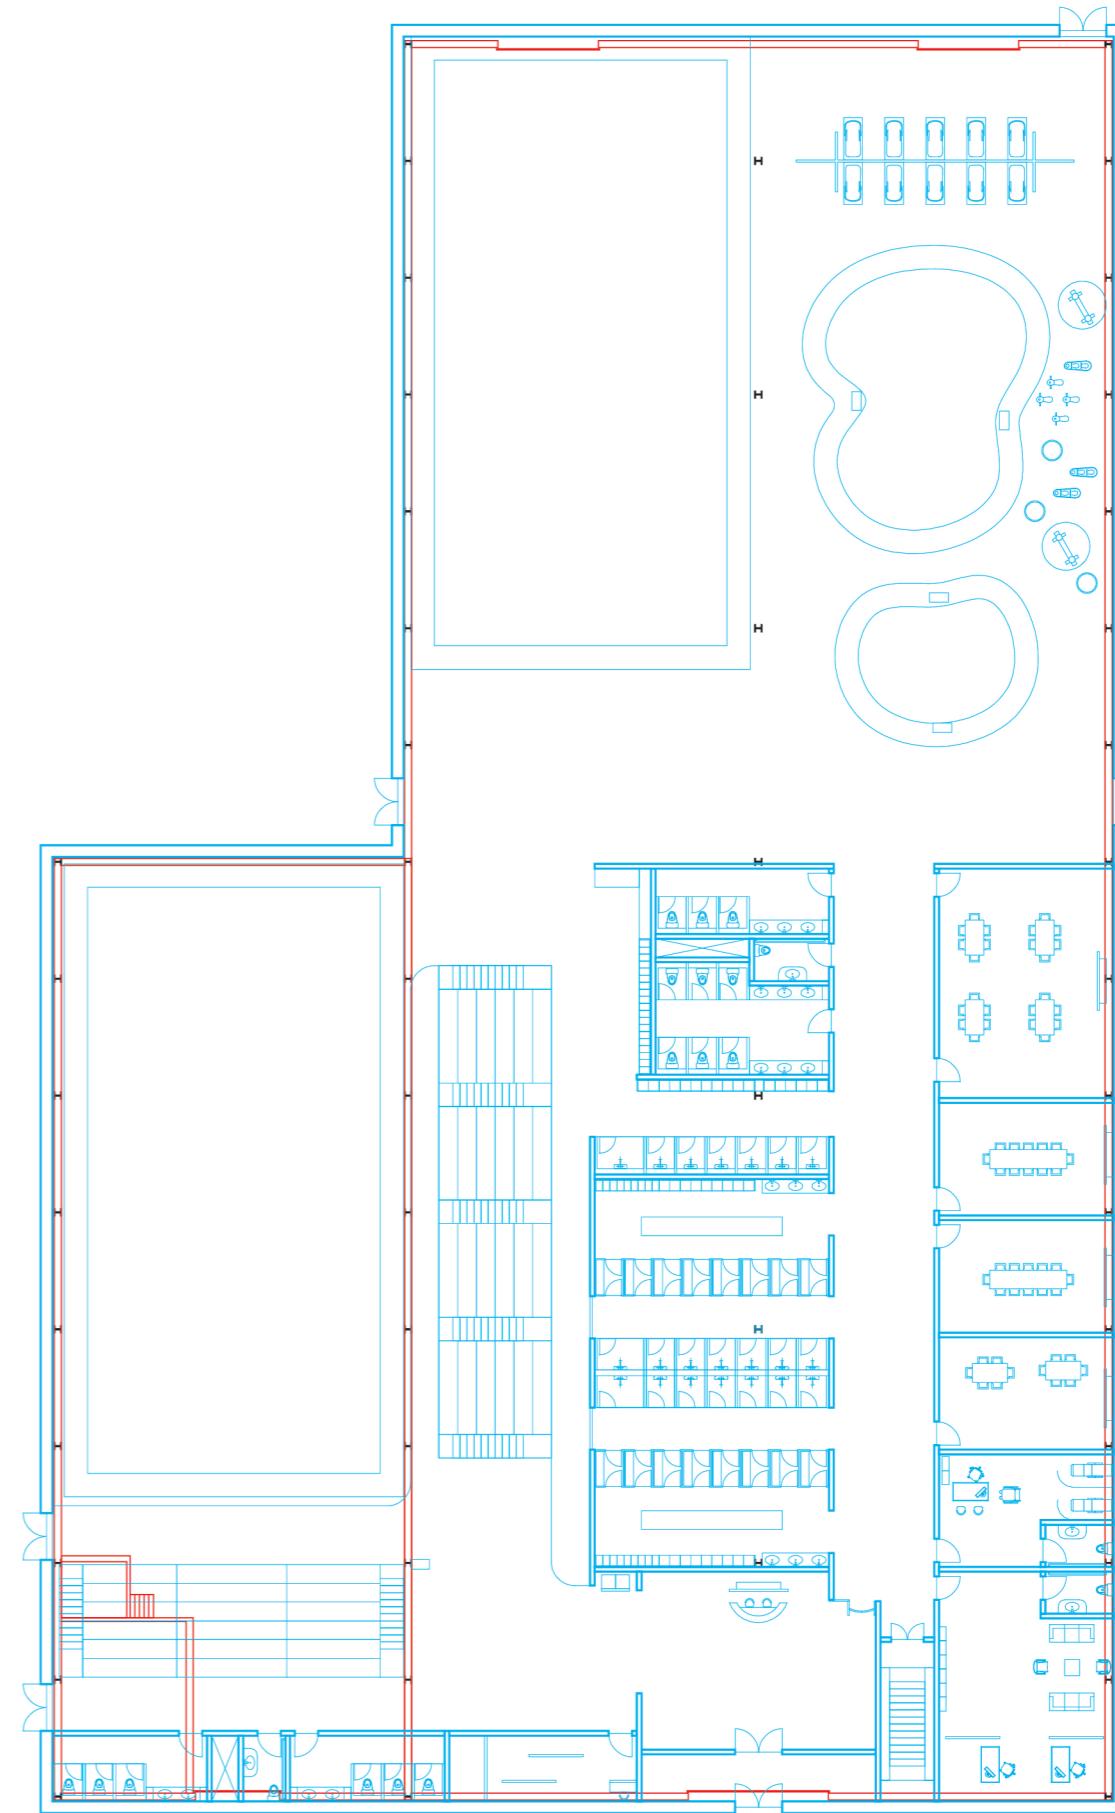
Intervention - Demolish, Keep, Add

— Keep
— Add
— Demolish

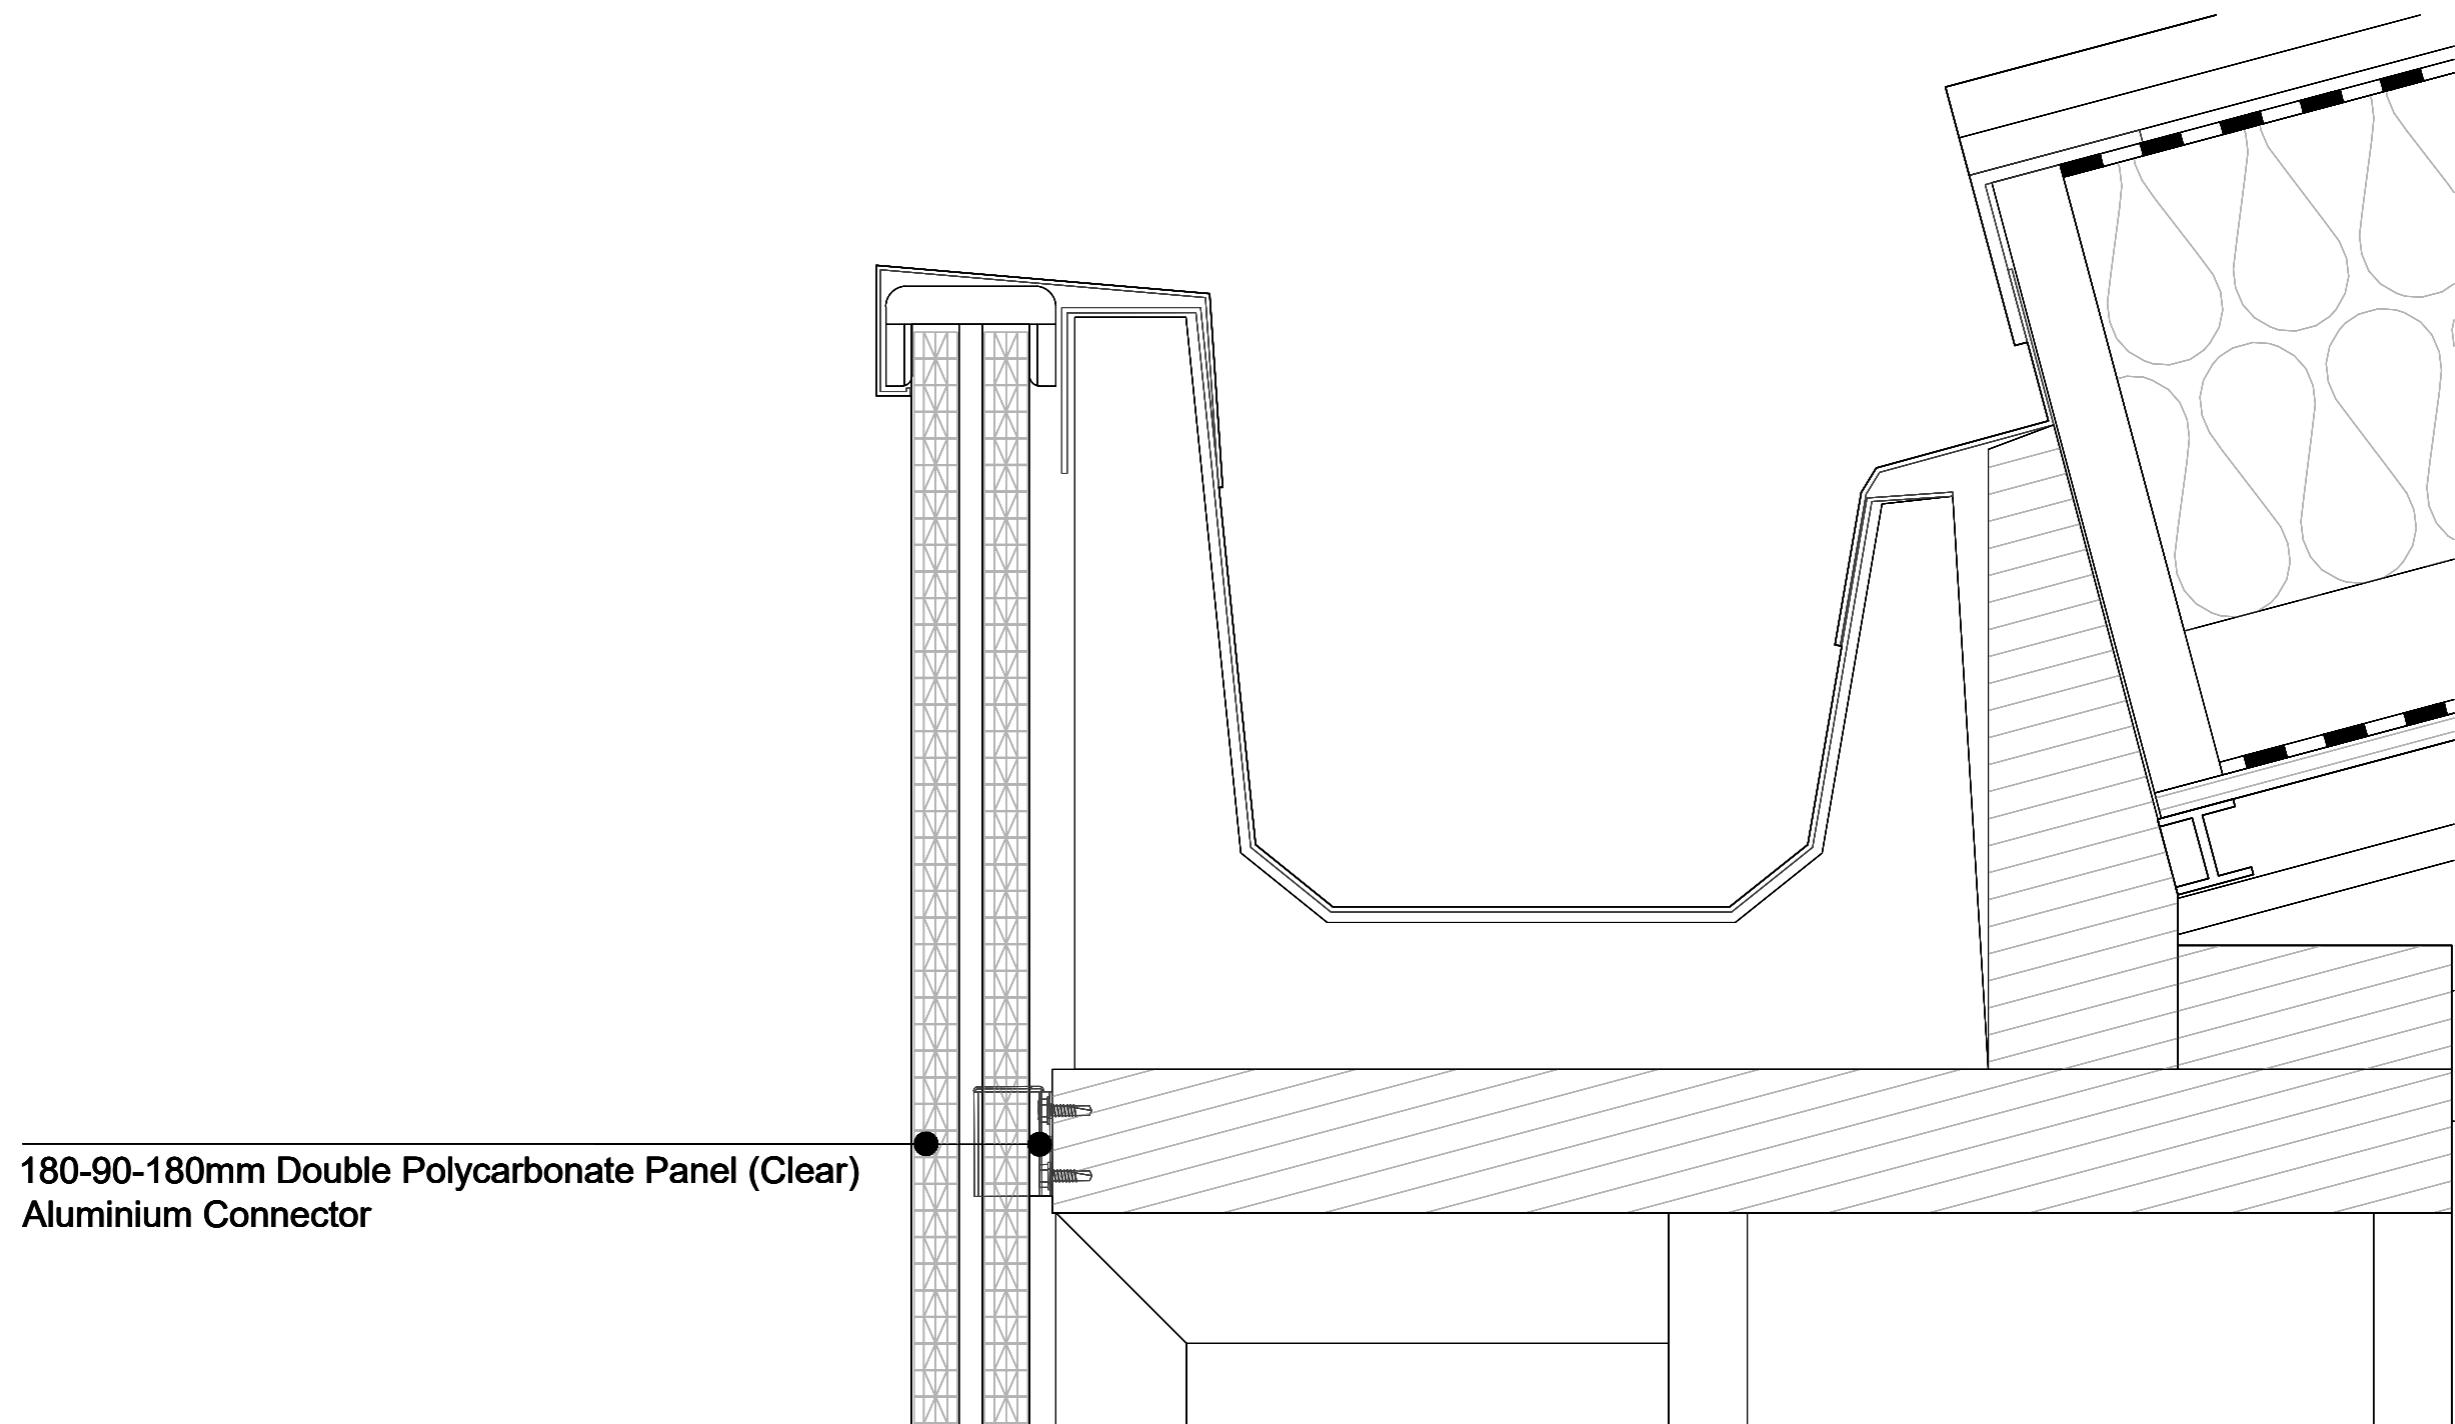
Construction Detail B 1:5

Recycled Corrugated Corten Steel Panel (Recoated)
Water-proof Membrane
150mm XPS Insulation
20mm Air Gap
Structural Frame
Vapor Control Membrane
Ceramic Tile

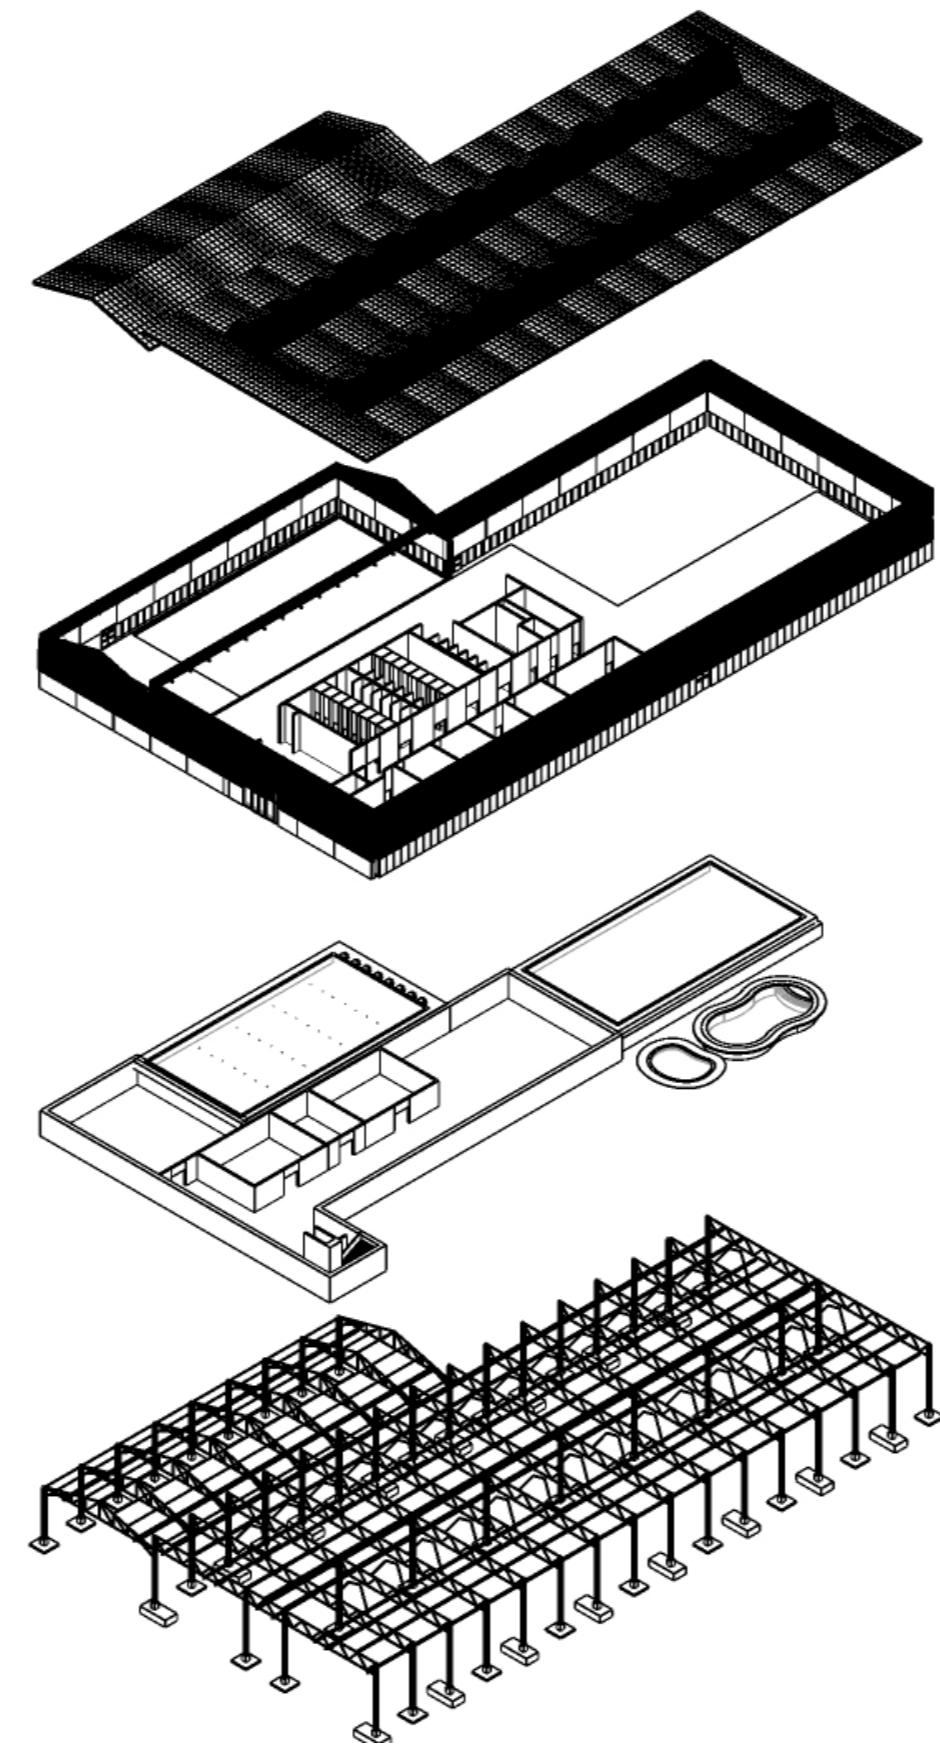
Exploded Axonometry

Roof

Skin

Space

Structure

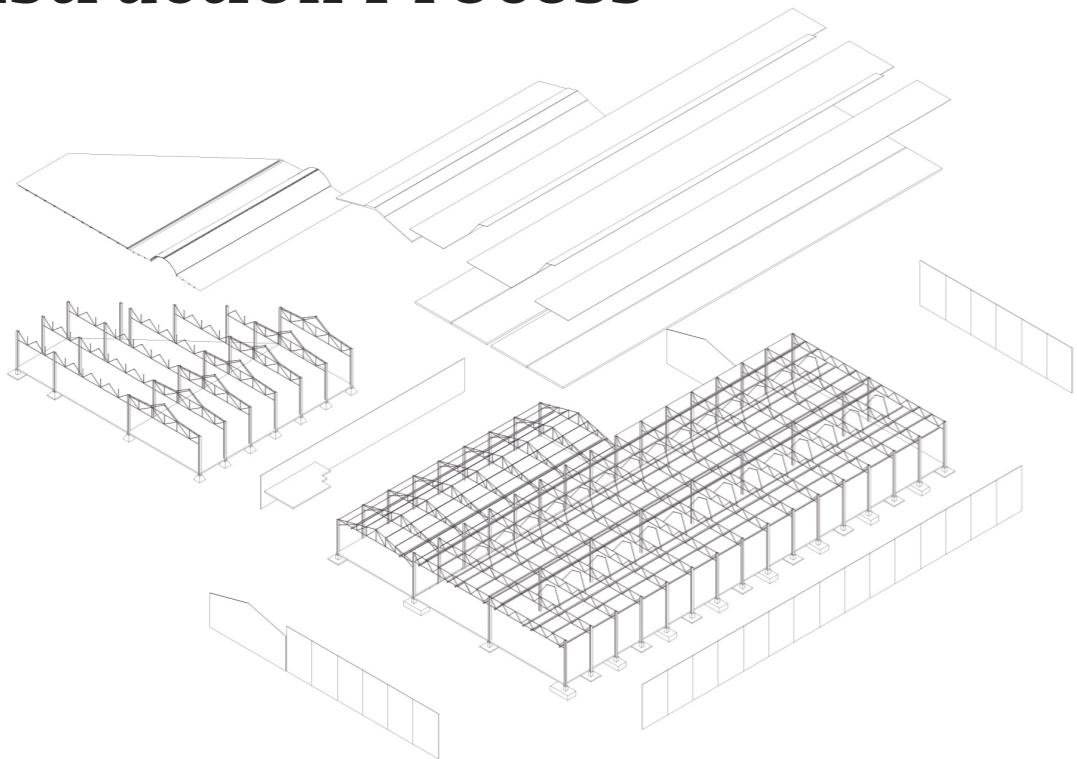
1. Removal of the existing skin, collect the taken down metal panels, repaint and prepare for reuse.

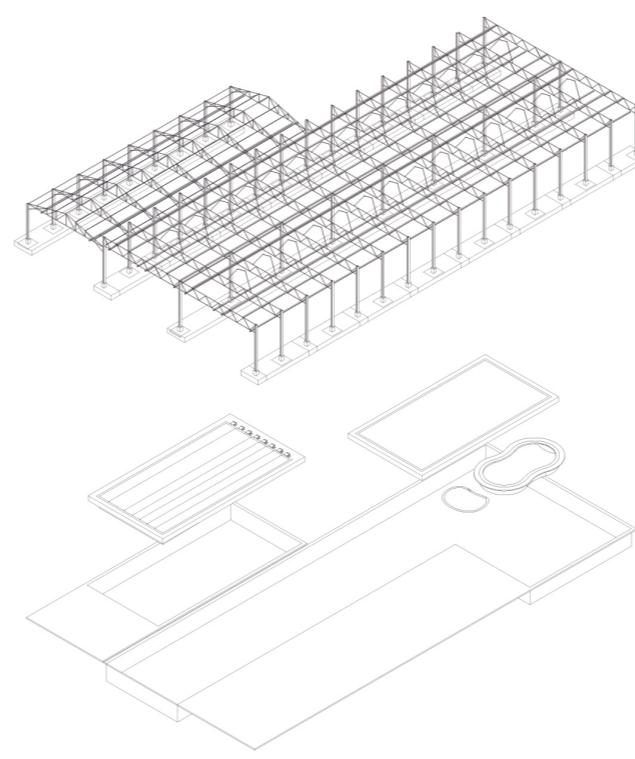
2. Dig in the earth to make space for the pools, and reinforce the foundation.

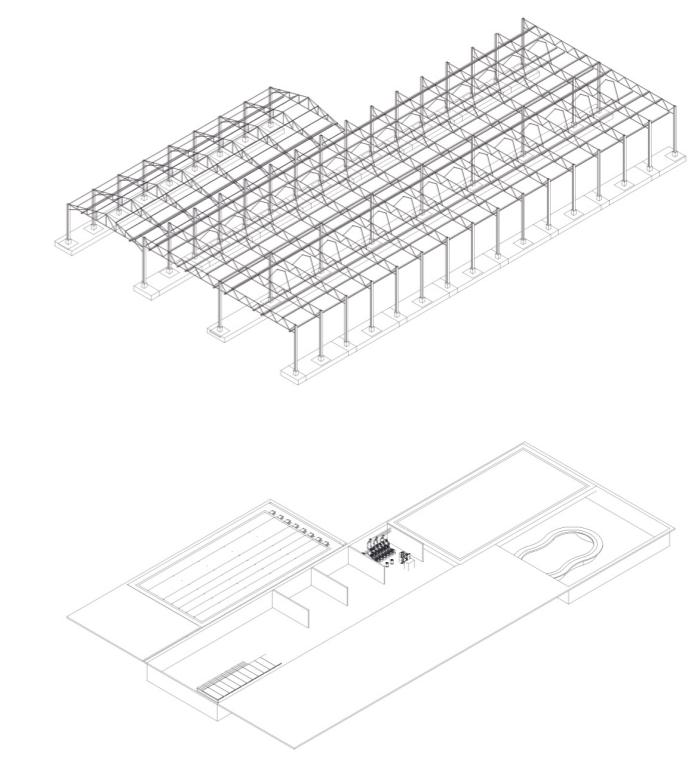
3. Set the machines in the underground equipment space, then construct the floor with prefab-concrete slab. Build in heating pipes.

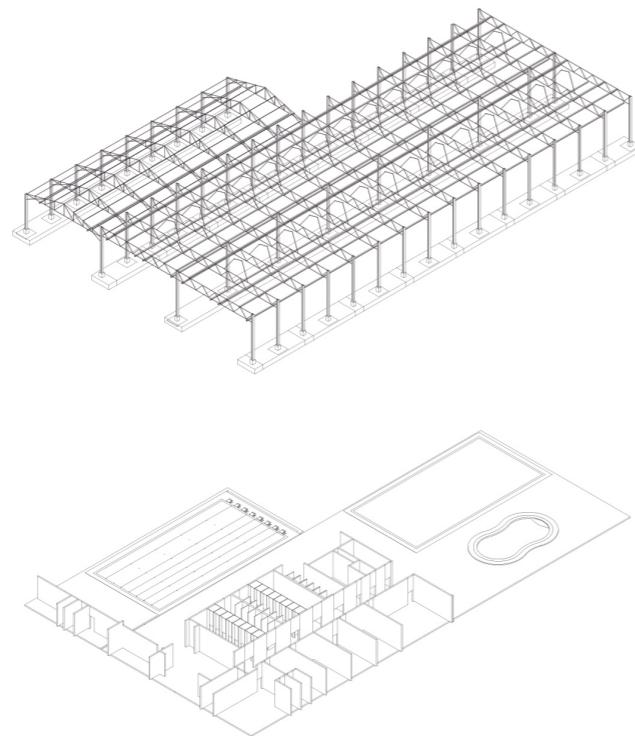
4. Construct the internal walls with prefab wall panels.

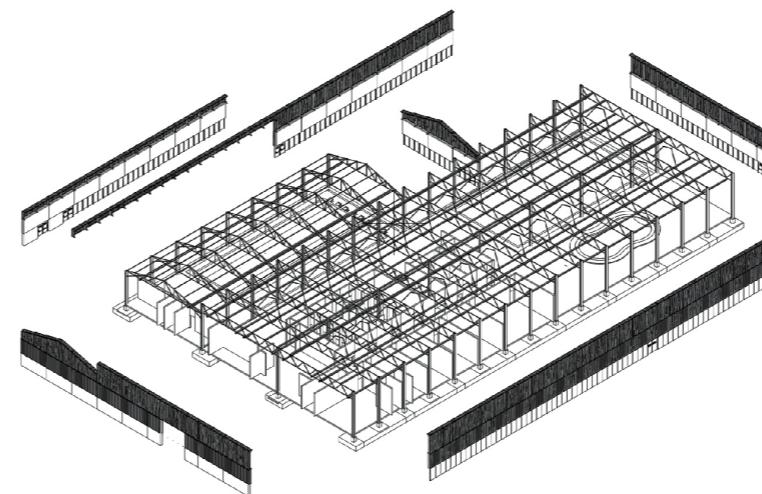
5. connect the external wall to the structure.

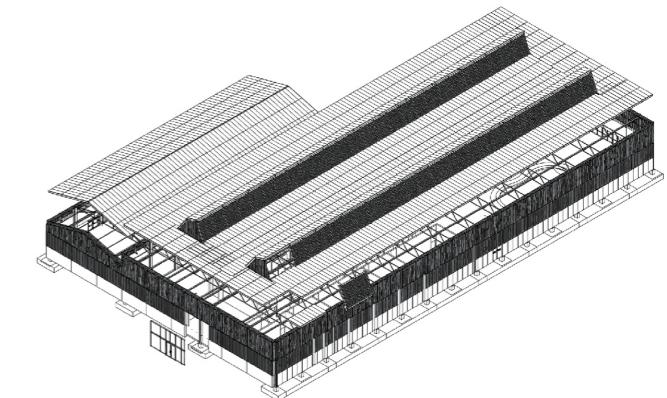
6. connect the roof panels (laminated timer panels & PC panels) to the trusses.

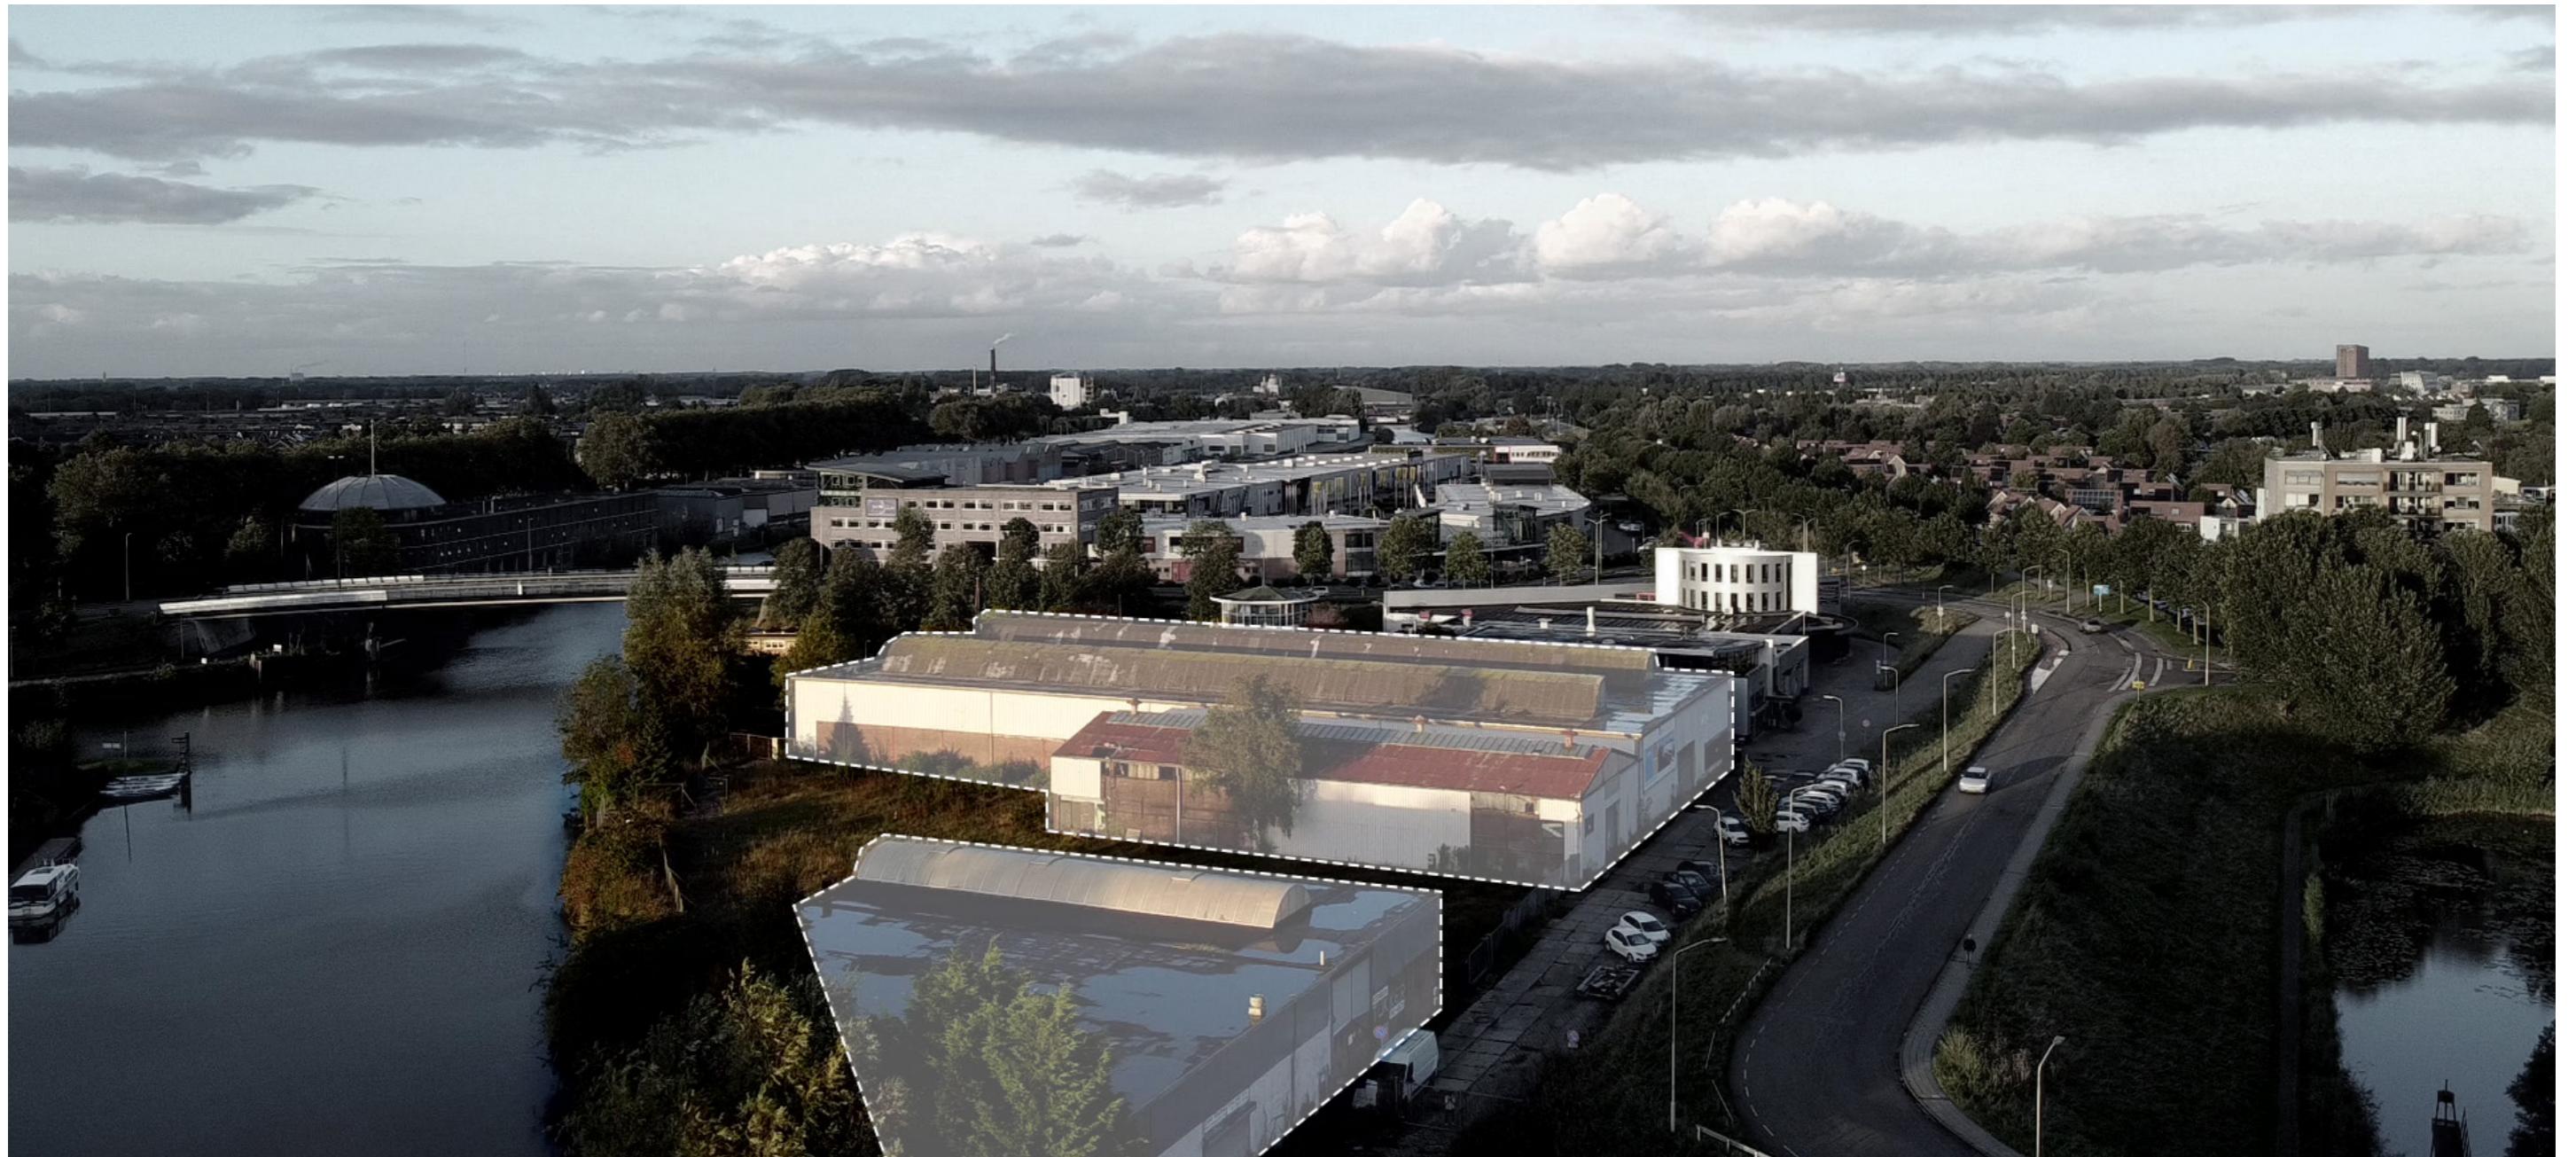
©Xiaoling Wei, Aerial Photo, De Vries Robbé warehouse between Linge River and Spijksedijk, Gorinchem (2024)
