Early detection of impact fatigue damage in an adhesively-bonded connection using acoustic emission

Engineering Structures

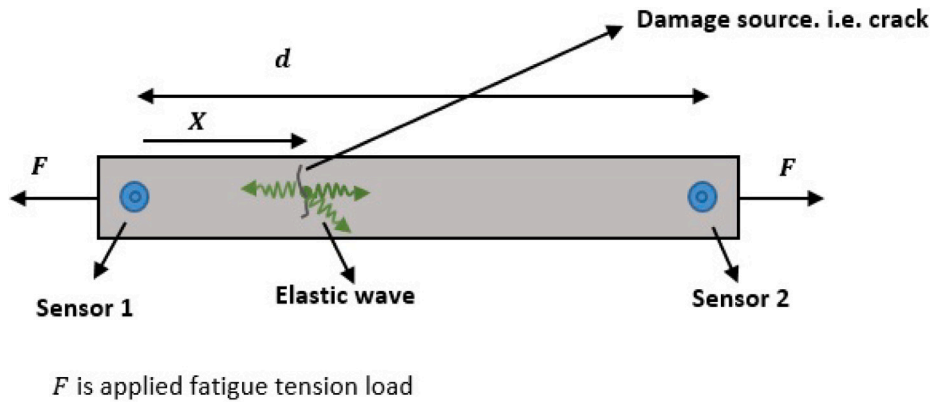
Fig. 1. Schematic illustration of the test specimen in a tension fatigue load with a damage source, i.e. crack and two sensors to identify the damage source.

Referring to the schematic of a test specimen subjected to a fatigue tension load F as shown in Fig. 1, X is the distance of the source of an AE event from Sensor 1, V is the velocity of the elastic wave associated with the event, Δt is the difference in the time of arrival of the event at Sensor 1 and Sensor 2 and d is the distance between the two sensors.

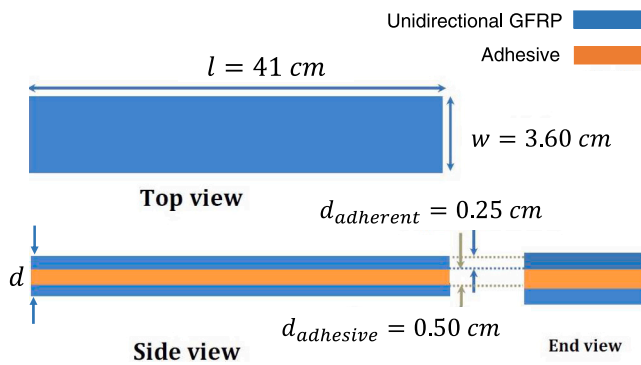
Fig. 2. Schematic illustration of a test specimen.

The test specimen used in the research was an adhesive joint representative of a spar cap-shear web adhesively bonded connection that would be seen in a wind turbine blade. Several test specimens were manufactured. Each test specimen consisted of two skins of unidirectional fiberglass which were made by the infusion of epoxy resin into three layers of unidirectional (UD(0)) fibers. These two skins were then bonded together by a layer of adhesive. The material properties of all components for manufacturing the test specimens are given in Table 1 and a schematic illustration of a test specimen is shown in Fig. 2.

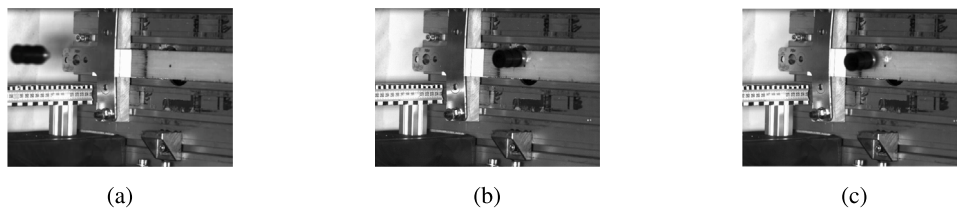
Fig. 4. Images of the projectile (a) before (b) during and (c) after hitting the test specimen.

In Fig. 4, images of the projectile before, during and after hitting the test specimen are shown.

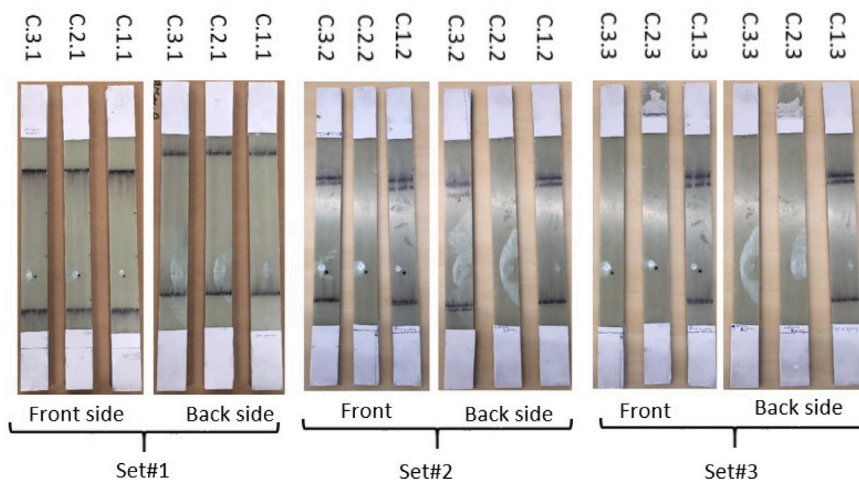
Fig. 5. The set of test specimens following the initial impact damage showing both front and back.

Three impact cases (Case 1, Case 2, and Case 3) representing different levels of impact damage were imposed on the test specimens. Photos of the impact-damaged specimens are shown in Fig. 5. The velocity of each projectile was measured using a high-speed camera. The characteristics of each impact including projectile properties, velocity, and energy level are given in Table 2.

For each impact case, three test specimens were damaged giving a total of nine test specimens used for the experiment. The test specimens after impact are shown in Fig. 5. In this figure, the nine test specimens are divided into three sets with each set showing the three different cases of impact damage.

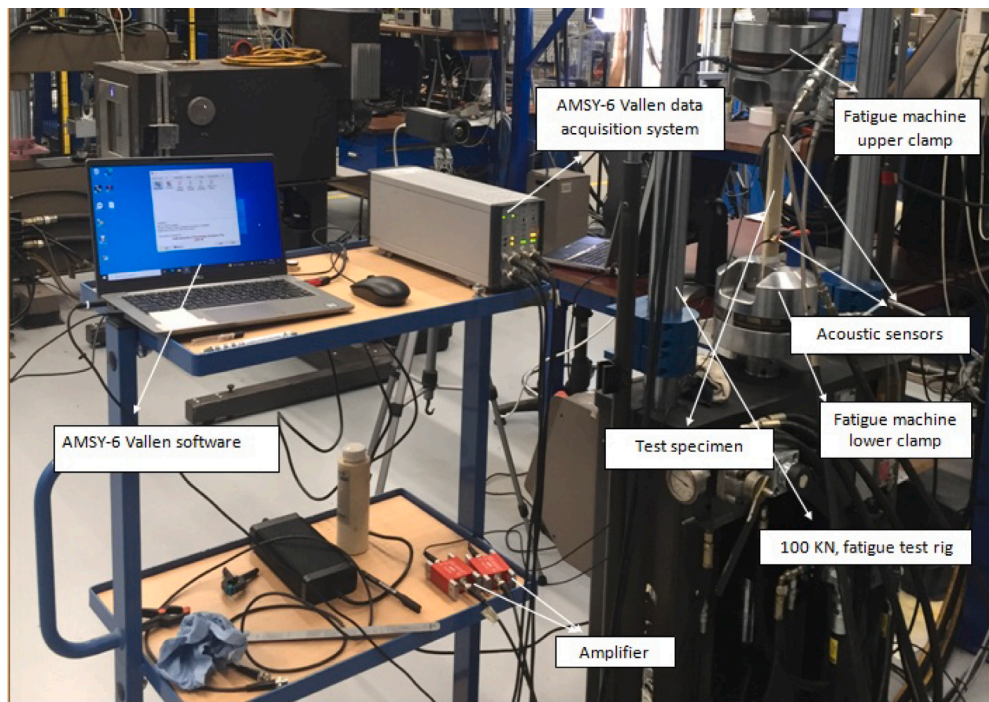
Fig. 6. The AE measurement and fatigue test set-up.

The impact damaged test specimens were subjected to a tension fatigue test using a 100 kN hydraulic fatigue rig under load control as illustrated in Fig. 6. The reason for conducting a fatigue tension test is that this test represents the loading condition that would be experienced by a joint that is used in the upper part of a spar cap

shear web assembly of a wind turbine blade. This has been justified and discussed in section 4.1 of a previous study [2]. To capture AE events, during the fatigue tests, two broadband, resonant-type, and single-crystal piezoelectric transducers from Vallen Systeme GmbH, AE1045SVS900M, with two external 34 dB pre-amplifiers were used. The optimum operating frequency range of the AE sensors was [100 – 900] kHz. To record the AE events, an AMSY-6 Vallen, 4-channel AE system with a maximum sampling rate of 10 MHz was used. The threshold of the receiving AE signals, sampling rate, Duration Discrimination Time (DDT) and Rearm Time (RAT), were 60 dB, 2 MHz, 200 μ s and 400 μ s, respectively. Sonotech Ultrasonic couplant was applied between the sensor and specimen surfaces to get an appropriate acoustic coupling. The functionality of the AE sensors and the data acquisition system was checked by performing a pencil lead break test according to the ASTM E976 standard. The test setup is shown in Fig. 6.

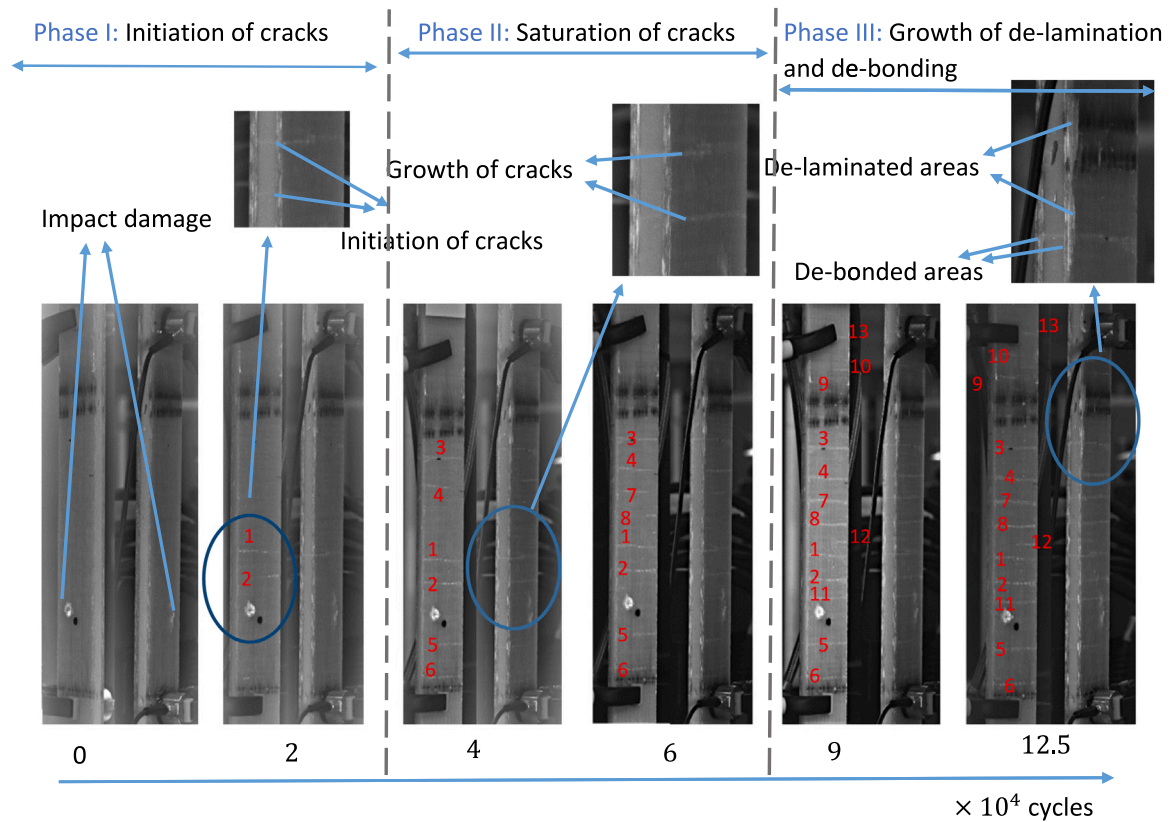
Fig. 7. Damage propagation in one of the test specimens (C.1,1) subjected to the low energy level impact. The left image of each pair shows the front where impact occurred and the right image is the back. Each photo shows an AE sensor attached at the top and bottom of each test specimen. Cracks which develop during the fatigue test are labeled with numbers for clarity.

The fatigue damage accumulation process for C.1.1 is shown in Fig. 7. As can be seen from this figure, damage initiates with cracks in the adhesive during the early stage of the fatigue test. This is the initiation phase of damage (Phase I). Cracks in the test specimen are transverse and initiate within the adhesive. They grow transversely and reach the interface of laminate and adhesive causing de-bonding of the laminate from the adhesive. Each horizontal white line seen

in Fig. 7 (at the position where a crack has occurred) is a de-bonded area. The width of each line shows how far the crack has progressed in depth within the test specimen. As the number of fatigue load cycles increases, cracks become widespread throughout the test specimen and this trend continues until the number of cracks reaches a saturation level. This phase of damage is known as the crack saturation level (Phase II). During Phase III, cracks deepen and consequently the de-bonded areas increase. The de-bonded areas grow as the number of fatigue load cycles increases. Finally, the de-bonded areas become connected leading to failure of the test specimen. The first crack is not within the impact zone and subsequent cracks which appear are not associated with this zone. This indicates that the fatigue damage accumulation process was not influenced by the size and location of the impact damage and it is identical to that seen in previous tests on an undamaged test specimen [2].

From the results of the three cases of damage, the AE measurements would seem to broadly confirm the levels of visual damage observed in Figs. 7–9. For the test specimens subjected to the Case 1 impact, fatigue damage is not correlated with the area of the initial impact. For the test specimens subjected to the Case 2 and Case 3 impacts, fatigue damage does appear to initiate close the area of impact, though there is some variability between the test specimens. In some cases, peaks in fatigue damage occur at the ends of the specimens which may be due to the gripping force induced by the end clamps where damage initiation and growth is facilitated.

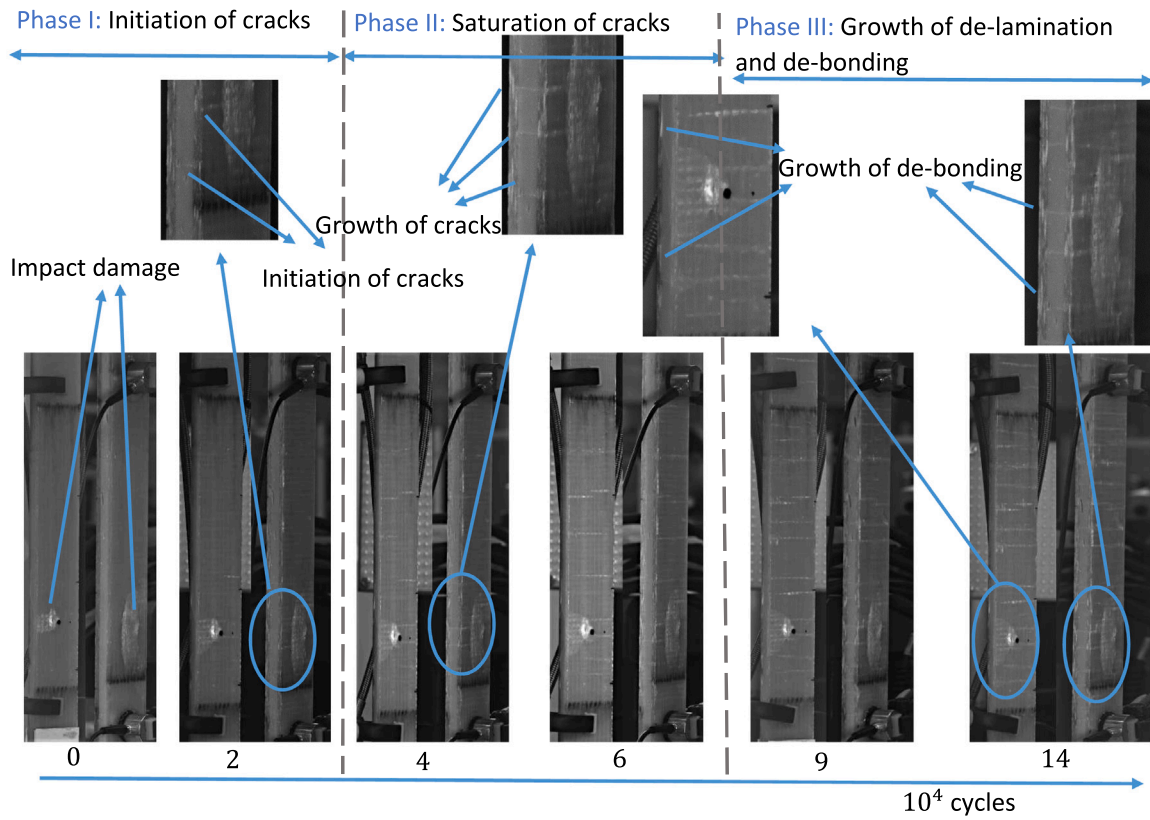
Fig. 8. As Fig. 7 but for C.2.1.

The fatigue damage accumulation process for C.2.1 is shown in Fig. 8. In this case, crack initiates close to the impact zone. As damage propagates, a higher crack density than in other areas of the test specimen is observed near the impact zone. The de-laminated area in the impact zone also grows more than elsewhere in the test specimen during the fatigue test ultimately resulting in failure in this zone.

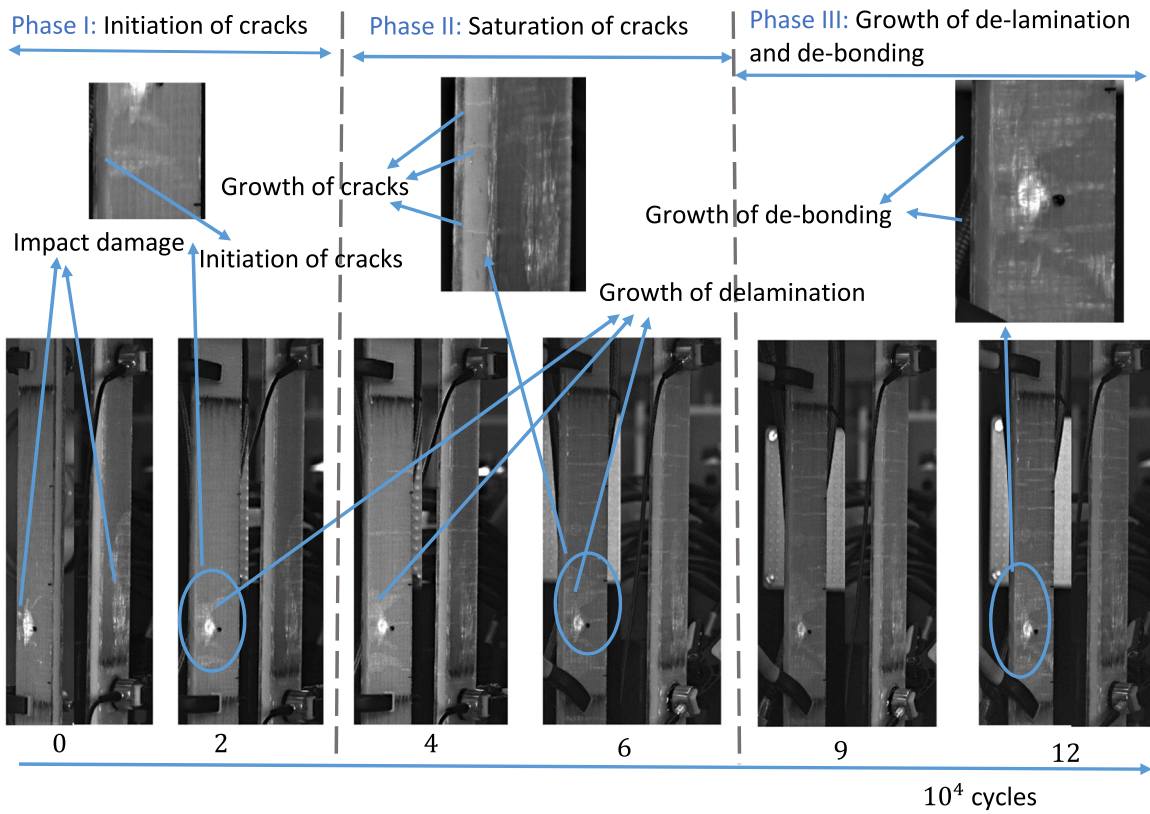
Fig. 9. As Fig. 7 but for the C.3.1.

The fatigue damage accumulation process for C.3.1 is shown in Fig. 9. Similar to C.2.1, the early cracks occur at the impact zone and the crack density in this zone is higher than other parts of the test specimen. In this case, the de-laminated area around the impact zone grows more extensively and faster compared with C.2.1 leading ultimately to failure in this zone.

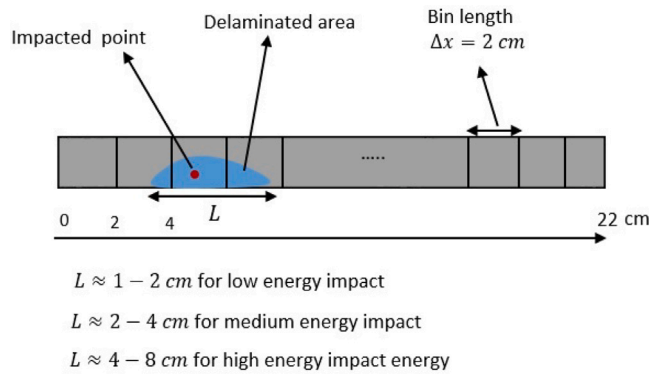
Fig. 10. Schematic illustration of the test specimen divided into 2 cm bins. Also illustrated are the impact point, and length of de-laminated area (L) in the lateral direction.

To detect the impact damage during Phase I of the fatigue test, the test specimens were divided into 2 cm bin lengths as shown in

Fig. 10. Each impact position was 4.2 cm from the lower AE sensor as shown in the photos in Figs. 7 to 9. The length (L) of the de-laminated area surrounding the impact point in the lateral direction depends on the impact energy level, varying from 2 cm to 8 cm. To detect the impact damage in the early stage, the normalized number of AE events during Phase I of damage in the fatigue test for each bin was calculated. Because impact damage accelerates the generation of AE events, it was expected that the bins located in the impact zone would have the highest number of events. In this section, results for all three test specimens subjected to the same level of impact energy are presented to show the degree of variability in damage localization.

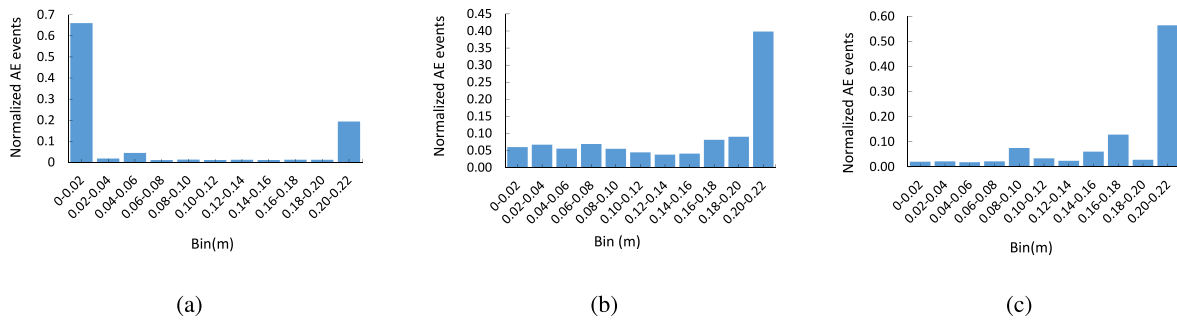
Fig. 11. The total number of normalized AE events by bin at the end of Phase I of the fatigue test for the three test specimens subjected to the Case 1 impact: (a) C.1.1 (b) C.1.2 (c) C.1.3.

The total number of normalized AE events by bin during Phase I of the fatigue test for the test specimens subjected to the Case 1 impact is shown in Fig. 11.

It can be seen for C.1.1 that the 0–2 cm bin (inside the impact zone) was not the most damaged section but rather the 20–22 cm bin, far from the impact area. For C.1.3, the most damaged section was located between 20–22 cm which is also far from the impact zone.

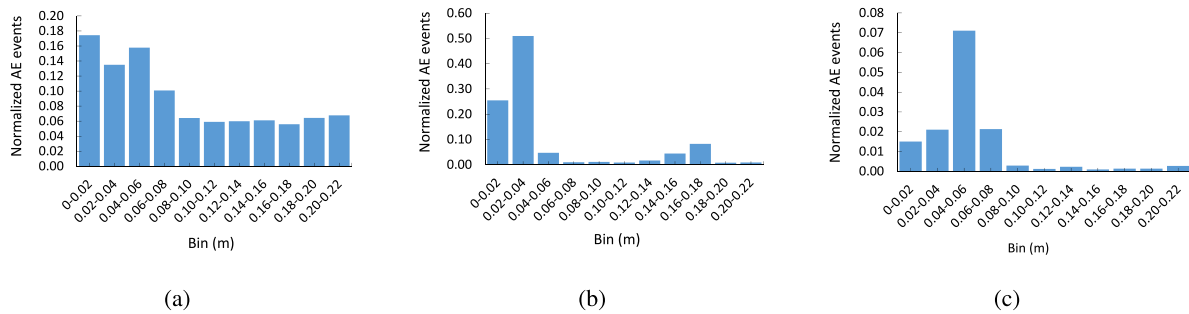
Fig. 12. The total number of normalized AE events by bin at the end of Phase I of the fatigue test for the three test specimens subjected to the Case 2 impact: (a) C.2.1 (b) C.2.2 (c) C.2.3.

The corresponding results for the test specimens subject to the Case 2 impact are shown in Fig. 12. It can be seen that the bins between 0–2 cm and 4–6 cm are the most damaged sections of C.2.1 which are relatively close to or within the impact area respectively.

The results for C.2.2 and C.2.3 show peaks in normalized events in bins 2–4 cm and 4–6 cm, respectively, which are inside the impact zone.

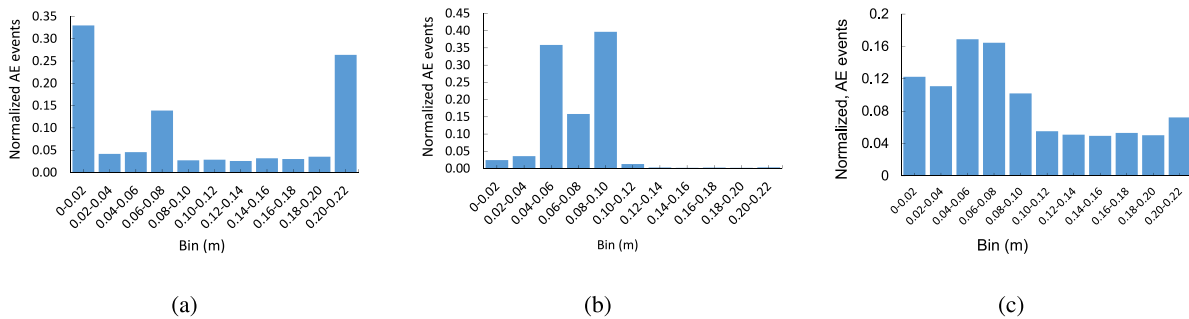
Fig. 13. The total number of normalized AE events by bin at the end of Phase I of the fatigue test for the three test specimens subjected to the Case 3 impact: (a) C.3.1 (b) C.3.2 (c) C.3.3.

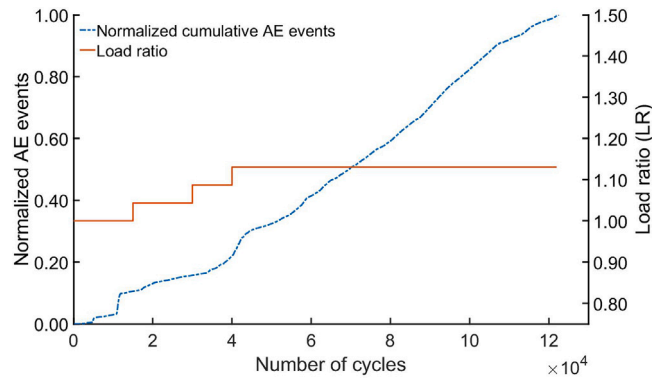
Fig. 14. Normalized AE events during the fatigue test for C.1.1.

Fig. 14 shows temporal changes in normalized AE events and load ratio during the fatigue test for C.1.1. This gives an indication of where changes in the load give rise to an increase in AE event generation, but

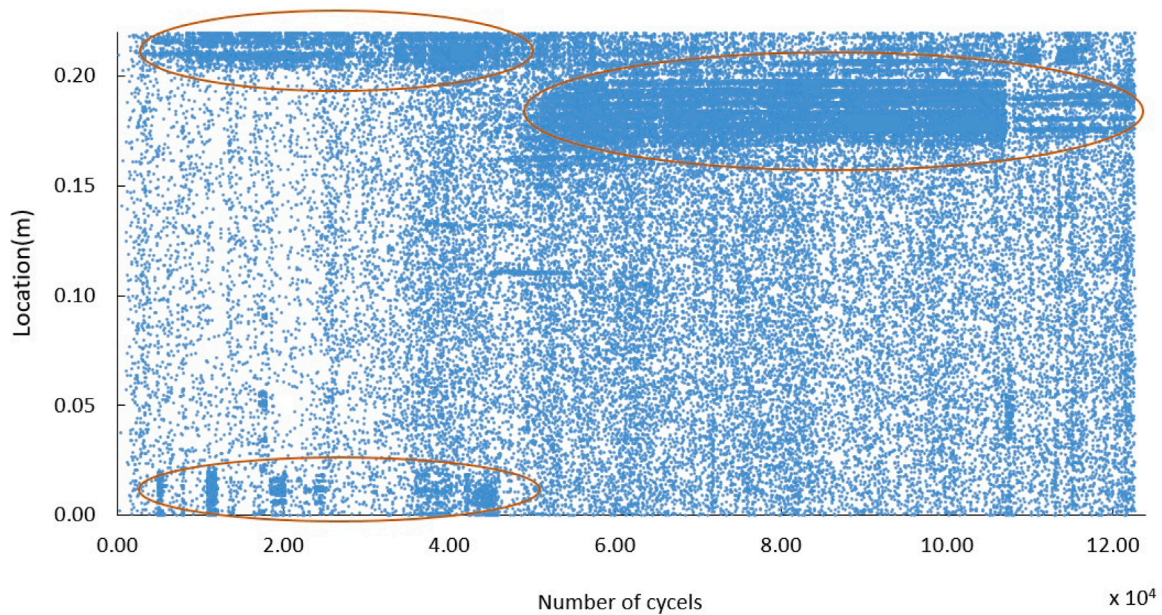
Fig. 15. Spatial distribution of AE events during the fatigue life, for C.1.1.

also shows where damage is accelerating where it is not necessarily associated with a change in the load. Fig. 15 shows the corresponding spatial density of normalized AE events. The damaged sections can clearly be seen during the fatigue life cycle marked in red. Initially, the [0–2] cm and [20–22] cm sections of the test specimen show significant damage. As the fatigue test progresses and damage propagates in the test specimen, the [17–20] cm section of the test specimen show significant damage. It is therefore clear that throughout the full fatigue test, the location of the fatigue damage is not associated with the impact zone.

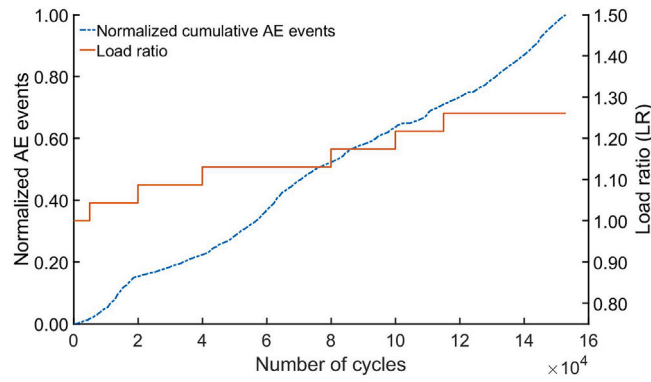
Fig. 16. As Fig. 14 but for the C.1.2.

Fig. 16 shows the changes in normalized AE events and load ratio during the fatigue test for C.1.2. The corresponding spatial density of AE events for this test specimen can be seen in Fig. 17. Similar results are seen compared to C1.1 and if anything, the damage is quite uniformly distributed throughout the test specimen for the duration of the fatigue test. Fig. 18 show the changes in normalized AE events and load ratio during the fatigue test for C.1.3 and Fig. 19 shows the corresponding spatial density of AE events. There a notable increase in events at around 3.5×10^4 cycles which corresponds to areas of damage indicated in red in Fig. 19, but otherwise damage in this case is quite

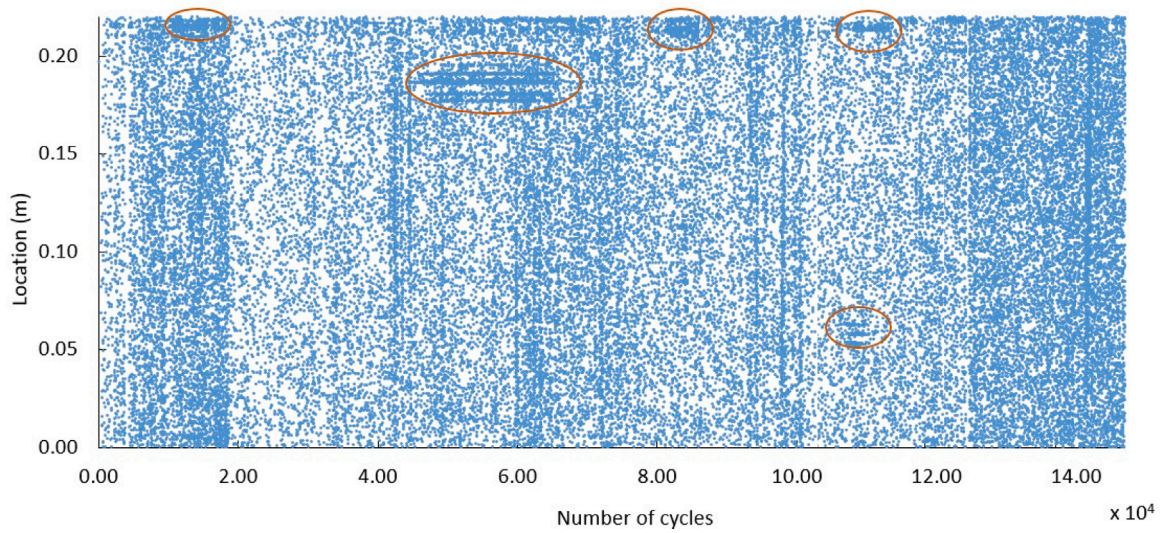
Fig. 17. As Fig. 15 but for C.1.2.

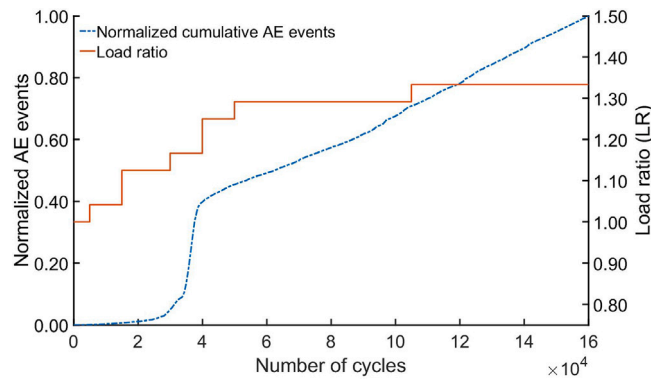
Fig. 18. As Fig. 14 but for C.1.3.

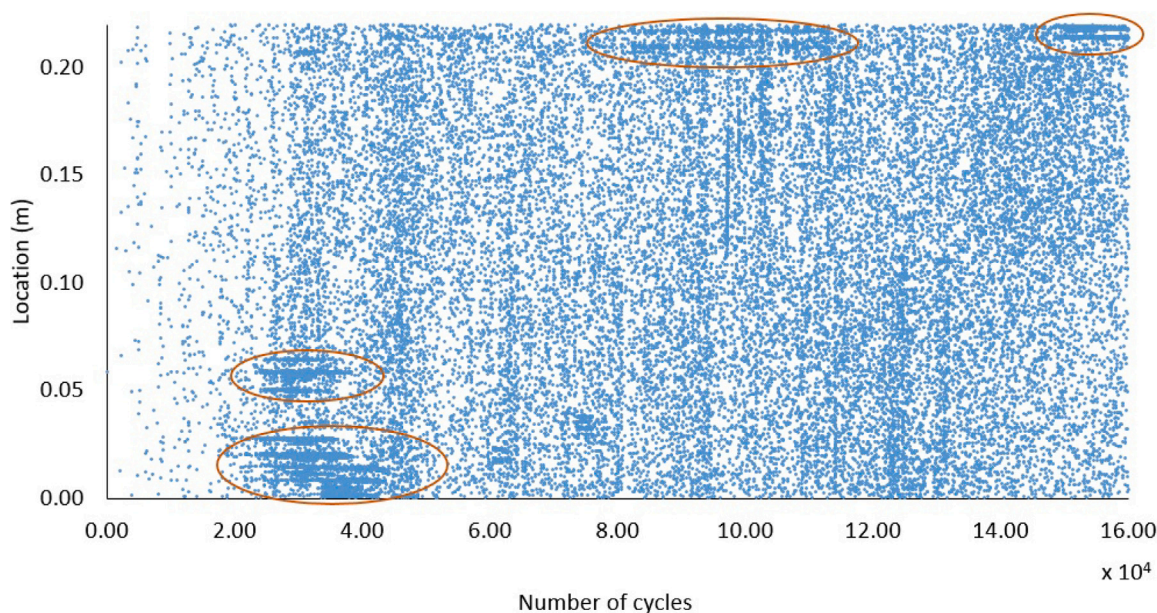
Fig. 19. As Fig. 15 but for C.1.3.

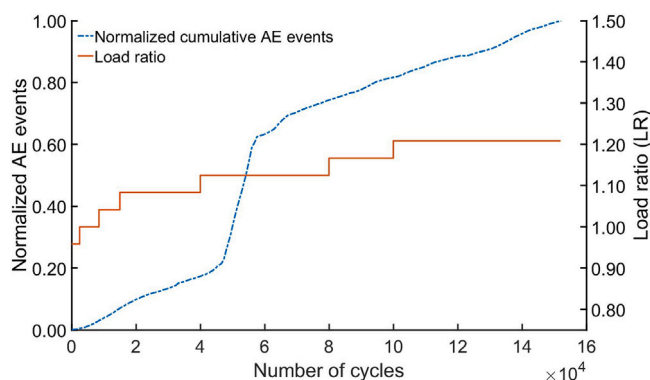
Fig. 20. Normalized AE events during the fatigue test for C.2.1.

Figs. 20 to 25 show the corresponding results for the test specimens subjected to the Case 2 energy impact. The increase in the density of AE events shows the damaged area. Continual growth in damage (higher density of AE events) within the impact zone for C.2.2 and C.2.3 can be seen until the end of the fatigue tension test. For C.2.1, the damage is initiated in the impact zone and then as the number of fatigue load cycles increases, it propagates to other sections of the test specimen. This propagation can be seen in Fig. 21 between load cycles 4×10^4 and 6×10^4 .

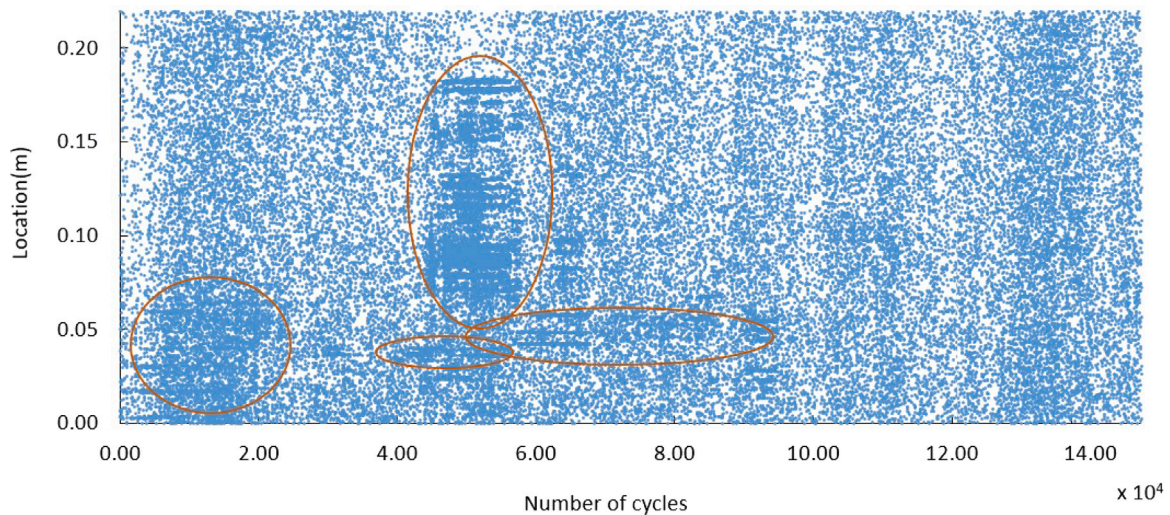
Fig. 21. Spatial distribution of AE events during fatigue life, for C.2.1.

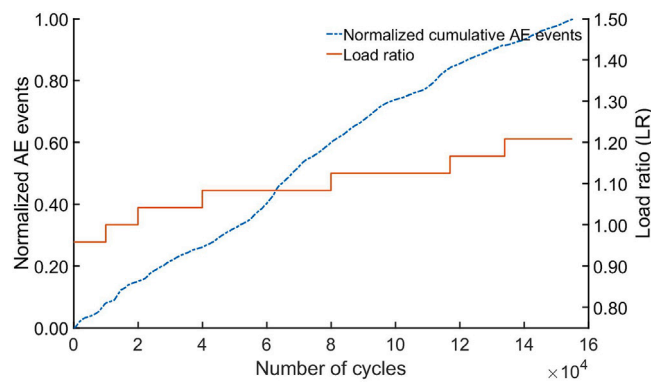
Fig. 22. As Fig. 20 but for C.2.2.

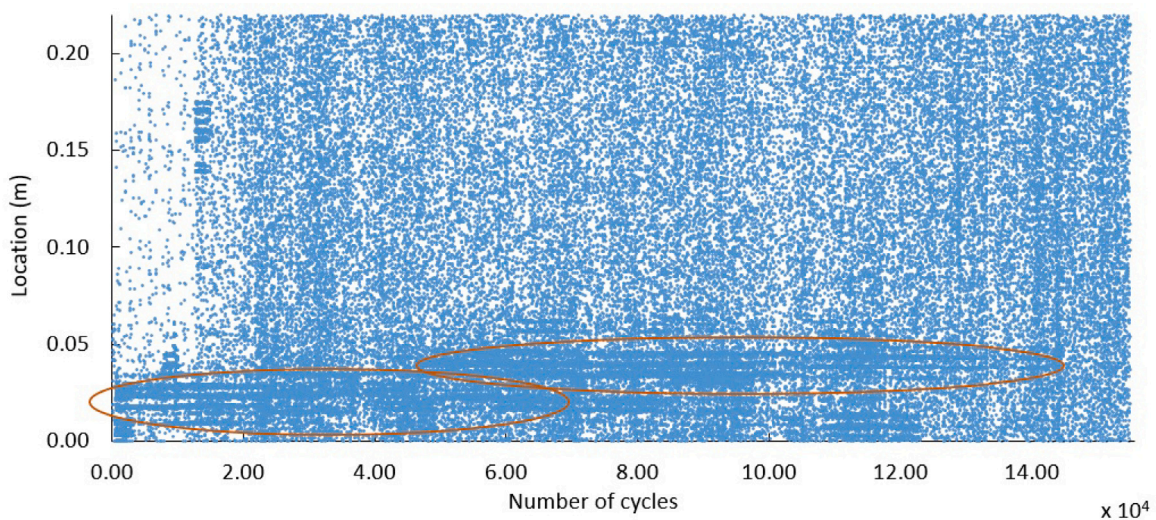
Fig. 23. As Fig. 21 but for C.2.2.

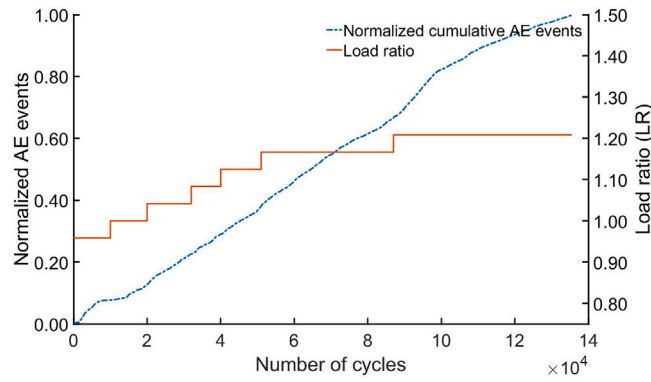
Fig. 24. As Fig. 20 but for C.2.3.

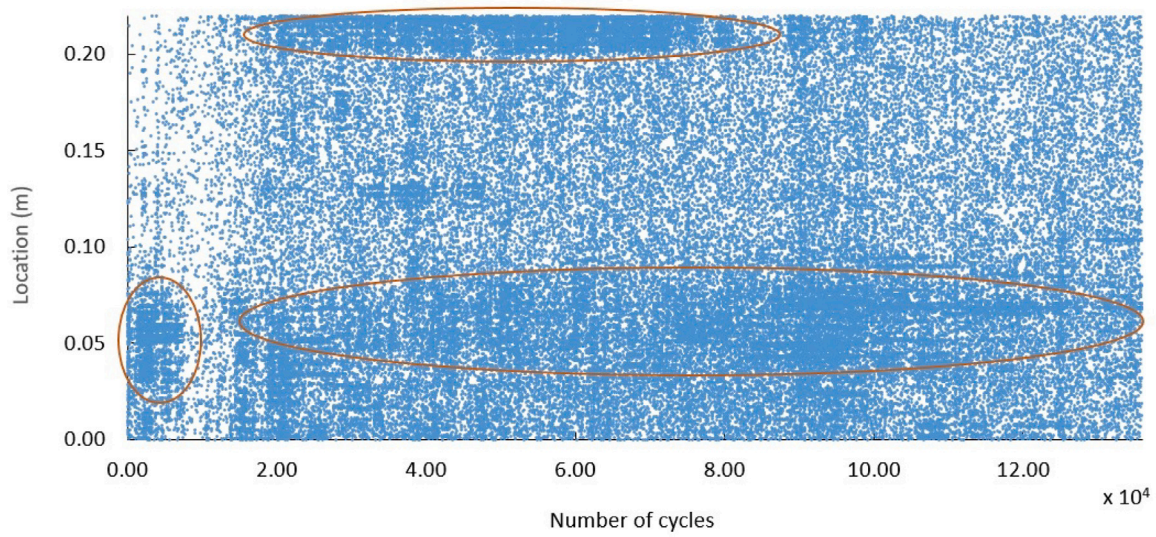
Fig. 25. As Fig. 21 but for C.2.3.

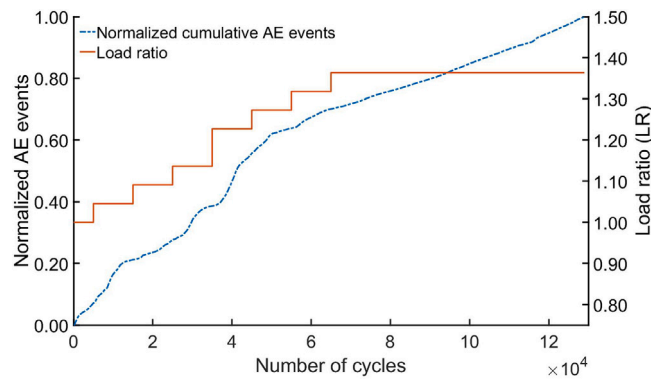
Fig. 26. Normalized AE events during the fatigue test for C.3.1.

Figs. 26 to 30 show the corresponding results for the test specimens subjected to the Case 3 energy impact. Similar results as for the Case 2 energy impact can be seen here. Only for impact energy case 3. Only for C.3.3, there is no significant change in the spatial density of AE events in the impact zone, at the beginning of fatigue test as seen in Fig. 31. However, as the number of fatigue load cycles is increased, growth of the damage in the initial impact zone can be seen. This behavior is in slight contrast to the results seen for C.3.1 and C.3.2.

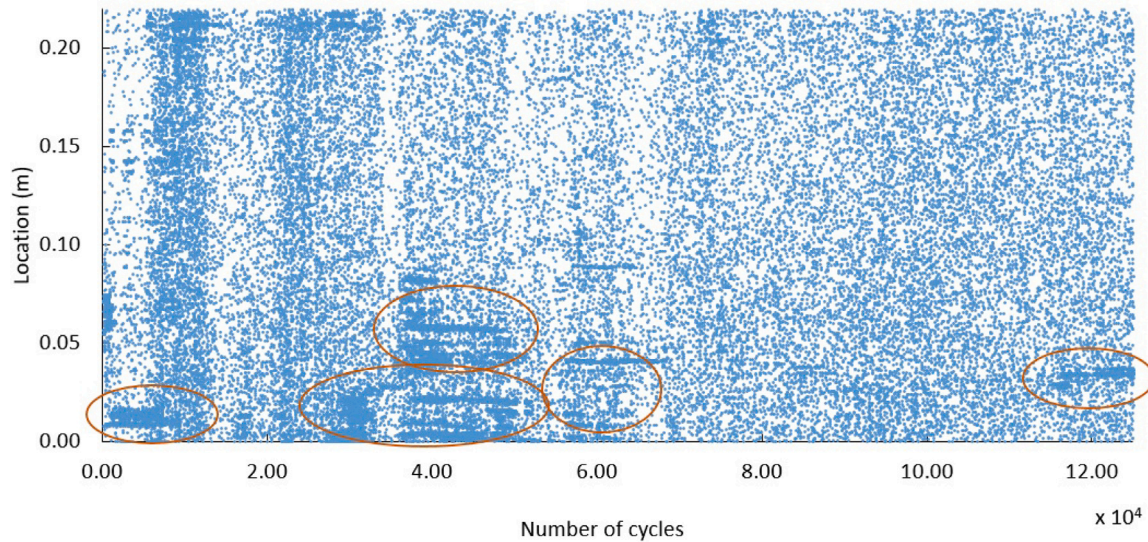
Fig. 27. Spatial distribution of AE events during the fatigue test for C.3.1.

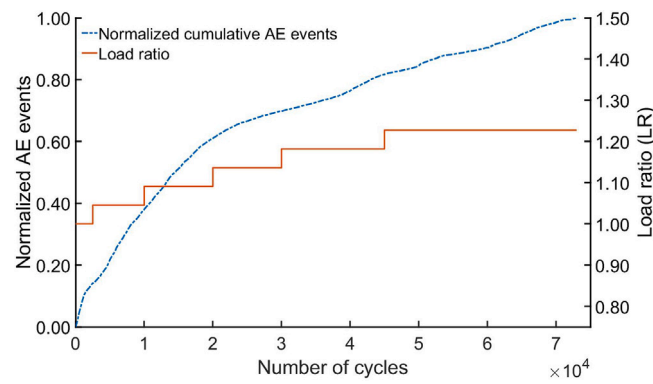
Fig. 28. As Fig. 26 but for the C.3.2.

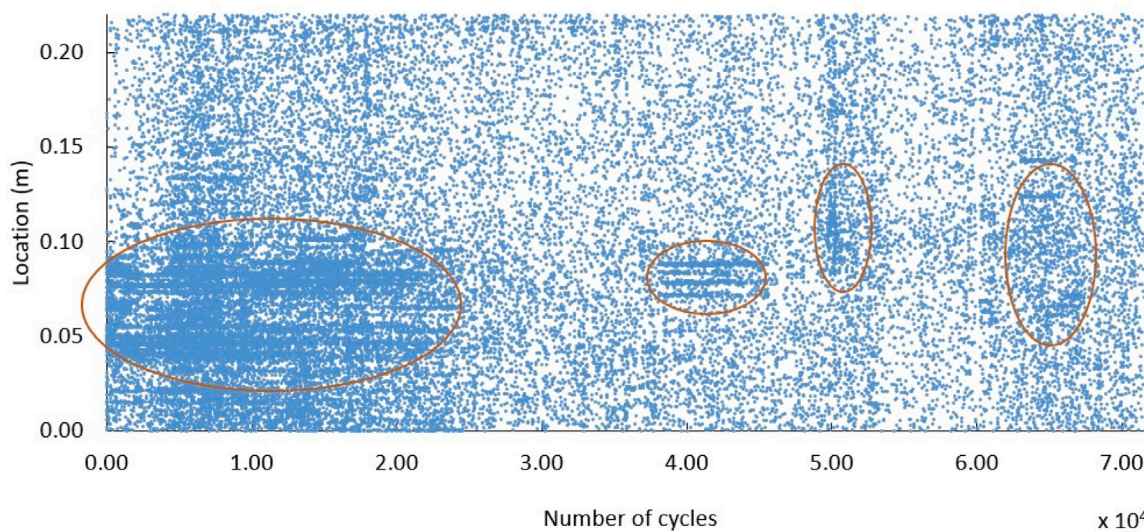
Fig. 29. As Fig. 27 but for the C.3.2.

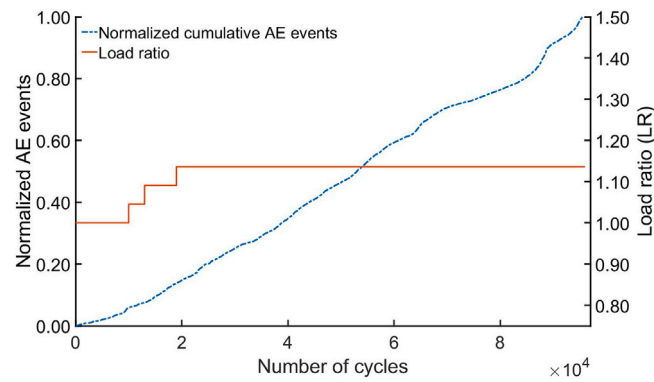
Fig. 30. As Fig. 26 but for C.3.3.

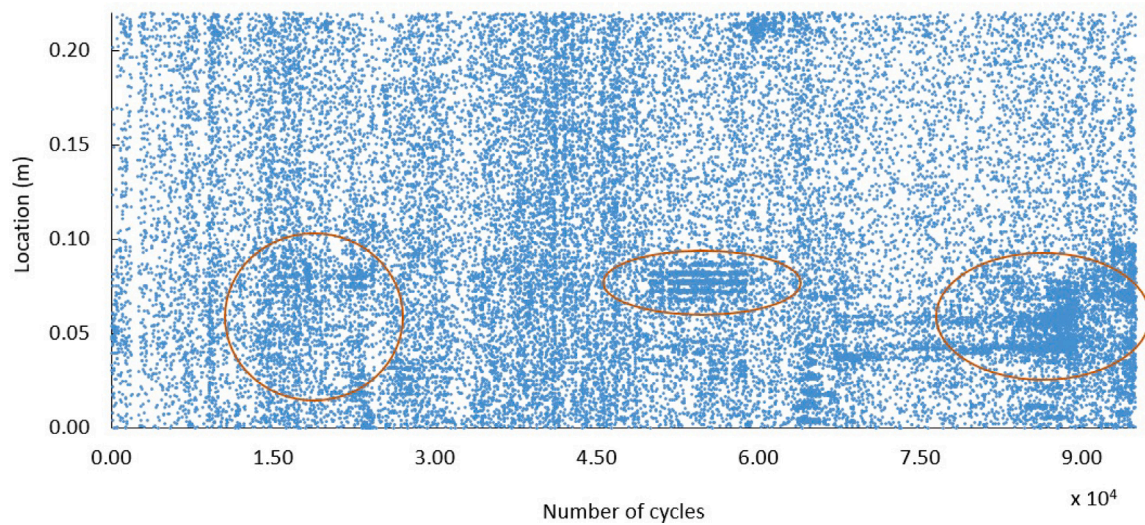
Fig. 31. As Fig. 27 but for the C.3.3.
