Detecting defects in diaphragm walls prior to excavation

1 Abstract

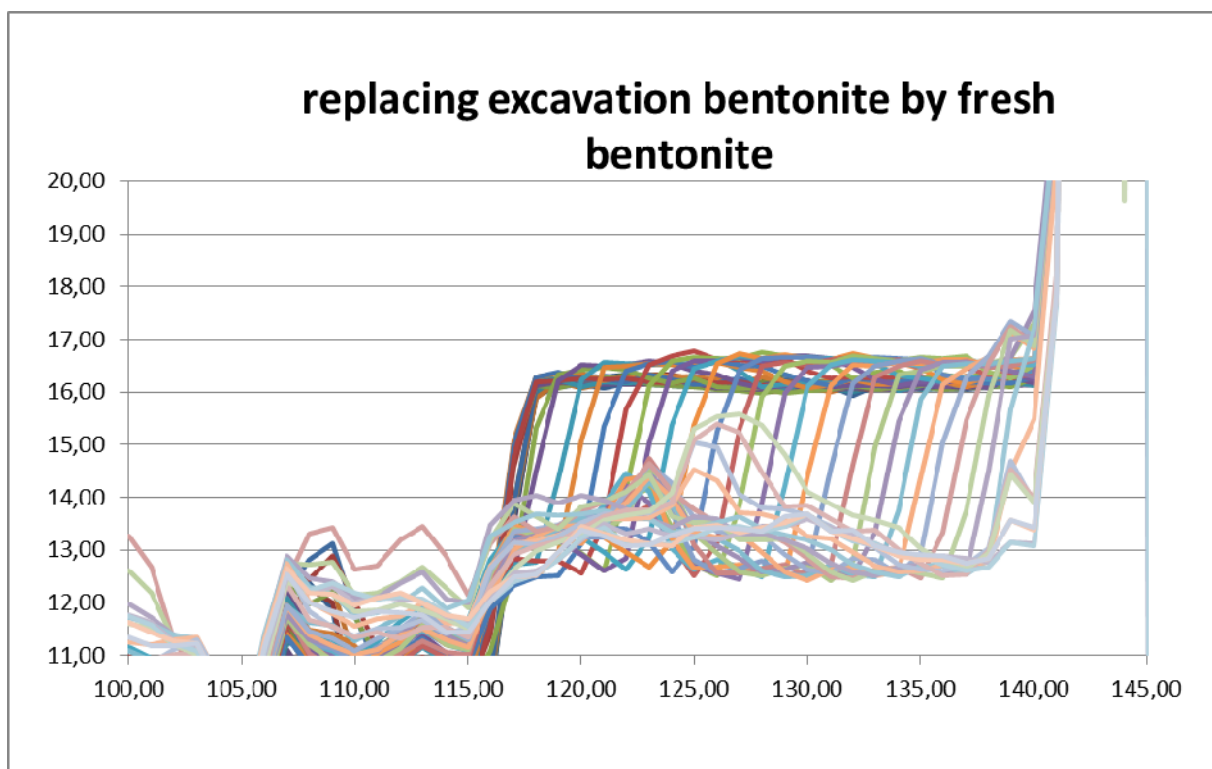
Figure 2: Fresh bentonite (12.5 °C) replacing excavation bentonite (16.3 °C), 117 m till 140 m along the sensor is in the trench

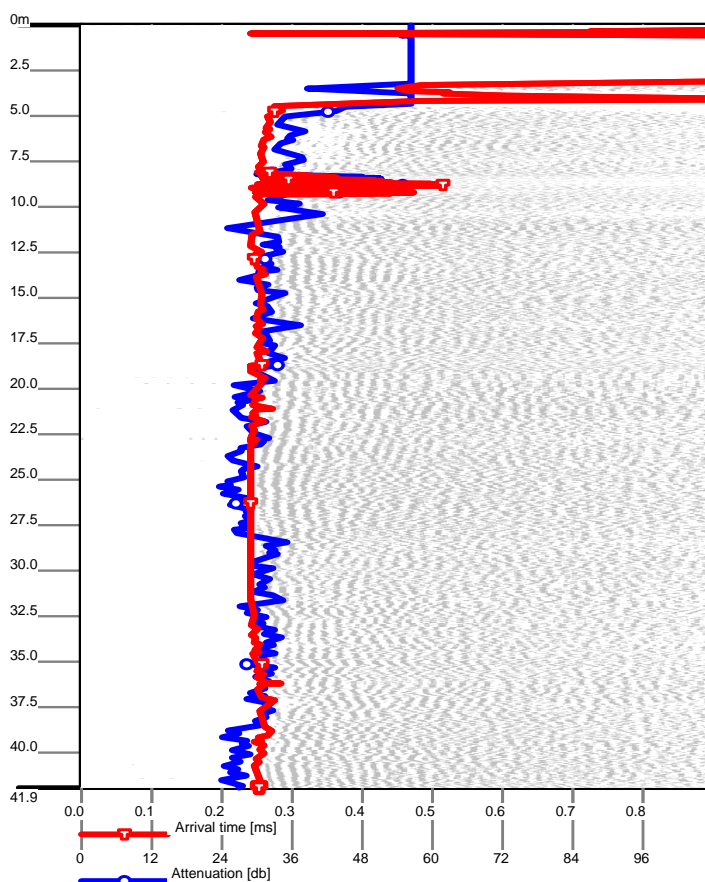
Figure 4: Cross-hole seismic profile with anomaly from 8 to 9.5 m

In Figure 4 the anomaly at 8-9 m minus surface level can clearly be seen. The upper 4 m consists of low grade concrete due to pollution with bentonite (1 m) and bentonite, as the upper 3 m were not concreted to facilitate easy construction of the concrete beam coupling the wall panels.

The anomaly found in the in-situ profile of Figure 4 shows 0.25 ms extra arrival time combined with 24 dB damping. If the laboratory samples prove to be representative, the size of the anomaly could be in the order of 0.25 m (based upon arrival time) and 0.35 m (based upon damping). When we combine the extra arrival time with the damping, we expect around 0.3 m of bentonite in the joint.

The resistivity profile was measured at the same joint as the CSL profile of Figure 4 in which an anomaly was detected at 8 to 9.5 m minus reference level. In Figure 8, at the same depth, there is a 30% (relative to the average 1 MOhm resistance) decrease of the resistivity over the diaphragm wall (REF in Fig. 9). The anomaly probably reaches to 1/3 of the wall thickness, based upon a decrease of the resistivity of 30%. The depth of the visible 'defect' has not yet been established because the defect is exactly at a strut level and is not accessible until the struts are removed.

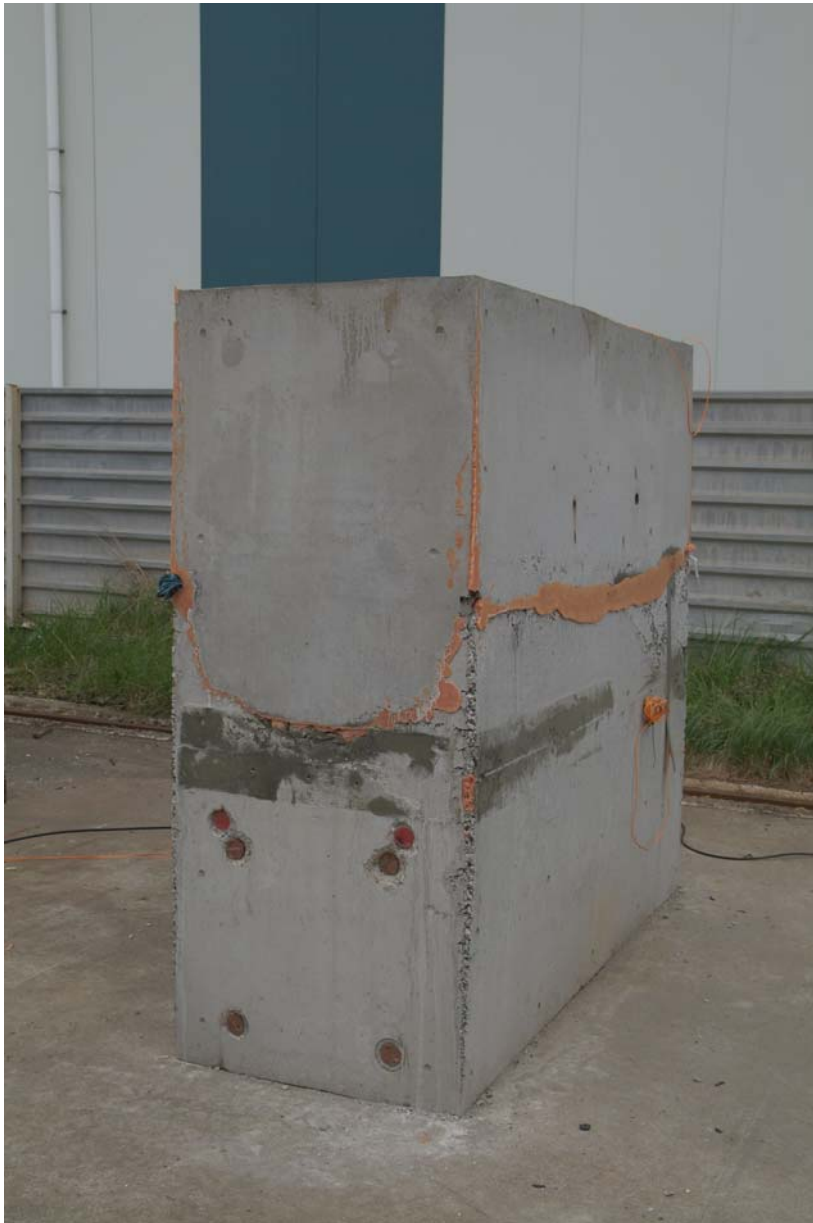
Figure 6: Laboratory block

From the laboratory tests (Fig. 8) a first indication of the anomaly size can be deducted. The test blocks were poured in a normal formwork with a steel joint profile as the lower boundary of the formwork. After curing of the first half, the block was inverted, an anomaly was sculptured in the joint area, the formwork was attached again and the upper block was poured. Instrumentation was set up similar to the in-situ tests.

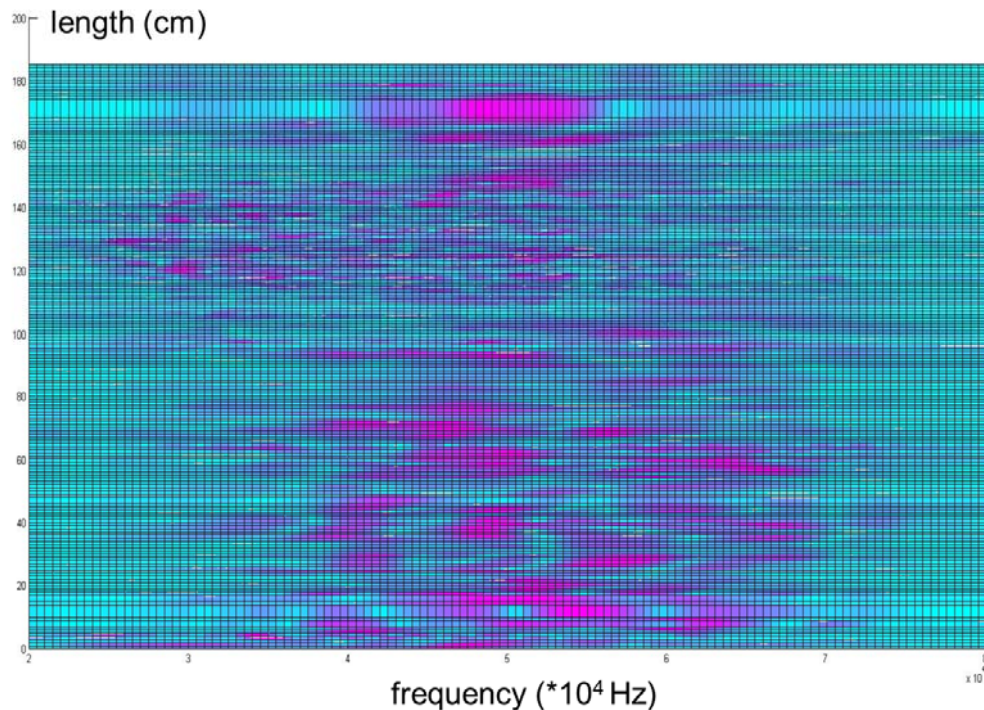
For further interpretation we are working on a frequency domain analyses of the signal passing through the joint. From the results of the test blocks (Figure 7) it seems that the higher frequency components of the signal are absorbed by the

inclusion to a higher degree than the lower frequency components. The spectral analyses of the recorded signal could help identifying the material in the inclusion. Materials with low stiffness (e.g. bentonite) tend to filter the high frequencies more than stiffer materials like sand or even low strength concrete.

Figure 7: Spectral analyses of the CSL signal

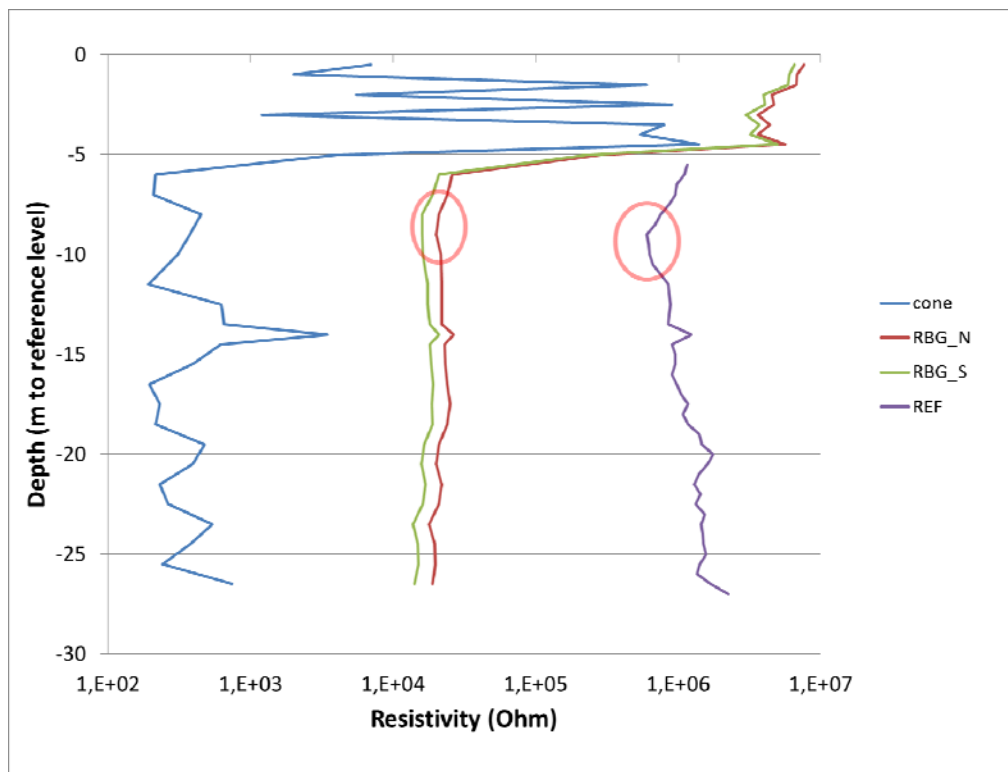
The local electrical soil resistivity was measured with the CPT cone (CONE in Figure 8), the electrical resistivity from the cone to the reference electrode outside the building pit was measured (REF in Figure 8) as well as the resistivity between the cone and the rebar grids on both sides of the joint (RBG_N, RBG_S in Figure 8).

Figure 8: Resistivity profile
