Assessment of Corbel Damages in Concrete Parking Structures

N. Assendelft, D.A. Hordijk

Keywords: finite element analysis; forensic engineering; parametric study; parking structures; reinforced concrete corbels; support end failure

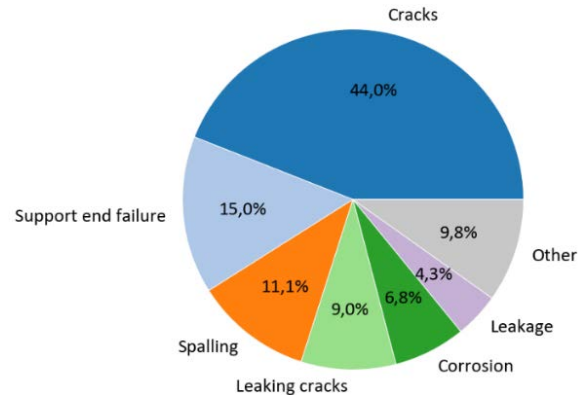
From the 145 forensic reports, a total of 234 damages were identified. Damage was predominantly found as cracks, support end failure, spalling, corrosion, and leakage (Figure 1).

Figure 1. Distribution of the 234 observed damages.

1. The findings of the data analysis of forensic reports from Adviesbureau Hageman in The Netherlands, indicate the three most common type of damage in parking structures, being cracks, support end failure, and spalling. Most of the encountered damages were found to be predominantly caused by faults in the design or execution stage. Additionally, there appeared to be a difference in frequency of occurrence of cracks and support end failure, for respectively above- or underground structures.

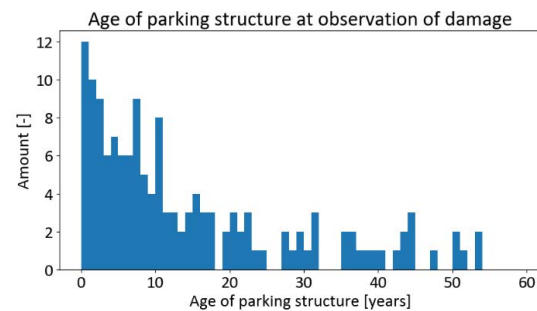
Additionally, the time between the year of construction and the year damage was observed, was registered (Figure 2). Most of the analysed structures were built after 1990. The results implied that the majority of the observed damage occurs within the first ten years after construction. Therefore, it could be argued that the main cause of damage is predominantly related to faults in design or execution of the structure, as degradation of the structure would be expected to arise as more time passed.

Figure 2. Histogram of elapsed time between year of construction and year of observation of damage.

The findings of the data analysis implied that most the observed types of damage, in Dutch parking structures, occur within 10 years after construction. Therefore, it indicates that these are predominantly arising from mistakes in the design or execution stage of a structure. Although, observations of degradation induced damage might increase in the future, due to the large amount of structures that is built after 1990. As only a limited number of forensic files were used in the data analysis, it affects the generalizability of the results.

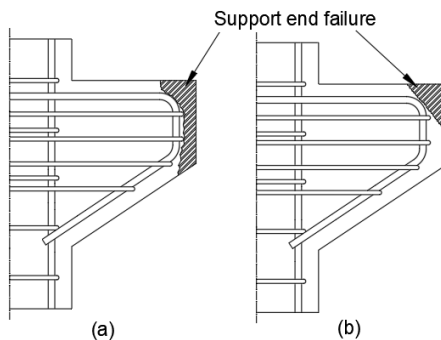
Kriz and Raths [4] were probably one of the first to categorise the support end failure as a secondary failure mechanism of concrete corbels. The damage is characterised by the local, brittle failure of the unreinforced concrete cover of a supporting element. Generally, it occurs either along the entire height (Figure 3a) or locally at the corner of the supporting element (Figure 3b).

Figure 3. Schematic presentation of potential support end failures.

For both configurations b and c, the support end failure crack propagated over the entire height of the corbel, as was suggested to be a potential failure plane in Figure 3 (a), rather than the local failure of the corner. This behaviour resulted from increased compressive stresses in the unreinforced cover of the corbel, caused by a disruption of the principal stress trajectory below the bearing pad due to the crack development. This process continued iteratively until the bottom of the corbel was reached and the cover over the total corbel height failed. A depiction of this process is provided in Figure 12.

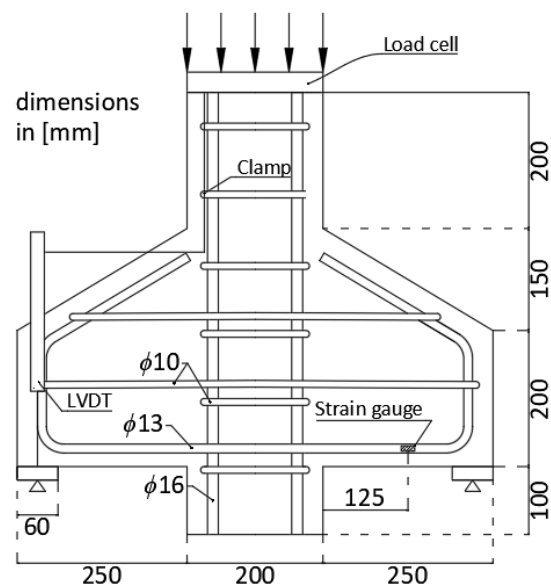
The results of one of the specimens of the series of experiments by Neupane et. al. [3] was used for verification. In the experiment a symmetric corbel element was loaded until support end failure occurred. The experimental setup of the applied specimen are shown in Figure 4. Support end failure occurred by loading the specimen at the column foot and supporting the cantilevering corbels on its outer edges by steel plates. In the experiment the applied load, the displacement between the steel plates, and the strain of the main reinforcement were measured. Alongside the experiment, Neupane et. al [3] accurately reproduced the experiment using a 3D non-linear numerical analysis.

Figure 4. Specimen and experimental set-up series by Neupane et al. [3].

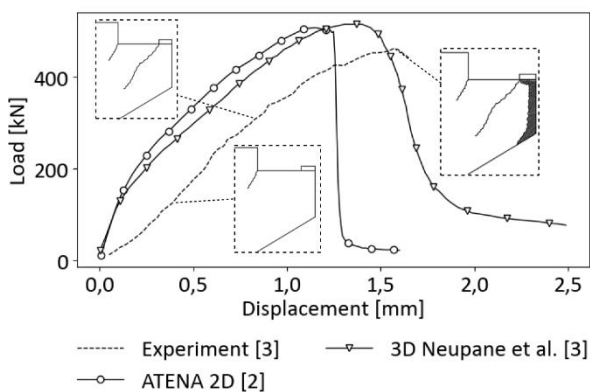
In Figure 5, the load-displacement of the experiment, 3D numerical model by Neupane et al. [3], and the 2D numerical model are displayed. The numerical results showed similarity to the failure load of the experiment. However, it also showed a disparity in the initial stiffness. Reason is setting of the gypsum layer between the steel bearing pads and the corbel [3].

Figure 5. Load-displacement curve [2], [3].

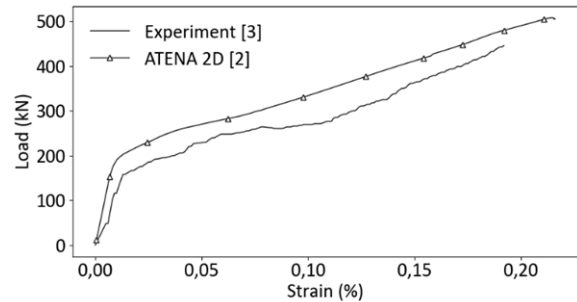
The load-strain relation found with the 2D numerical analysis fits rather well to the experimental result (Figure 6). As can be seen, at failure the reinforcement did not yield, since the yield strain of 0,26 (%) was not yet reached.

Figure 6. Load-strain relation in main reinforcement [2], [3].

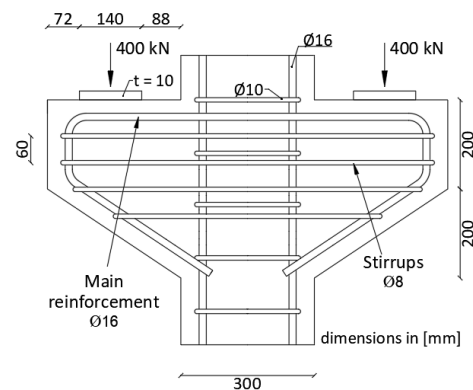
For the ‘Eurocode design’ a symmetric corbel specimen was designed for a vertical design load of 400 kN. Concrete strength class C40/50 and reinforcement steel with grade B500b was used. Furthermore, an elastomer was used as support material, as it was expected to distribute the bearing stresses more uniform onto the corbel. The configuration of the reference corbel is shown in Figure 7. Furthermore, the corbel had a uniform depth of 300 mm.

Figure 7. Corbel design in accordance with Eurocode 2 [2].

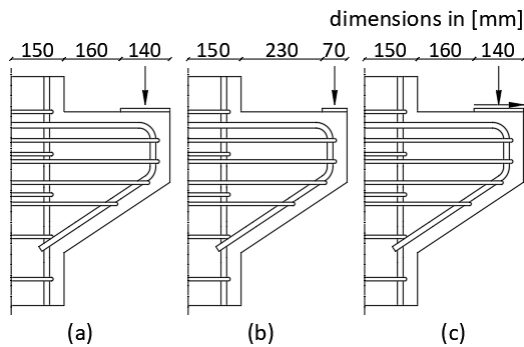
In the parameter study the effect of a misplacement of the bearing material (towards the edge) and of an additional horizontal load was examined (Figure 8). These loading conditions were chosen partly based on causes of support end failure occurring in practice, as obtained by the data analysis. Furthermore, these were chosen because misplacements of supports without any damage in the corbel often leads to discussions in practice as far as the effect on the corbel behaviour is concerned. The three configurations are, respectively, the bearing pad placed on the edge of the corbel (a), a bearing pad on the edge and reduced in width (b), and combined horizontal and vertical loading (c) (Figure 8).

Figure 8. Corbel loading conditions as applied in parameter study.

Configurations a and b reflect situations from practice such as the ‘walking’ of support material during a structures’ lifetime or incorrect placement of the support during execution. Moreover, configuration c represents horizontal loading due to imposed shrinkage of the supported element, which in practice is probably the most frequent occurring reason for corbel damage.

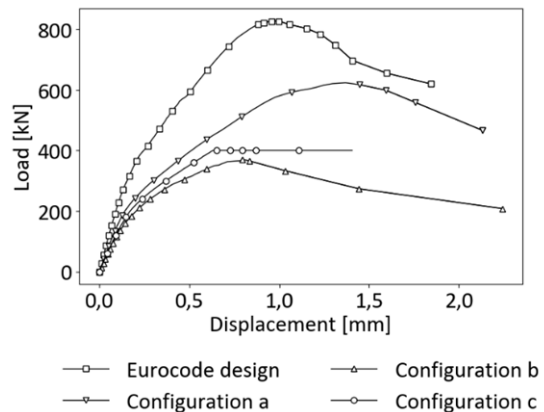
The load-displacement relations obtained from the numerical analyses are presented in Figure 9. For the corbel configuration according to Eurocode design the maximum load that could be applied, was 826 kN. After the peak load the displacement was further increased till failure occurred at a load of 748 kN. For configurations a and b, in which the elastomeric support was positioned on the edge of the corbel (a) and also reduced in size (b), a maximum load, corresponding to the failure load in practice, of respectively 623 kN and 372 kN was obtained, whilst the configurations failed at a load of respectively 599 kN (a) and 353 kN (b). The maximum load and failure load of configuration c occurred at a horizontal load of 69 kN.

Figure 9. Load-displacement relations for the Eurocode design, configurations a, b and c.

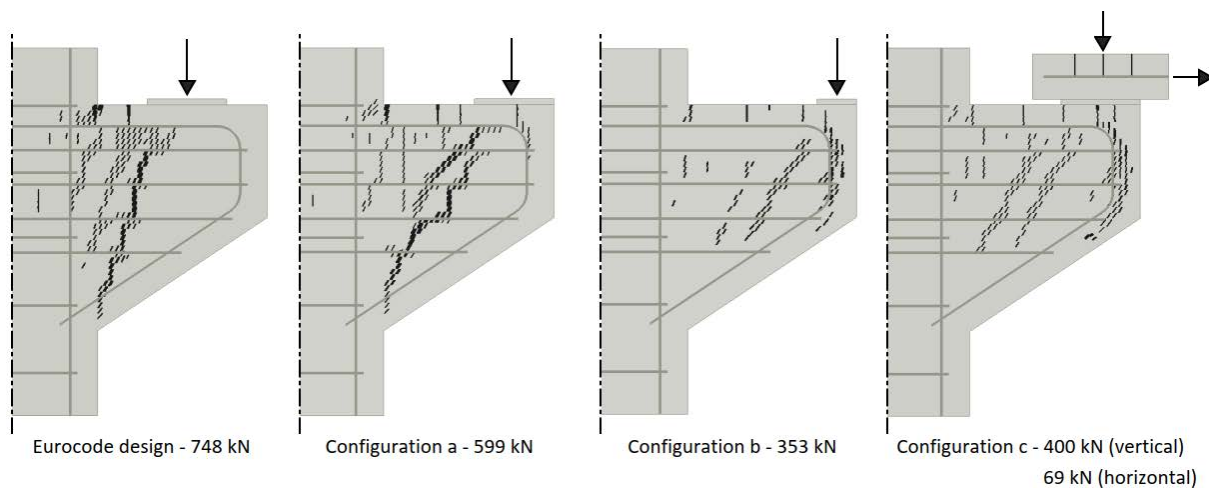
The crack pattern at failure for the Eurocode design and configurations a, b and c is given in Figure 10. The failure mechanisms of the corbel configurations changed in response to adjustments in the design. The first cracks in the Eurocode design occurred at the re-entrant corner of the corbel, followed by splitting cracks along the compressive strut.

Figure 10. Cracks in numerical model at failure load for Eurocode design and configurations a, b and c (cracks with a crack width larger than 0,05 mm are shown).

The latter eventually led to the failure of the corbel. A similar crack development and failure was observed for configuration a, along with some additional cracks related to a support end failure. For configurations b and c, the corbels failed by support end failure.

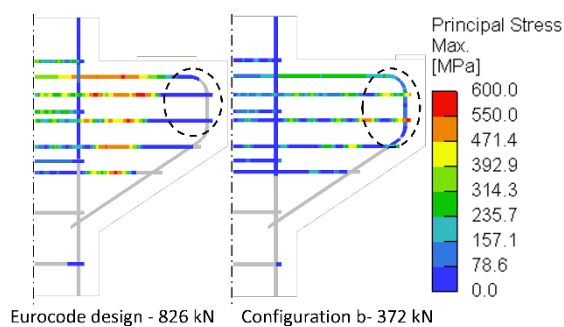
A closer inspection of the failure mechanism of configurations b and c showed a noticeable difference in the tensile stresses in the main reinforcement, as compared to that for the Eurocode design (Figure 11), especially in the vertical bent section at the outer ends of the corbel (at the elliptical sections in Figure 11). Crack propagation along the vertical section of the main reinforcement, in configurations b and c, resulted in increased tensile stresses of the main reinforcement in this region up to 200 MPa. In contrast, near-zero tensile stresses were observed in this section of the main reinforcement for the Eurocode design.

Figure 11. Tensile stresses in the main reinforcement at maximum load for Eurocode design and configuration b.

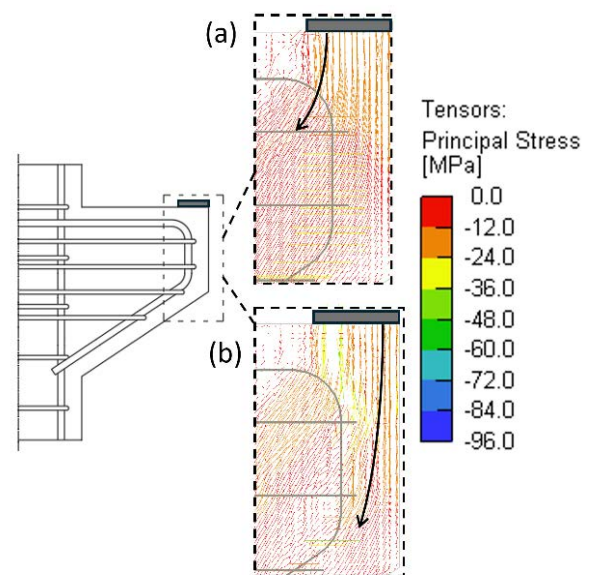
Figure 12. Development of principal compressive stress trajectories at 328 kN (a) and 372 kN (b) for configuration b.

4. The numerical analyses of configurations b and c showed that support end failure cracks continued over the entire height of the corbel. It was found that this behaviour is caused by the initial support end failure cracks, which reroute the compressive strut of the corbel through the unreinforced cover, inducing tensile

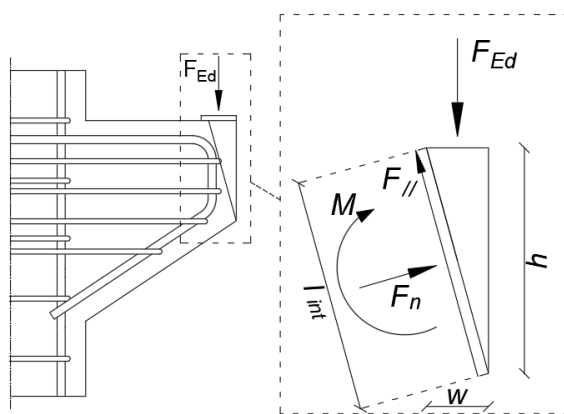
The resistance of the shear interface can be calculated by assuming an arbitrary failure plane. In Figure 13, a free body diagram is presented of such failure plane for configuration b.

Figure 13. Free body diagram of shear interface for configuration b.

Acting on the failure plane is a shear force ($F_{//}$), normal force to the plane (F_n), and a bending moment (M). The forces and stresses on the free body diagram can be calculated by Eqns. (2-3).

plane were estimated as height (h) is 200 mm, width (w) is 55 mm, and interface length (l_{int}) is 208 mm. A rough interface is assumed, resulting in roughness factors c and μ of 0,45 and 0,7, respectively [5]. The mean tensile strength (f_{ctm}) is 3,5 MPa, based of concrete strength class C40/50. For these values, with the analytical model for a vertical load and configuration b a capacity of 113 kN was calculated [2]. For comparison, the failure load obtained by the numerical analysis was 372 kN. So, the applied analytical model is very conservative and, as was seen in the numerical analysis, shearing off a corner of the corbel was also not the failure mechanism.
