Cultivating life from neglected past

Resilience Rooted in Traces

Haraldsgade area, Copenhagen

Conservation value of industrial heritage in Haraldsgade area

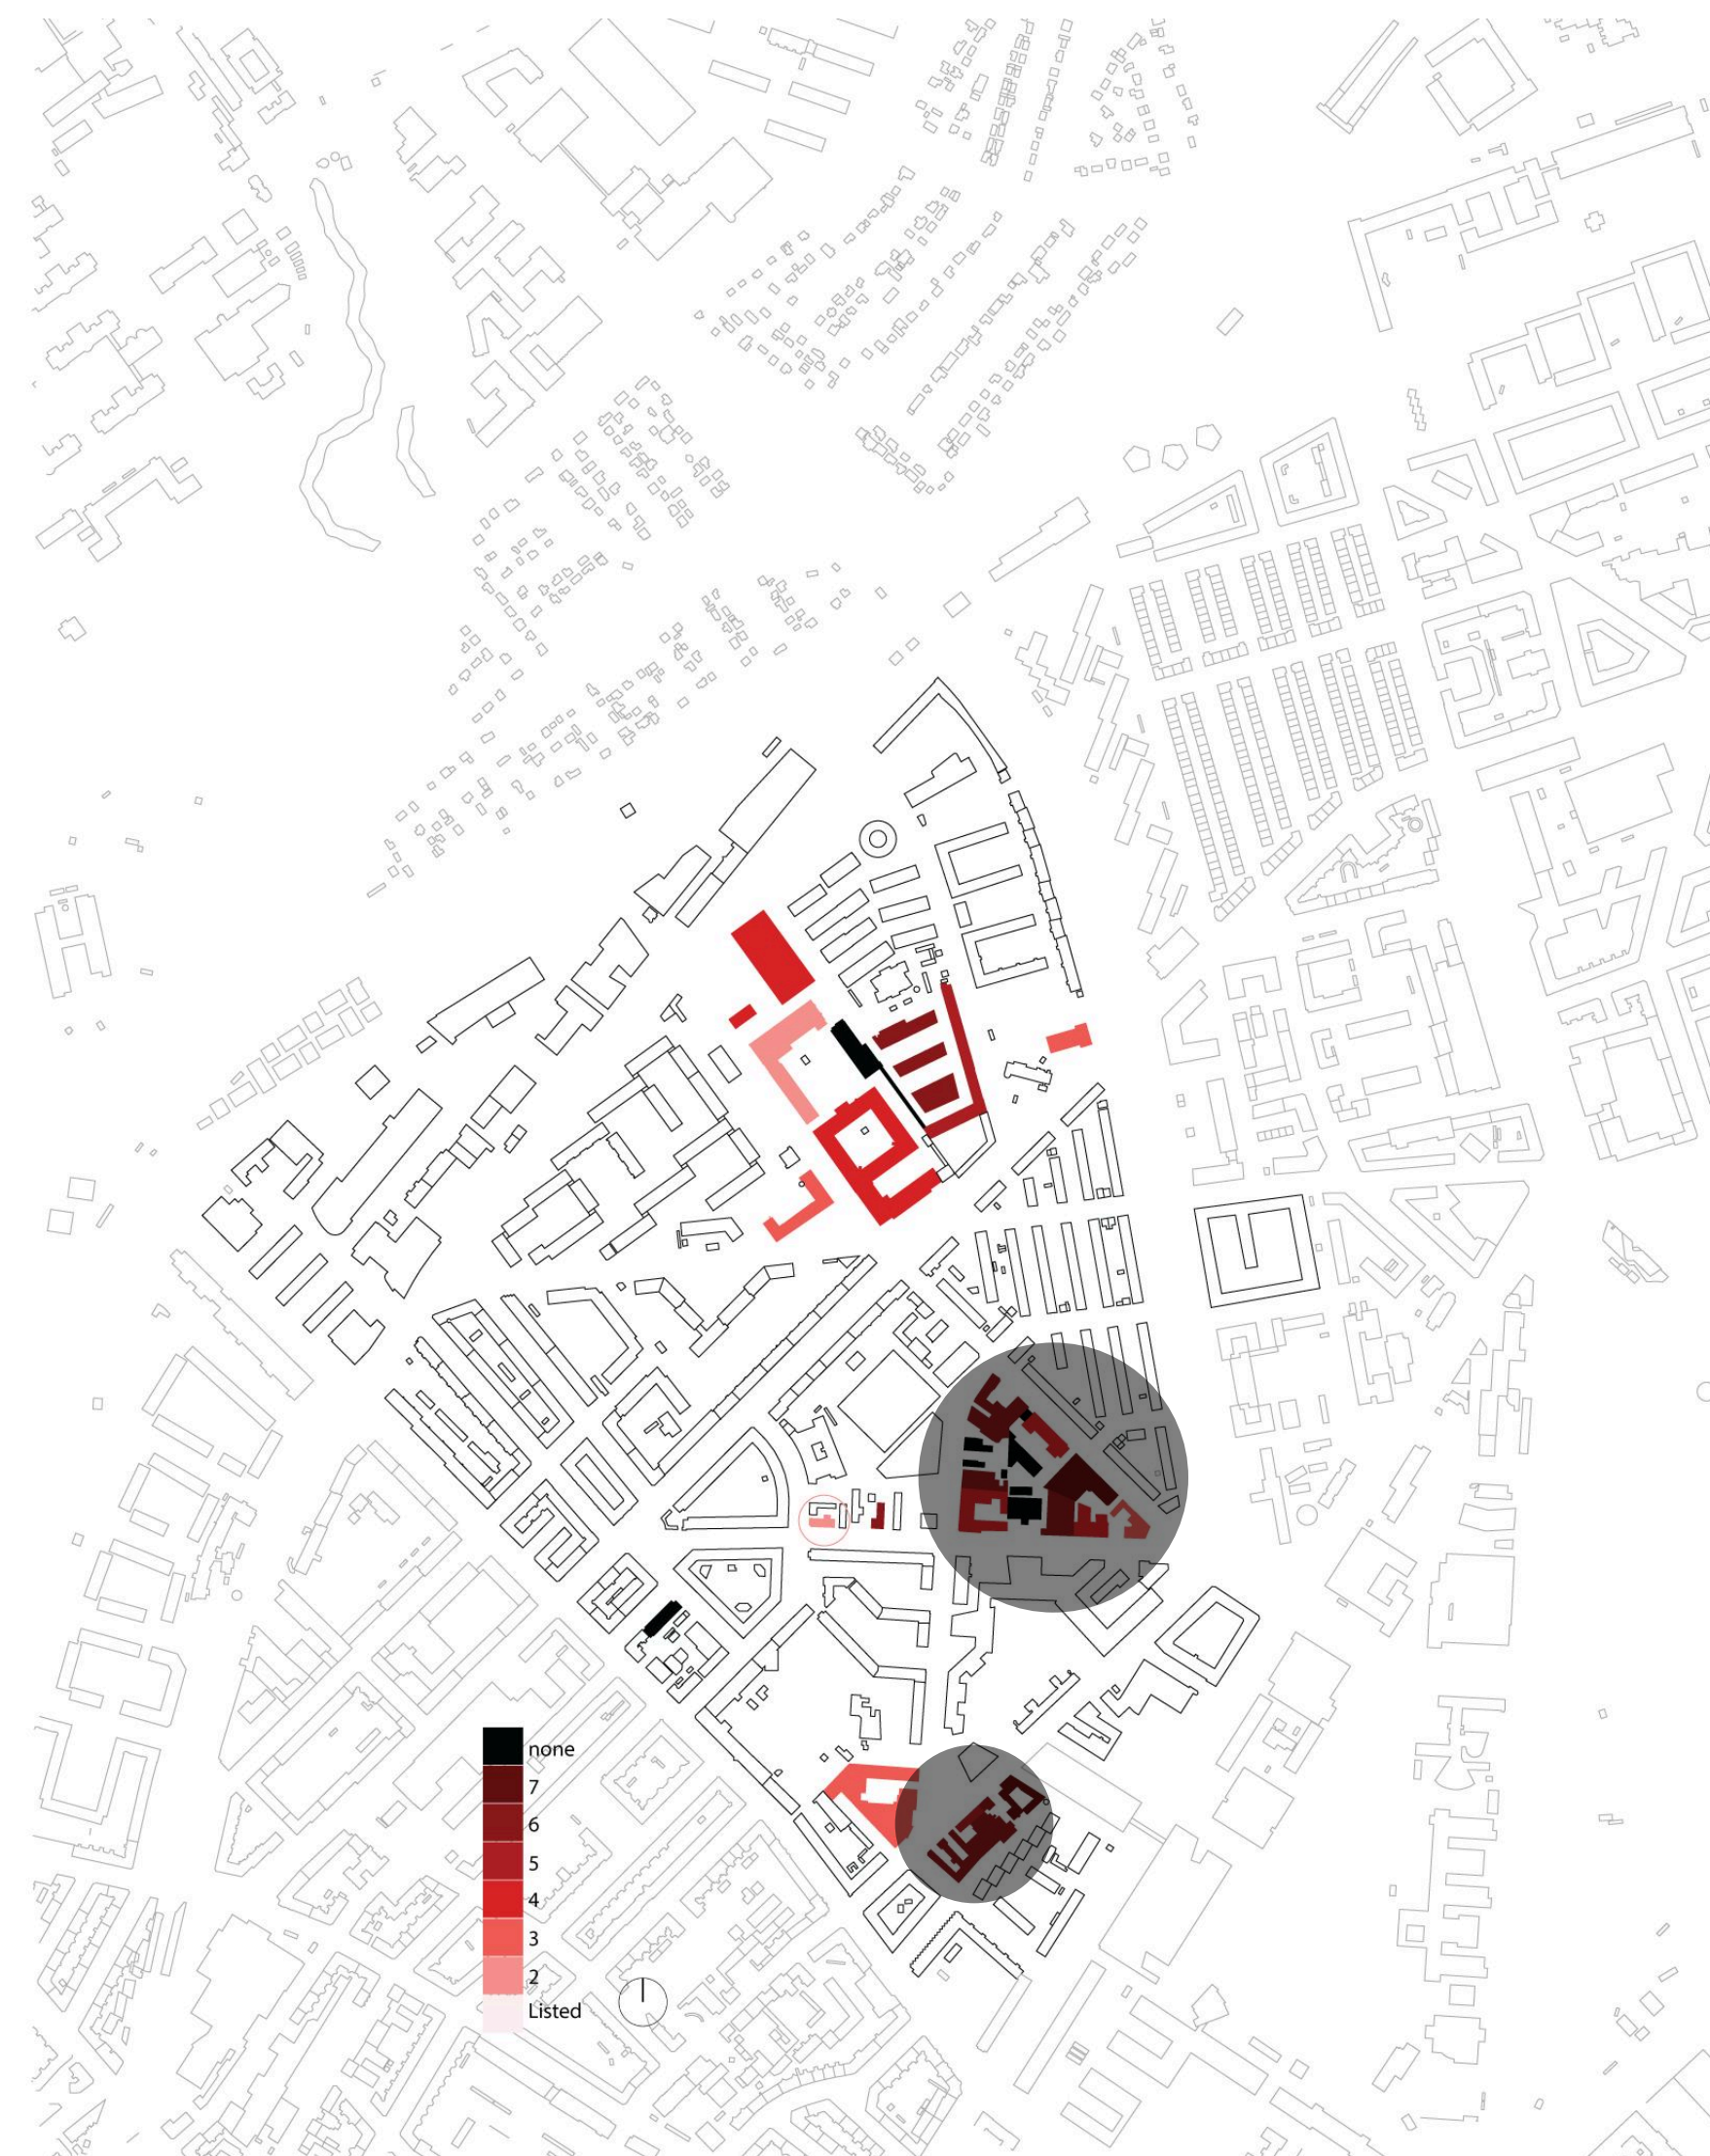
Conservation value of industrial heritage in Haraldsgade area

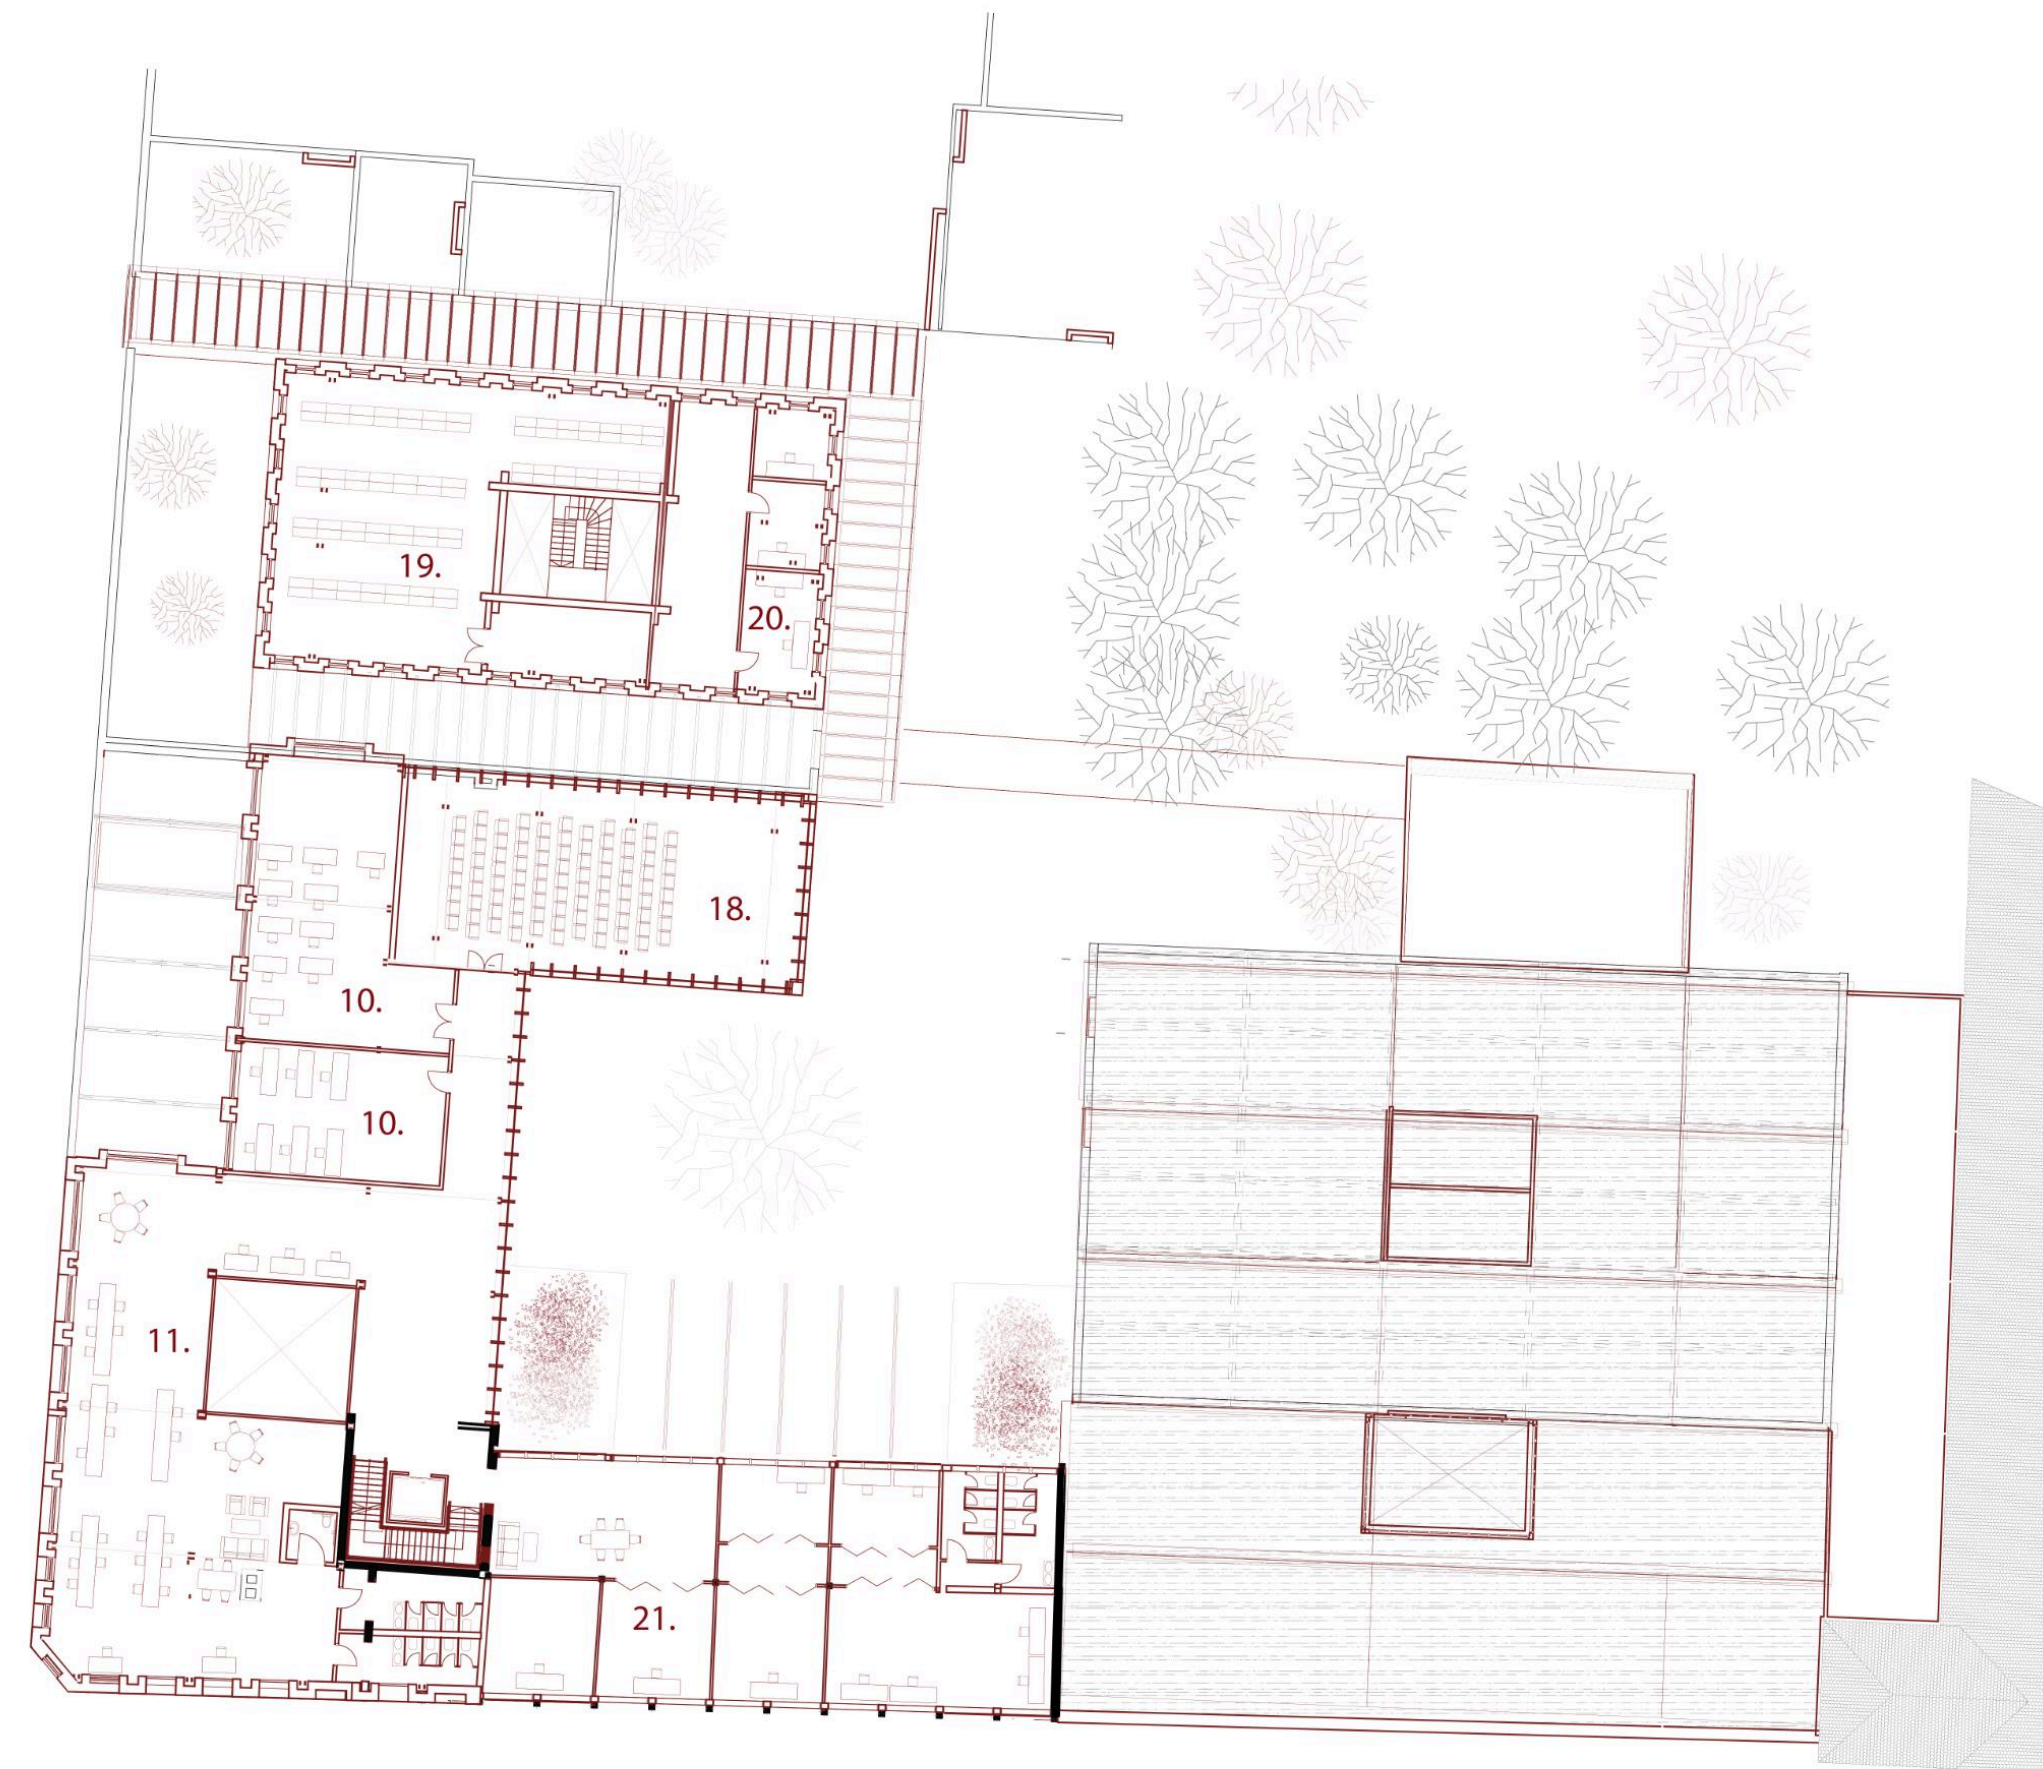
- 1.Public living room
- 2.Library
- 3.Computer room
- 4.Small cafe Kitchen
- 5.Library recepttion
- 6.Entrance reception
- 7.Cafe
- 8.Break room with coffee corner
- 9.Clay workshop
- 10.Class rooms
- 11.Co-working space
- 12.Wood workshop
- 13.Room with machines to work with wood
- 14.Exhibition and event space
15. Shops to sell and buy crafts
16. Entrance for materials
- 17.Storage
- 18.Auditorium
19. Archive
- 20.Offices
- 21.(Semi-) Private workshops

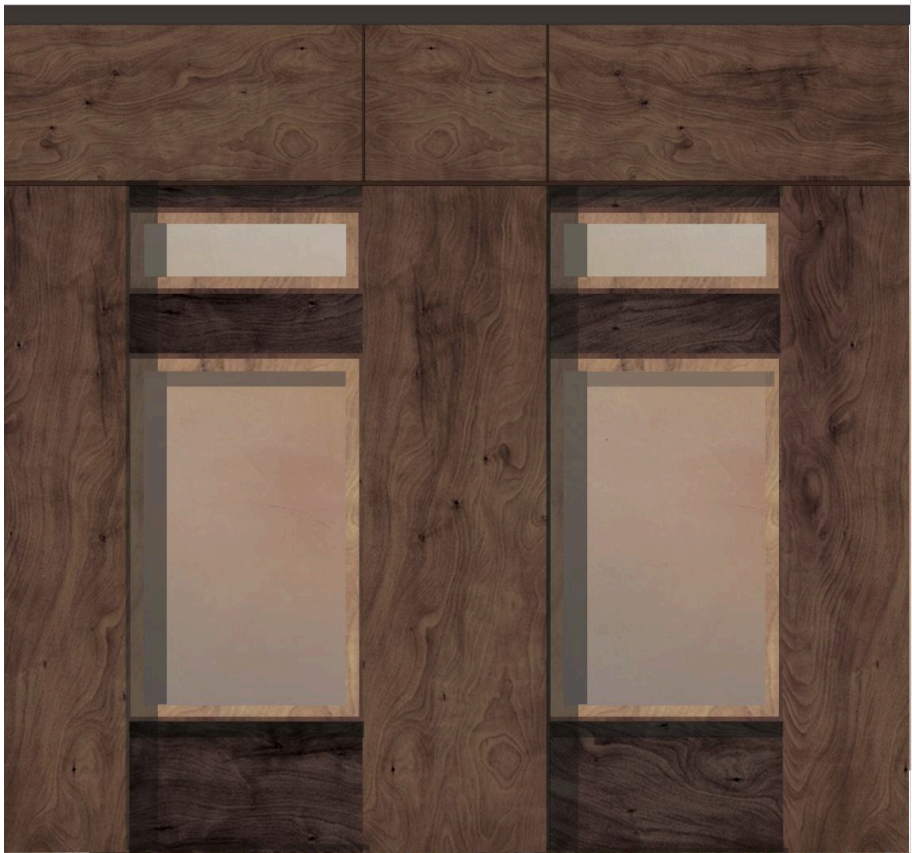
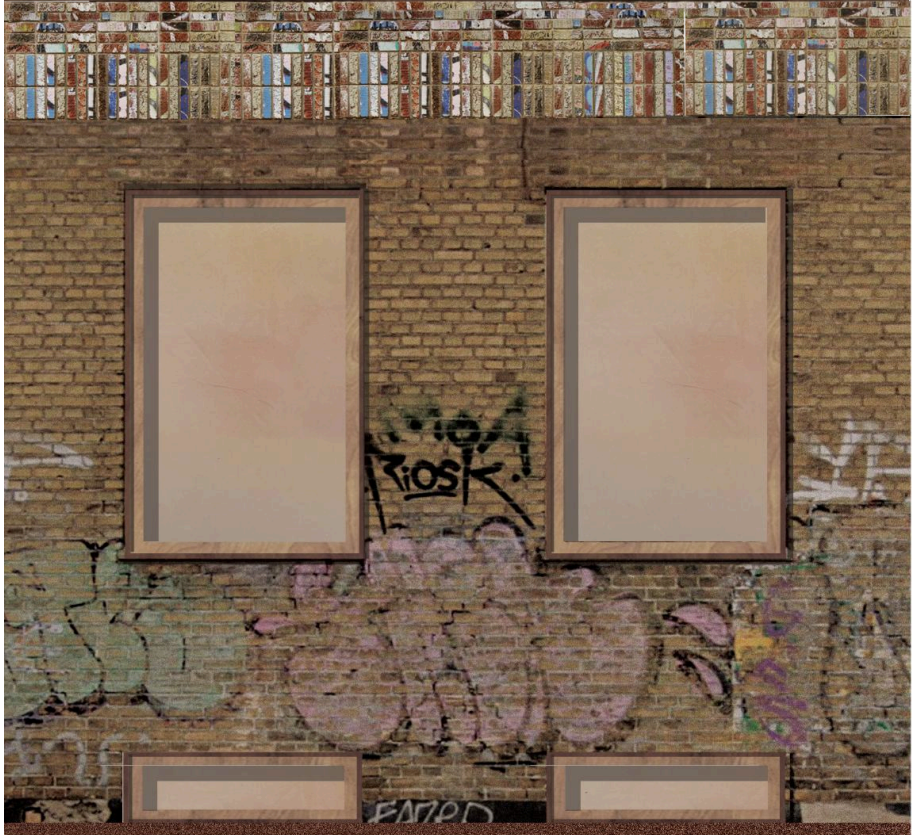
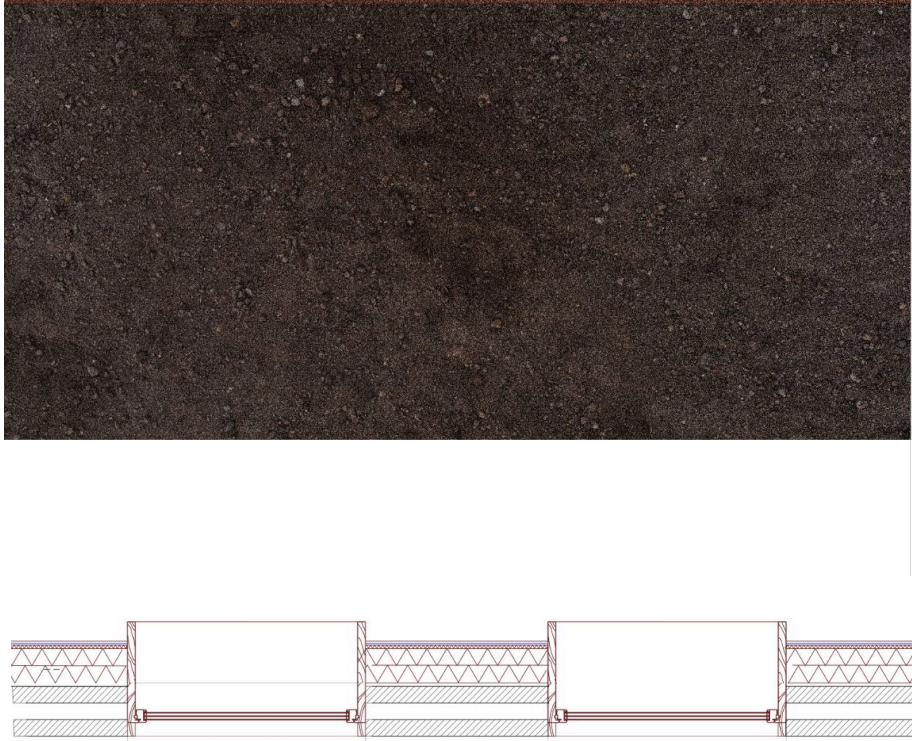
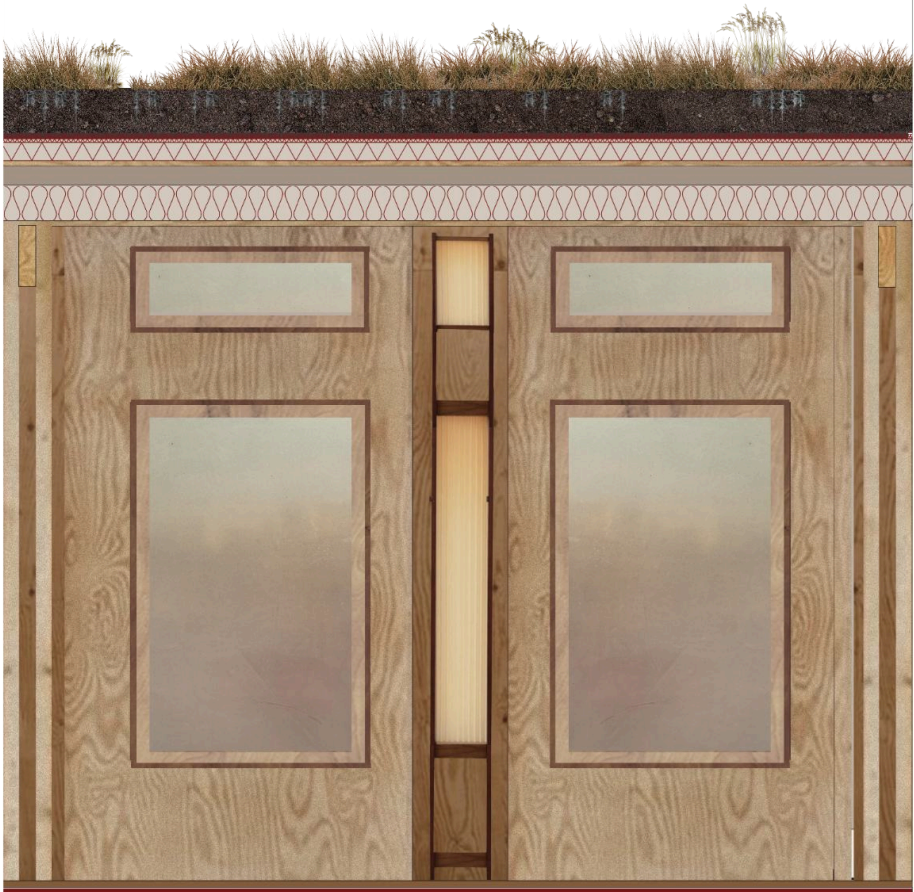
1. 10 mm Lime Green Solo one coat finishing plaster with white lining mesh
2. Vapour barrier
3. 2x120mm Gutex Thermomom carbon-negative natural wood insulation board
4. Gutex Thermo Adhesive mortar for bonding Thermomom insulation boards
5. 20 mm Düsen Thermactive lime and cork based insulating plaster
6. Waterproofing membrane
7. 100 mm existing brick wall
8. 84 mm Cavity
9. 100 mm existing brick wall

1. Plywood Finish
2. Service Cavity 45 mm
3. Vapour Retarder (Smart membrane)
4. Structural Framing with Dense-Pack Cellulose (200 mm D=5.7)
5. Weather-Resistive Barrier (vapour-open membrane)
6. Ventilated Air Cavity 91 mm + Vertical and horizontal supports
7. 13x 1200 x 4450 mm Siding Frontwood Panel

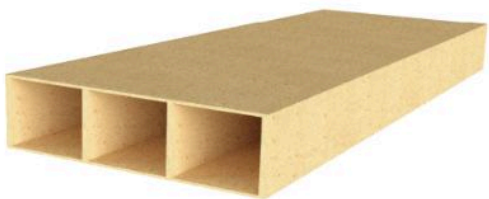
Kerto-Ripa floor elements

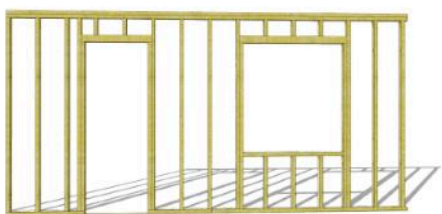
Timber frame walls (vertical extensions)

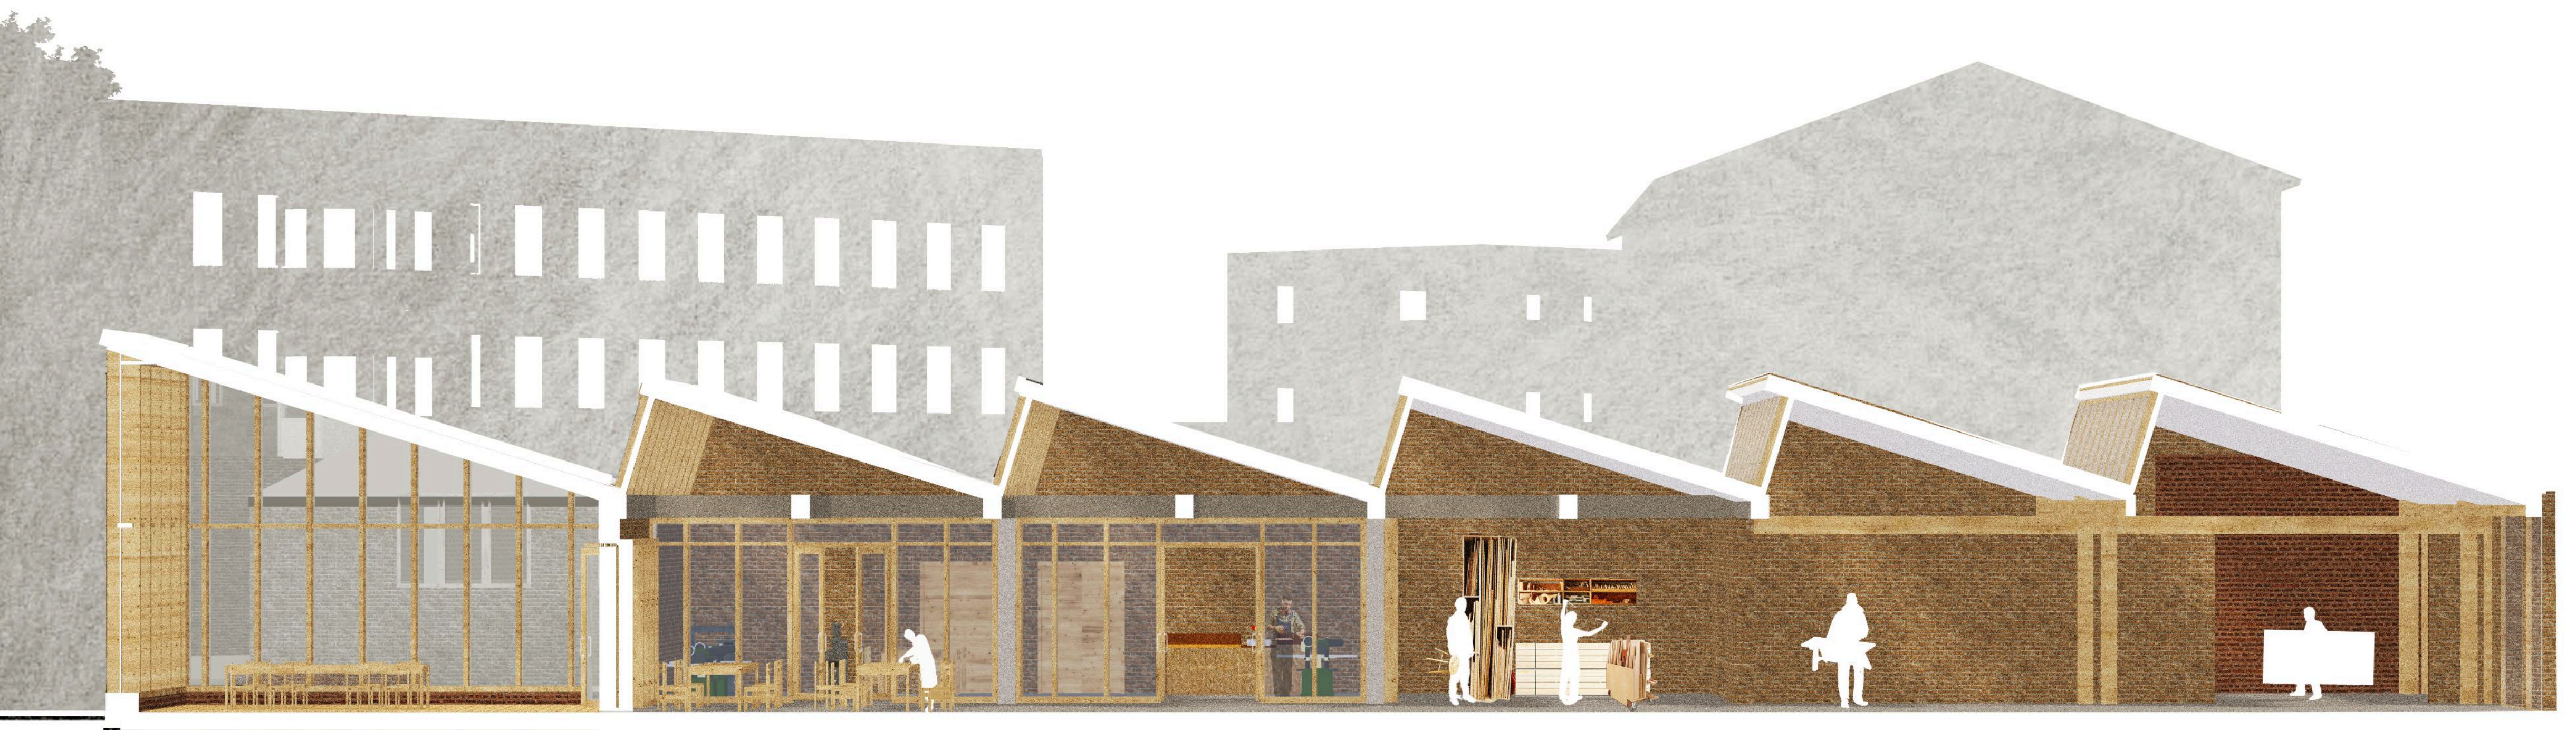
BARK Stick curtain wall system
