Intervention
1/200
Ground Floor

Intervention
1/5

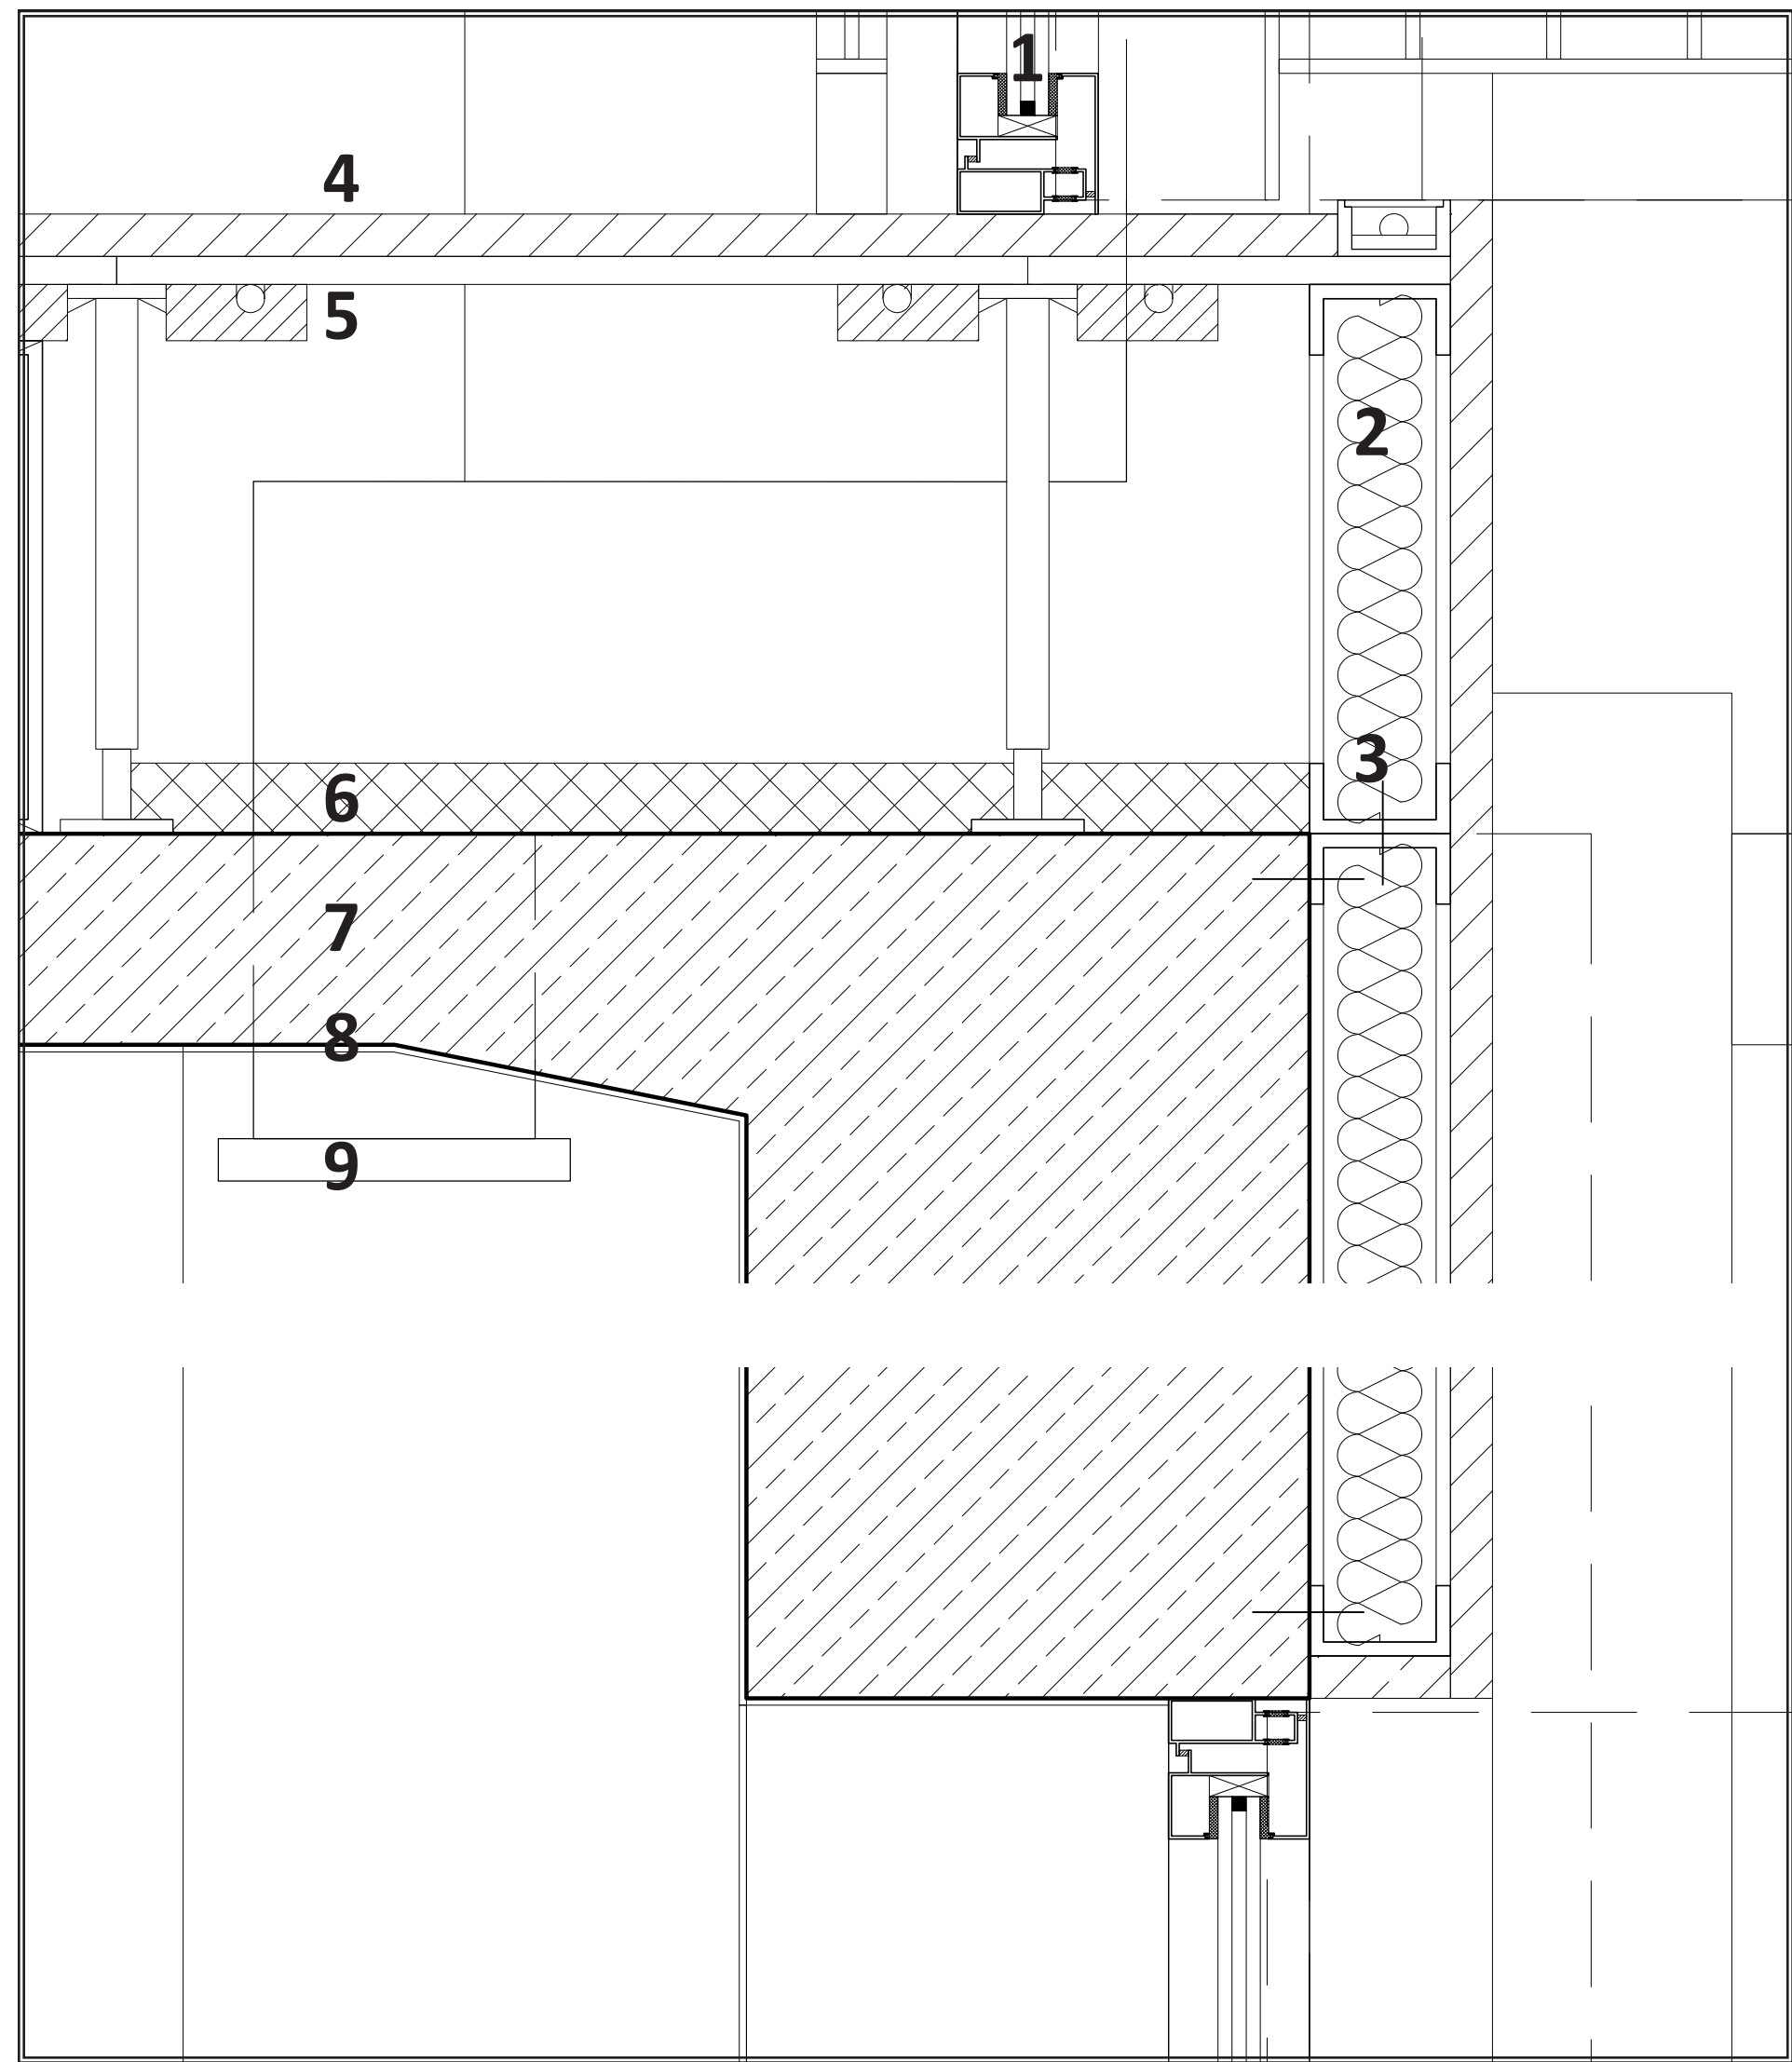
Detail 2

- 1 Double glazing
- 2 Insulation XPS 100mm
- 3 C-shaped aluminum
- 4 Wooden flooring
- 5 Floor heating
- 6 Sound insulation
- 7 Existing structure- reinforced concrete
- 8 Clean and apply cement if stain unremovable
- 9 Air outtake GF

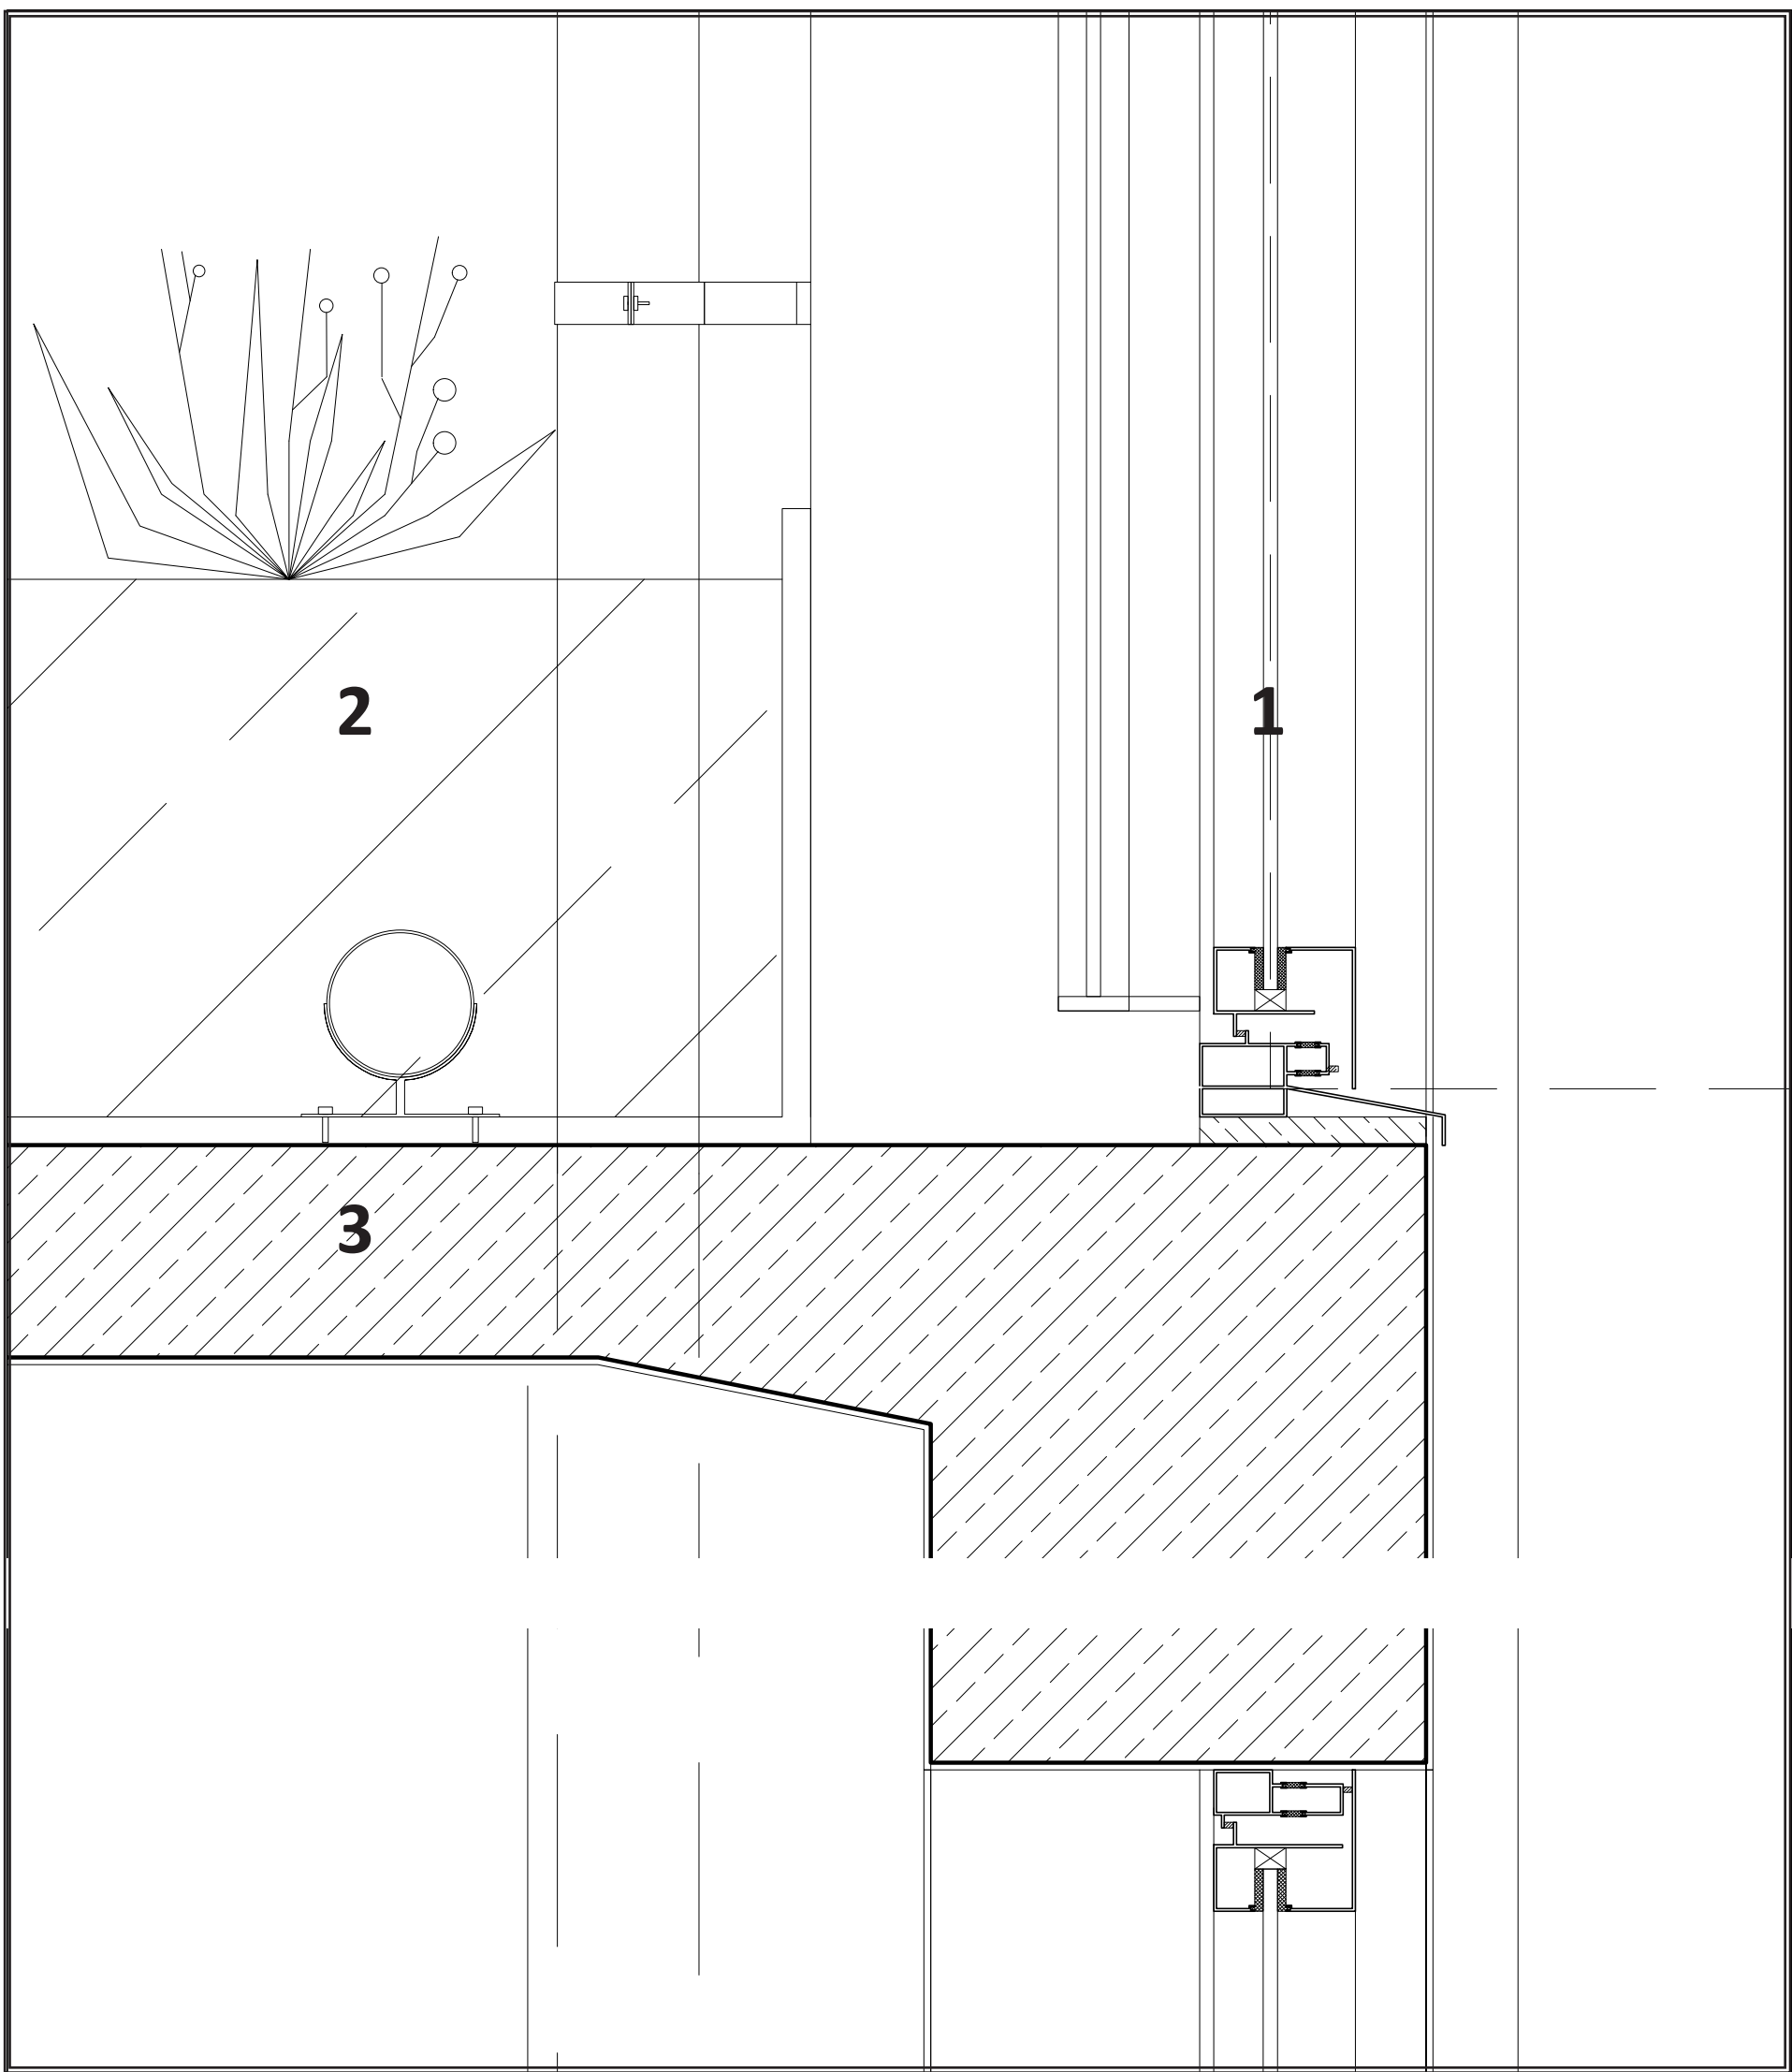
Detail 5

- 1 Single glazing
- 2 Water tank (The water is used for controlling incoming air temperature and humidity. Water temperature range is from 15°C -23°C, year round.)
- 3 Existing structure- reinforced concrete

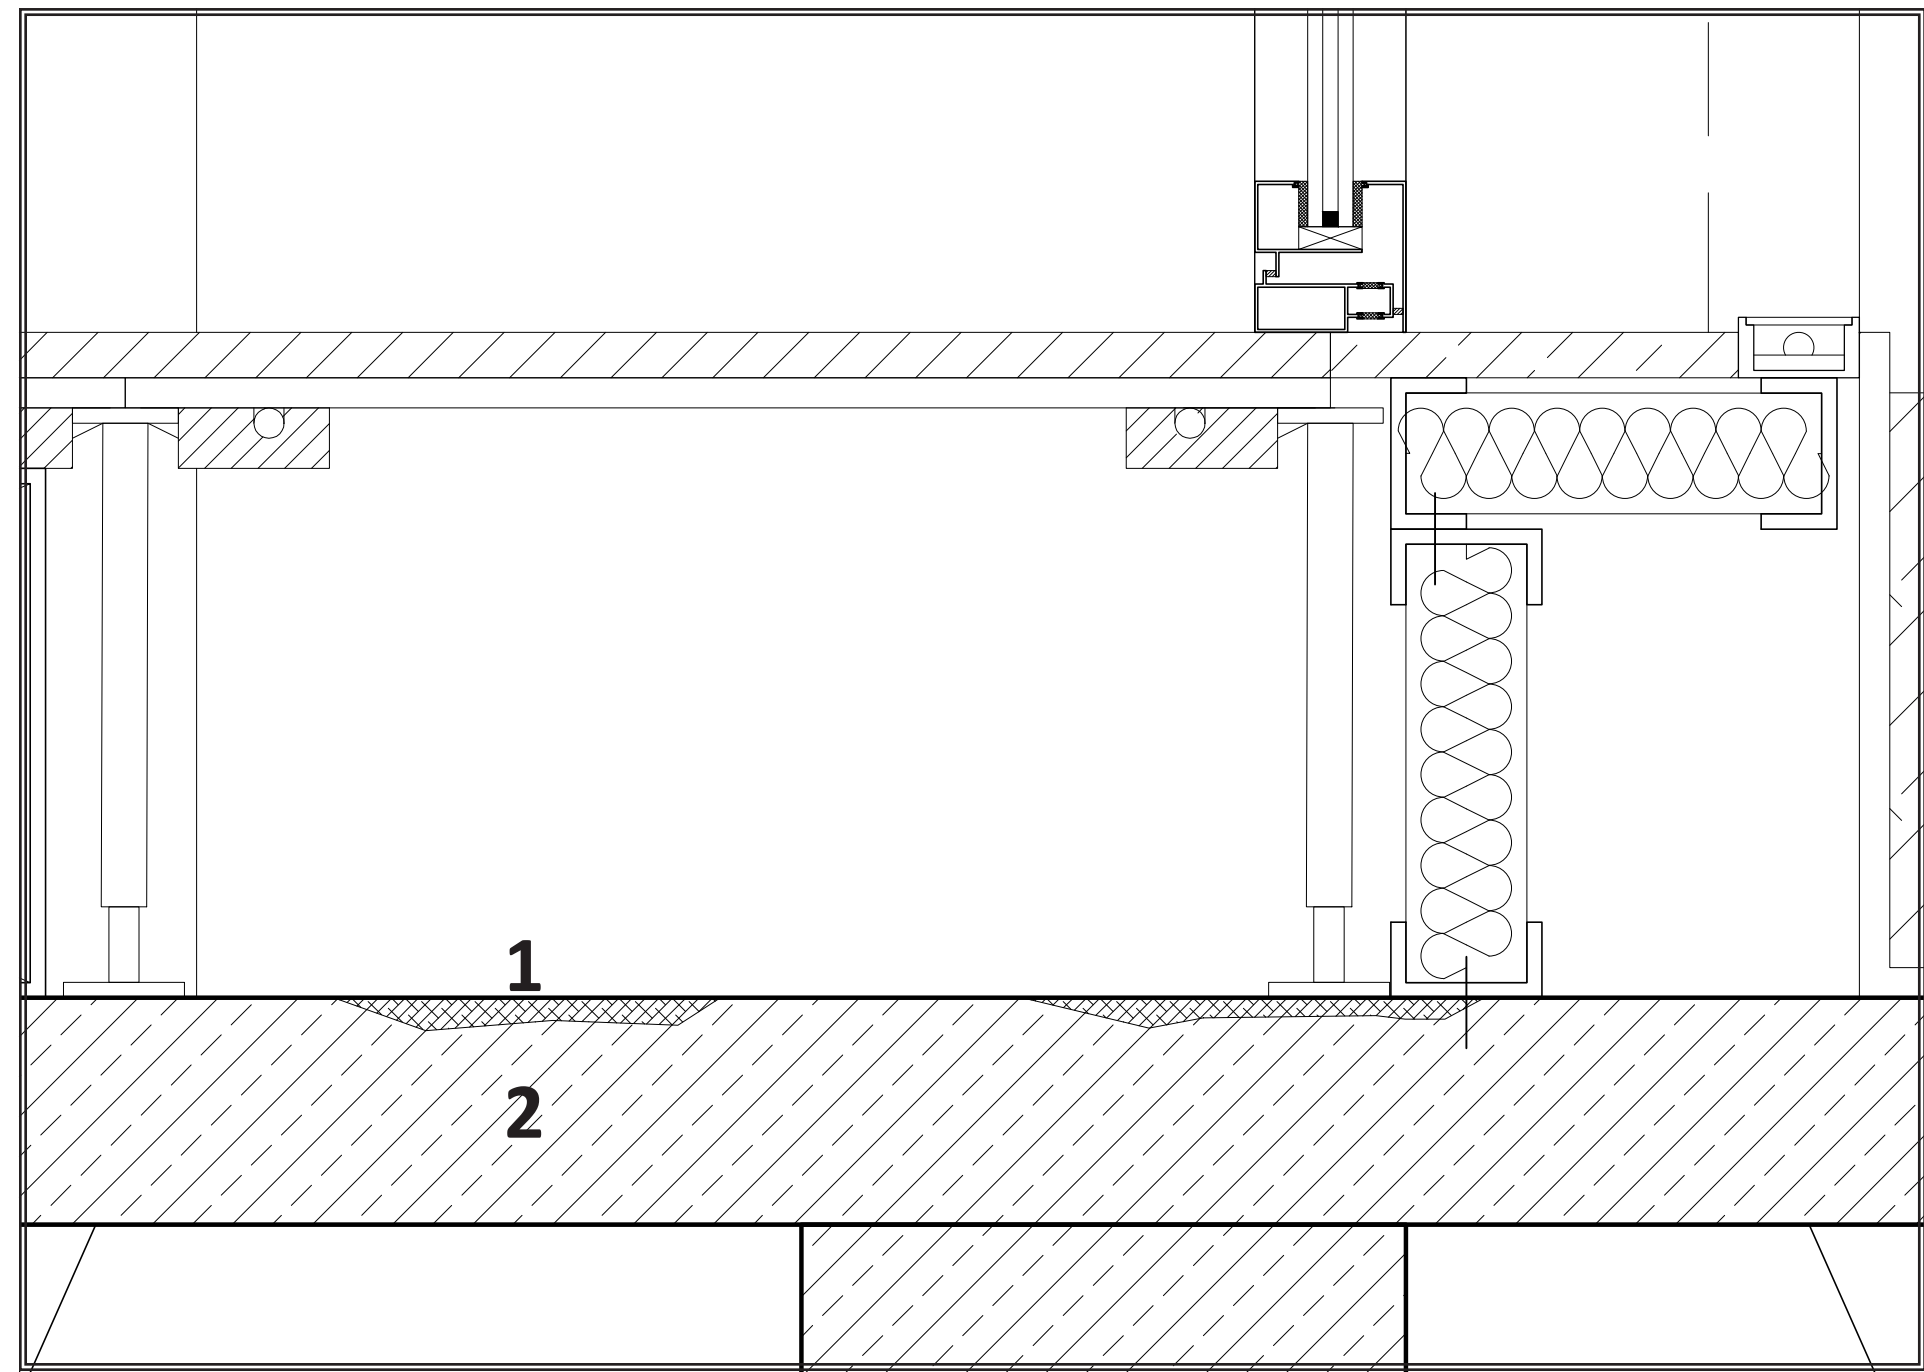
Detail 3

- 1 Polymer mortars for larger damage
- 2 Existing foundation- reinforced concrete

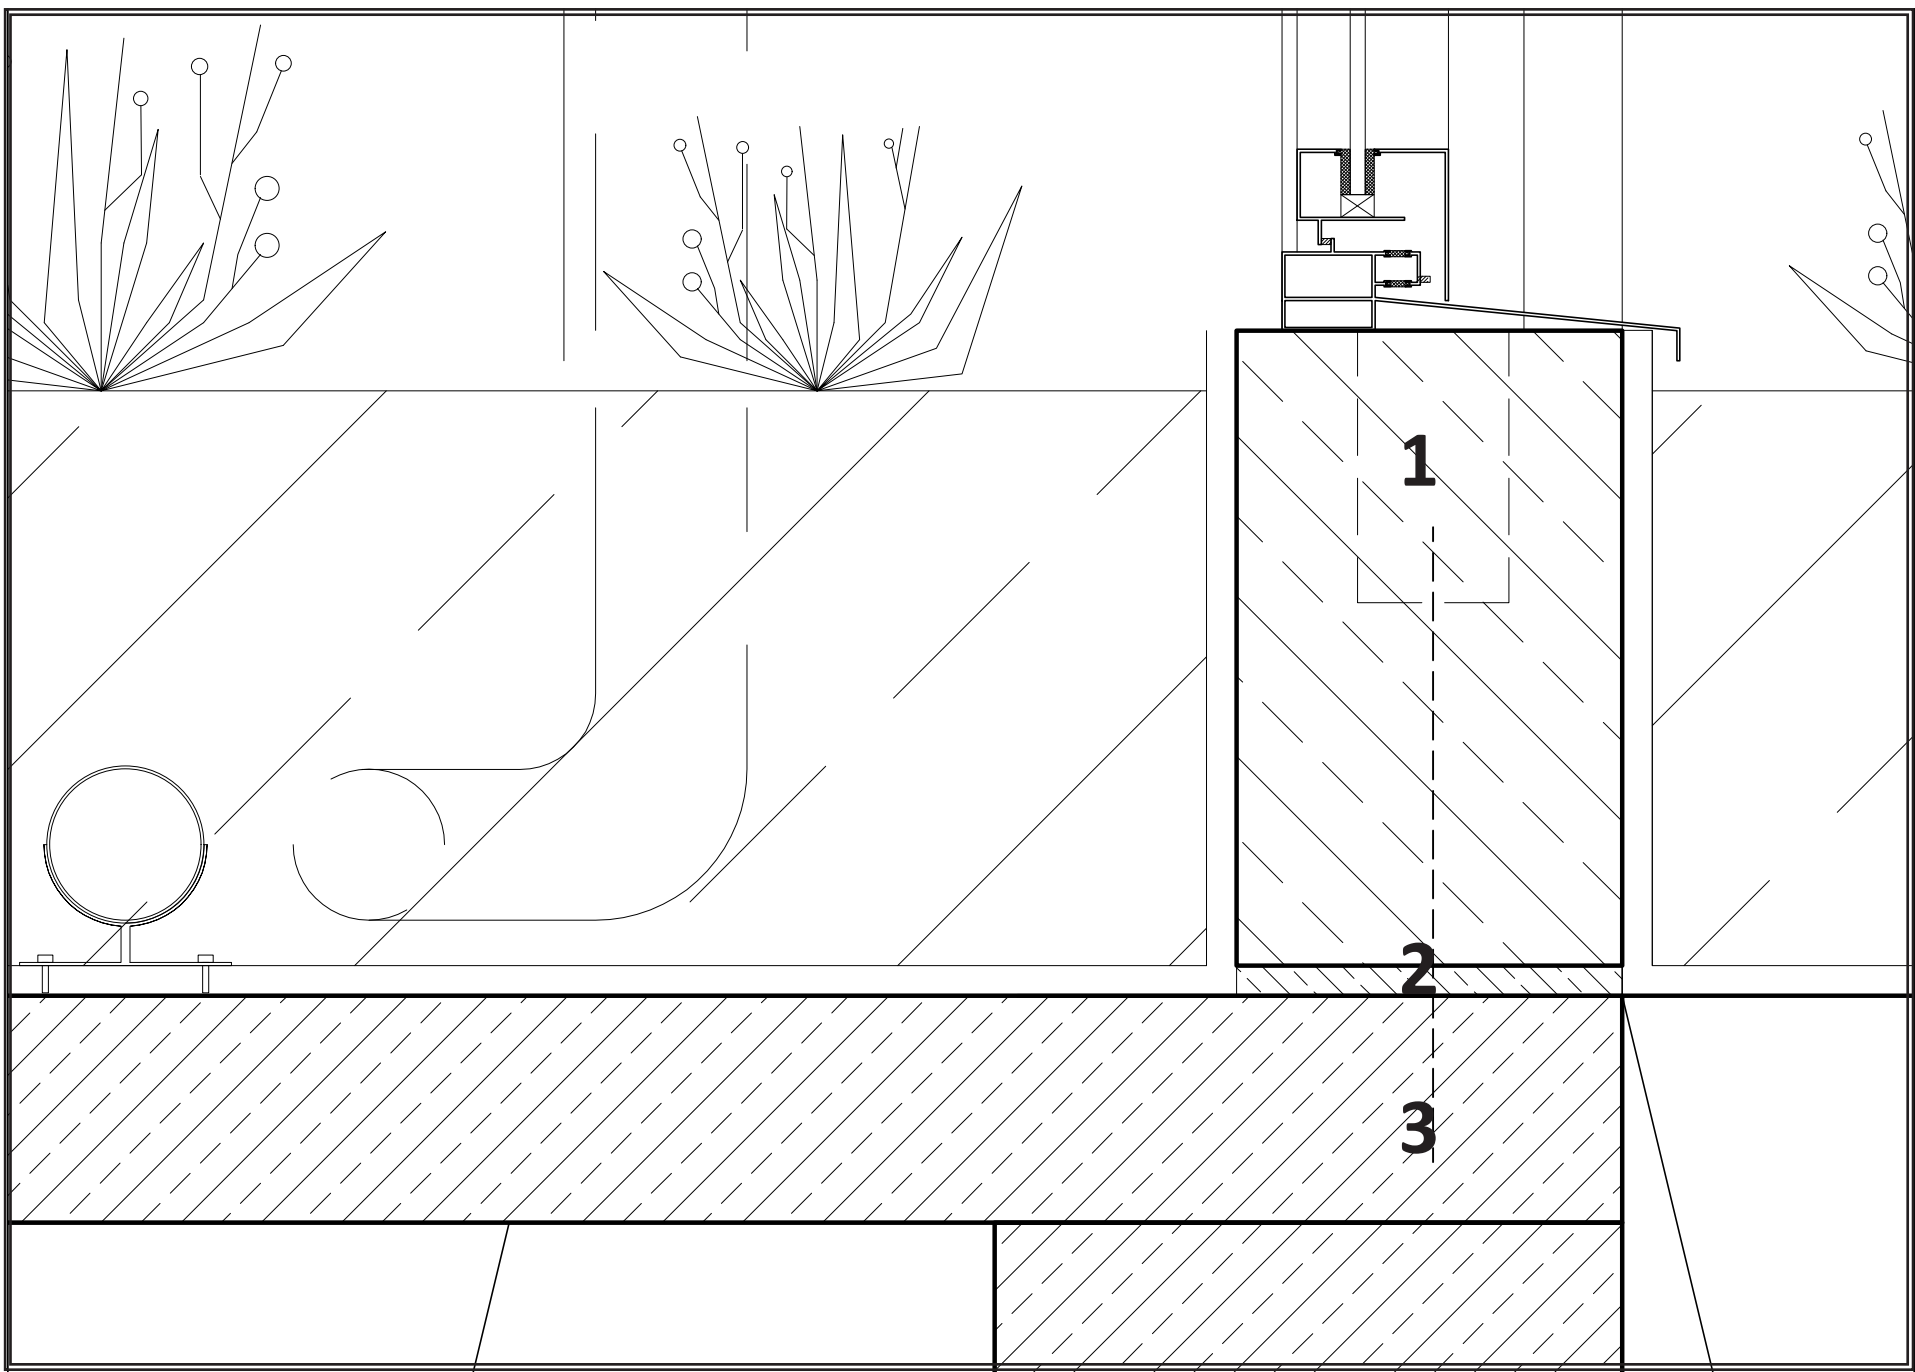
Detail 6

- 1 Prefabricated concrete base
- 2 Leveling cement if needed
- 3 Existing structure- reinforced concrete
