# Quality of visual sewer inspection data: the need for a new coding system?!

Jojanneke Dirksen, Arjan van der Steen, Jeroen Langeveld, François Clemens

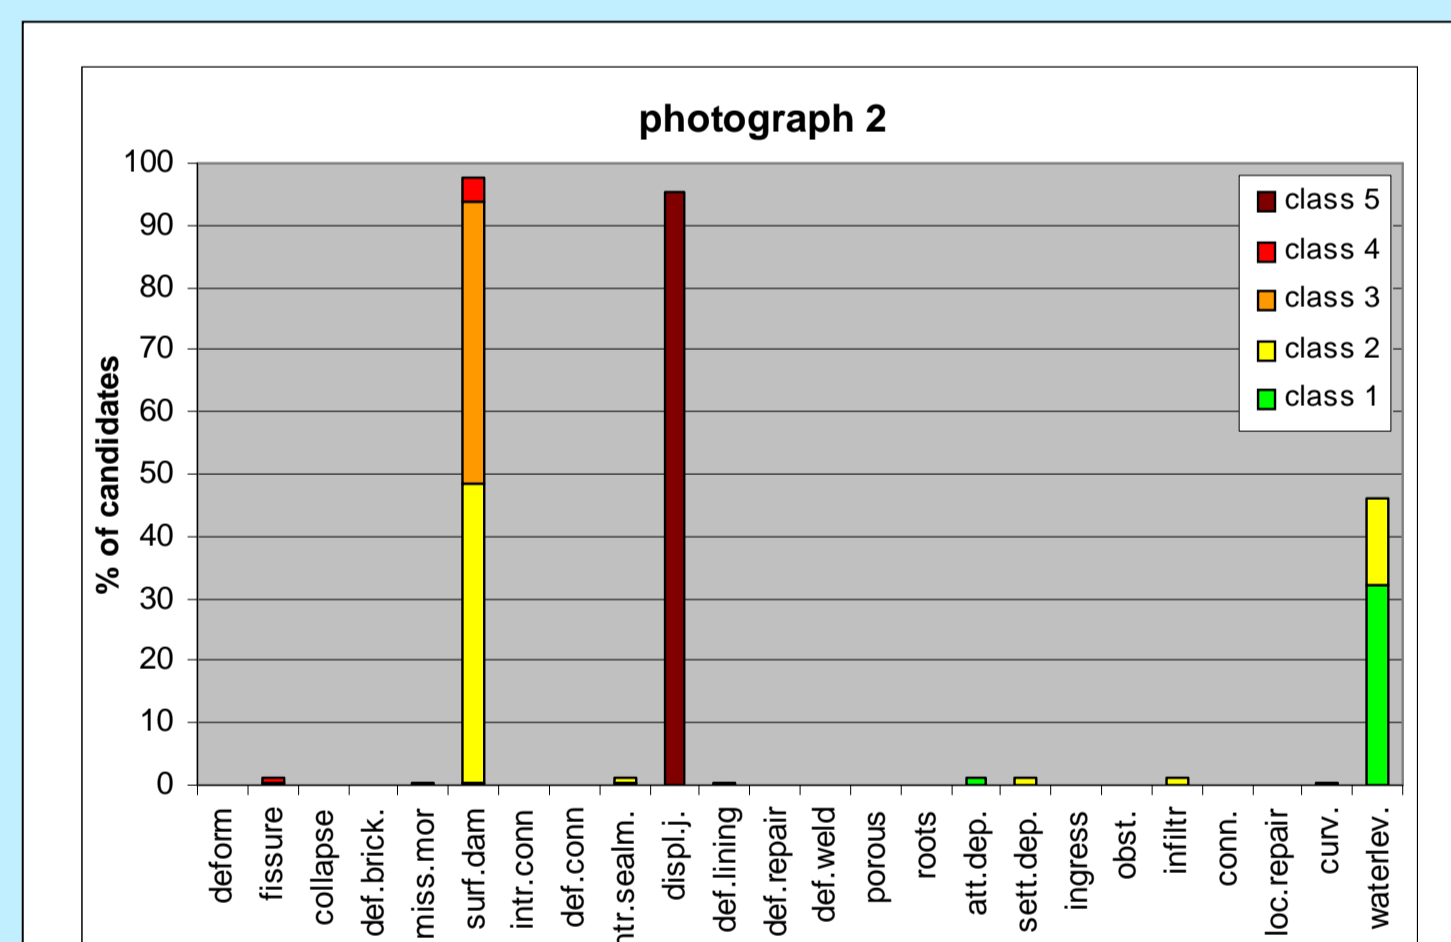
Below you find three photographs used for the examination. Look carefully at the photographs and decide which defects are present (you find a list of defects below the poster). If you flip the image, you find the answers given by the candidates.

From the graph it is clear that the defects of the sewer shown in this photograph were easy to recognize: surface damage and a displaced joint (it is not obligatory to denote water level class 1:  $h < 10\%$  of the diameter).

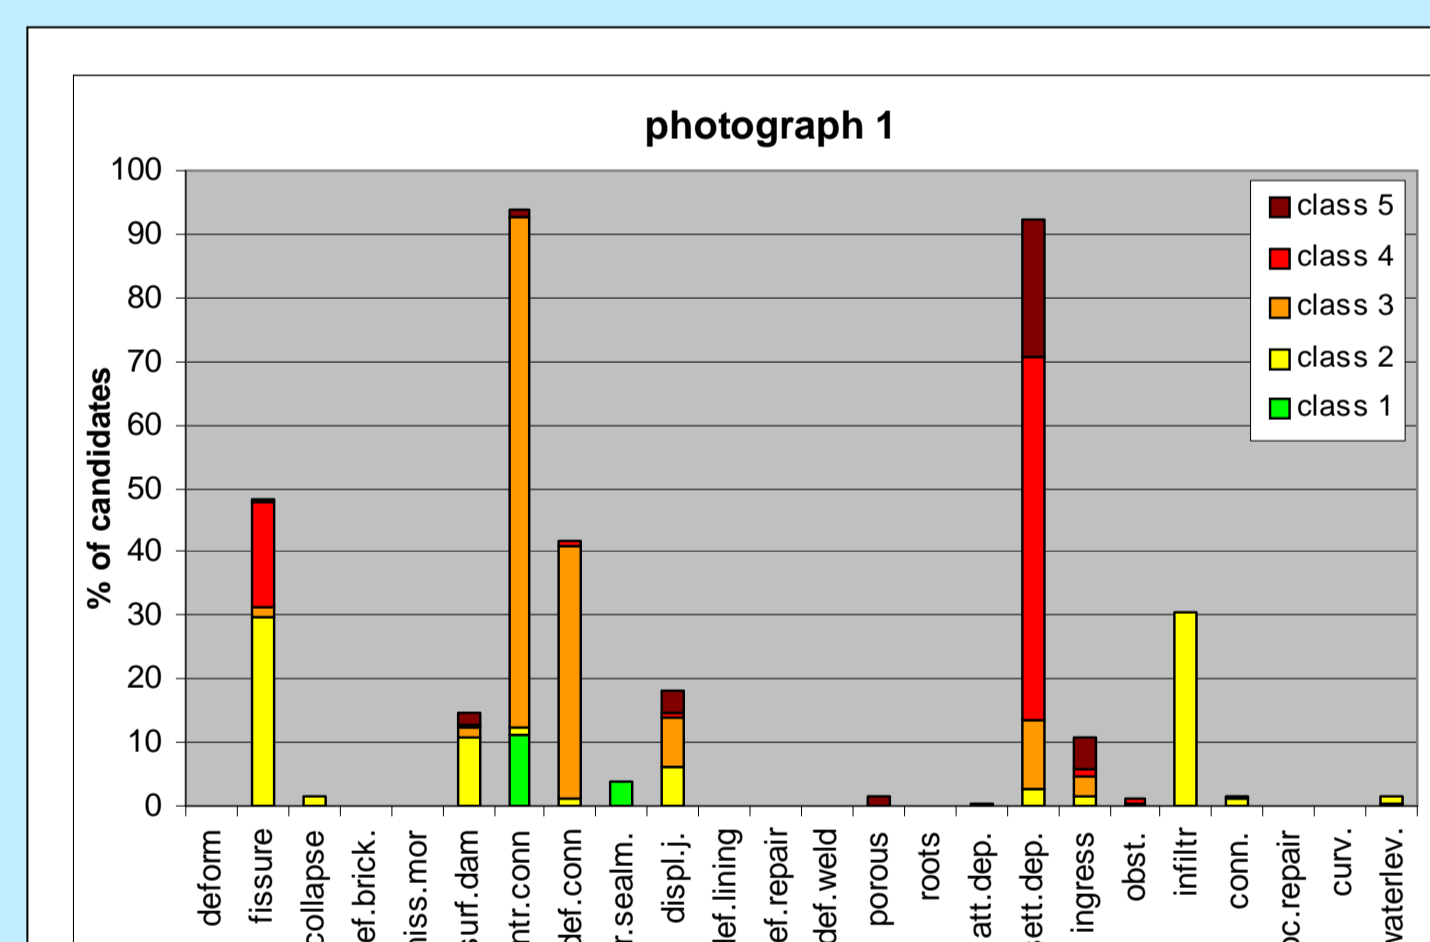
The responses of the candidates do not make clear what kind of defects were present in the photographed sewer. For this sewer the candidates did not agree on the presence of the defects fissure, defective connection, displaced joint and infiltration.

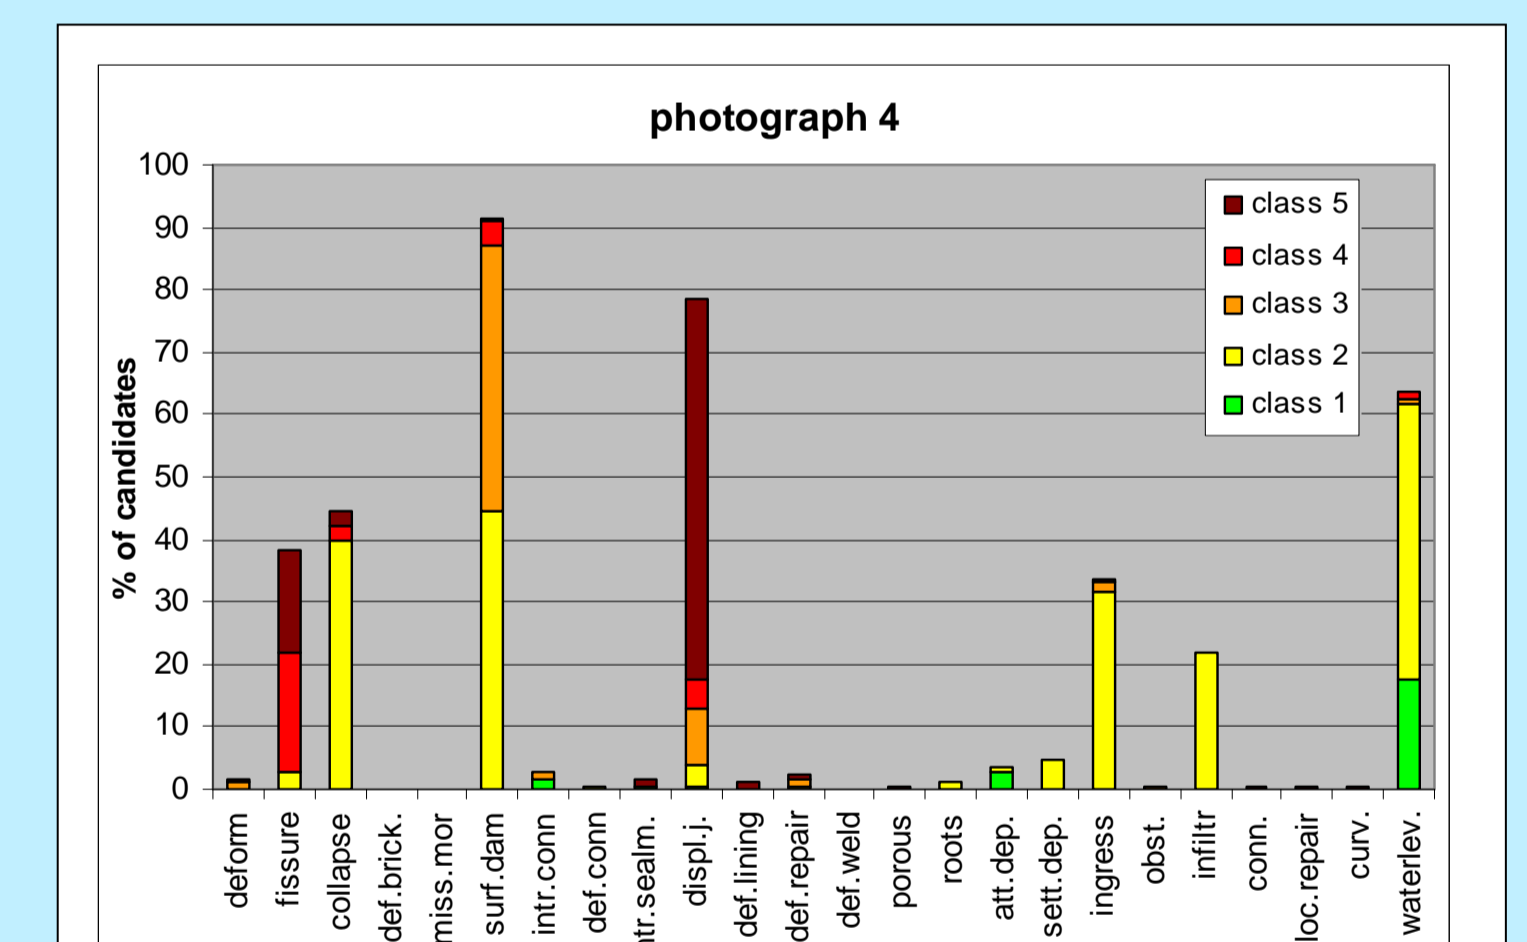
Photograph 4 shows a sewer with a crack on the soffit and bottom of the pipe. Two thirds of the candidates recognized this crack and described it as a fissure (36%), collapse (26%) or both (18%).
