## Experimental investigation on breaching of embankments

ZHU YongHui<sup>1,2\*</sup>, VISSER P J<sup>3</sup>, VRIJLING J K<sup>3</sup>, WANG GuangQian<sup>1</sup>

**embankments, breaching, experiments, headcut, erosion**

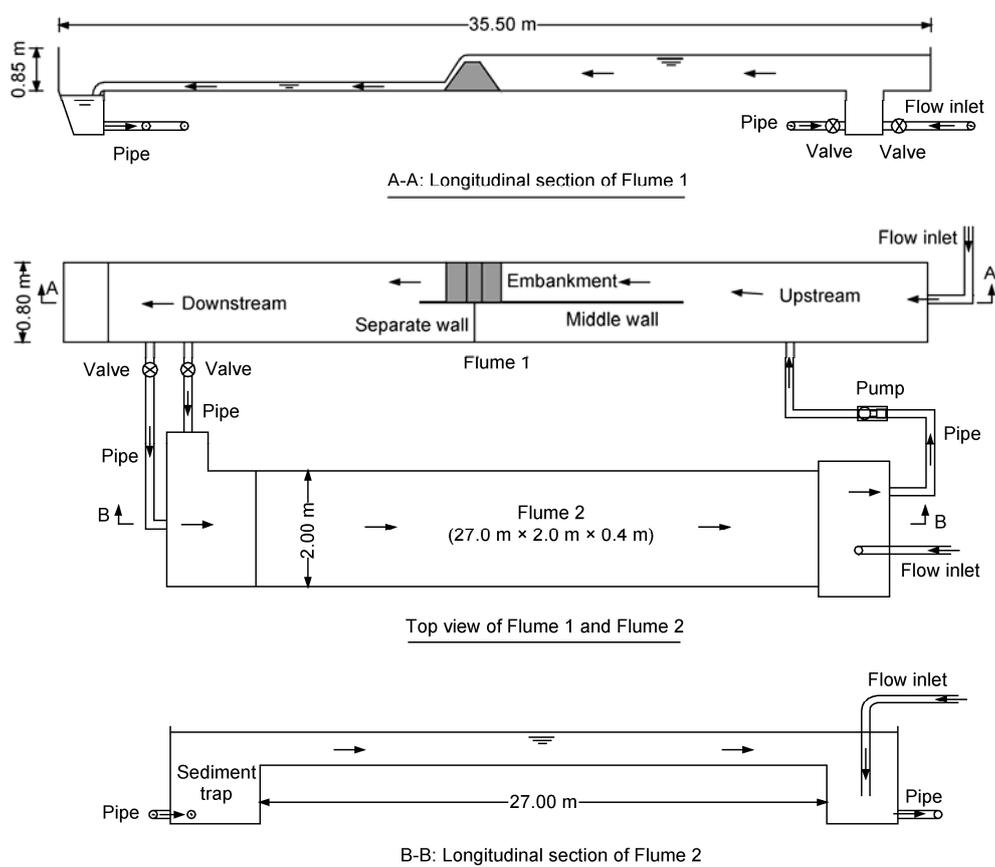
**Figure 1** Sketch of the two flumes in the experiments.

The tests were conducted in a straight flume 35.5 m long, 0.8 m wide and 0.85 m deep (see Flume 1 in Figure 1). Another straight flume (Flume 2 in Figure 1), 27.0 m long, 2.0 m wide and 0.4 m deep was used as a "storage basin" for water recirculation during the experiments; this flume had a sediment trap at one end and a water inlet at the other end.

Due to the limited width of Flume 1, the tests focused on the first three stages of the five-step breach erosion process in embankments [17, 30], in which the breach develops mainly vertically with only ignorable widening. A vertical wooden wall was placed in the middle of Flume 1 to narrow the length of the embankment section to 40.0 cm. Another vertical wooden wall was constructed perpendicularly to the middle wall to separate the upstream from the downstream, see Figure 1.

the embankment before the upstream water level had risen to a certain height (normally 5.0 cm above the embankment crest). Whereafter the wood block and sandbag were taken away quickly to start the embankment breaching process. From then on, water was recirculated by pump and pipes (see Figure 1).

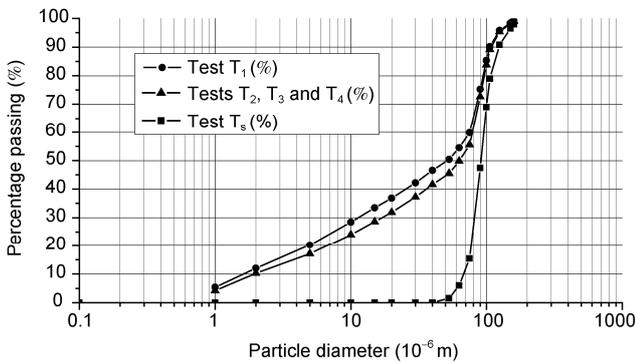
**Figure 2** Soil particle size distributions.

Altogether five tests were conducted, one with an embankment constructed with sand (test  $T_s$ ), four with embankments constructed with different mixtures of sand, silt and clay (tests  $T_1, T_2, T_3$  and  $T_4$ ). Much attention was paid to get a proper sand-silt-clay mixture. A series of tests were carried out to measure the properties of the soil. Soil wet density ( $\rho_s$ ) and water content ( $\omega$ ) were determined for each compacted layer of the embankment during embankment construction. Soil particle size distribution was determined by sieve analysis and sedigraph analysis. The pycnometer was applied to measure the soil particle specific density ( $G_s$ ). Soil optimum water content ( $\omega_{opt}$ ) and maximum dry density ( $\rho_{dm}$ ) were determined by proctor compaction tests for test  $T_1$ . Soil unconfined compression tests were run by use of triaxial test apparatus to measure the undrained shear strength ( $c_u$ ) for each of the four embankment tests with sand-silt-clay mixtures. Figure 2 shows the particle size distributions of the sand (for test  $T_s$ ) and the sand-silt-clay soil mixtures (for tests  $T_1, T_2, T_3$  and  $T_4$ ). Table 1 summarizes the results of those soil property tests.

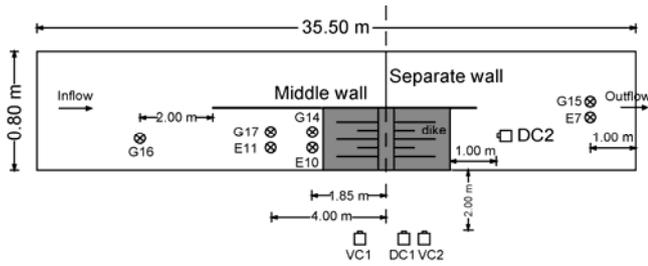
**Figure 4** Top view of experimental apparatus in the flume (drawing not to scale).

The water levels both upstream and downstream the embankment were measured with four wave height meters, see G14, G15, G16 and G17 in Figures 4 and 5. Flow velocities in the flume axis and transverse directions were measured with three electromagnetic velocity sensors (EMSs, see E7, E10 and E11 in Figures 4 and 5). The process of breach growth was videotaped with two digital video cameras (VC1 and VC2 in Figures 4 and 5) and photographed with two digital cameras (DC1 and DC2 in Figures 4 and 5) placed at one side of the flume, except DC2 above the flume at the downstream side of the embankment. To facilitate reading of the development of the embankment profile from the recorded pictures and videos, horizontal and vertical lines were drawn on the glass sidewall of the flume at mutual distances of 10 cm.

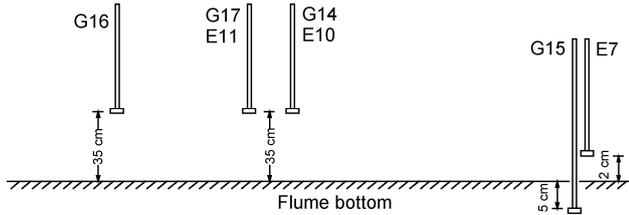
**Figure 5** Vertical positions of experimental apparatus in the flume (drawing not to scale).

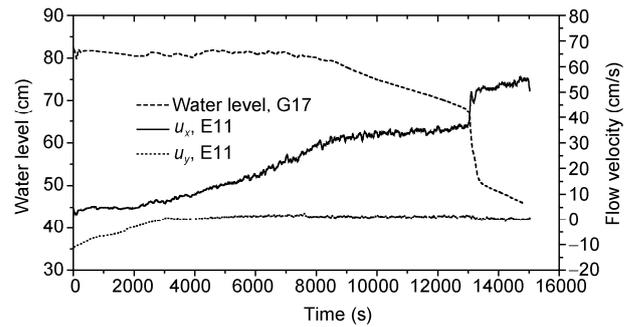
**Figure 6** Results of water level measurement of G17 and flow velocity measurement of E11 for test T<sub>2</sub>.

Water levels and flow velocities were measured during all the tests. Figure 6 shows the results of water level measurement of G17 and flow velocity measurement of E11 for test T<sub>2</sub>, and Figure 7 the results of water level measurement of G14 and flow velocity measurement of E10 for test T<sub>4</sub> ( $u_x$  and  $u_y$  indicate the flow velocities measured in the flume axis direction and transverse direction, respectively).

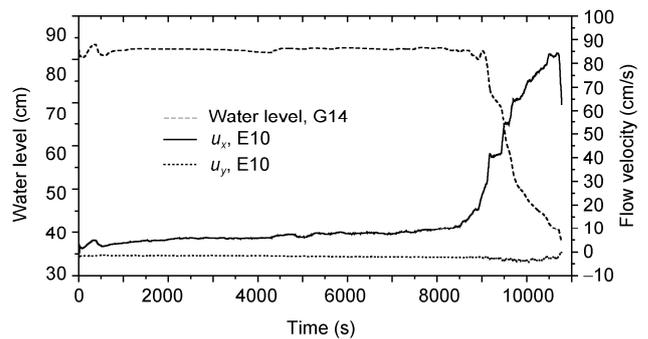
**Figure 7** Results of water level measurement of G14 and flow velocity measurement of E10 for test T<sub>4</sub>.

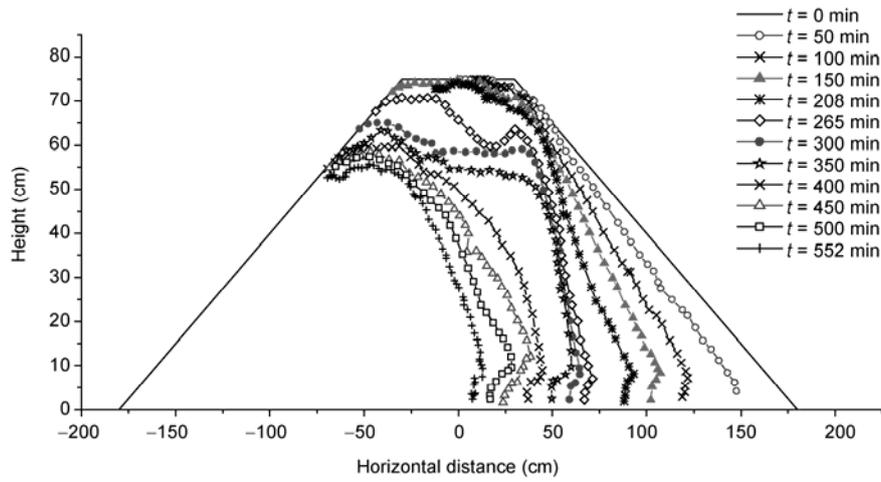
Figure 8 Embankment profile development of test T<sub>1</sub>.

Evolution of the embankment profile was determined from the videos and photographs. For tests T<sub>1</sub>, T<sub>2</sub>, T<sub>3</sub> and T<sub>4</sub> (i.e. the tests with sand-silt-clay mixtures), it was observed that erosion usually occurred first at locations close to the toe of the embankment when the embankment was overflowed (except for test T<sub>4</sub>). Soon this erosion extended to the entire slope, with a larger erosion rate occurring at the lower part of the slope than at the upper part, inducing a steepening of the slope in time (see e.g. Figures 8, 9, 10 and 11). Besides the toe of the embankment, the transition area between the embankment crest and the downstream slope was the second place susceptible to earlier and faster erosion. Erosion at the embankment crest was relatively slow, depending mainly on the erosion resistance of the soil material. However, this erosion lowered the height of the embankment and increased the breach flow rate in time, which

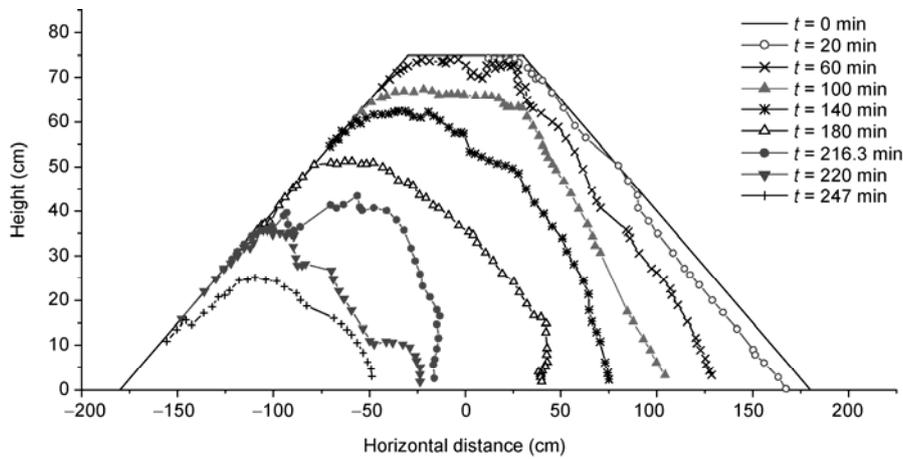
Figure 9 Embankment profile development of test T<sub>2</sub>.

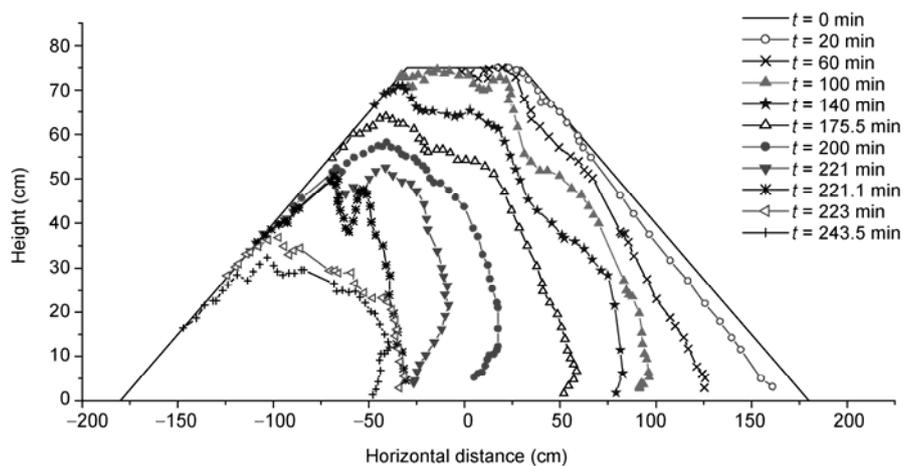
Figure 10 Embankment profile development of test T<sub>3</sub>.

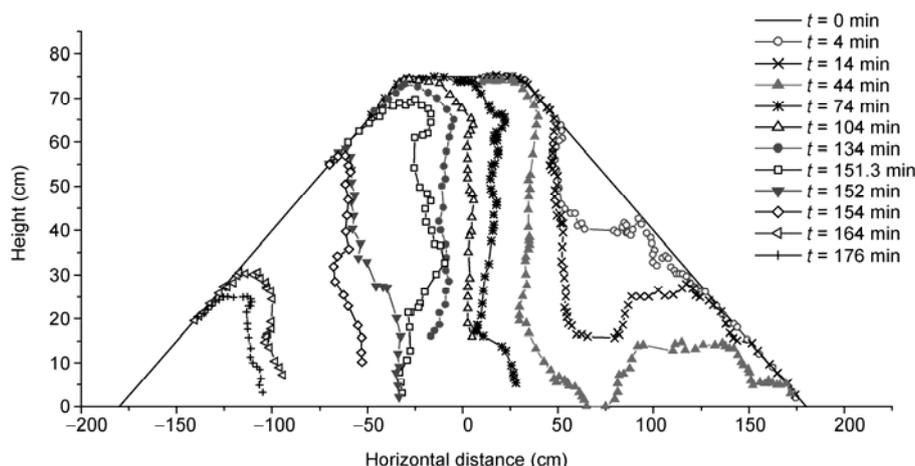
**Figure 11** Embankment profile development of test T<sub>4</sub>.

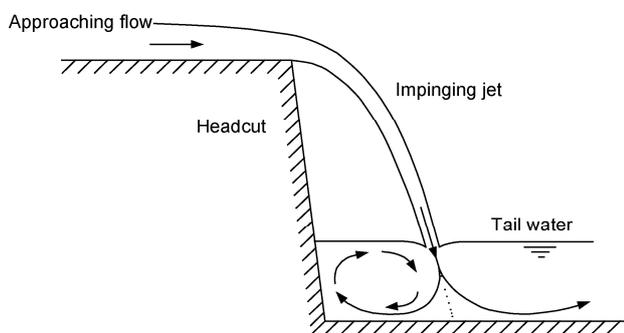
**Figure 12** Sketch of a headcut.

The steepened downstream slope of the embankment evolved gradually into a headcut (a headcut here means a vertical or near vertical drop or discontinuity on the flow-bed; see Figure 12). Then, instead of flowing down attaching to the headcut slope, the breach flow impinged like a jet onto the downstream flume bottom, imposing considerable erosive forces on the toe of the slope (see Figure 13). Strong scour of the toe of the slope (i.e. headcut undermining) due to the jet impingement was observed in all the four tests with sand-silt-clay mixtures. This undermining generally resulted in a reverse slope at the lower part of the headcut (see e.g. Figures 8, 9 and 10). It was observed that when the breach flow rate was very large, the action point of the jet flow on the flume bottom was relatively far away from the toe of the headcut. Under the circumstances of flat and non-erodible headcut foundation as in the present tests (i.e. the flat steel bottom of the flume), the portion of flow reflecting towards the headcut was relatively small and therefore the headcut undermining actually was somewhat slower compared with a smaller flow rate situation. However, the erosion occurring at the top of the headcut was faster with a larger flow rate. In case of an erodible embankment foundation, a scour hole would be expected to form in the foundation. It enlarged in time, both vertically and towards the headcut, undermining the headcut slope.

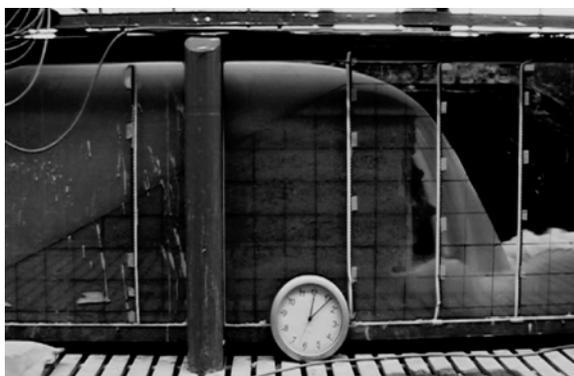
**Figure 13** Headcut and breach flow jet impingement (test T<sub>4</sub>).

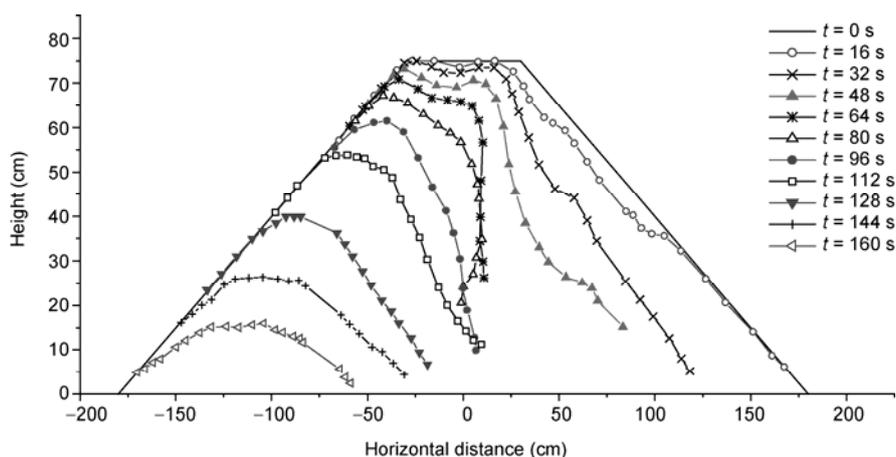
**Figure 14** Embankment profile development of test Ts.

For the sand-embankment test T<sub>s</sub>, erosion was first observed to occur at the upper half of the downstream slope of the embankment, and then a bar was developed at the lower part of the slope (see Figure 14). The upper portion of the slope was steepened in time and a headcut was also formed, showing similar characteristics as the tests with sand-silt-clay mixtures (which were not expected before the test). The mainstream of the breach flow also fled away from the headcut at the headcut brink, however, no large slope mass failure was observed from the headcut. The backward migration of the headcut was mainly due to the surface erosion from the slope. Later, when this erosion approached the upstream slope of the embankment, the gradient of the headcut became gentler and remained more or less constant thereafter, indicating more or less uniform erosion along the slope.
