Experimental Comparison of Cracking in Four Masonry Walls with Different Boundaries and Material

18th International Brick and Block Masonry Conference

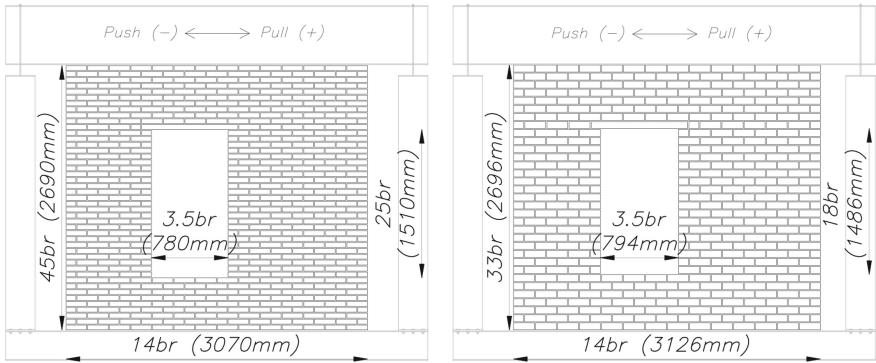
Fig. 1. The two types of geometry for fired-clay, left, and calcium-silicate brick, right.

Four full-scale masonry walls of about 3.1 m wide and 2.7 m tall (see Fig. 1) were tested in-plane. The tests were performed displacement-controlled and considered cyclically increasing lateral drift. Two walls were built of calcium-silicate bricks with a cementitious general mortar in joints of 10 mm. Additionally, two walls of fired-clay brick masonry were constructed and tested in a similar manner (see Table 1). Note that the fired-clay units were 50 mm high while the calcium-silicate units were 70 mm high. An opening for a window, located asymmetrically towards the centre of the wall and covered with a precast concrete lintel, divided the walls in two piers and two spandrels, and would later serve for the initiation of cracks. These four walls join a database of similar walls tested at the Delft University of Technology in the past.

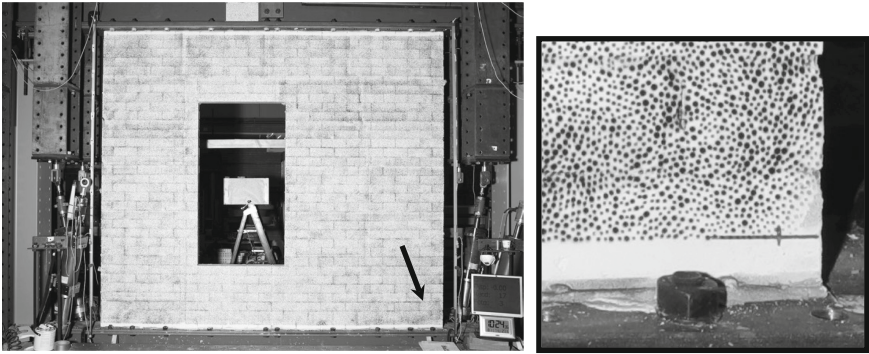
Fig. 2. Calcium-silicate brick wall painted white with a black speckle pattern for Digital Image Correlation. Zoom-in of the bottom right corner.

The specimens were painted white and a black pattern of random dots was applied to monitor displacements on the surface of the wall using Digital Image Correlation. Figure 2 presents a photograph of the wall with a corner zoomed-in to show the speckle pattern. The 2D, in-plane displacements of approximately one million gridpoints, spaced about 2.8 mm from each other, were surveyed simultaneously at an accuracy of 20 µm.

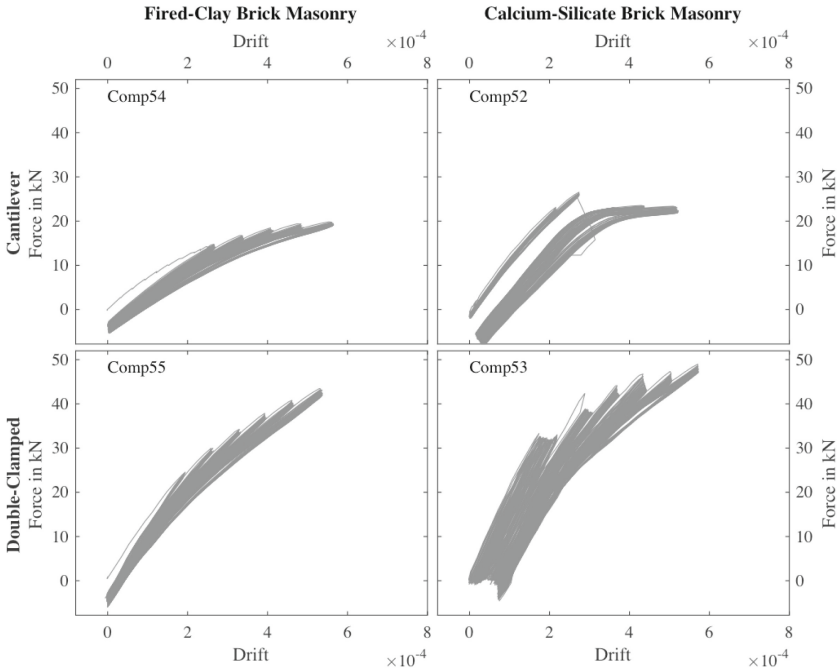
Fig. 3. Force-Drift curves for the four walls during the repetitive loading protocol.

The lateral force opposed by the walls when applying the prescribed displacements was recorded. When plotted against the enforced drift, a force-displacement curve can be drawn. Figure 3 compares the four walls for the repetitive part of the protocol (when the drift was applied only in one direction without reversal). The five or six incremental steps are visible. The curves reveal that the doubled-clamped tests reached a higher capacity—this is expected since the overburden was also higher. However, both walls, independent of the material, also achieved noticeable higher forces at each step while the cantilever tests quickly reached their capacity and present a more plastic force-drift envelope. In terms of hysteretic energy, no remarkable differences can be observed for all four walls, while the calcium-silicate walls do show slightly larger energy release.

In Fig. 8, the comparison is first conducted in terms of force. The behaviour observed in Figs. 3 and 4 is here emphasised: the cantilever tests display a lower capacity. It is also clear that the fired-clay specimen shows a lower capacity for the cantilever boundary and for the double-clamped tests. The force at each step degrades; in the positive direction, this occurs during the repetitive protocol, while for the cyclic protocol, this occurs only in the negative direction since the positive direction has already been damaged. The degradation is more consistent during the double-clamped tests. A hypothesis is that the predominantly shear behaviour, that follows from this boundary condition, is also linked to the observed reduction in force.

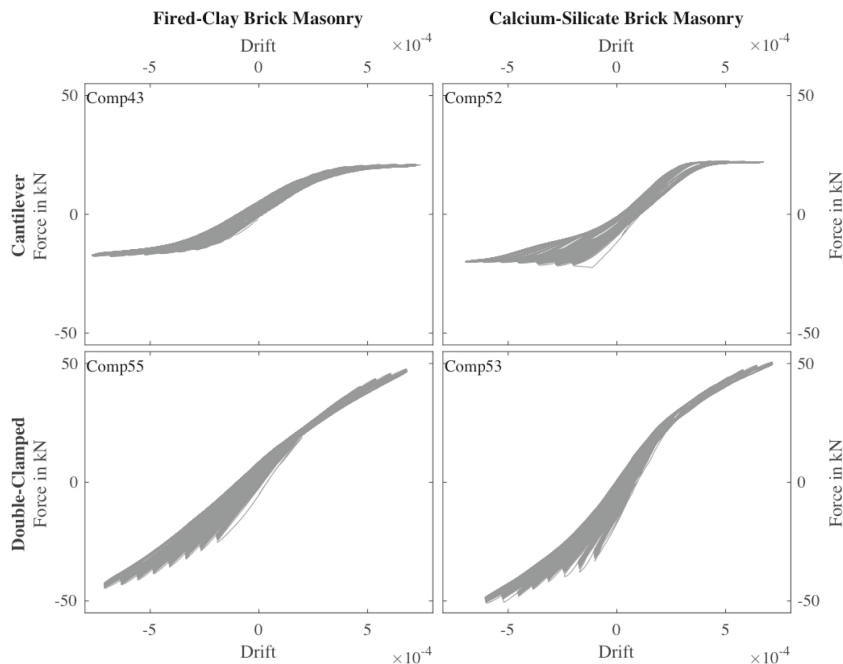
Fig. 4. Force-Drift curves for the four walls during the two-way cyclic loading protocol.

A similar comparison is conducted for the two-way cyclic protocol that followed. Here, the positive drift direction is already damage and most of the energy release occurs in the negative direction. Indeed, the calcium-silicate walls show a slightly larger release followed by the double-clamped test of the fired-clay wall. At each loading step, the force degradation is very clear for the double-clamped condition: one can observe that at each repetition of the drift, a lower lateral force is required. The force degradation is coupled to a reduced stiffness, meaning that the walls progressively become more flexible.

The force-drift behaviour of the walls could be idealised with a bi-linear diagram. For the cantilever walls, the upper branch would be more horizontal, while the double-clamped walls display a steeper branch. Beyond light-damage, a tri-linear diagram could be used; see next section (Fig. 4).

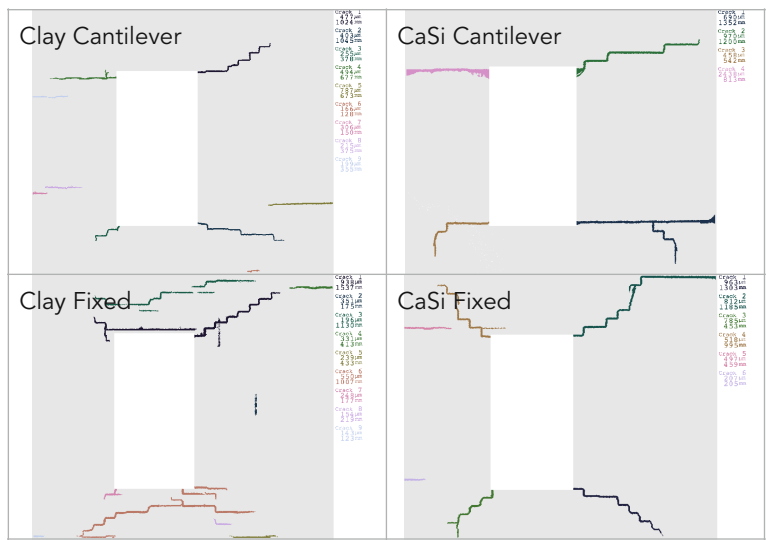
Fig. 5. Summative crack pattern at the end of the cyclic protocol.

At the end of the cyclic protocol, the summative crack pattern is gathered in Fig. 5. Clear differences can be observed for the two materials and the two boundary conditions. For the cantilever cases, cracks appeared more horizontal and followed a somewhat diagonal path. For the fixed-fixed condition, a steeper path is visible. Similarly, the CaSi walls display more diagonal and even vertical paths, cutting through the units. Moreover, the double-clamped cases seem to show more smeared cracks while the cantilever walls display more localised cracks directly propagating from the window corners. Nonetheless, the cracks for the fixed-fixed boundary are consistently wider, but not remarkably so.

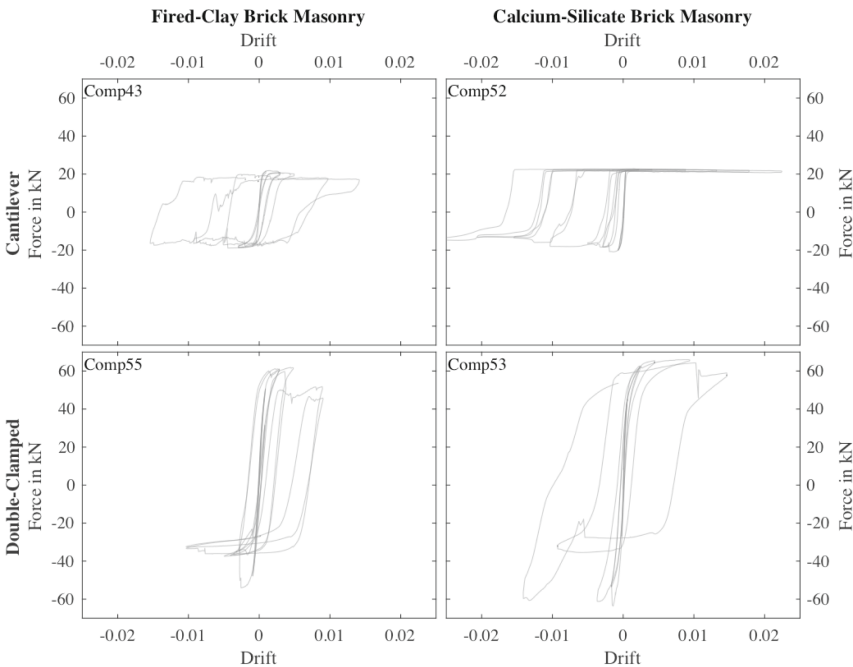
Fig. 6. Force-drift curves for the near-collapse protocol.

The shape of the force-drift curves are linked to the failure mechanism of each test. In general, pure rocking with crack opening and closing, and pure shear, with only sliding at the crack interface, can be distinguished. The various walls exhibited combinations of these mechanisms at different degrees on the two possible directions. For example, Comp43 displays mostly sliding in both directions; Comp52 in contrast, shows sliding only in the negative drift direction while the positive direction is associated with pure rocking. The other two walls, in doubled-clamped configuration, present a mixed mechanism. The boundary motivates sliding but is also accompanied by Mode I crack opening and closing. For Comp55, the negative direction sees little sliding while the positive direction is associated with pure rocking. Comp53, after clear failures, starts to slide (Fig. 6).

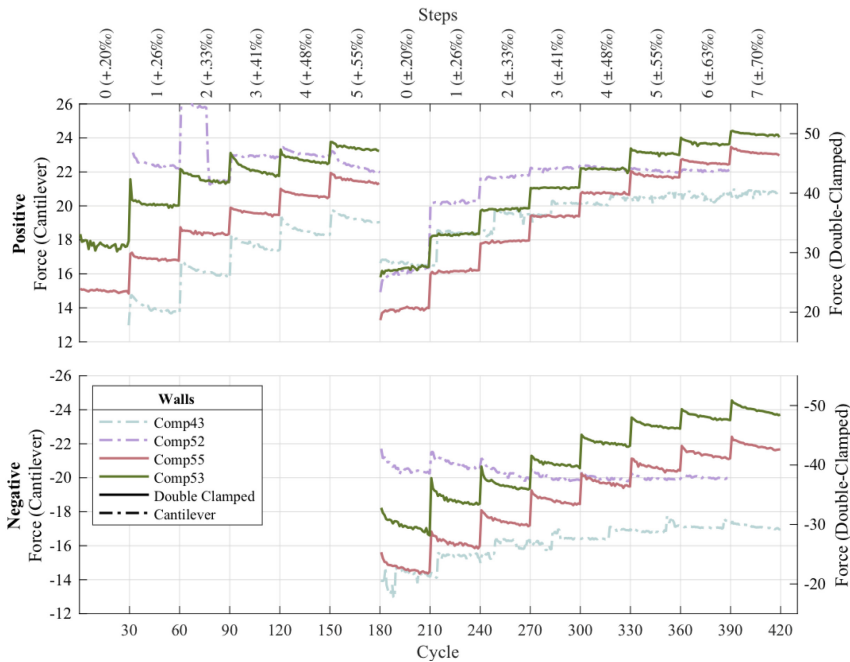
Fig. 8. Maximum force reached during each cycle for the positive drift direction, top, and the negative direction, bottom. Fired-clay: Comp43 and 55. Calcium-silicate: Comp52 and 53.

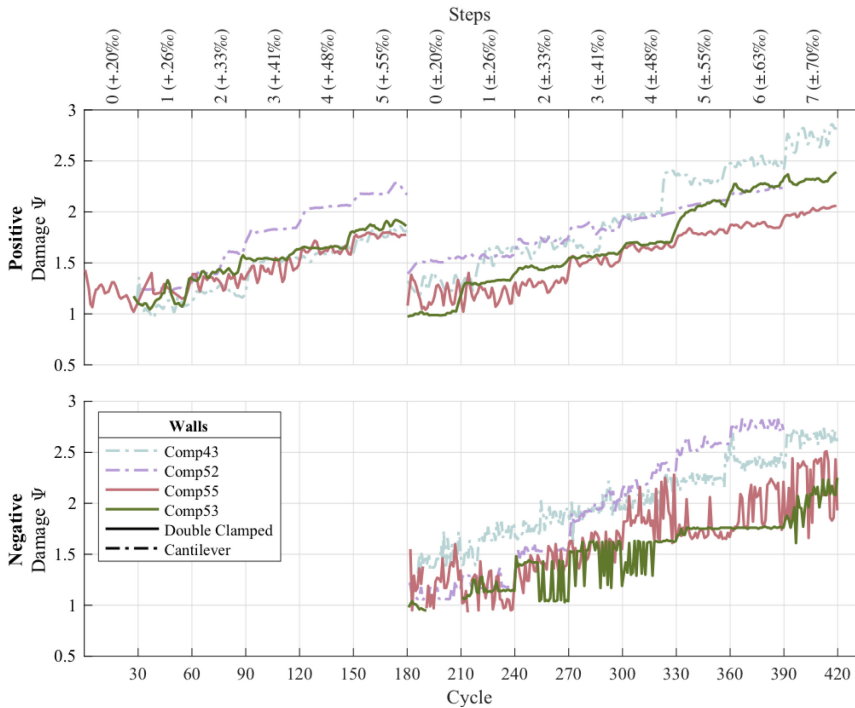
Fig. 9. Damage, measured with Ψ , at each step over the repetitive and cyclic protocols.

A similar behaviour can be observed if the force is replaced by crack-based damage measured with Ψ as in Fig. 9. Here, one can observe that damage increases as the applied drift increases. While clear increases occur when the drift is changed, this happens even within each step where the applied drift is constant. In particular, towards the end of the protocol, the increase in damage within each step is clear. In the negative direction, measuring Ψ appears noisy, especially for the double-clamped protocol. This might be related to the sensitivity of the DIC system but also suggests that the configuration of the cracks changes during the step. It is possible that progressive sliding—linked to a force degradation—also leads to an alternating picture of cracks that are more and then less open.

In general, all walls exhibit similar damage. Consistently, Comp55, the fired-clay wall under double-clamped condition, shows the least damage. The calcium-silicate

specimen, double-clamped, follows, though is more comparable to the cantilever tests. These two present the most damage, though overall the calcium-silicate specimen gets damaged earlier. Damage ranges from $\Psi = 1$ (just visible cracks) to almost $\Psi = 3$ at the end of the light or minor damage.
