Effect of salt spray ageing on the fracture of composite-to-metal bonded joints

Arouche, M.M.; Saleh, M.N.; Freitas, S. Teixeira de; Barros, S. de

International Journal of Adhesion and Adhesives

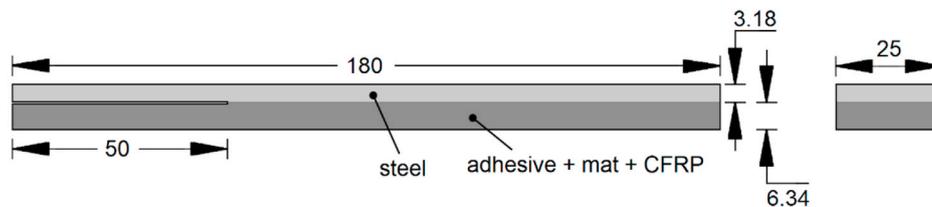
Fig. 1. Specimen geometry (dimensions in millimeters).

Specimens were cut from the plates using a bandsaw with a high-speed steel blade and cutting oil. Measurements of width and thickness were obtained with a digital caliper at 30 mm from both ends and at center of the specimens. Specimen geometry is shown in Fig. 1. The specimens have an average width of 25.28 ± 0.18 mm and an average thickness of 9.52 ± 0.19 mm. The average length of 180 ± 1 mm was measured with a ruler. An anti-friction material was applied between the metal plate and the adhesive in order to produce a pre-cracked region.

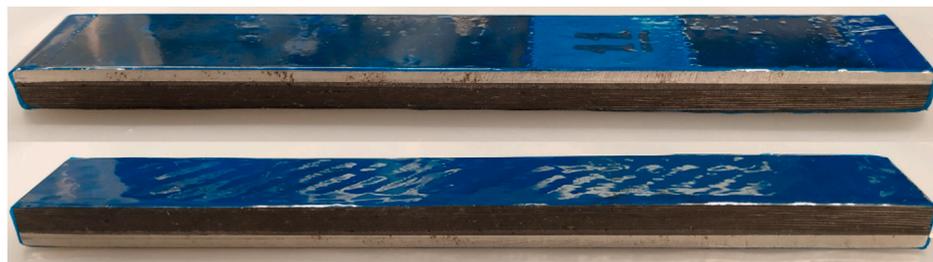
Fig. 2. A specimen prepared for ageing.

Specimens were placed for ageing in a salt spray chamber. A solution of 5% mass sodium chloride [NaCl] was atomized at 200 ml/h and 35 °C. The exposure zone remained in a relative humidity between 95% and 98% and pH between 6.5 and 7.2, according to the ASTM B117 standard practice [30]. Specimen's top and bottom surfaces were covered with a layer of tape to avoid degradation of the adherends as shown in Fig. 2.

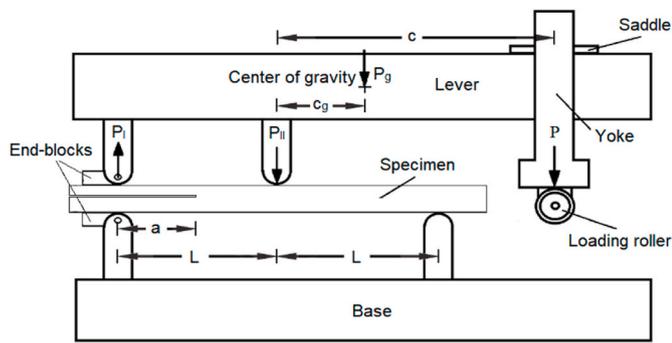
Fig. 3. MMB test scheme.

The MMB test was chosen for the experimental mixed-mode fracture analysis of the specimens. During the procedure, loading is applied from a yoke to rollers attached to a lever and loaded just above the mid-plane of the test specimen, as shown in Fig. 3. The test loading (P) is decomposed in opening (P_I) and shear (P_{II}) loadings in a constant ratio determined by the lever length (c). The mode I fracture ratio increases with the lever length. The lever weight produces a load (P_g) on the specimen

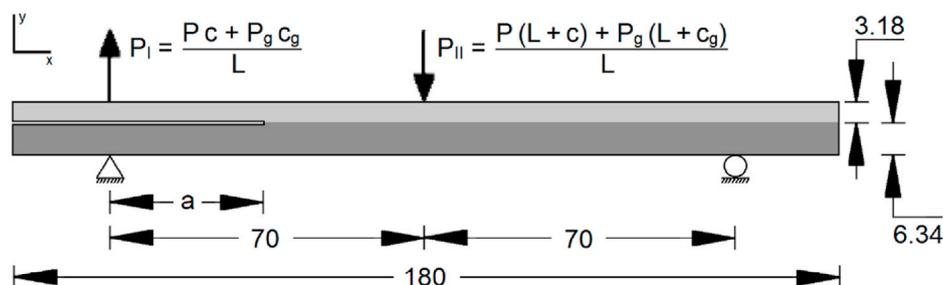
Fig. 4. Model geometry and contour conditions.

A 2D finite element (FE) model was developed in Abaqus Standard. The geometry was modelled based on the specimen measurements, as presented in Fig. 4. Loadings and contour conditions were applied in order to simulate the MMB test conditions. Boundary condition were defined by constraining displacements in x and y directions at the left side and displacements in y direction at the right side of the beam. The opening and shear loadings were applied at the top surface. Isotropic materials were selected from the properties presented in Table 1. A FE mesh of 4-node bilinear plane strain quadrilateral solid elements (CPE4) was applied in the whole model for optimized computational costs.

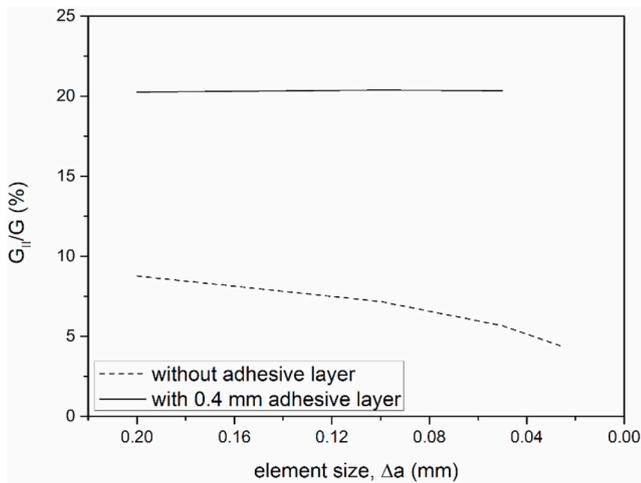
Fig. 5. Mesh sensitivity analysis.

A mesh sensitivity analysis was performed using the model of the MMB test with a crack length (a) of 30 mm. Elements of the same size were used on both sides of the crack and the aspect ratio of the elements in the vicinity of the crack tip was maintained at 1/1. The numerical analysis takes into consideration the effects of geometric nonlinearity. Results are shown in Fig. 5. The calculated fracture mode ratio (G_{II}/G) of a model without the adhesive layer showed dependency on the element size around the crack tip (Δa) and did not represent the actual fracture

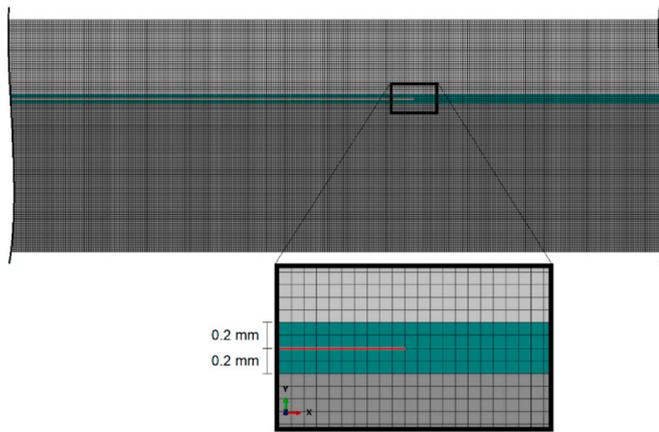
Fig. 6. Detail of the FE mesh around crack tip.

element size. A global mesh with elements of 0.1 mm was chosen for the determination of the fracture energy at the load-crack length points, as shown in Fig. 6.

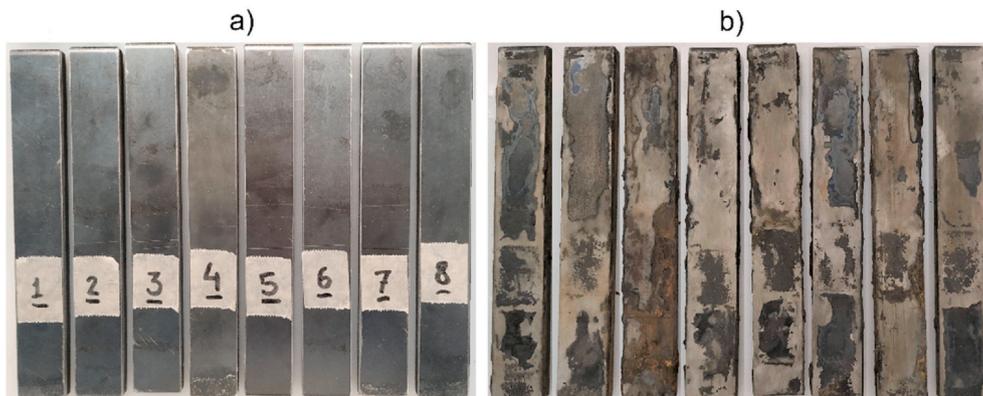
Fig. 7. Steel outer surface (a) non-aged and (b) aged conditions.

Fig. 7 shows the outer surface of the steel arm of non-aged and aged specimens. The effect of corrosion on the outer steel surface is negligible. This can be observed by comparing non-aged specimens (Fig. 7a) with the condition after ageing (Fig. 7b). The application of tape on the outer surfaces of the specimens showed to be effective in diminishing the degradation of metal adherends aged in salt fog. However, the average weight measured from the aged specimens is 142.9 ± 1.7 g, which means a decrease of 1.1% of the initial weight. This shows that the weight reduction due to corrosion of the steel member under long-term exposure to harsh environmental conditions had dominant effect against the weight increase due to moisture absorption of the adhesive [4] and the composite laminate [11]. These combined parameters make it difficult to determine the degree of moisture saturation at the bonded interface based on the measured weight during the conditioning process.

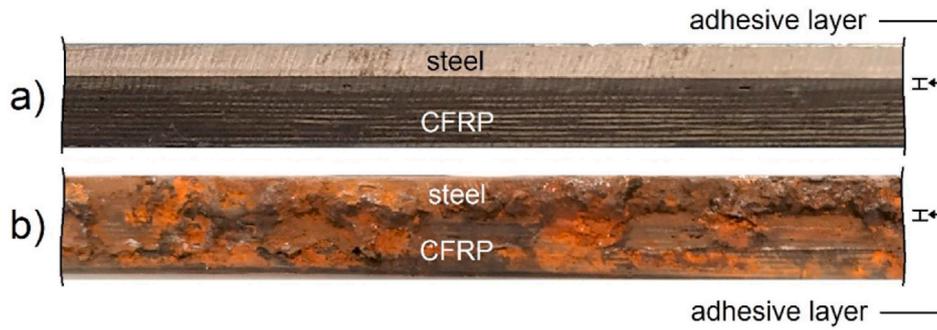
Fig. 8. Side view of a section of (a) non-aged and (b) aged specimens.

The effect of corrosion is noted on the sides of specimens, as shown in Fig. 8. The presence of corrosion products is observed over the metal and composite sides of aged specimens (Fig. 8b), in comparison with the non-aged sample (Fig. 8a). This shows the degradation of the sides of the steel member exposed during the ageing period. Literature states the galvanic corrosion of the composite material occurs as consequence of corrosion product depositions, acting as electric bridges between steel and exposed carbon fibers [17]. Overall, only the sides of the specimens were significantly affected by the ageing conditions.

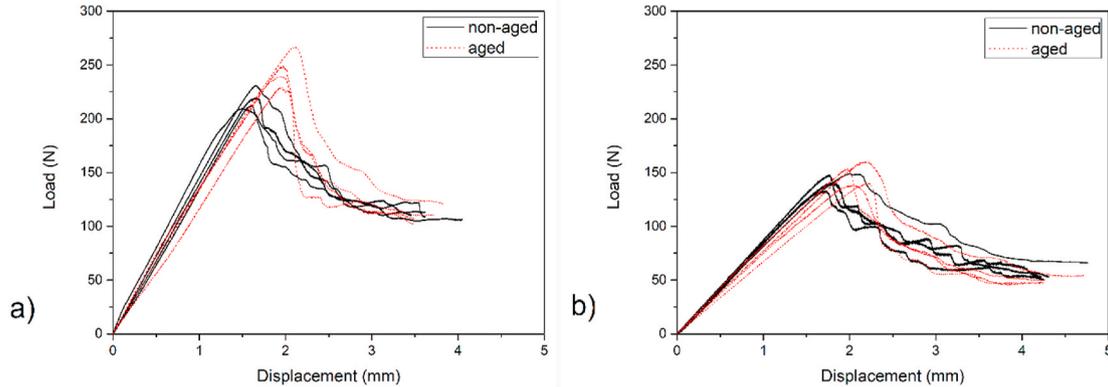
Fig. 9. Load-displacement curves of tests with lever length of (a) 110 mm and (b) 150 mm.

Fig. 9 shows the load-displacement curves obtained from the MMB tests. Composite-to-metal bonded joints exhibited typical curves, similar to standard symmetric specimens subjected to ageing conditions [25]. Results of non-aged and aged specimens tested with a lever length of 110 mm are presented in Fig. 9a. It can be noticed that the maximum load achieved by the aged sample is higher than the non-aged ones. This means that the bonded structure required higher loadings for crack initiation after ageing in saline atmosphere. However, specimens tested with a lever length of 150 mm presented similar curves in both non-aged and aged condition, as shown in Fig. 9b. The ageing process did not affect the performance of the bonded joint when tested at 150 mm. The overall stiffness of the structure was hardly affected by the ageing conditions, given the reduced effect of corrosion at the steel member (see Fig. 7) as well as the stability of carbon fibers in the presence of moisture [12]. Moreover, the effect of galvanic coupling seems to be negligible to the stiffness of the laminate.

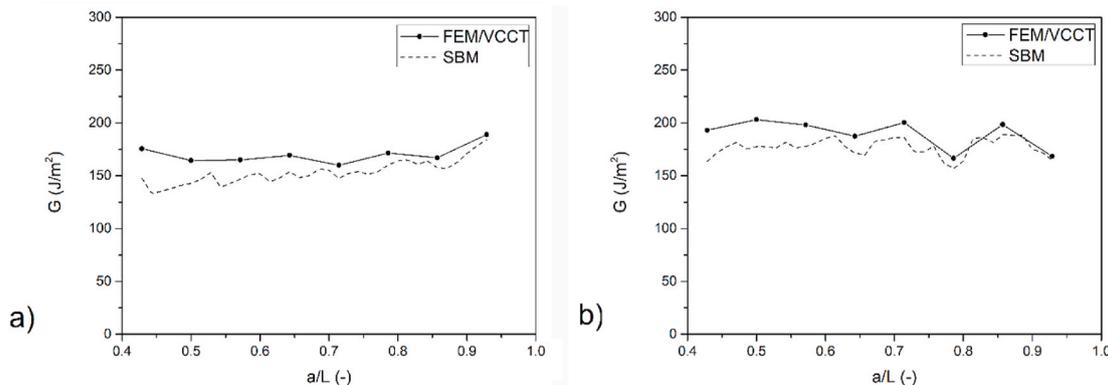
Fig. 10. Fracture energy of a representative specimen tested at a lever length of (a) 110 mm and (b) 150 mm.

Fig. 10 shows comparative results of the fracture energy obtained from the FEM/VCCT and the SBM in the two different testing configurations. Numerical values of the total fracture energy are shown to be consistent along crack propagation. Results calculated using the SBM deviated by 15% from the FEM/VCCT at crack initiation and converged as the crack length increases. This is attributed to the effect of shear stresses that are not considered in the SBM but can be significant when testing beams with high thickness-to-span ratio [29].

energy is noted at 15% mode II. As expected, the SBM showed good agreement with the numerical results. Moreover, the average fracture energy obtained from the SBM deviated by 15% from the FEM/VCCT at crack initiation (Figs. 12a) and 6% during propagation (Fig. 12b), as observed in Fig. 10.

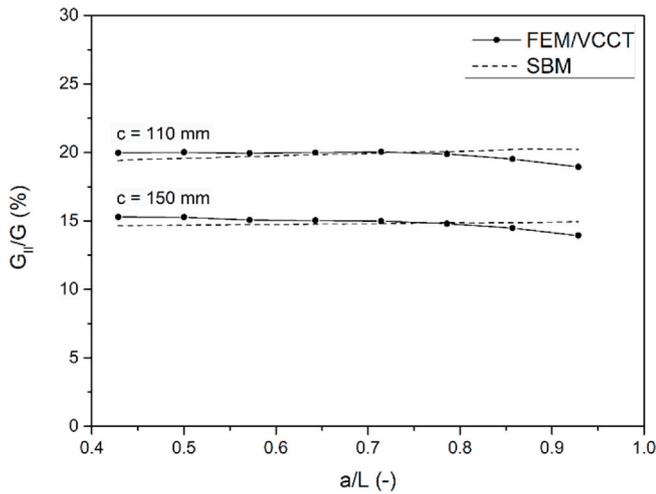
Fig. 11. Fracture mode ratio.

The fracture mode ratio obtained from numerical and analytical methods is presented in Fig. 11. Numerical results (FEM/VCCT) presented nearly constant results along the crack propagation with a slight reduction of the mode II portion at the crack propagation points near the

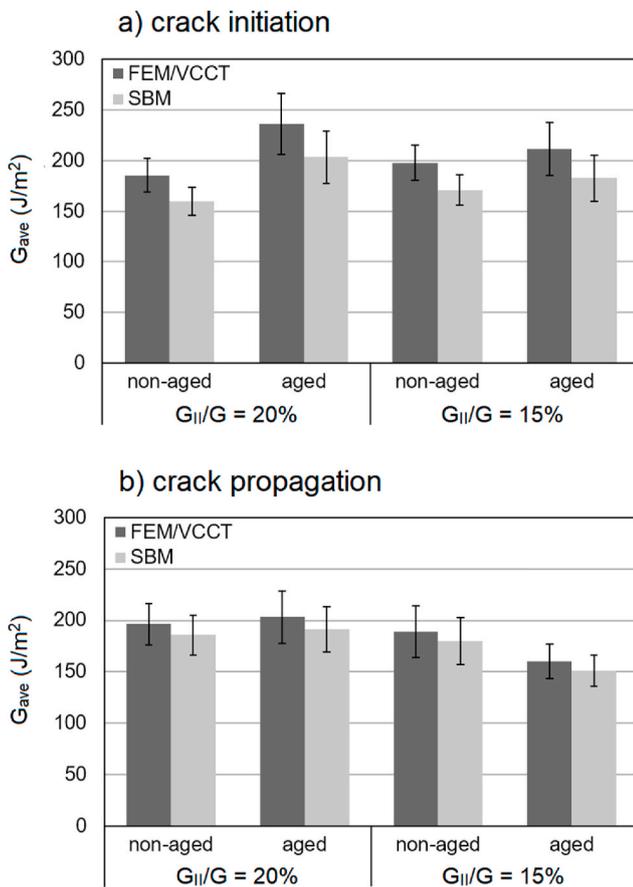
Fig. 12. Average fracture energy at (a) crack initiation and (b) propagation.

The average fracture energy (G_{ave}), presented in Fig. 12, provides a comparable data for the evaluation of the ageing effect on the fracture performance of the tested specimens. Fig. 12a shows the mean fracture energy at crack initiation of the 4 repeats of each configuration. It reveals a significant increase of 27% of the fracture energy at crack initiation when tested in 20% mode II. In the case of specimens tested in 15% mode II, the fracture energy showed a slight increase of 7% at crack initiation. The region of crack initiation is directly affected by the moisture across the whole width and resulted in an increase of the fracture toughness. This seems to be related to the shear behavior of the adhesive and is attributed to the effect of plasticization [19,21].

Fig. 12b shows the mean fracture energy at crack propagation points (from 35 to 65 mm crack length) of the 4 repeats of each configuration. A negligible variation is observed of 3% of the fracture energy at 20% mode II during crack propagation, while a reduction 15% of the fracture

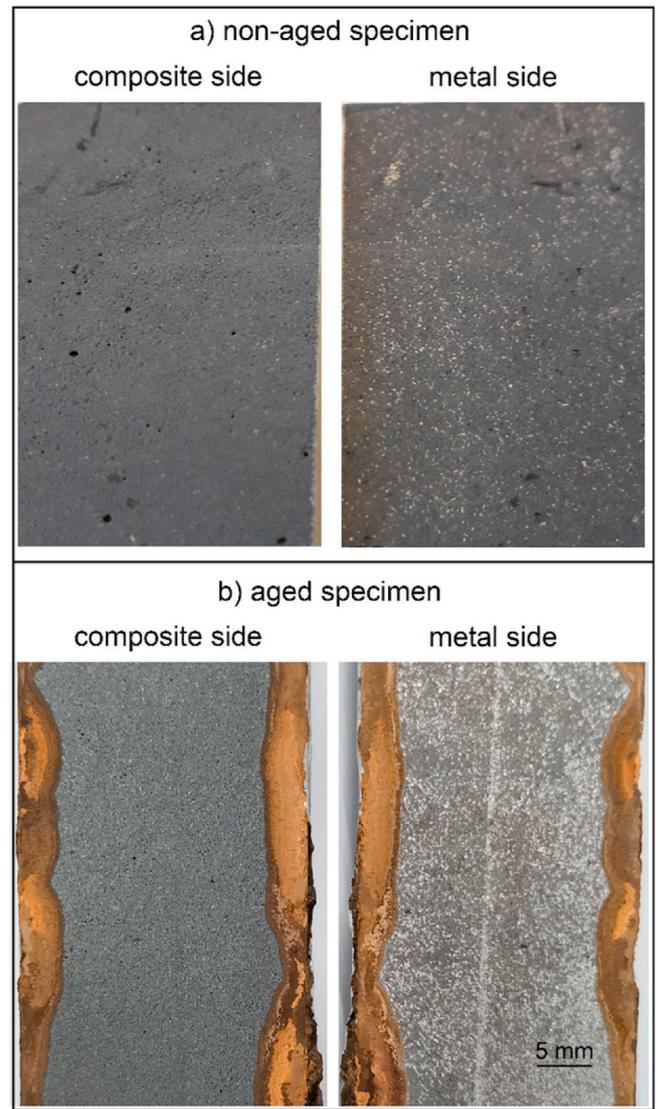
Fig. 13. Fracture surfaces of (a) non-aged and (b) aged specimens.

Representative images of the fracture surfaces are presented in Fig. 13. Both non-aged and aged specimens presented most of the adhesive stuck to the composite adherend (lower surface), while a thin layer of adhesive remained on the metal side (upper surface). Overall, the non-aged specimens (Fig. 13a) exhibited thin-layer cohesive failure as the triggering failure mode. This observation confirms good bond quality and ensures high joint efficiency. In the case of the aged specimens (Fig. 13b), moisture penetration is noticed on both side edges of the fracture surfaces.

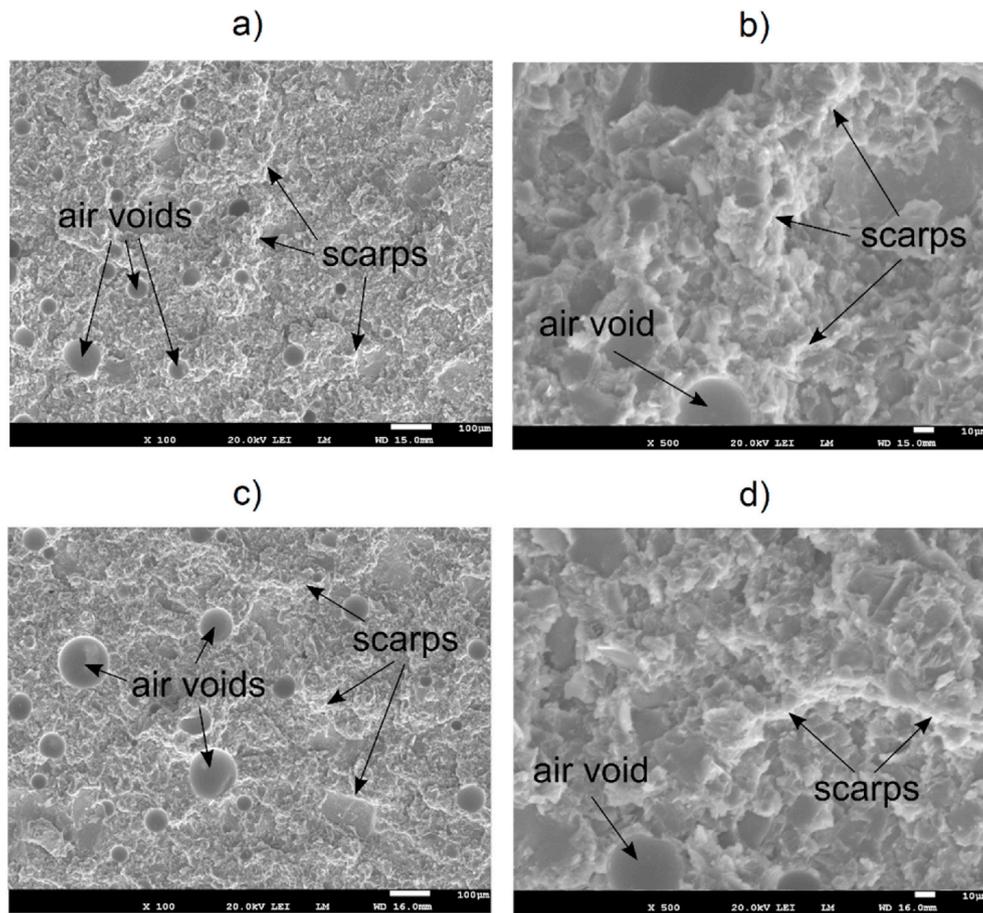
Fig. 14. SEM images of non-aged specimen tested with $c = 110$ mm (20% mode II) at (a) x100 and (b) x500 and tested with $c = 150$ (15% mode II) mm at (c) x100 and (d) x500.

A detailed analysis of the fracture surfaces was performed using a field emission scanning electron microscope (SEM) (JSM-7500F, JEOL, Japan). Prior to examination, samples were coated with two ultra-thin (15 μm) layers of gold using a sputtering system (Q300T D, Quorum Technologies, United Kingdom) for the SEM analysis of non-conductive materials. Fig. 14 shows typical fracture surfaces from the metal side of non-aged specimens using magnifications of 100 and 500 times. Crack propagation direction is from the left to the right side of the images. Both test configurations of 20% mode II (Fig. 14a and b) and 15% mode II (Fig. 14c and d) demonstrated similar surfaces of cohesive failure with the presence of air voids and scarps. These features confirm that the fracture occurred with dominant mode I loadings in both test configurations [11,14]. No significant difference in the failure mechanisms was noticed between the two mode ratios.

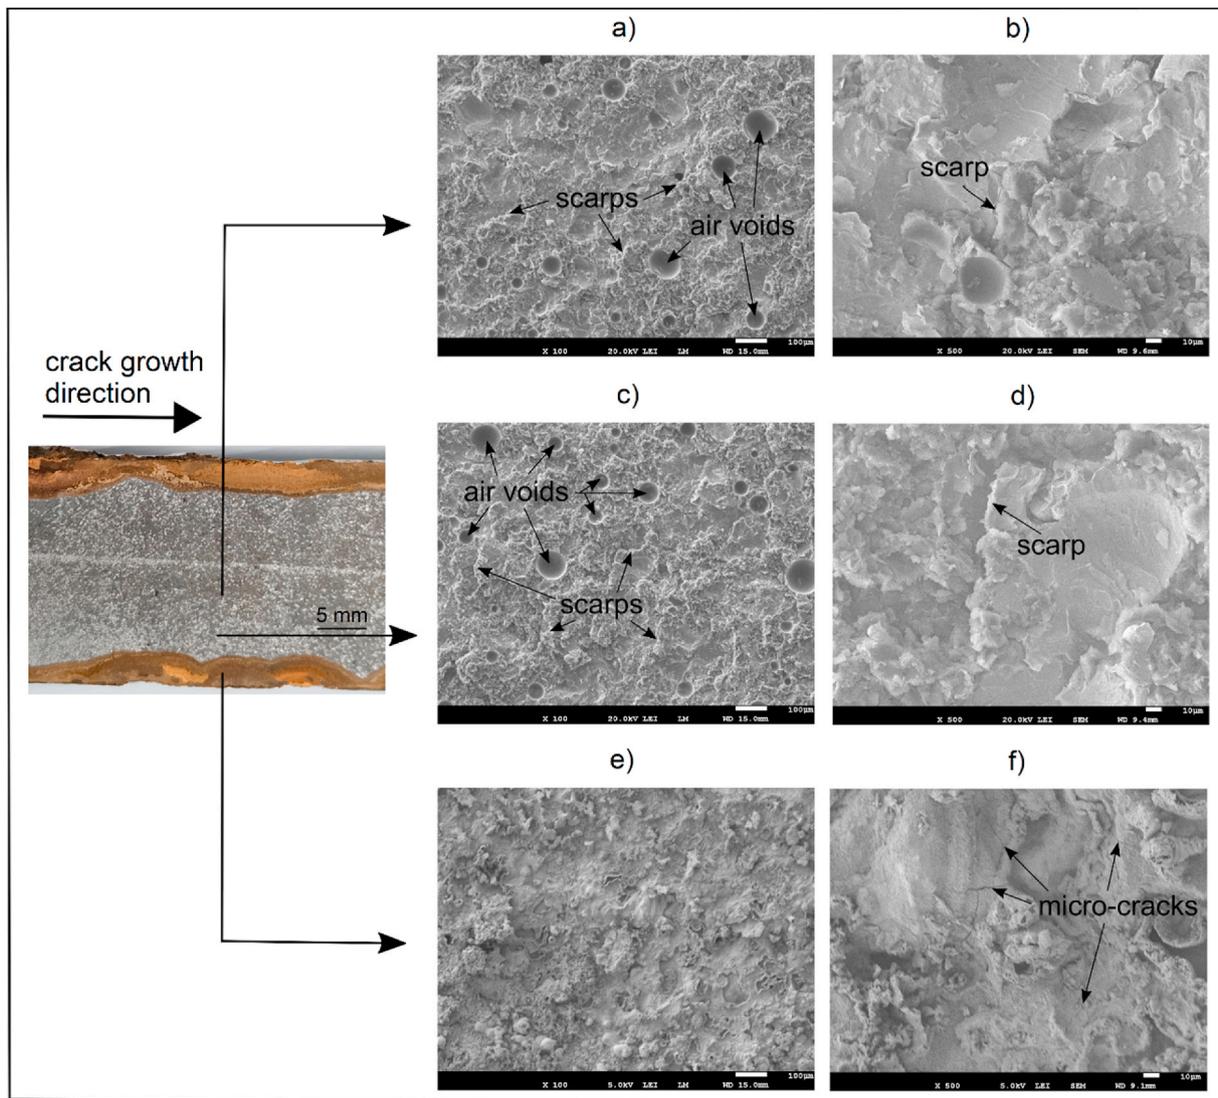
Fig. 15. SEM images of aged specimen in 100x and 500x, respectively, at (a, b) center, (c, d) intermediate and (e, f) edge regions of the fracture surface.

Fig. 15 shows the fracture surfaces from the metal side of an aged specimen using magnifications of 100 and 500 times. Images were obtained in three different regions: at the center of the surface, near the edge, and in an intermediate region. Images from the center (Fig. 15a and b) and intermediate (Fig. 15c and d) regions show the presence of adhesive attached to the metal surface indicating cohesive failure, such as the non-aged specimens in Fig. 14. However, slight less scarps on the adhesive surface can be observed, indicating a certain variation of the failure mechanism in these regions. Images obtained from regions affected by moisture (Fig. 15e and f) showed remarkably distinct fracture surfaces of seemingly adhesive failure. The occurrence of micro-cracks observed at high magnification (Fig. 15f) indicates the presence of corrosion products at the interface due to the degradation of the metal adherend.

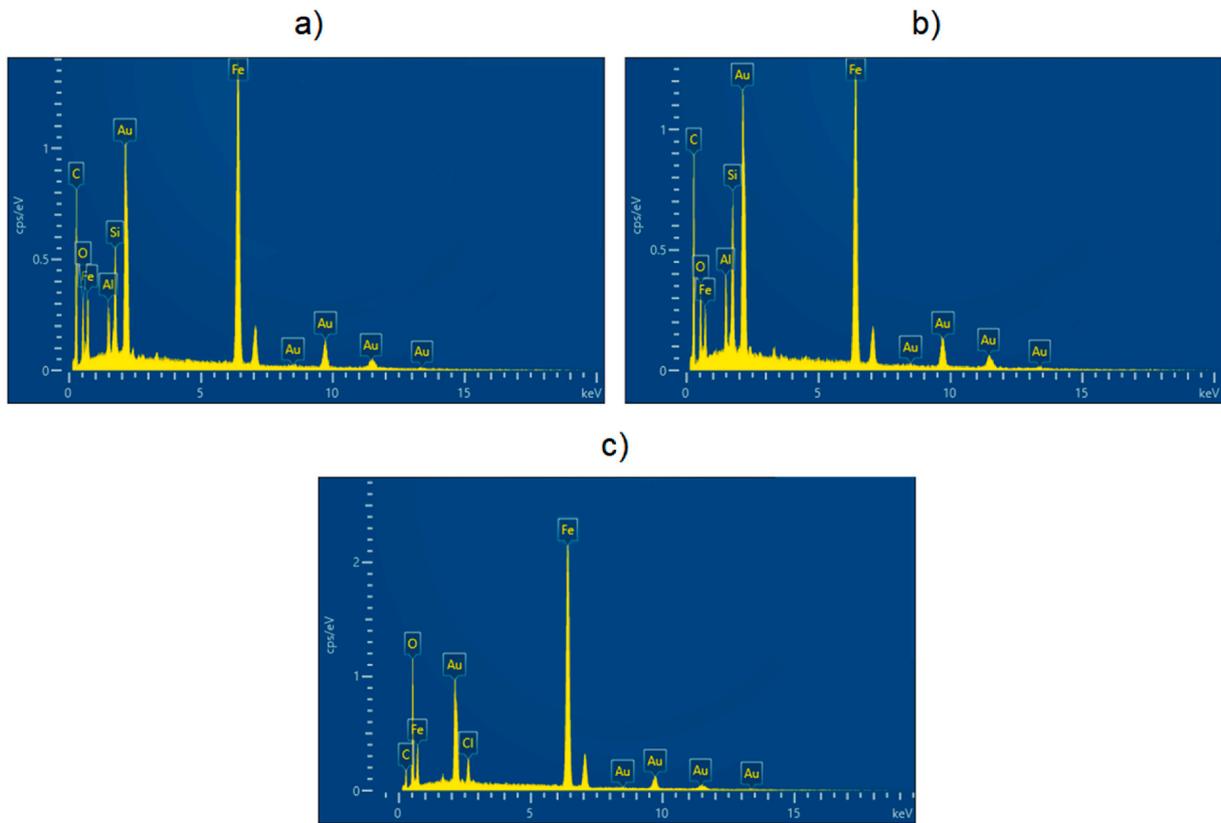
Fig. 16. EDS of aged specimen at (a) center, (b) intermediate and (c) edge regions.

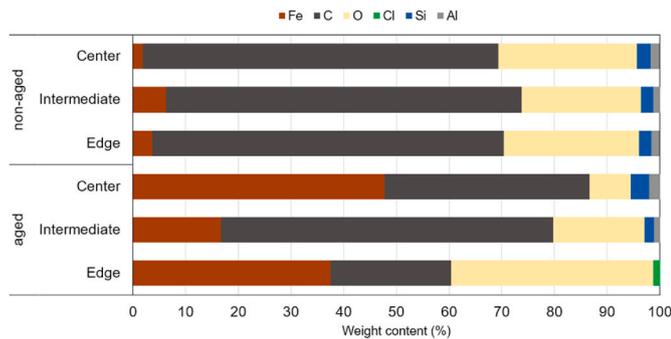
Fig. 17. EDS of aged specimen at center, intermediate and edge regions of the fracture surface.
