Preserving spatial quality when transforming churches: different spatial solutions and their effects

Research Report

Defining the spatial quality and Characteristic building elements in Neo Gothic churches

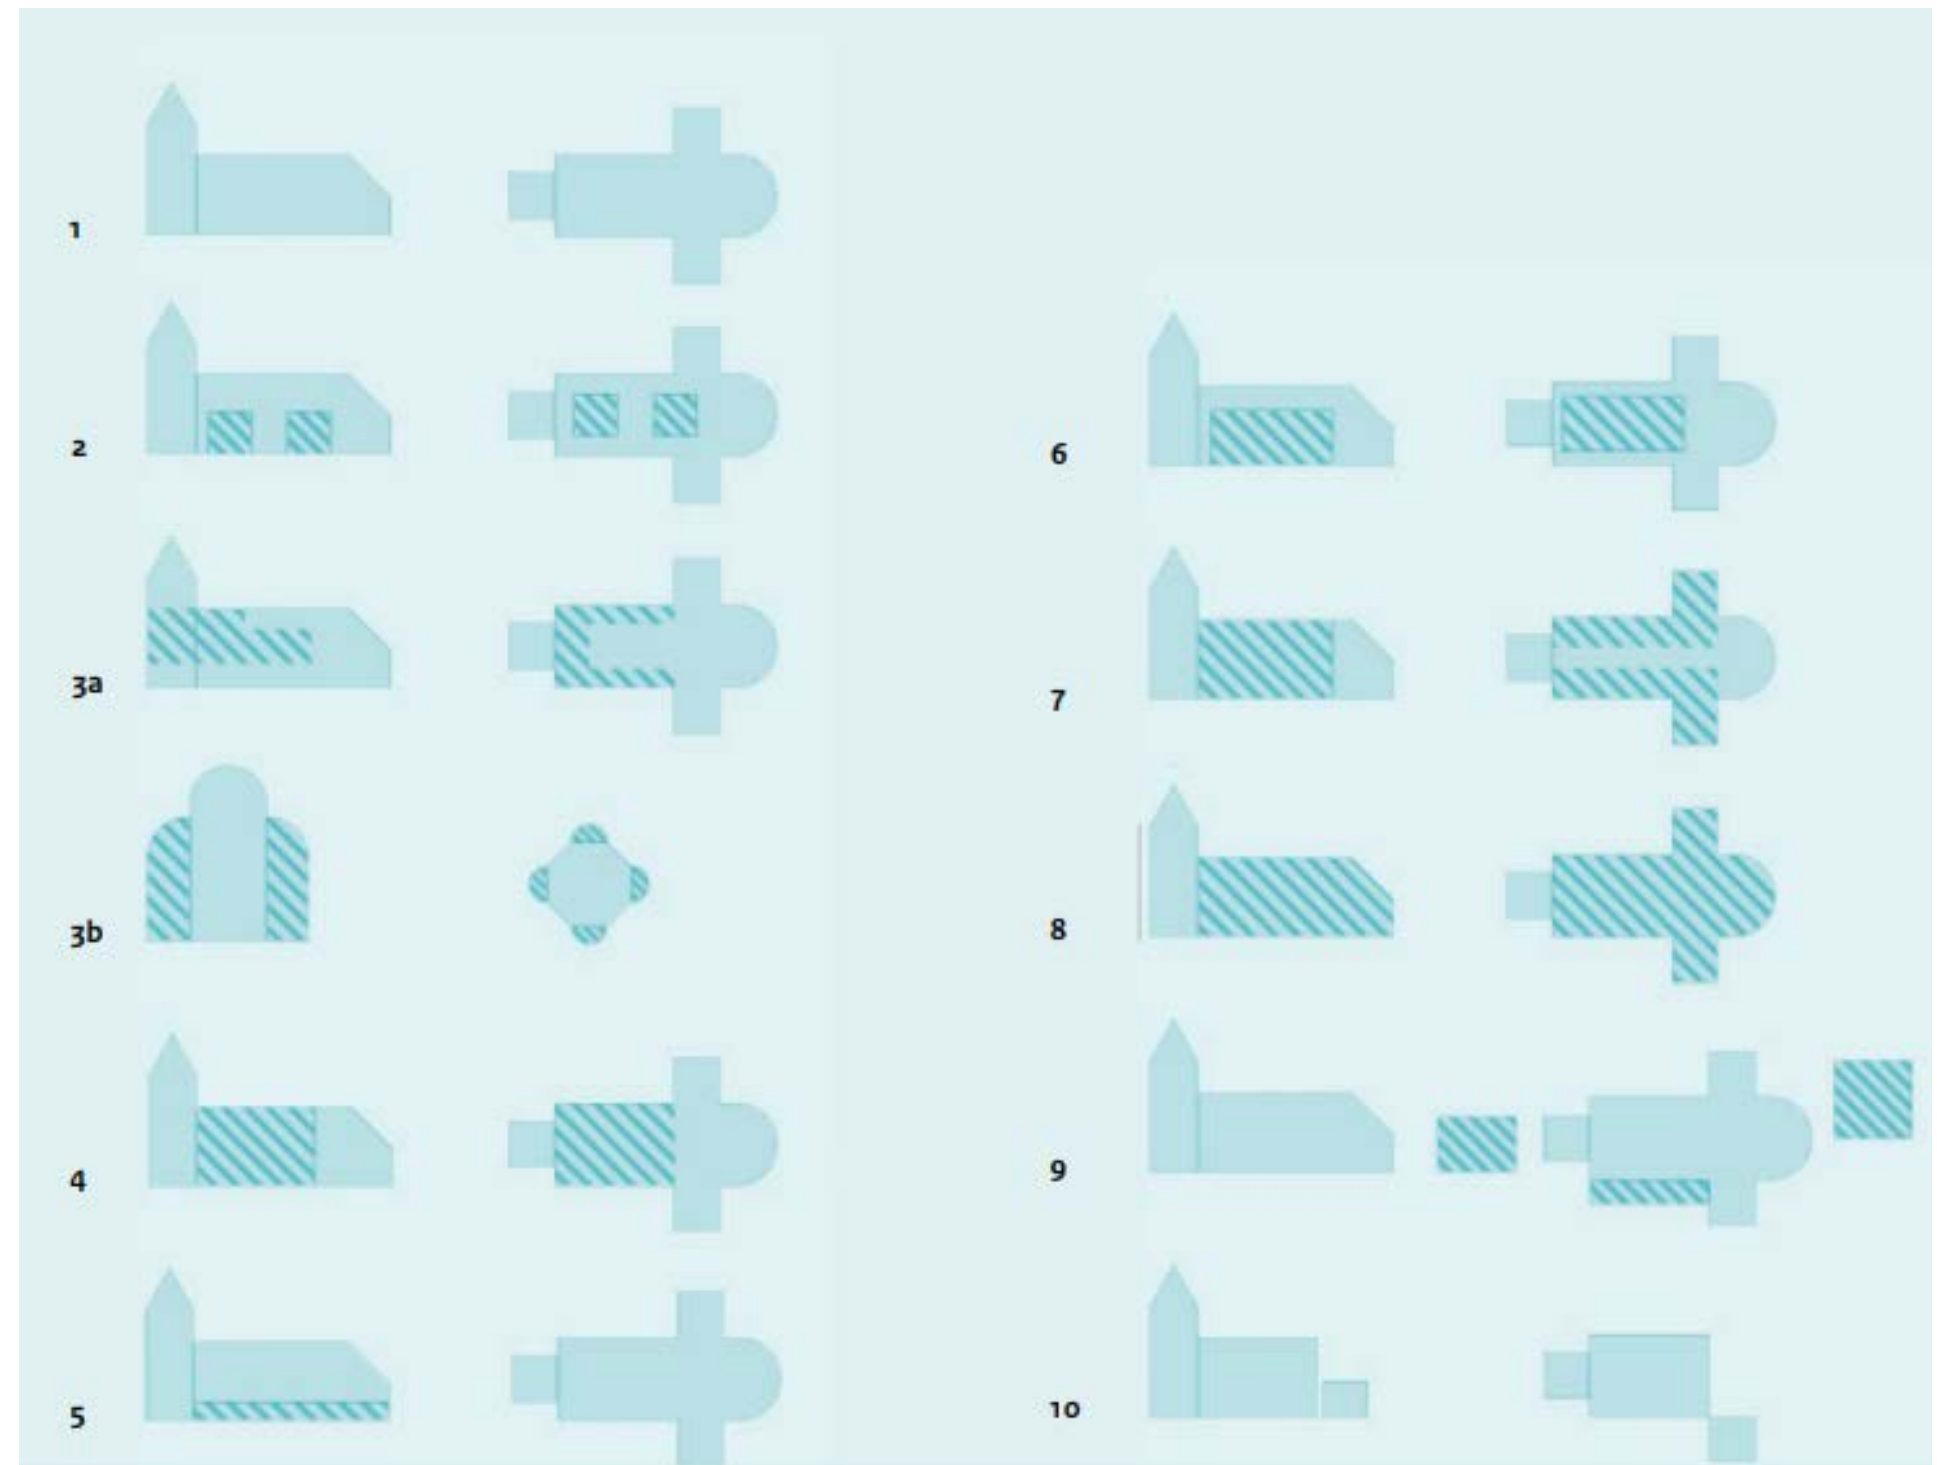
1. Full space remains intact
2. Loose built-in
3. Use ancillary spaces
4. Vertical splitting
5. Horizontal splitting

6. Box in the church
7. Lines of sight preserved
8. Fill
9. Additions
10. Partial demolition

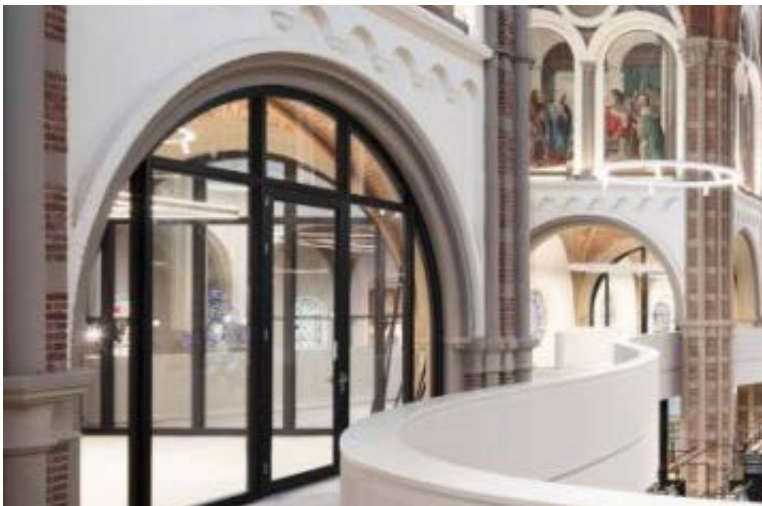
The windows are placed inside the existing voids of the arches of the building and thus the rhythm is the same, the rhythm of the mullions is not derived from the existing church
- Detailing

The detailing of the windows is very sleek and smooth in contrast with the ornamental detailing of the church

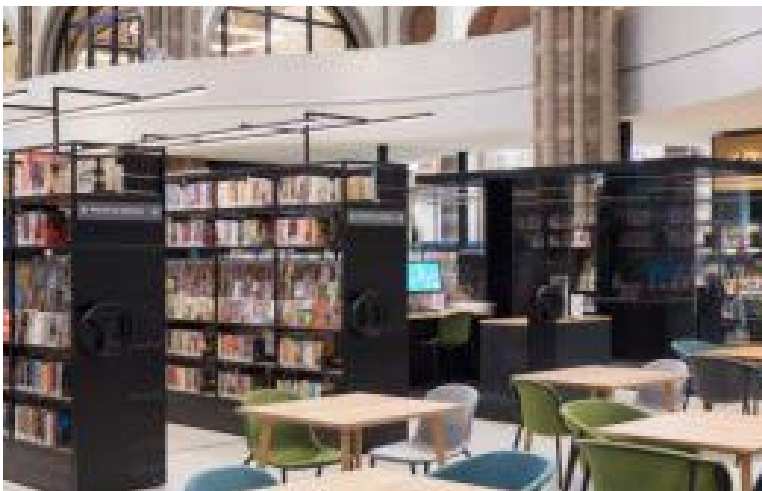
Element: Bookcases

The bookcases are placed in rows on a certain grid. This grid has no reference to the grid of the church except that it all fits in the main nave of the church.
- Detailing

The detailing is very sleek and smooth in contrast with the ornamental detailing of the church

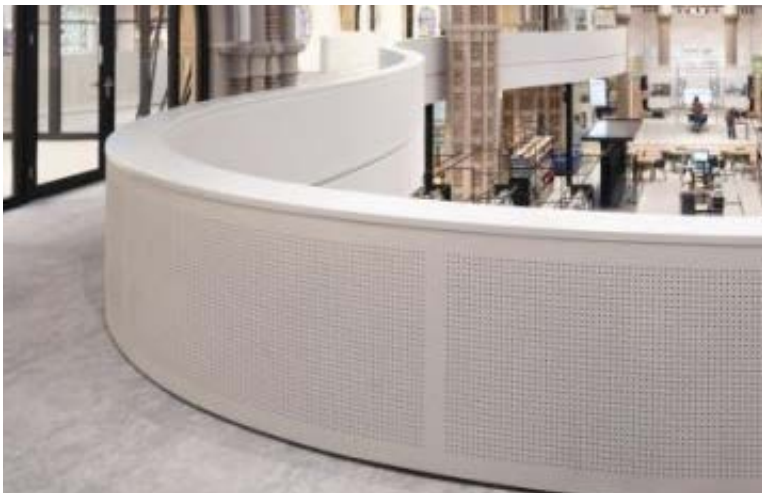
Element: Floor and railing

There is no rhythm to be found in the waving shape of the floor, so there is contrast.
- Detailing

The detailing is again very sleek and smooth but the wood of the railing has been perforated with small holes which suits with the ornamental detailing of the church.

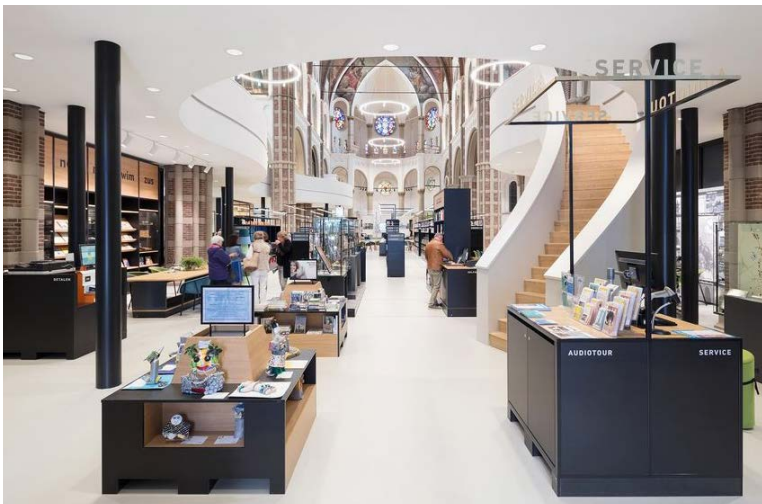
Element: Columns

The shape of the columns is round, this is in continuity with the round shaped columns that can be found in the side aisles of the church.
- Material/Texture

The columns are black, this color is nowhere to be found in the existing building.
- Rhythm

It looks like the columns are placed randomly in the space, in fact the columns are positioned to follow the shape of the floor. This does not have coherence with the existing grid.
- Detailing

The detailing is again very sleek and smooth in contrast with the ornamental detailing of the church

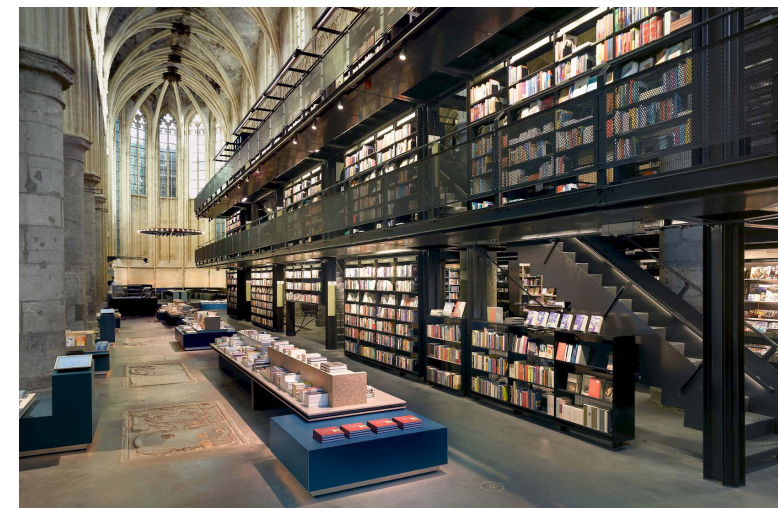
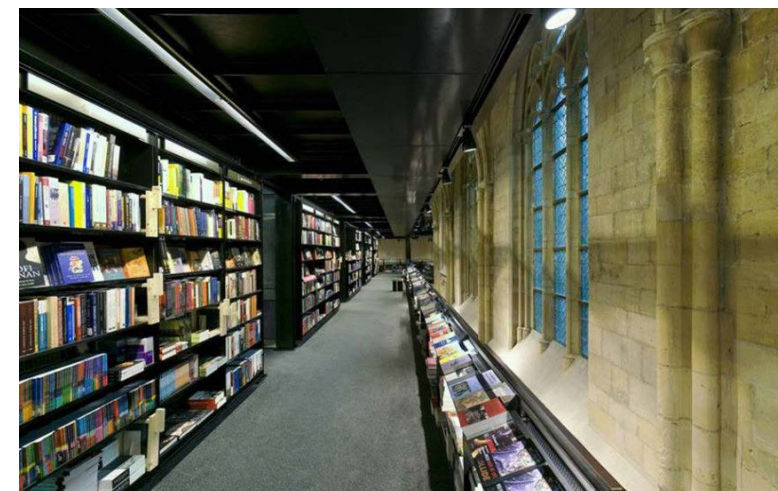
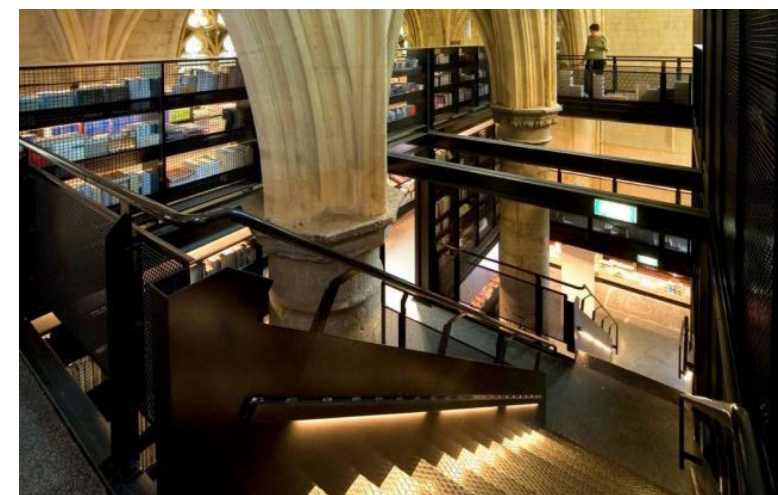
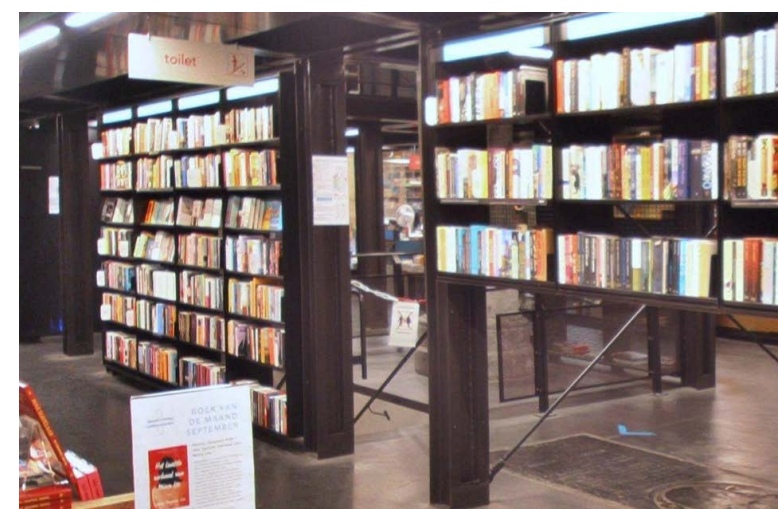
- **Shape** The columns are steel HEA profiles and thus are visual functional looking.
- **Material/Texture** The columns are made of steel and have a smooth surface, this is a contrast with the columns of the church.
- **Color** The columns are black, this color is nowhere to be found in the existing building.

- **Rhythm** The floor and railing itself follow the rhythm of the structure
- **Detailing** The detailing is very sleek and smooth in contrast with the ornamental detailing of the church. The only detail is the handle on the railing and the perforated panels.

- **Rhythm** The columns are much like the bookcases placed within the same rhythm as the church.
- **Detailing** The detailing is very sleek and smooth in contrast with the ornamental detailing of the church

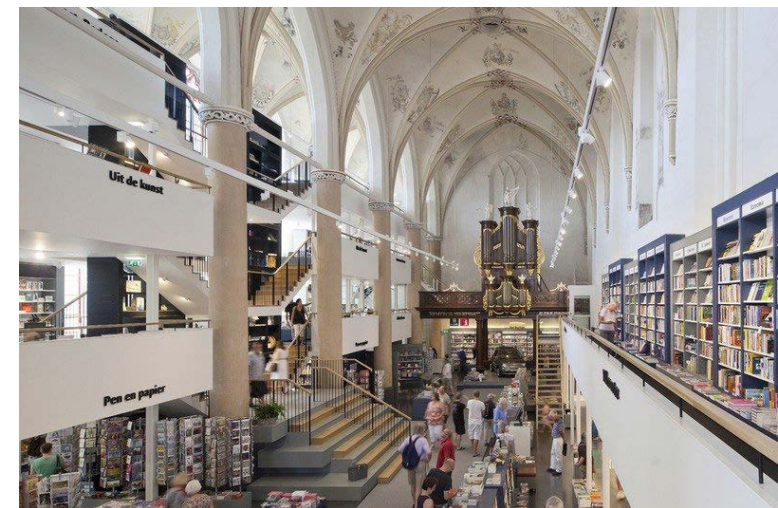
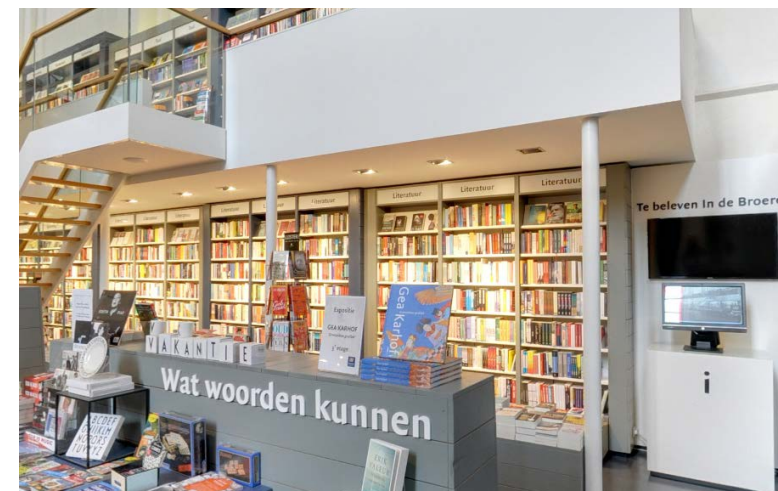
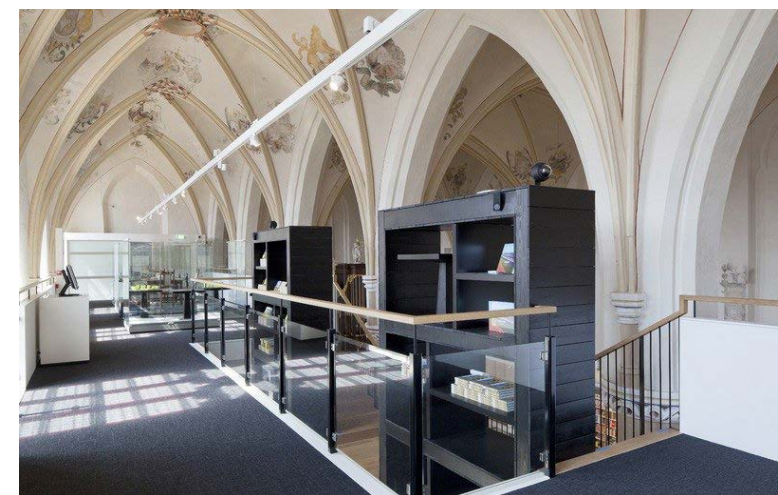
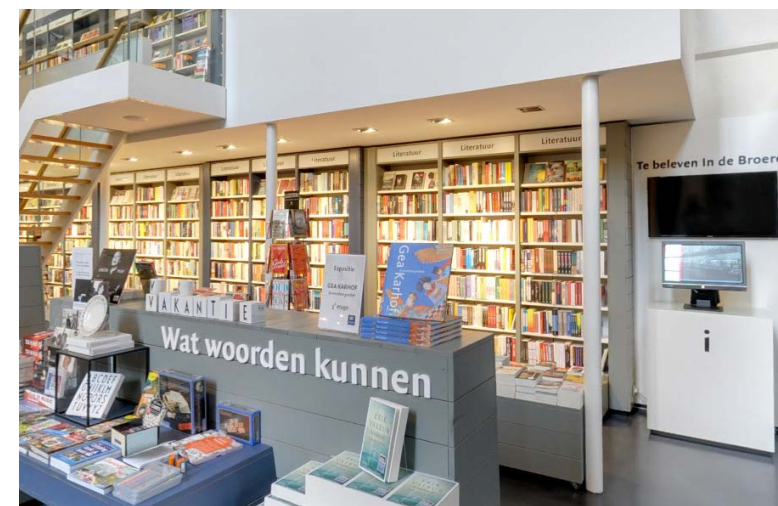
- **Rhythm** The floor and railing itself follow the rhythm of the structure
- **Detailing** The detailing is very sleek and smooth in contrast with the ornamental detailing of the church. The only details are the handle on the railing and the steel posts in some of the railings.

- **Rhythm** The columns are much like the bookcases placed within the same rhythm as the church.
- **Detailing** The detailing is very sleek and smooth in contrast with the ornamental detailing of the church

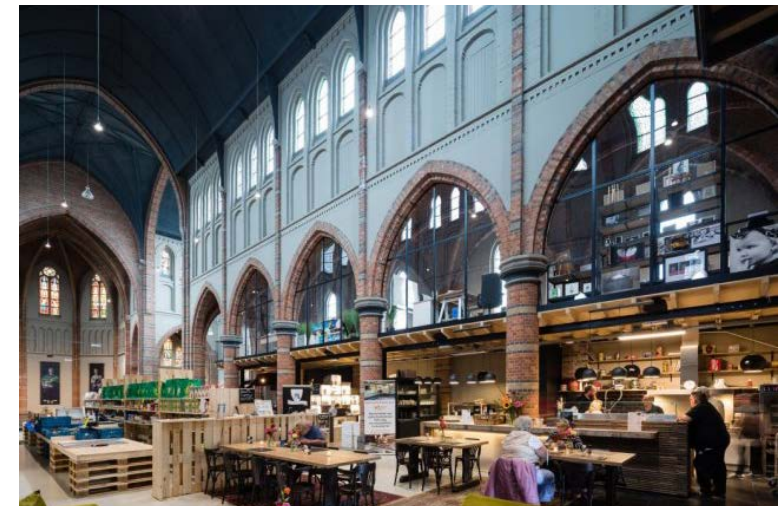
- **Shape** The shape of the whole intervention consists of an extra first floor in the side aisles of the church and new windows to separate this top space from the nave.
- **Material/Texture** The floors are made from wood, the construction of steel and the windows from aluminium and glass.
- **Color** The floors are from wood and are not treated. The steel is black

- **Rhythm** The floors follow the shape of the side aisles, as well as the windows and construction.
- **Detailing** The detailing is very minimalistic and modern. In contrast with the ornamental detailing of the church.

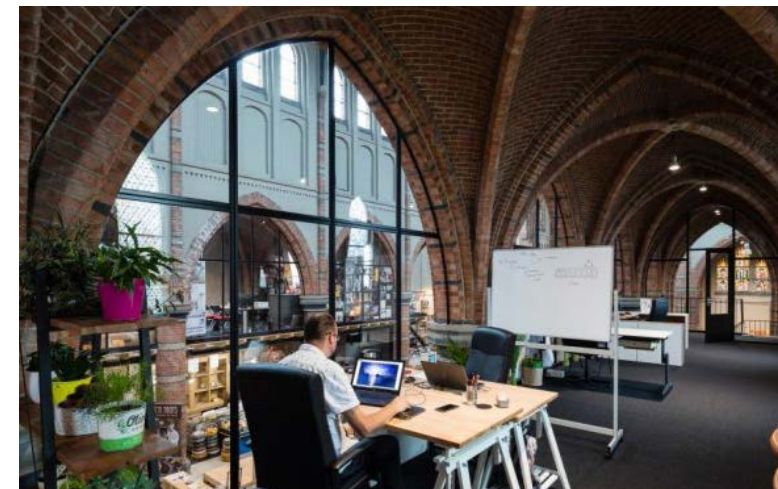
Element: Windows

- **Shape** The windows follow the shape of the arches that separate the side aisles from the nave, on the bottom, they are attached to the floor
- **Material/Texture** The windows are from aluminium with glass, they have a smooth texture
- **Color** The color of windows is black, a contrast with the rest of the church

- **Rhythm** The windows follow the rhythm of the arches of the church. There is continuity.
- **Detailing** The detailing is very sleek and smooth in contrast with the ornamental detailing of the church

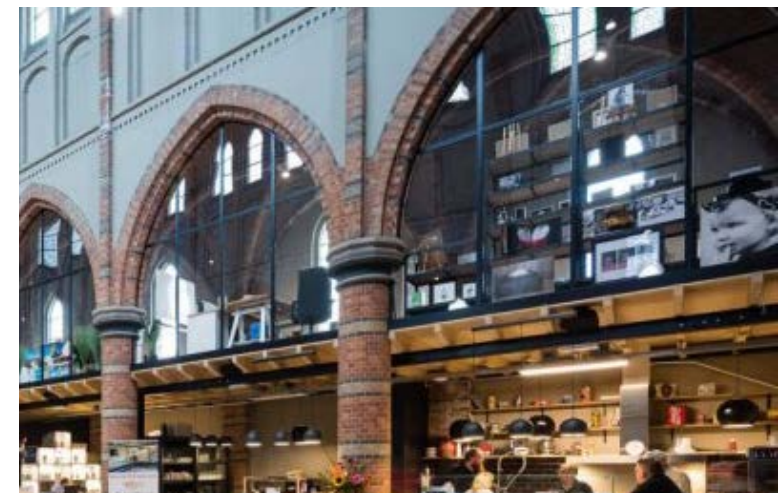
Element: Floor

- **Shape** The added floors are located in the side aisles and you can see the beams and floor plates.
- **Material/Texture** The floors are made from untreated wood with a carpet finishing.
- **Color** The wood is untreated, the wood texture is visible. The carpet is black, both a contrast with the existing.

- **Rhythm** The two floors follow the shape of the side aisles, the rhythm of the church is still good visible.
- **Detailing** The detailing of the floors is basic. The floor beams and wooden plates are visible from the bottom.

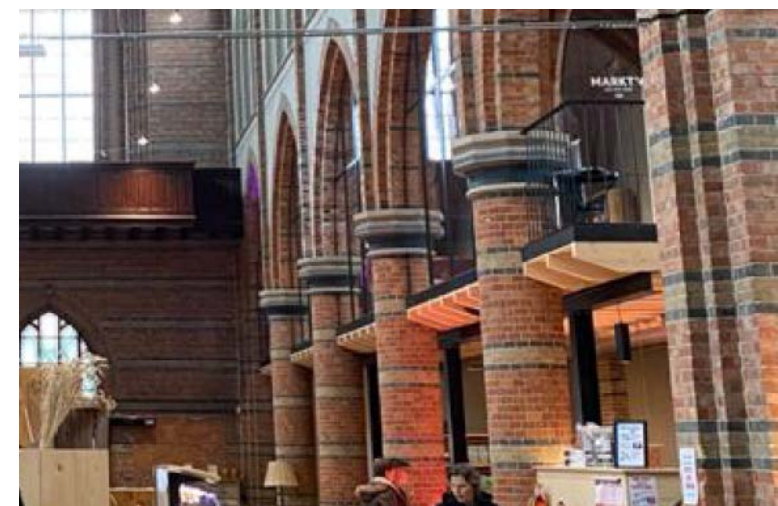
Element: Columns and structure

- **Shape** The columns and beams that carry the floor are square shaped. A contrast with the existing church.
- **Material/Texture** The columns and beams are made from steel. A material not used in the church before.
- **Color** The columns and beams are black, a contrast with the church.

- **Rhythm** The columns are placed behind the existing columns of the church and thus follow the rhythm of the church. The beam is also located there.
- **Detailing** The detailing is very sleek and smooth in contrast with the ornamental detailing of the church

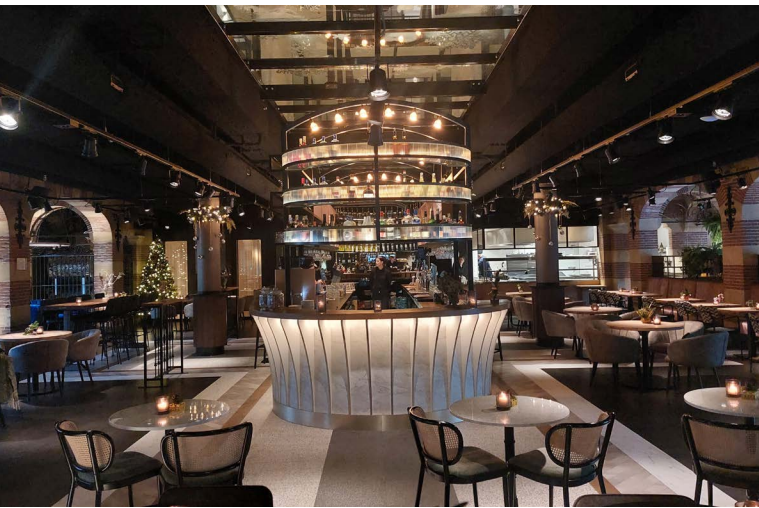
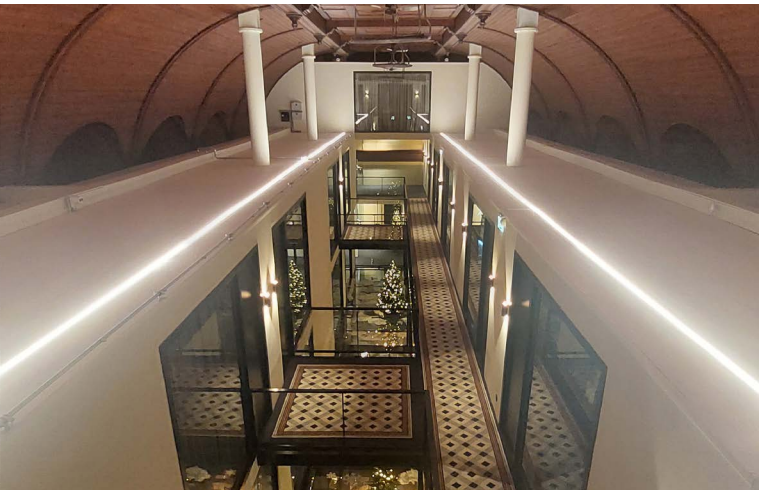
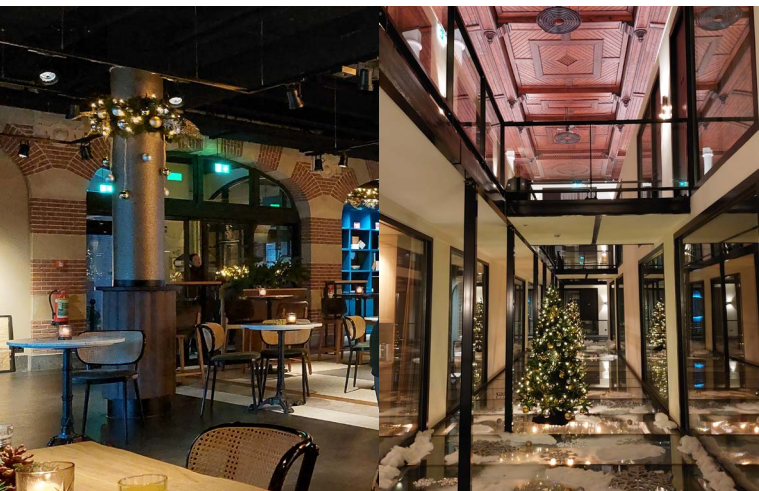
- **Rhythm** The hotel rooms are located on the first and second floor, they ignore the rhythm of the church
- **Detailing** The hotel rooms have a clean detailing in contrast with the ornamental detailing of the church

- **Rhythm** The columns follow the new added elements and ignore the existing rhythm
- **Detailing** The detailing is very sleek and smooth in contrast with the ornamental detailing of the church

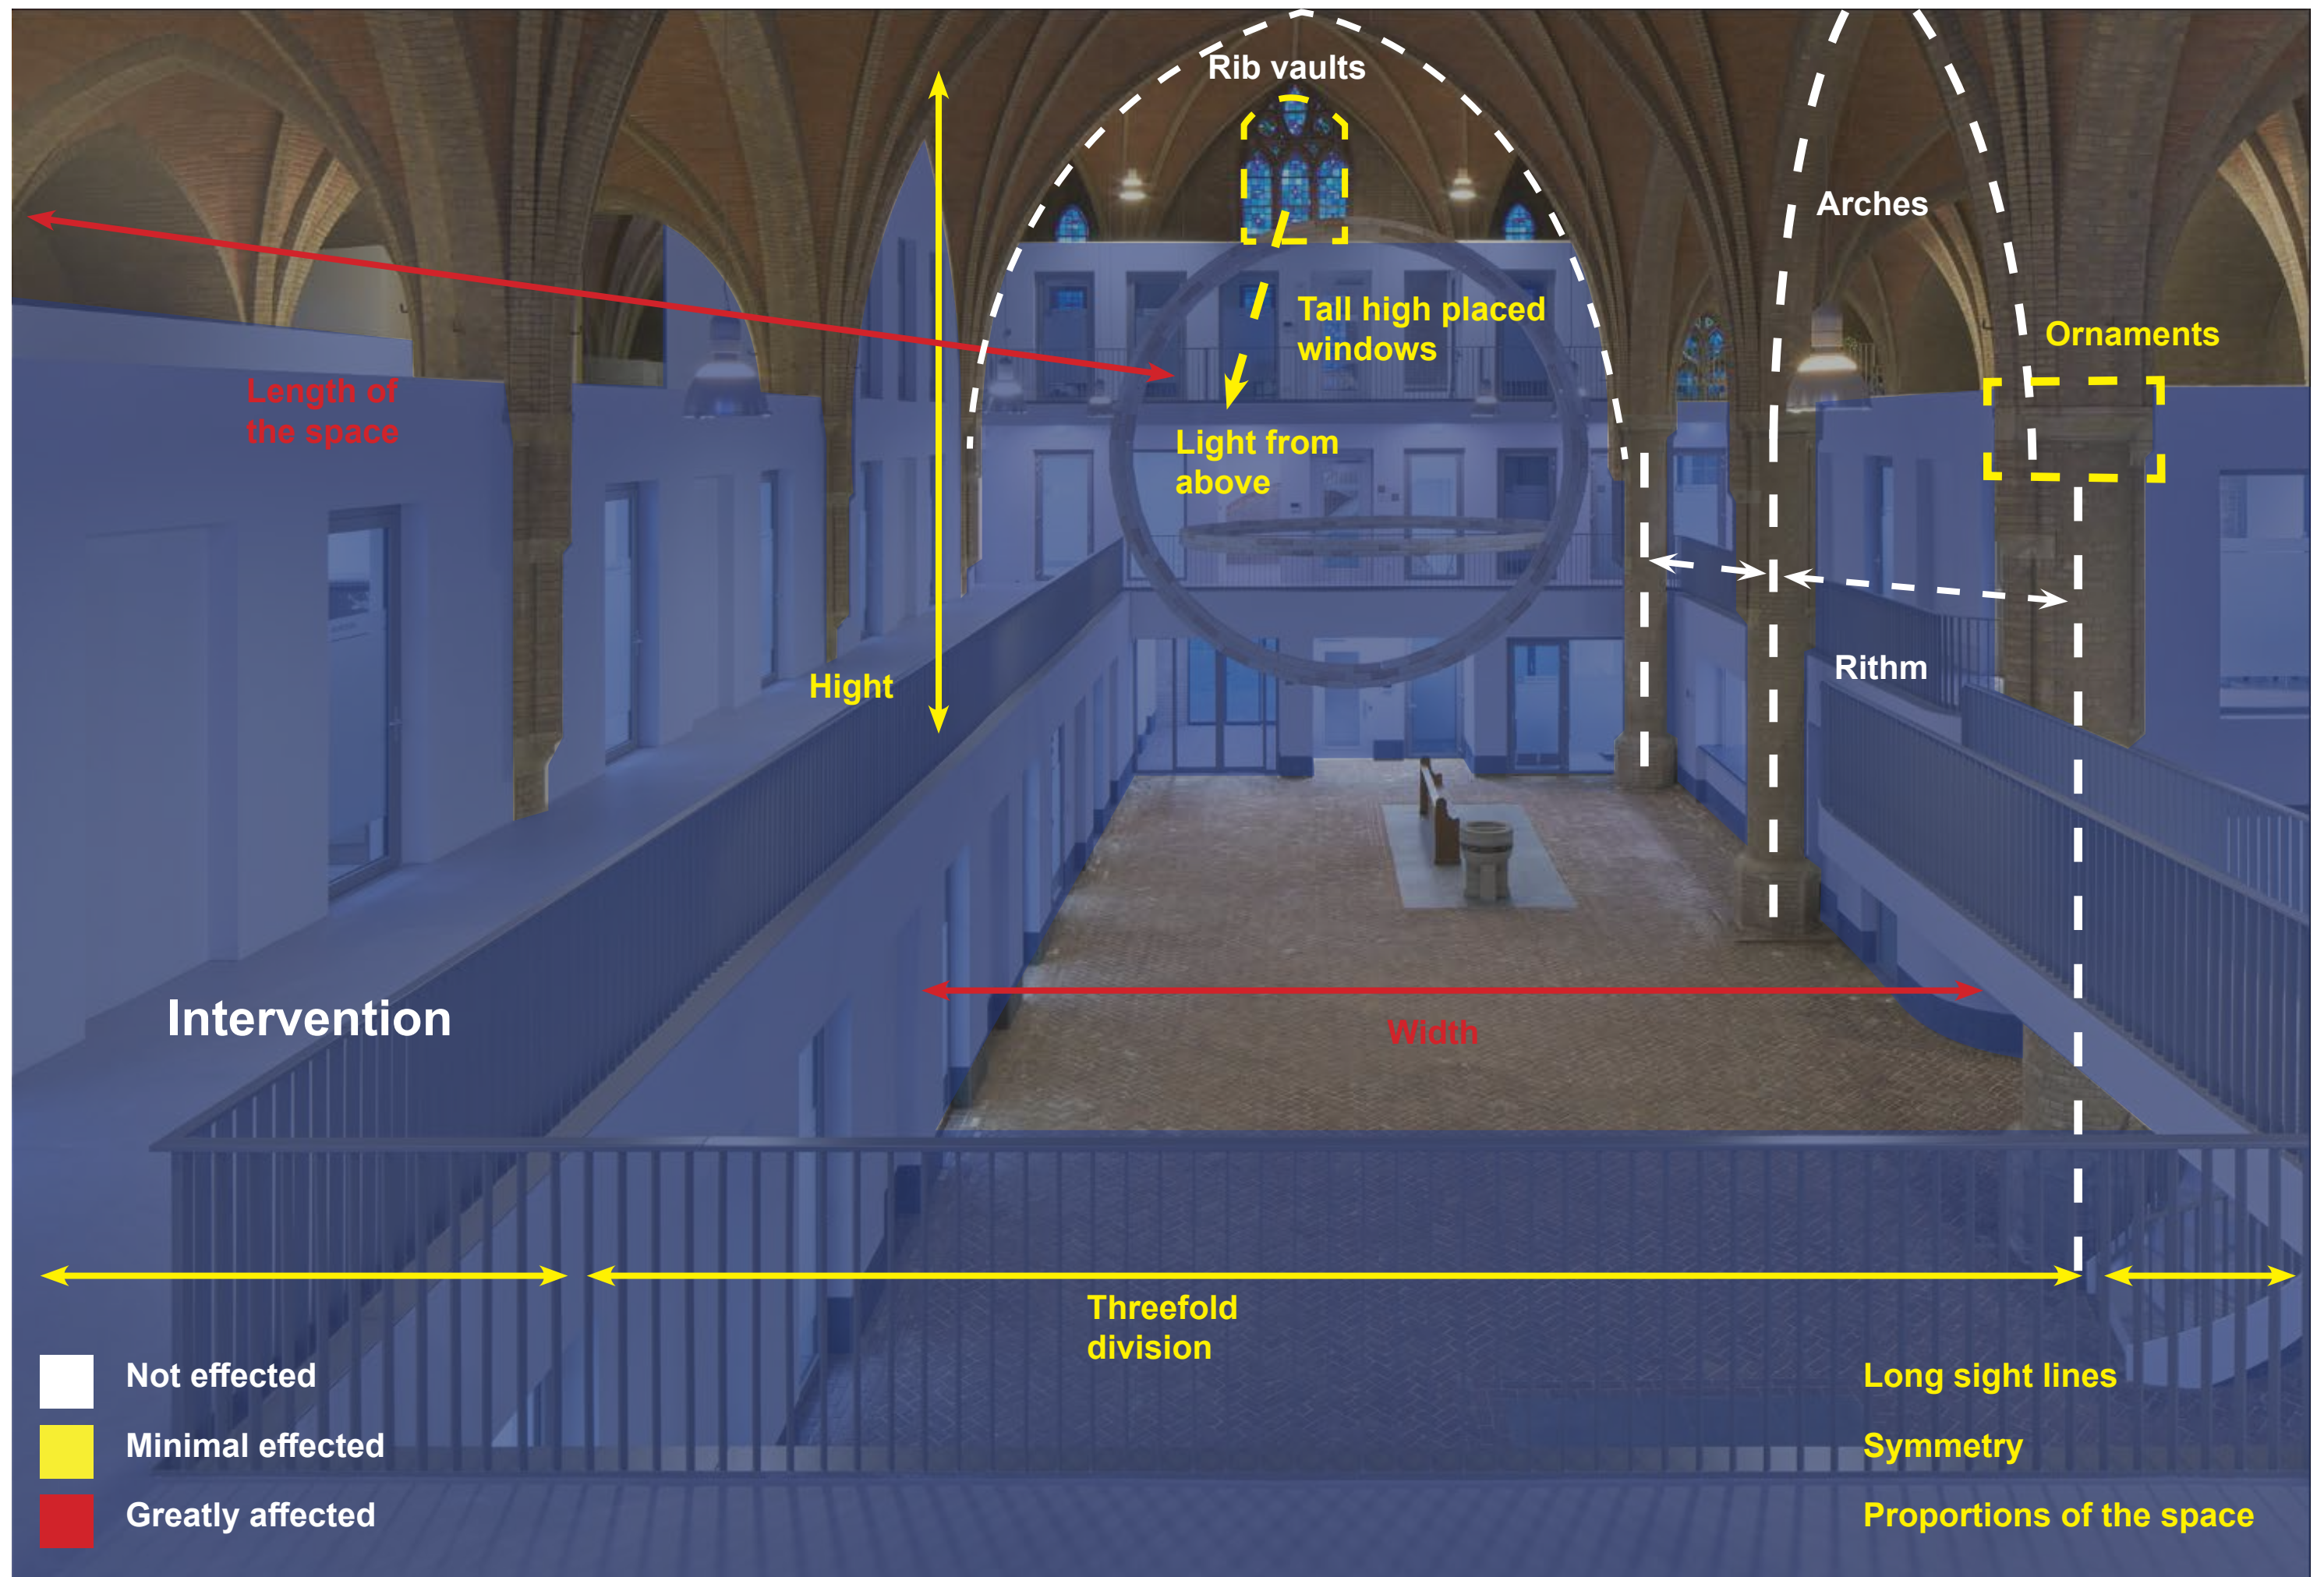
Image 18

Spatial solutions used:

7. Lines of sight preserved (partly fill)

Attributes defining the spatial quality in Neo Gothic churches			
Attribute	Is the attribute affected by the Intervention?	Effect	Which type of intervention caused this effect?
Dimensions of the space			
Height	minimal	The height of the space is affected mostly in the side aisles but also partly in the nave at the front and back where additional rooms have been added and the added galleries that are made in the nave.	7. Lines of sight preserved (partly fill)
Width	yes	The width of the space is made smaller because of the added rooms on the side. There is only a small open space in the middle now.	7. Lines of sight preserved (partly fill)
Length	yes	The length of the church has also been affected with new additions on the front and back.	7. Lines of sight preserved (partly fill)
Threefold division	minimal	The threefold division is still there and is still noticeable but less obvious.	7. Lines of sight preserved (partly fill)
