APPENDIX L

FAILURE MECHANISMS AND PROTECTION OF DIKE SLOPE AND DIKE TOE

L.1 Principal mechanism of sea dike and revetment failure in Vietnam

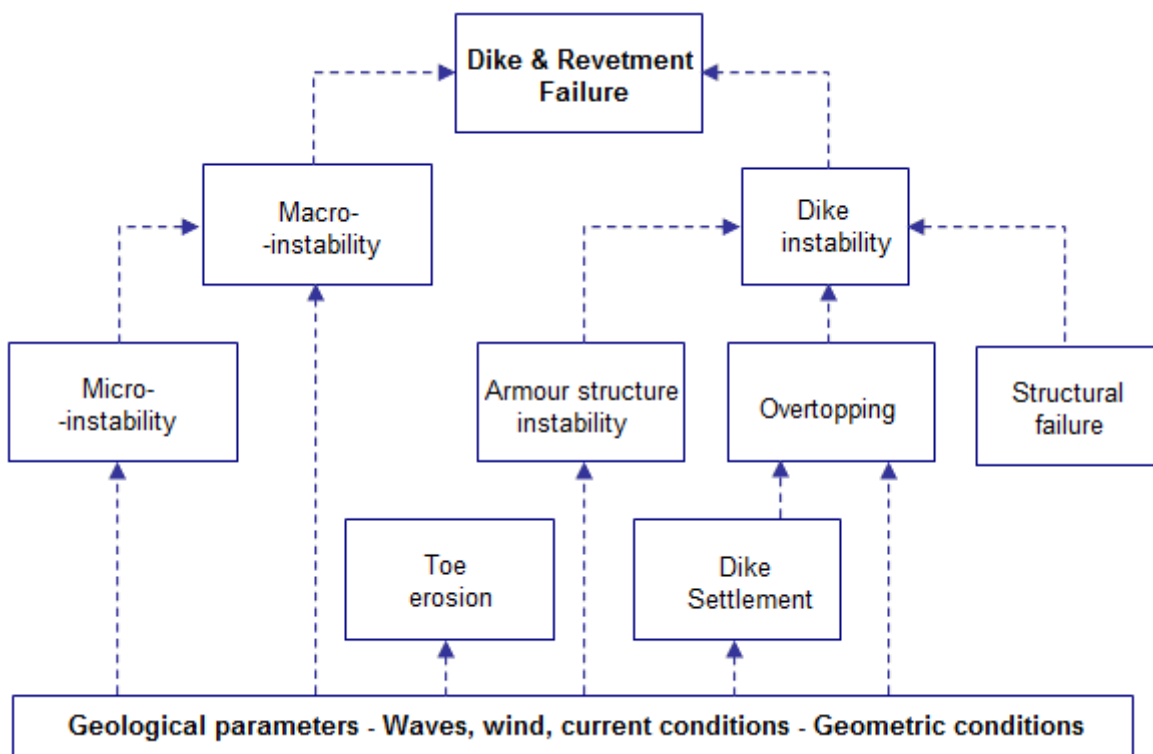
Figure L-1. *Diagram of dike & revetment failure*

Fig. L-1 illustrates common failure mechanism for sea dikes. Note that the occurrence of a certain mechanism will sequentially result in others, and consequently leads to dike breach. For example, the foreshore erosion or dike toe erosion will cause the instability of toe structures or dike toe. This instability will result in the instability and failure of the revetment if no remedial solutions are adopted. Consequently, under the impacts of waves, unprotected dike slopes will be eroded. The erosion continues until the dike body is entirely destroyed, leading to dike failure.

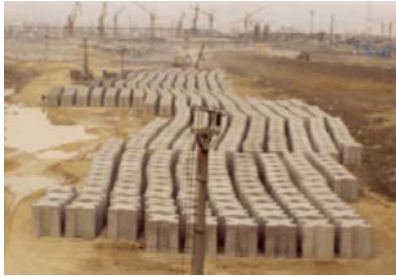
(a) Notched faces concrete blocks (Empty Block)

Figure L-7 Some types of precast concrete slope armour elements with self-joining and array-linking patterns

Fig. L-7, L-8 and L-9 illustrate some types of precast concrete slope armour elements with self-joining and array-linking patterns and their common specifications.

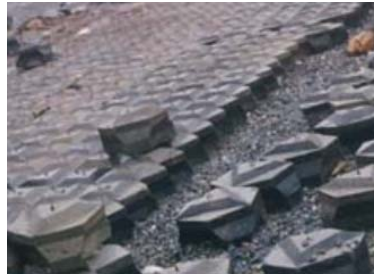
(b) TSc-178 blocks

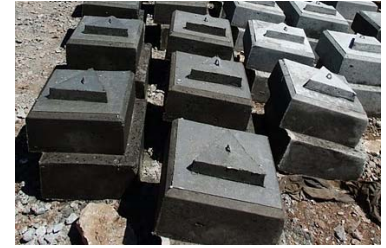
(c) Rectangular blocks with positive-negative joining pattern

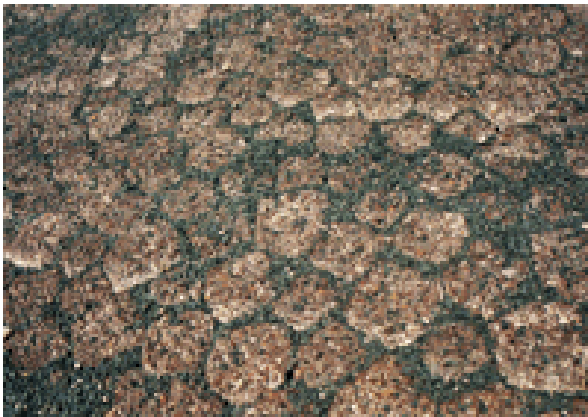
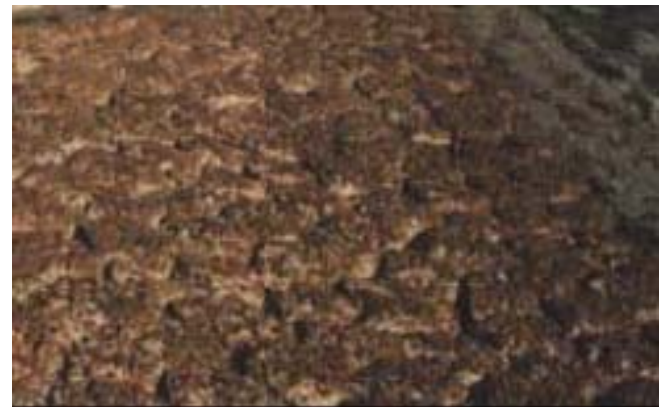
Figure L-12 Basalton-ECO[®] blocks

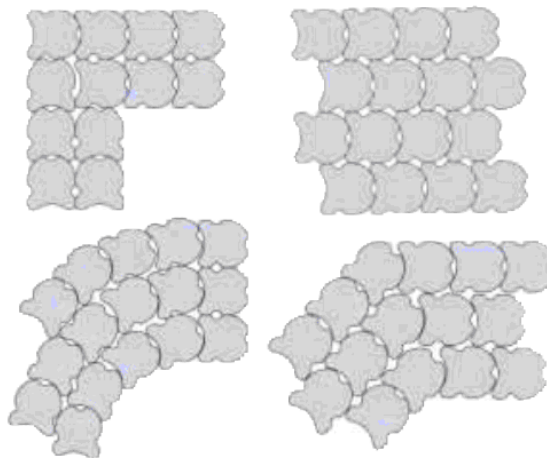
Figure L-13. *Linking patterns of Hydroblock®*

Hydroblock[®] is another typical type of precast column-typed concrete blocks, also includes 2 common types: standard Hydroblock[®] and Hydroblock-ECO[®] (see *Fig. L-13*).

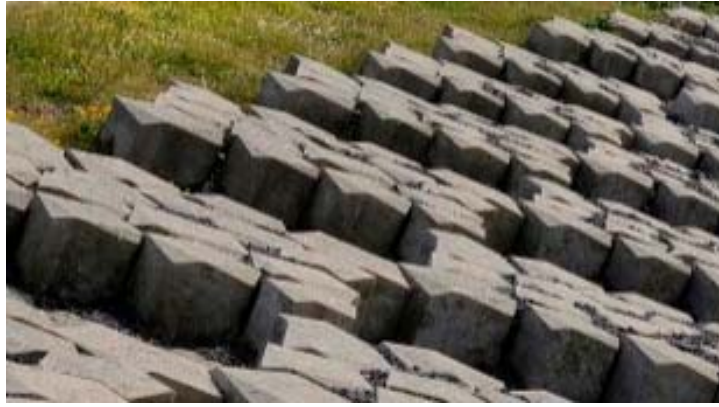
Figure L-14. *Discontinuous placement of Basalton® on dike slope*

In fact, blocks of this type can be arranged discontinuously on dike slope in order to give the best efficiency of wave run-up attenuation and wave energy decay (see **Fig. L-14**).

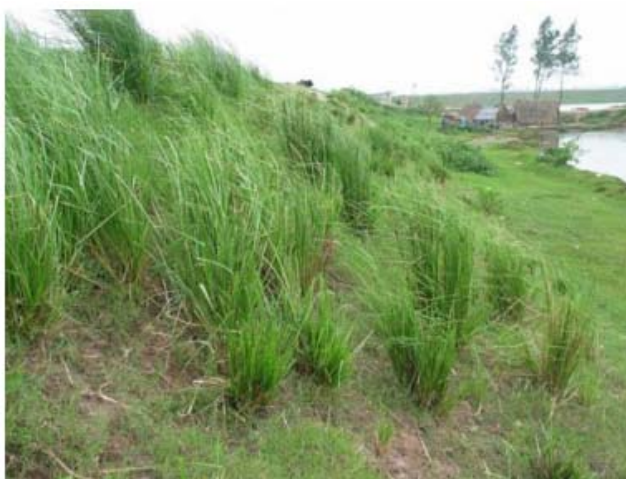
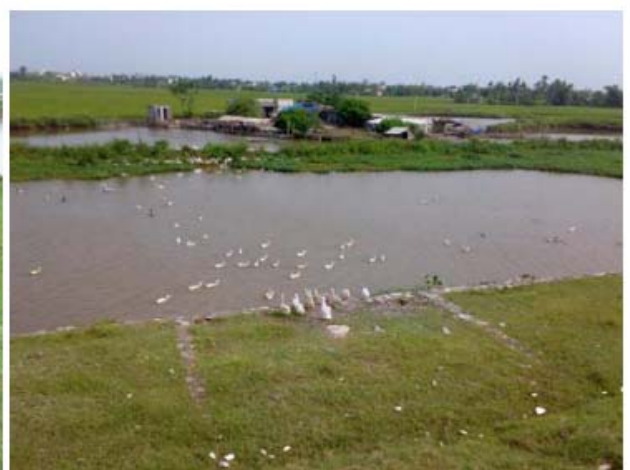
Figure L-15. Types of inner dike slope protection. Left: Vetiver planted on inner dike slope with no structural toe protection. Right: grass planted in grouted stone framework, dike toe is protected by grouted stone longitudinal beam.

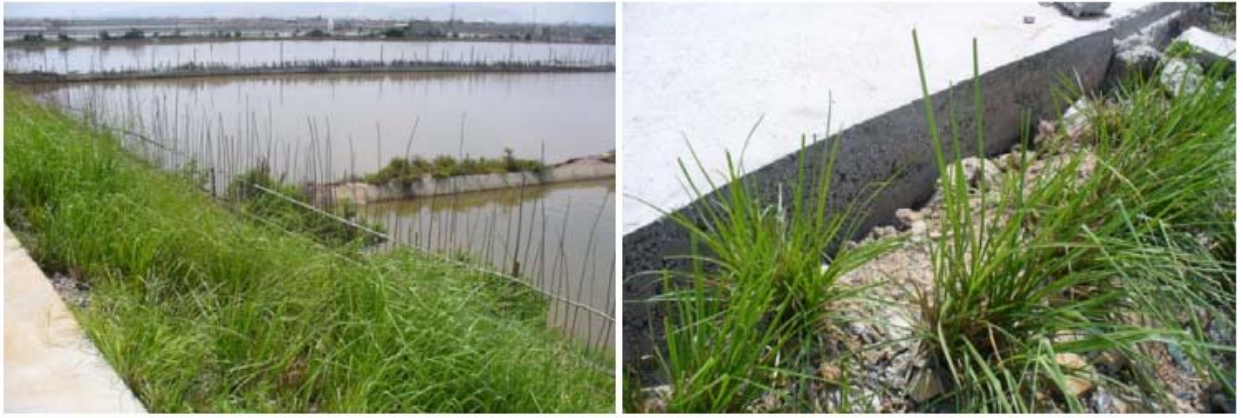
Figure L-16. *Types of inner dike slope protection using grass layers and steel sheet piles*
