# Estimating the (remaining) service life of timber bridges with the use of factor methods

And incorporating these methods in the calculation of the total costs of ownership

to obtain the degree of Master of Science  
at the Delft University of Technology,  
Faculty of Civil Engineering and Geosciences,

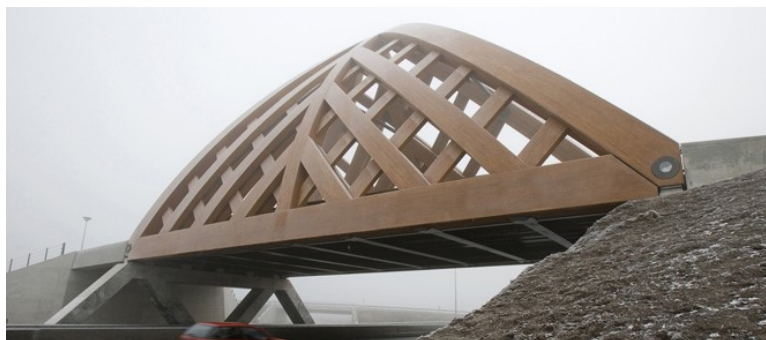
Figure 1.1: One of the two timber traffic bridges in Sneek [1]

Despite this current trend it can however be expected that in the near future we will also see a revival of timber as a construction material in bridge constructions. Rijkswaterstaat, the organisation responsible for the Dutch infrastructure and waterways, is currently investigating the application of more timber in the Dutch road- and waterworks [3]. Their intention of using more timber has for instance already led to the construction in 2008 of two timber traffic bridges crossing the N7 motorway in Sneek, see figure 1.1.

Another way of increasing the durability of wood is by modifying it. An example of this is the acetylated Acoya wood, which is used in the construction of two timber traffic bridges in Sneek, the Netherlands, see figure 1.1.

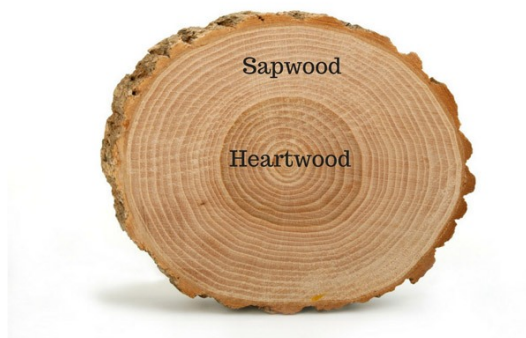
Figure 2.2: Cross section of a tree with a clear distinction between the darker heartwood and the lighter sapwood [21]

Within a tree itself wood can be divided into two zones: the heartwood and the sapwood. The heartwood, which is located in the centre of the cross section, generally only consists of dead cells while in the sapwood, the outer zone, also living cells are present. Heartwood can usually be distinguished from sapwood due to its darker colour, see figure 2.2. Within a tree the properties of the wood differ between the two zones, the natural durability of heartwood is usually much higher than that of sapwood for instance [1].

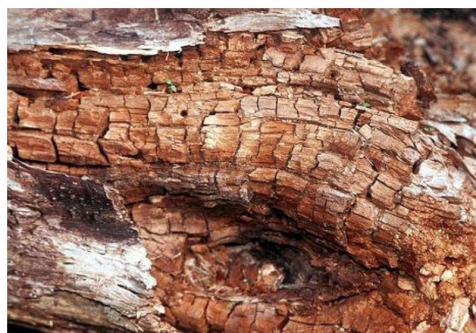
Figure 2.5: Typical example of wood degraded by brown rot [1]

Brown-rot fungi grow inside the cell cavities of the wood from where they predominantly break down the cellulose while they lignin stays more or less intact. Due to the cellulose breaking down the wood loses its strength and mass. It also gives the wood a dark brown colour and causes the wood to crack in a deep cubic cracking pattern, see figure 2.5. Most brown-rot fungi attack preferably softwoods, whilst hardwoods are more frequently attacked by white- and soft-rot fungi [1] [3].

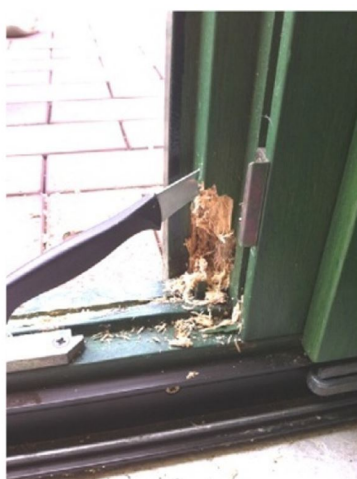
(a) White rot [3]

Figure 2.6: Examples of white- and soft rot

White-rot fungi degrade both the cellulose and the lignin in wood. Wood attacked by white rot has a bleached colour and becomes fibrous in texture, see figure 2.6a. In all white rot types, the wood strength properties are reduced to a lesser extent than in brown-rotten wood, since at the same mass loss, lesser cellulose is consumed, and it does not come to cracking or cubical rot [17].

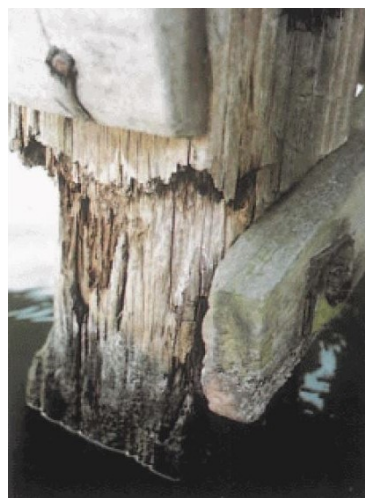
(b) Soft rot and its eroding effect [5].

The third type of rot, soft rot, degrades the cellulose, hemicellulose and the lignin inside the wood [17]. Soft rot often develops at wood that has a constantly high wetness, for instance around the water line of poles supporting bridges, see figure 2.6b. Soft rot often leads to erosion of the timber surface [5].

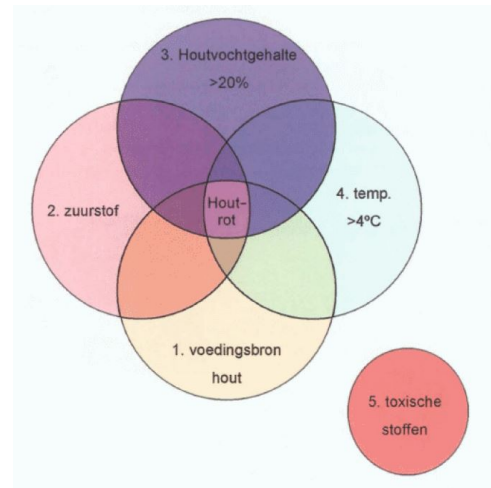
Figure 2.7: Conditions for the development of wood deteriorating Fungi [5].

In the Netherlands the main type of wood decaying organisms are different sorts of fungi. For these fungi to develop, the following five conditions need to be met [5]:

To prevent biological deterioration from developing only one of these five conditions needs be excluded. Conditions 1 and 4 cannot be prevented when using timber in the Dutch climate. Condition 5 is often made use of by impregnating wood with preservatives which contain substances that are toxic to the deteriorating organisms. Conditions 2 and 3 can be taken into account in the detailing.

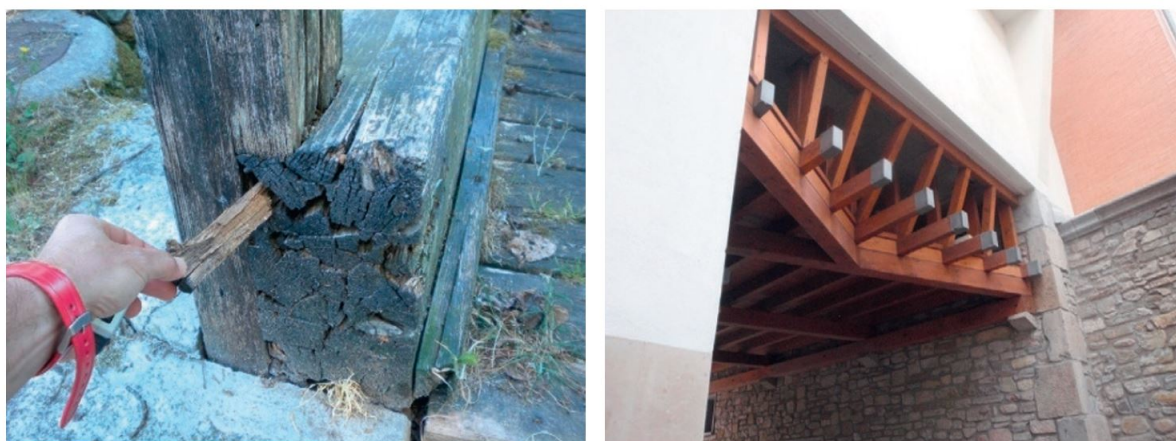
Figure 2.8: End grain protection. Left, timber bridge in Spain without end grain protection of severely decayed main beam. Right, end grain metal covers of projecting exterior beams. [2]

Water is particularly liable to infiltrate wood in the grain direction. An important protective measure is thus to cover the end grain surfaces so that no water can penetrate, see figure 2.8.

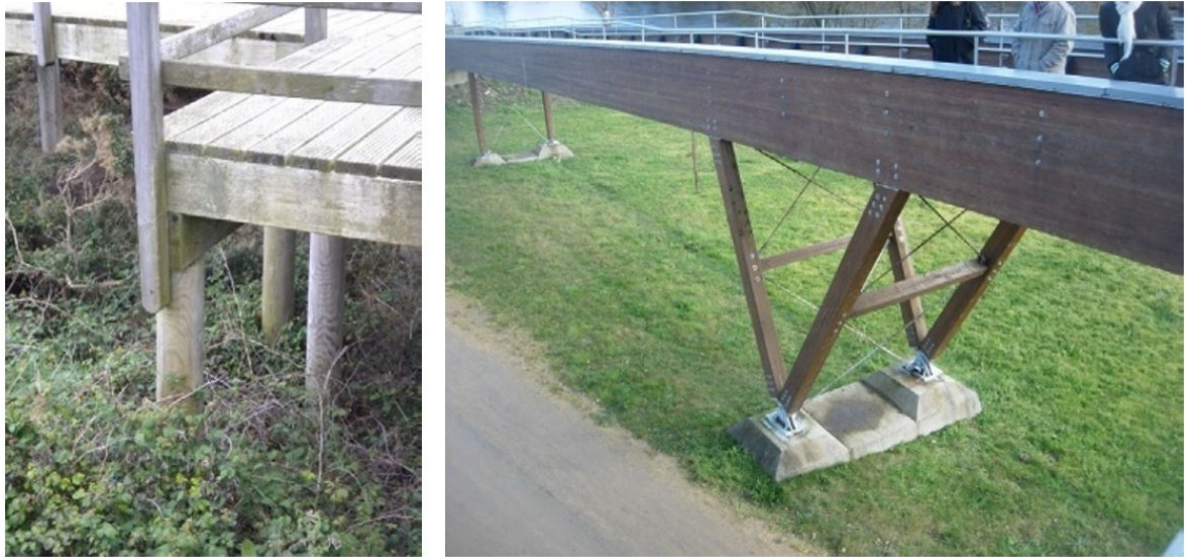
Figure 2.9: Protection from ground contact. Left, pedestrian bridge with pillars in direct contact with ground. Right, pedestrian bridge in Galicia, Spain, with concrete fundamentals and loadbearing pillars separated from the ground. [2]

Timber should be isolated from the ground and from moisture retaining materials or wet surfaces by either an impermeable damp proof membrane or, preferably, by providing sufficient air gaps to prevent absorption or capillary action [18]. Examples shown in figures 2.9 and 2.10.

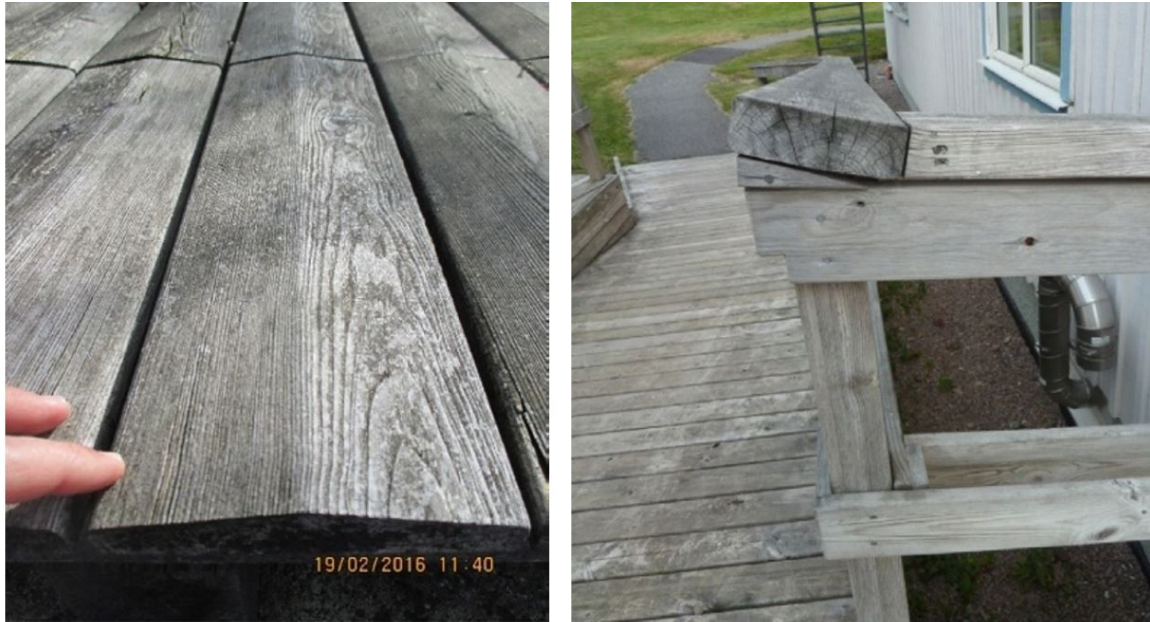
Figure 2.11: Water draining and avoidance of water trapping. Left, decking with good details design to allow dripping rainwater and space between two boards to avoid water accumulations. Right, hand rail in Kristineberg, Sweden: Declined surface but gap between two elements with potential for water trapping. [2]

- Sufficient slope to horizontal surfaces to prevent water lying on the surface.
- Drainage to ensure that junctions between exposed components and connections do not become water traps

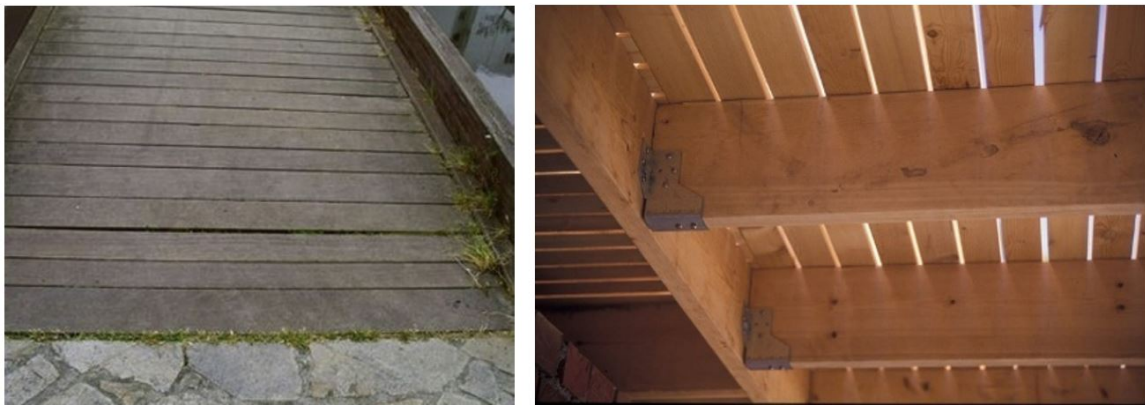
Figure 2.12: Protection from water accumulation. Left, decking with no correct design due to contact board to board. Right, decking well designed thanks to a good separation between boards that avoid water accumulations. [2]

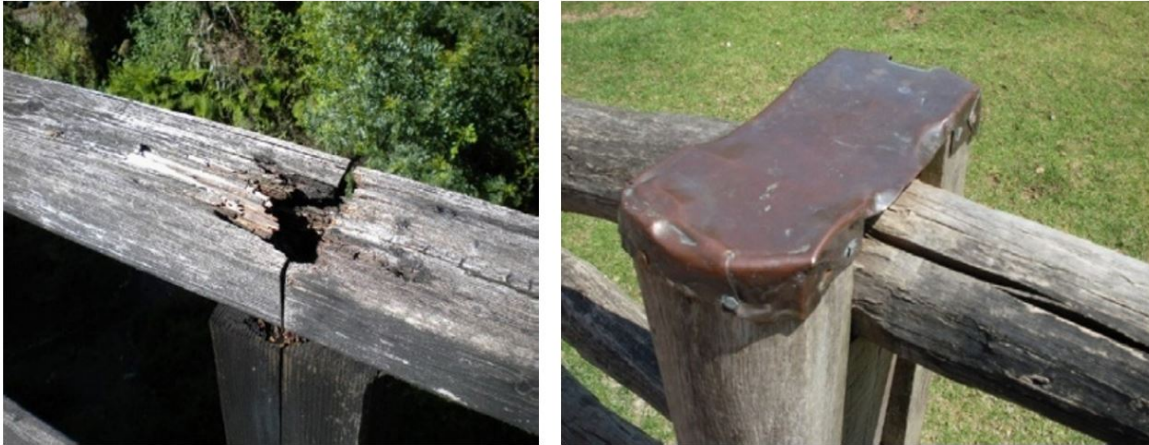
Figure 2.13: Effect of covers. Left, end grain joint on railing without cover protection. Right, fence post with traditional copper cover to protect joint area. [2]

Protecting the timber from wetting can for instance be achieved by placing (metal) covers on top of beams like in figure 2.13. Wetting of the timber can also occur due to splashing, of which an example is shown in figure 2.14.

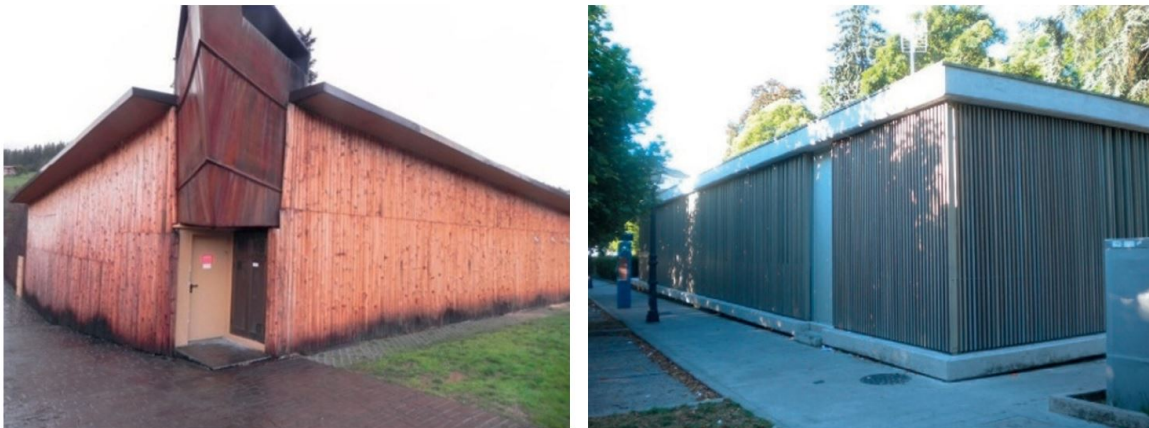
Figure 2.14: Protection from splash water. Left, wetting of cladding made from thermally modified wood in north Spain due to splash water — growth of moulds and disfiguring fungi. Right, cladding in north Spain with correct detail design to avoid splash water. [2]

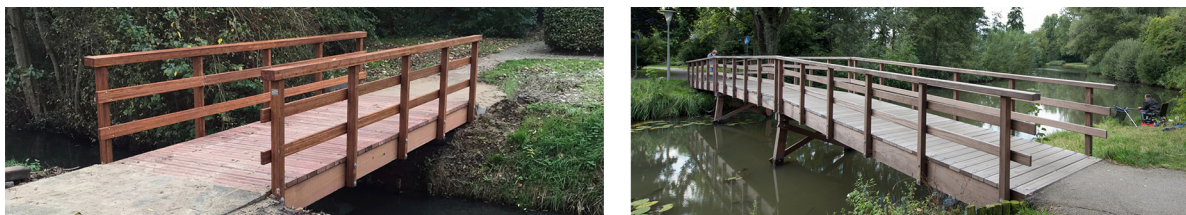
Figure 3.1: Two examples of beam bridges, both located in Arnhem. A single span bridge (left) and a bridge with multiple spans (right) [8].

Beam bridges generally are the simplest and most common type of timber bridges [15]. For relatively small spans they usually consist of a number of longitudinal beams that are simply supported on both ends of the crossing. For larger crossings one or more extra intermediate supports might be needed, see figure 3.1. With beam bridges the deck is usually placed on top of the main beams and can thus, if designed properly, protect these main beams against weather conditions such as rain [9].

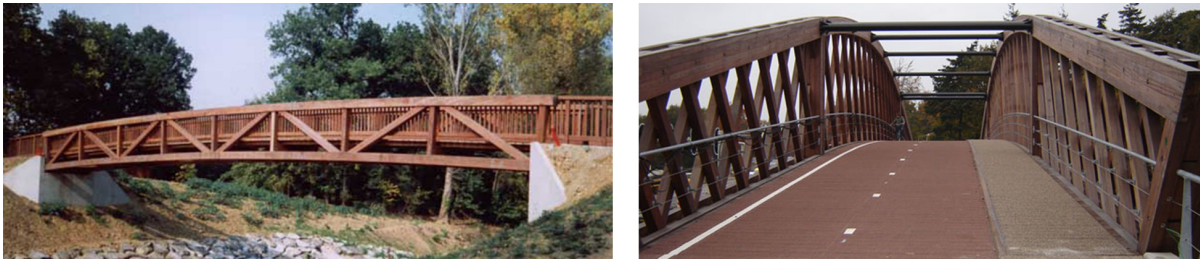
Figure 3.2: Two examples of truss bridges. In the left picture the deck is placed somewhere halfway the top and bottom chords. The right picture shows a timber bridge near Harderwijk where the deck is positioned at the bottom chord. Also noticeable here are the steel cross beams providing lateral stability to the top chord. [7].

The main structural system of a truss bridge usually consists of two trusses that are composed of a top and a bottom chord which are connected by diagonals and posts which leads to a lot of connection points. When placed above the top chord, the deck could protect the trusses against rain. However in most cases, where the clearance below the bridge is of importance, the deck is placed at the height of the bottom chord and thus provides no protection to the main load bearing elements, see figure 3.2.

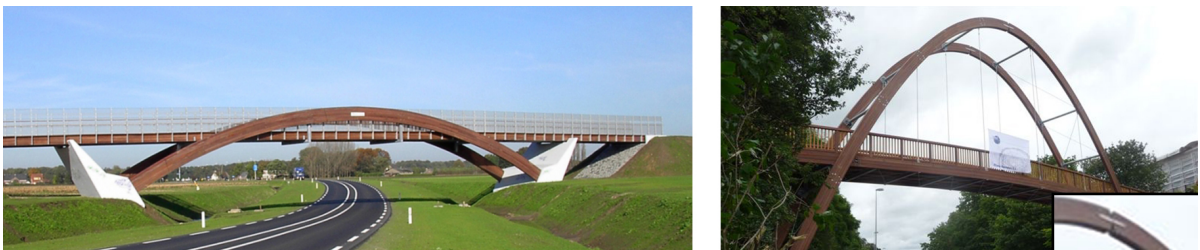
Figure 3.3: A bridge for pedestrians and cyclists consisting of two timber arches crossing the N18 at Lichtenvoorde (left) [8] and a timber arch bridge near Kopenhagen, Denmark (right) [20]. A close look at the connection at the top suggests that this is a three hinged arch.

Modern timber arches are usually made of glulam beams that are curved in the factory after which they are transported to the building site. The bridgedeck can be placed at the top or at the bottom of the arch, or somewhere in between. This choice is often dictated by the local environment of the bridge [14]. In the design of an arch bridge the choice is often made between a two hinged arch, with two hinged supports, and a three hinged arch with an extra hinge at the top [15], see figure 3.3.

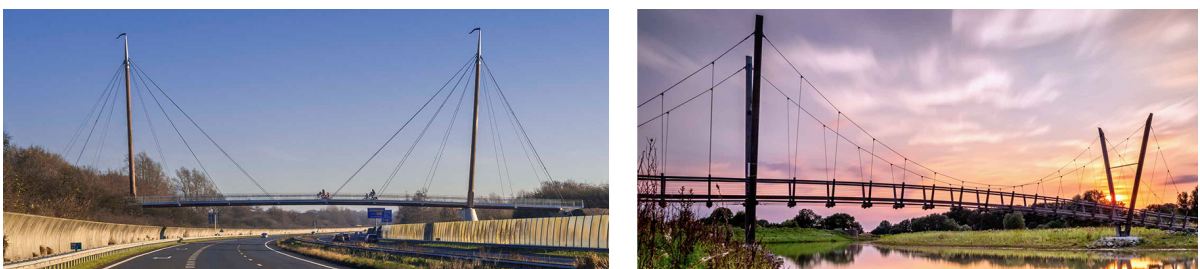
Figure 3.4: Timber cable stayed bridge at Harderwijk for cyclists and pedestrians (left) [20] and a timber suspension footbridge near Arnhem (right) [8].

Suspended bridges can be divided into two different types, namely the suspension bridge and the cable-stayed bridge, see figure 3.4. Although they are different types of load bearing systems they are both characterised by a deck that is supported by steel cables which transfer the forces to two or more towers or masts (for cable stayed bridges only one tower or mast could already be sufficient).

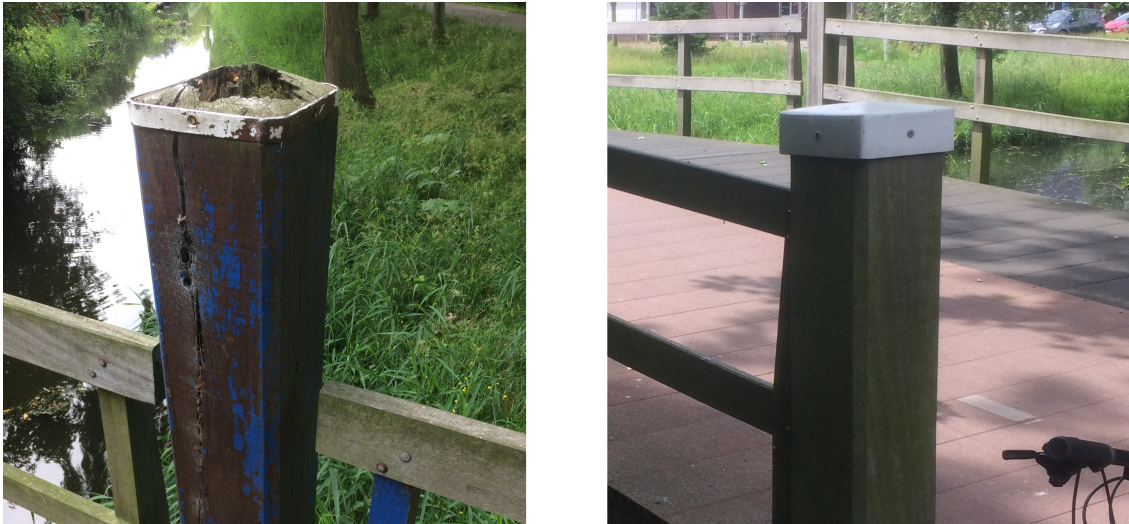
Figure 3.6: Left picture shows an example of a bridge post with unprotected end grain surface. On the right a similar bridge post is shown where the end grain surface is covered to prevent water adsorption. (Both bridges located in Pijnacker)

As already stated in section 2.6, an important aspect of protective design is the covering of end grain surfaces of beams and posts. Figure 3.6 shows two pictures of timber bridge posts, one with an open end grain surface and one with the end grain surface covered. The cover should still allow for ventilation of the end grain surface so that any water that gets trapped below is able to escape [5].

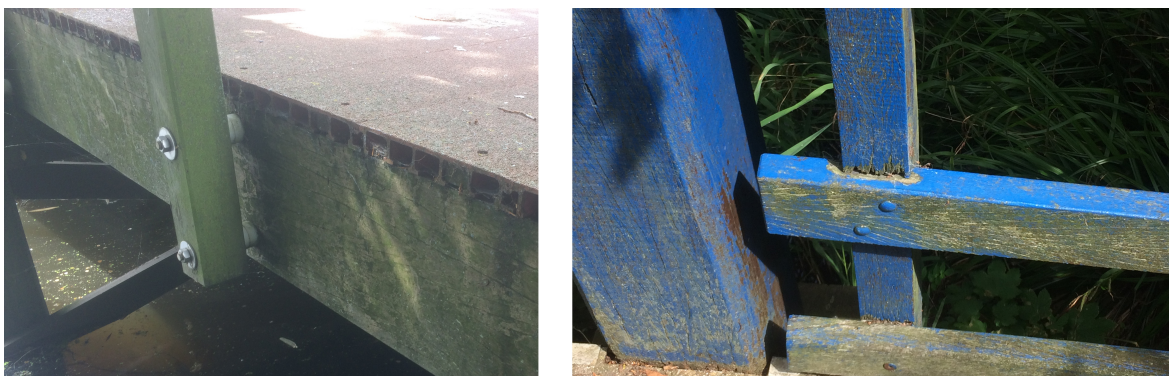
Figure 3.7: Left, railing joint usign spacers to create a gap between the railing post and main beam for drainage and ventilation. Right, railing joint susceptible for water trapping. (Both bridges located in Pijnacker)

Water getting trapped in capillary planes, like in figure 3.5 example 3, should be avoided. An example of how to avoid this is shown in figure 3.7 on the left. With the use of spacers between the two wood surfaces, water and dirt have no change of accumulating between the surfaces and it provides ventilation so that the wood dries faster when wet.

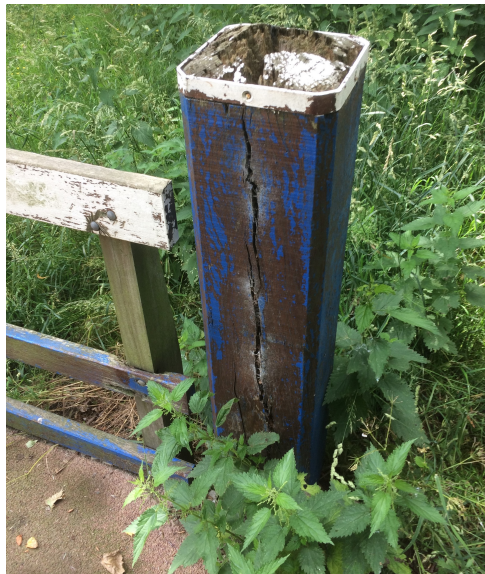
Vegetation on or close to timber elements leads to a long term high moisture content in combination with oxygen. These conditions, which are ideal for the development of fungi, lead to an accelerated deterioration of the timber close to the vegetation. Therefore a situation like in figure 3.8 should be avoided.

Figure 3.8: Example of vegetation growing around a timber pole

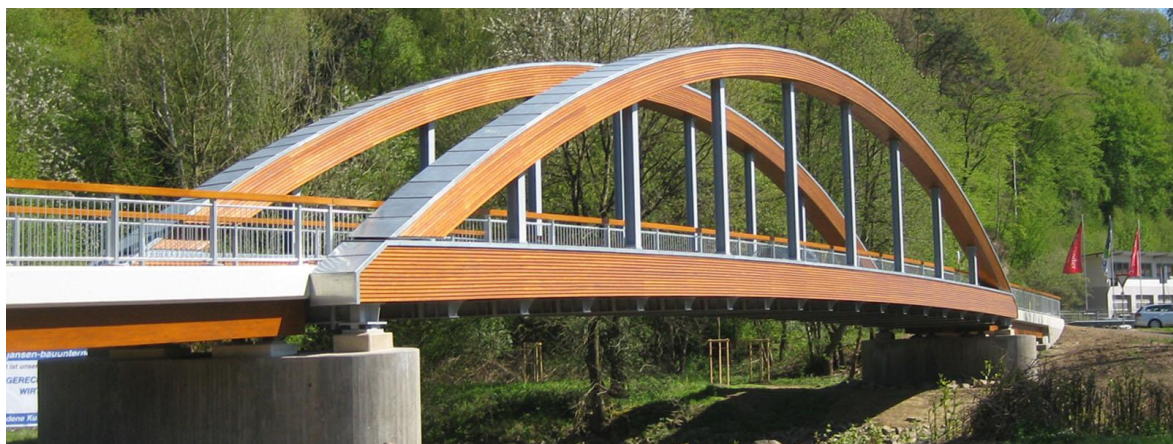
Figure 3.9 shows a timber bridge in Germany of which the main structural timber elements are completely covered. The top surfaces are covered with steel covers, while the sides are protected by timber cladding which, besides protecting it, also maintains the timber look of the bridge. This type of protective bridges are often found not only in Germany but also in Scandinavian countries. The protection ensures that the main timber elements can be made of timber species with a lower natural durability, such as some softwoods that are much found in these countries.

Figure 3.9: Fully protected timber arch bridge located in Lohmar, Germany, build in 2014. The main structural timber elements (arches and main girders made from glue laminated spruce) are protected by titanium zinc covers on top and cladding made from larch on the sides [16]

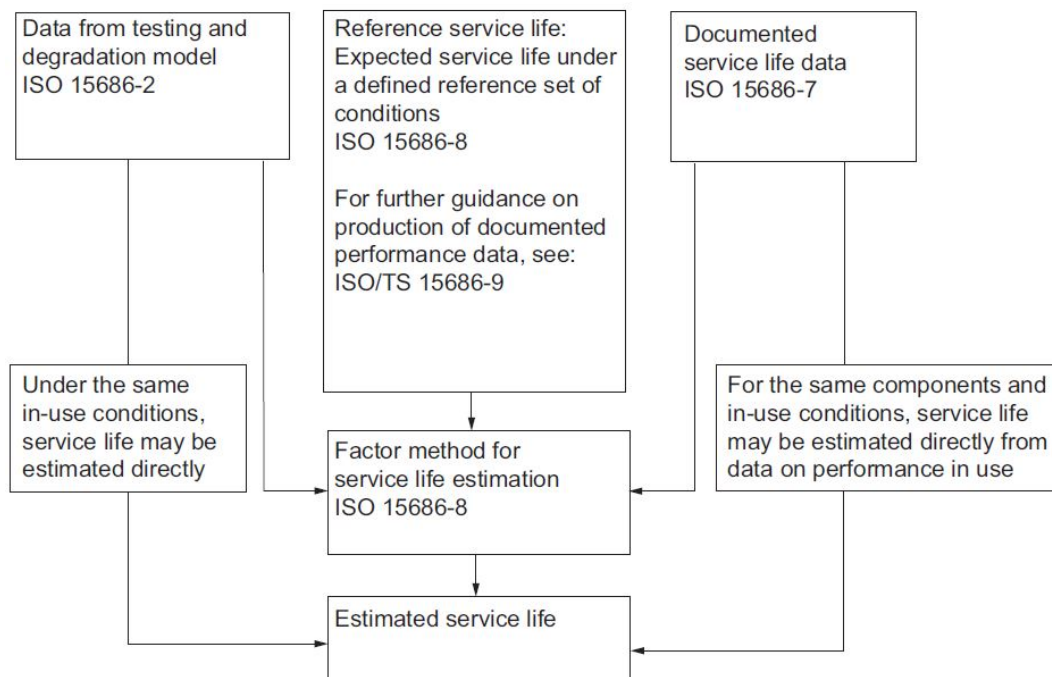
A general description of factor methods can be found in the NEN-ISO 15686 series, the Dutch publication of the international standard ISO 15686 "Buildings and constructed assets — Service life planning". This series discusses service life estimation as a part of the larger process of service life planning. The parts of the series that are involved in service life estimation are shown in figure 4.1.

Figure 4.1: Overview of the approaches to service life estimation as described in the NEN-ISO 15686 series. [13].

In an ideal scenario, the service life of a component is predicted by knowing the intended conditions (such as the microclimate), the performance of the component under these conditions, and the construction and maintenance routine. However this data is often not completely available and thus other sources need to be used as a basis of the service life prediction. These sources can for example come from testing (ISO 15686-2), from documented service life data (ISO 15686-7) or from a reference situation (ISO 15686-8), see figure 4.1.

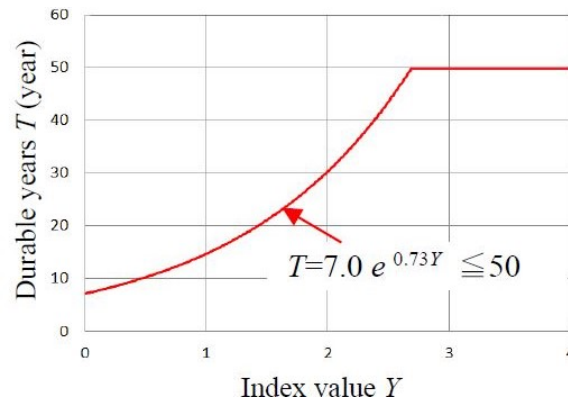
Honda and Araki found, after a first evaluation of 12 timber bridges, that the ESL prediction from formula 4.3 becomes off for bridges with a service life larger than 16 years. Therefore they proposed the following exponential function for the service life estimation with a maximum service life of 50 years, see also figure 4.2:

Figure 4.2: Estimated service life as a function of Y [4].

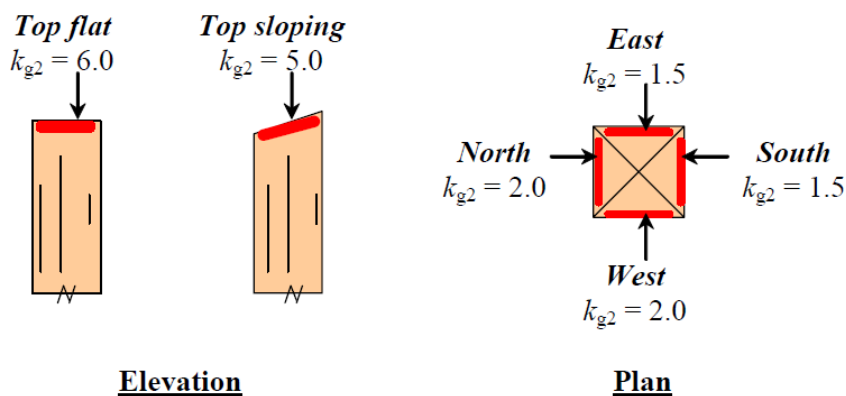
For vertical members the position factor  $k_{g2}$  depends on the orientation of the surface that is being assessed. The following six options are possible: (see also figure 4.8)

- Top (flat)  $k_{g2} = 6.0$
- Top (sloped)  $k_{g2} = 5.0$
- facing north  $k_{g2} = 2.0$
- facing south  $k_{g2} = 1.5$
- facing east  $k_{g2} = 1.5$
- facing west  $k_{g2} = 2.0$

*Non-contact surfaces - Vertical member*

Figure 4.8: The different orientations for factor  $k_{g2}$  for vertical members [21].

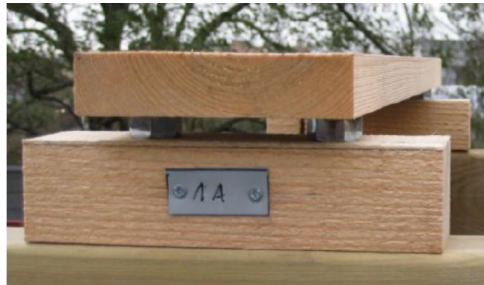
Based on field tests, the annual reference exposure dose has been determined for the reference object shown in figure 4.12. This reference object consists of a horizontally exposed Norway spruce board with no moisture traps. The annual reference exposure dose depends on the climate conditions of the region the bridge is located at. It is a function of the relative humidity, rainfall and temperature of the location. In the DuraTB project multiple ways of determining the exposure dose have been discussed. In the final report the exposure dose has been estimated with the help of the following simplified logistic dose model (SLM) described by Isaksson et al [6]:

Figure 4.12: Reference element for climate exposure – horizontally exposed spruce board without moisture traps [17]

- $D_{E0}$  is the annual reference exposure dose depending on the geographical location. The reference exposure dose is determined for a horizontal timber element exposed to outdoor conditions such as rain, relative humidity and temperature, see figure 4.12.
- $k_{E1}$  is a factor accounting for the effect of local climate conditions and driving rain.
- $k_{E2}$  is a factor accounting for the effect of sheltering.
- $k_{E3}$  is a factor accounting for the distance to the ground .
- $k_{E4}$  is a factor accounting for the effect of durable detail design.
- $c_a$  = 1.4, is a calibration factor estimated on the basis of reality checks, safety considerations and expert estimates.

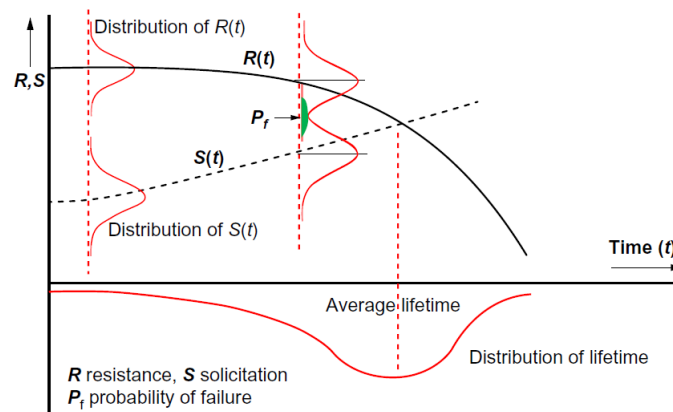
The distribution of  $Z(t)$  over time is shown in figure 4.15.

Figure 4.15: Lifetime distribution of structures [19]

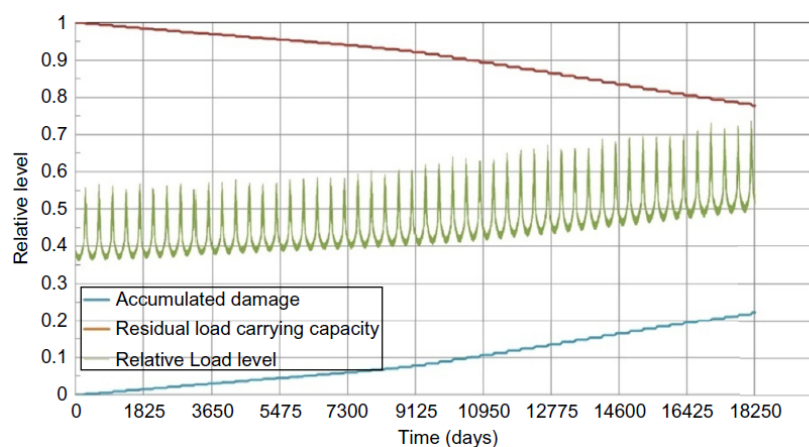
The method is applied by van de Kuilen and Gard to determine the service life of an outdoor glulam beam. Visual inspection of the beam showed that it suffered from fungi decay and delamination cracks. A linear exponential damage accumulation model is used to calculate the degradation due to the load effect, and an assumed constant decay rate is used to calculate the deterioration due to biological decay. One of the results is shown in figure 4.16.

Figure 4.16: Service life calculation for 50 years, load case 2 (dead load + live load + snow load) and biological deterioration 0.5 mm/year with a delay time of 5 years. [19]

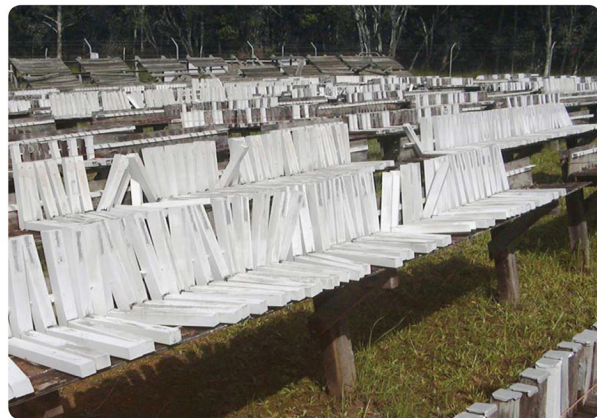
The first of these field tests consists of a series of L-joint tests initiated in 1987 and performed over a period of 20 years. The test objects were mortise and tenon L-joints as shown in figure 5.1. The tests were performed at 10 different test sites scattered over the east coast of Australia. Multiple wood species were tested. Nine reference species were tested at all 10 sites and 33 more species were installed at one specific site only. For each species, 24 painted and 24 unpainted replicates were installed at each site.

Figure 5.1: Dimensions of the L-joint test objects (left) and photo of one of the test sites (right) [21].

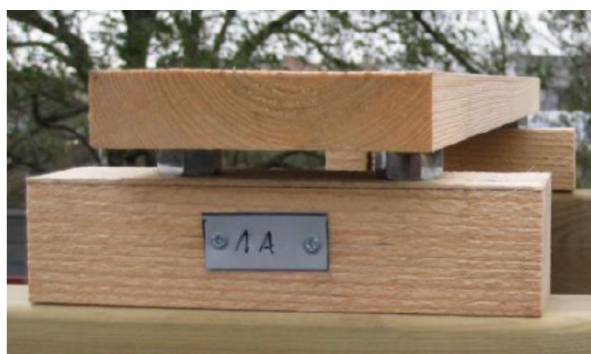
The tested elements were spruce boards, see figure 5.2.

Figure 5.2: Swedish reference situation, spruce board above ground contact.

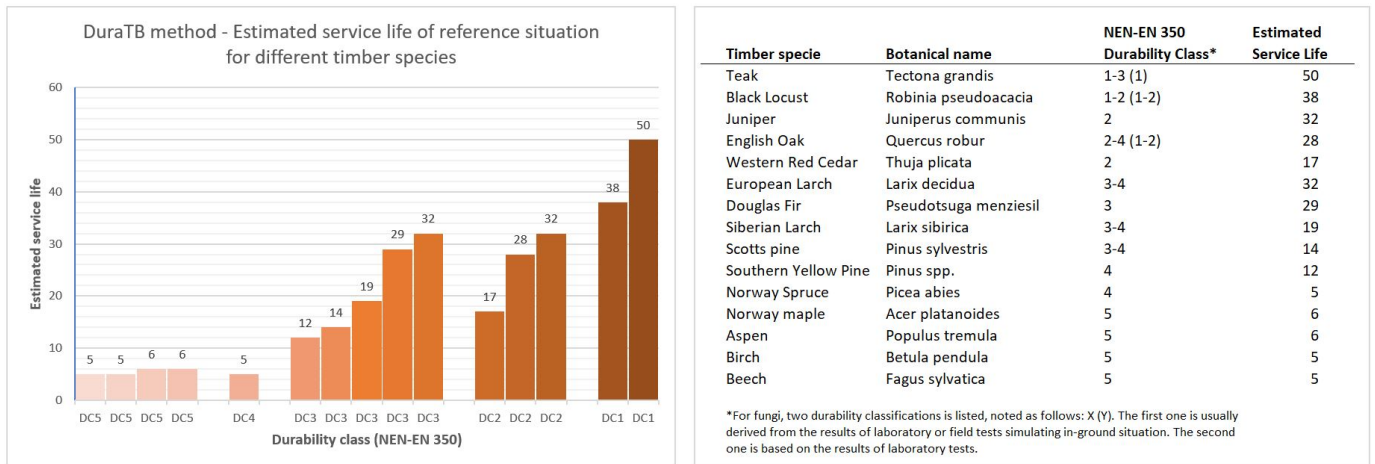
Figures 5.5 and 5.6 show the influence of the timber specie on the estimated service life.

Figure 5.5: Swedish DuraTB method: Influence of timber specie on the estimated service life for the reference situation. This service life corresponds to a rating of 1 (slight decay) on the 0 to 4 decay scale from EN 252, in the Swedish report labelled as 'the onset of decay'.

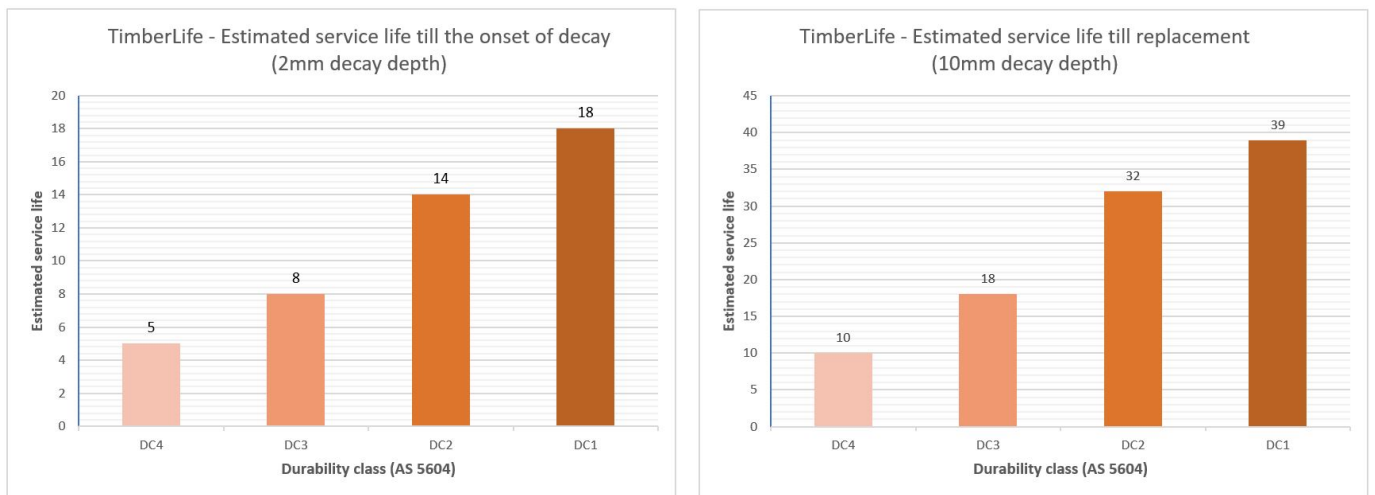
Figure 5.6: Australian TimberLife method: Influence of timber natural durability class on the estimated service life for the reference situation. This service life corresponds to a decay depth of 2 mm (left) and 10 mm (right) labelled as the onset of decay and moment of replacement. The 4 natural durability classes are conform the Australian standard AS 2

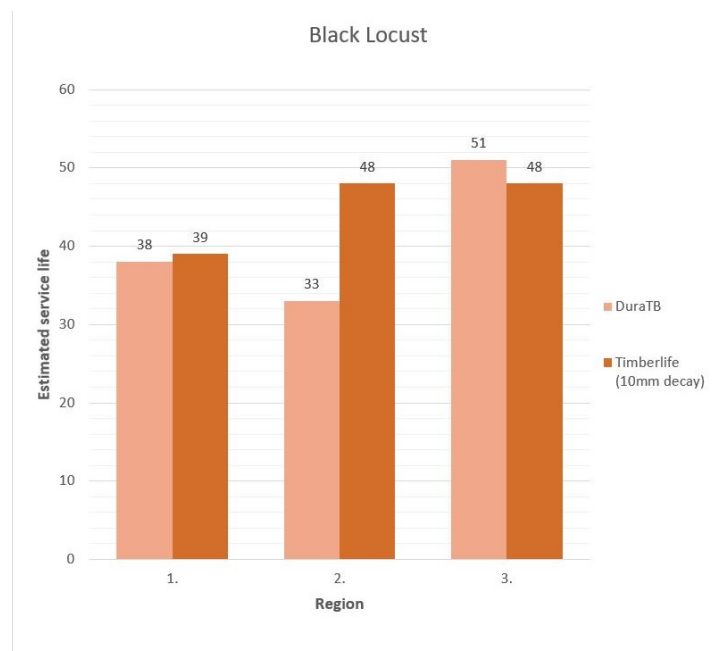
Figure 5.8: Influence of the climate factor on the estimated service life.

To find out what is the influence of these factors, two fictitious climates are introduced. Table 5.7 shows these two fictitious climates and their climatic properties relative to the Dutch climate. The influence of these climates has been determined for the same reference situation as before shown in figure 5.4. The factor values of tables 5.4 and 5.3 also apply here, except that the climatic factors are now variable instead of the timber specie factors. Figure 5.8 shows the influence of the climate parameter on the estimated service life. It is shown for a timber specie from natural durability class 1 (both NEN-EN 350 and AS 5604).

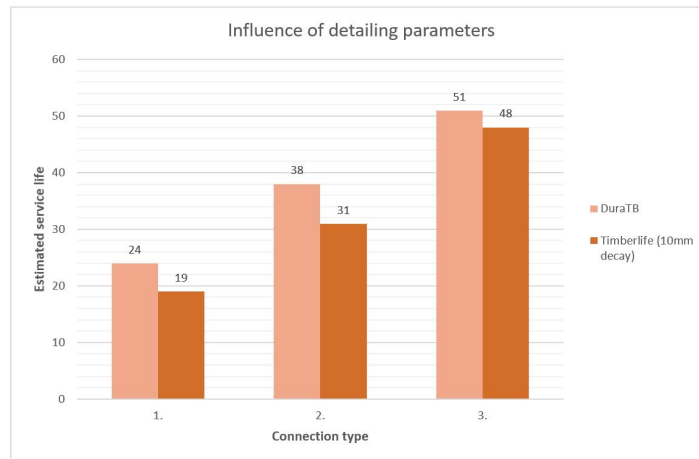
Figure 5.10: Estimated service life for the three different connection types shown in figure 5.9.

Figure 5.10 shows the estimated service life for the three different railing details shown in figure 5.9.

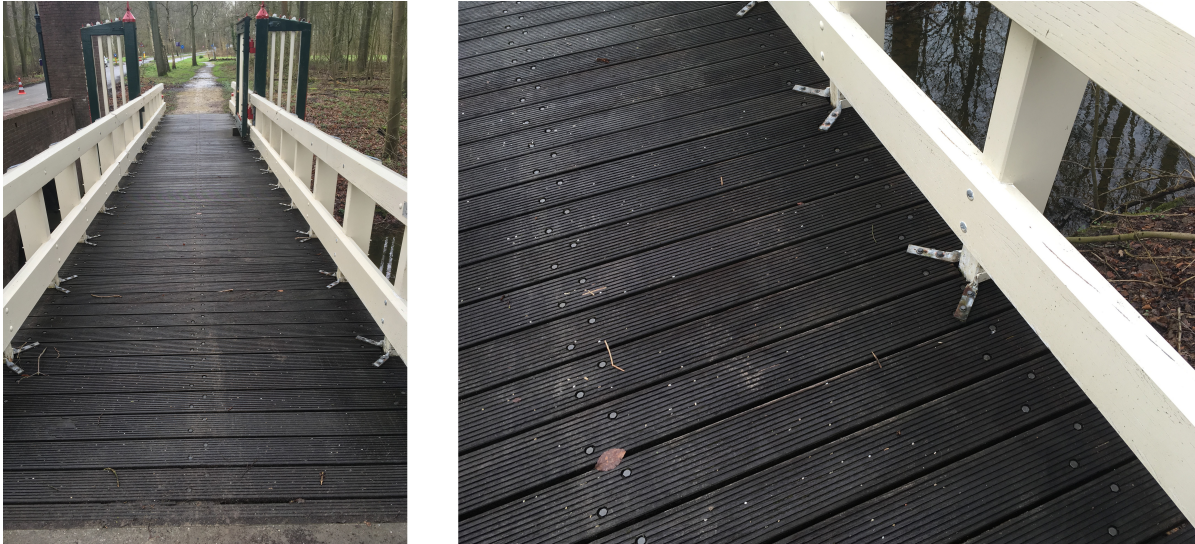
Figure 7.8: The top of the timber deck is still in good condition.

After 15 years, the Azobé deck is still in a good condition and on the top surface shows no visual signs of decay, see figure 7.8. The end surfaces of most of the deck boards shown no to very little decay. At a few boards however the decay at the end surface is already more developed and can clearly be noticed, see figure 7.9.

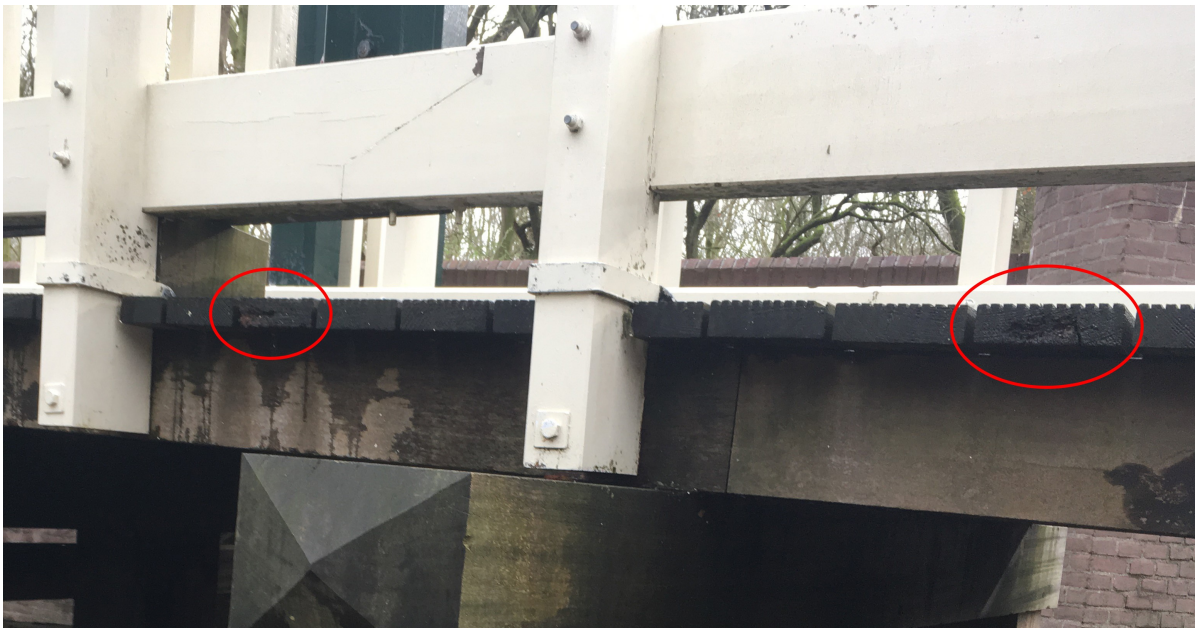
Figure 7.9: End grain surfaces of the deck boards are overall still in good condition. A few boards show beginning amounts of wood rot (highlighted with red circles).

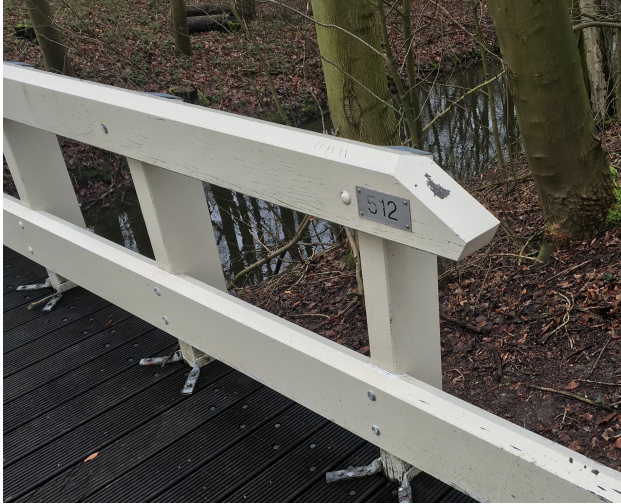
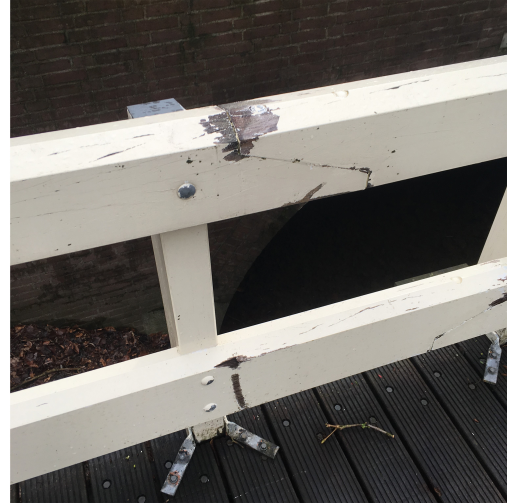
Figure 7.10: Left: Large parts of the railing, covered with a layer of paint, show no visible decay. Right: Longitudinal connection showing paint erosion but no visible sign of decay.

The railing is completely covered with a layer of paint. The embedded connections between the railing and the railing posts seem after 15 years to still be in good condition and show no visual signs of decay, see figure 7.10. At a few places some paint erosion is found and a large amount of decay is found at the connections between the railing and the two fence posts at the centre of the bridge, figure 7.11.

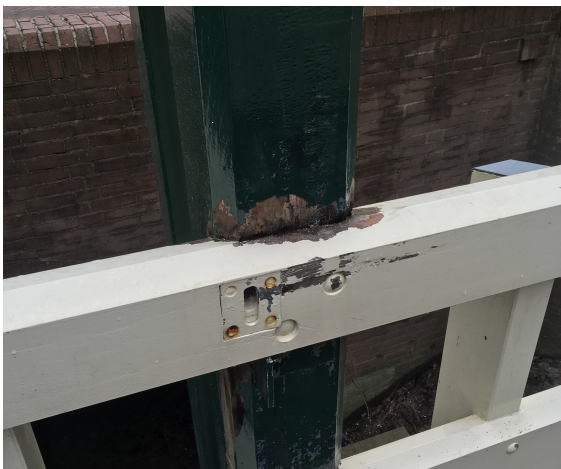
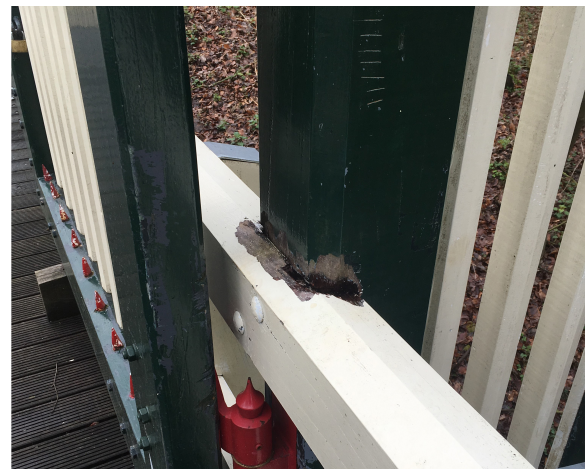
Figure 7.11: At both sides of the fence the connection between fencepost and bridgerailing shows a significant amount of decay.

Something that was not expected was the large amount of decay at the connection between the railing and the gate, shown in figure 7.11. Another look at the construction documents from the renovation in 2005 shows that the gate has not been replaced during these works. During the works in 2005 the gate was removed and later again installed on the new timber superstructure. This means that the timber of the gate post is circa 50 years old instead of 15 and thus explains the amount of decay shown in figure 7.11.

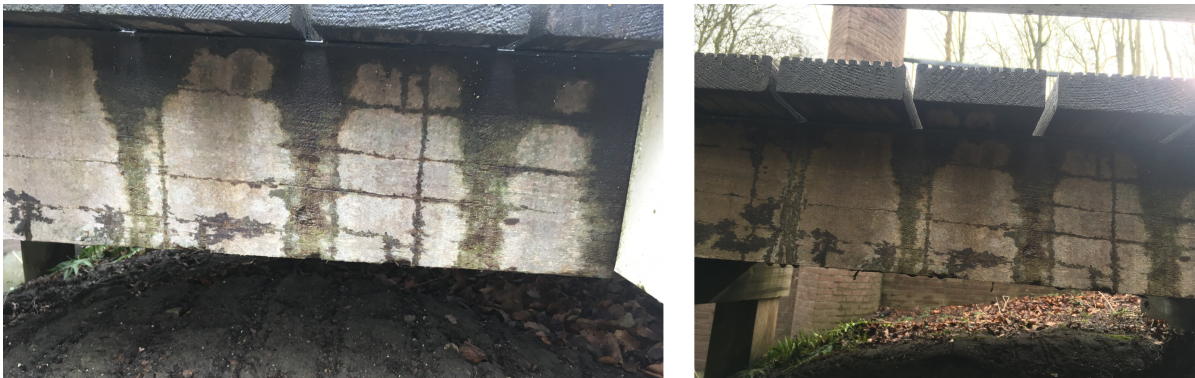
Figure 7.12: Left: Large parts of the railing, covered with a layer of paint, show no visible decay. Right: Longitudinal connection showing paint erosion but no visible sign of decay.

The longitudinal beams below the deck seem to still be in a good condition and shown no signs of visual decay, see figure 7.12.

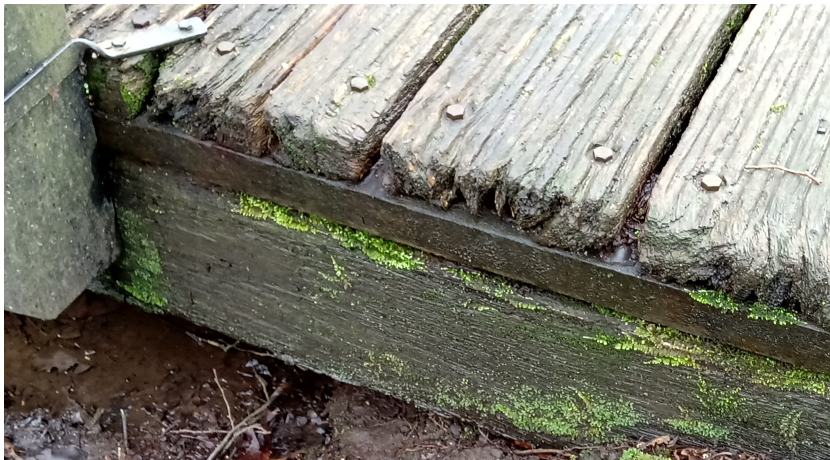
Figure 7.18: End grain surfaces of the deck show large amounts of wood rot.

After 17 years, the deck made of European oak is in a bad condition, see figure 7.17. The top surface shows large amounts of decay and at some places temporary reinforcement measures have already been taken. As can be seen in figure 7.18, also the end-grain surfaces of the boards show large amounts of decay.

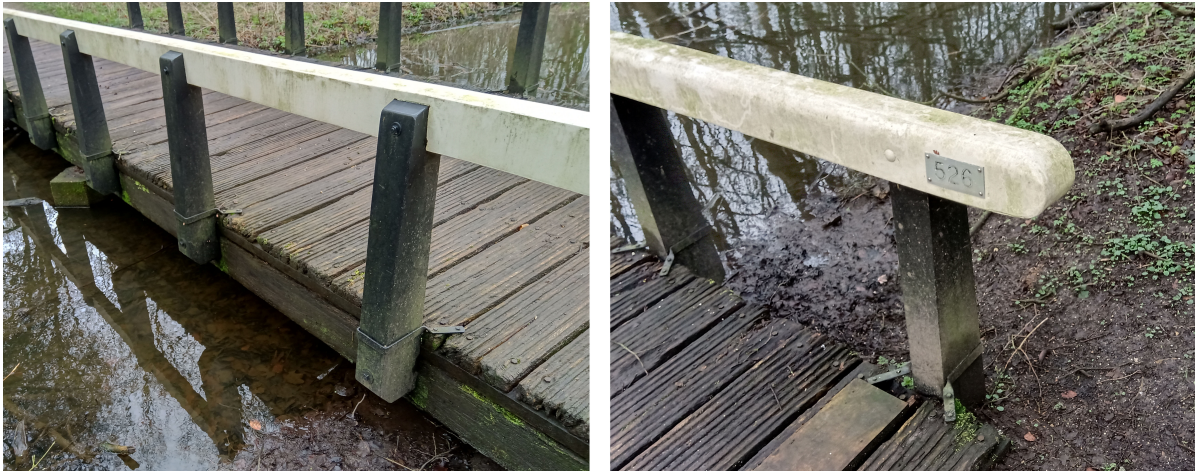
Figure 7.19: The railing, covered with a layer of paint, shows no visible decay.

The railing is covered with a layer of paint. The embedded connections between the railing and the railing posts seem after 17 years to still be in good condition and show no visual signs of decay, see figure 7.19.

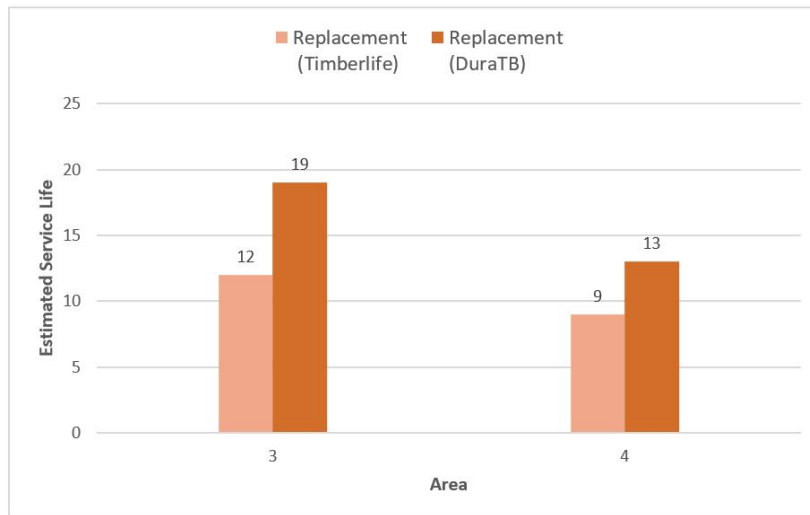
Figure 7.20: Estimated service life of the European oak deck boards classified in durability class 3 instead of class 2.
