# Estimating the (remaining) service life of timber bridges with the use of factor methods

And incorporating these methods in the calculation of the total costs of ownership

to obtain the degree of Master of Science  
at the Delft University of Technology,  
Faculty of Civil Engineering and Geosciences,

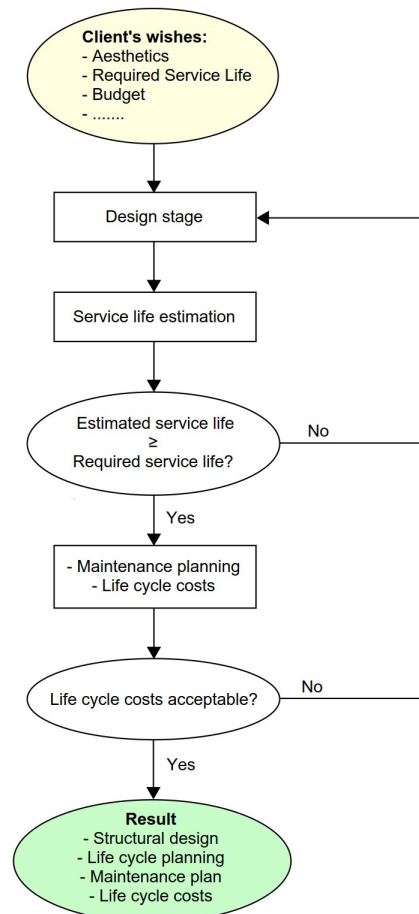
Figure 8.1: Flow chart showing how service life planning can be integrated in structural design.

Service life planning usually requires iterations of the design process to identify the preferred way of meeting the performance and maintenance requirements at an acceptable cost. This iterative process is shown in the flow chart in figure 8.1.

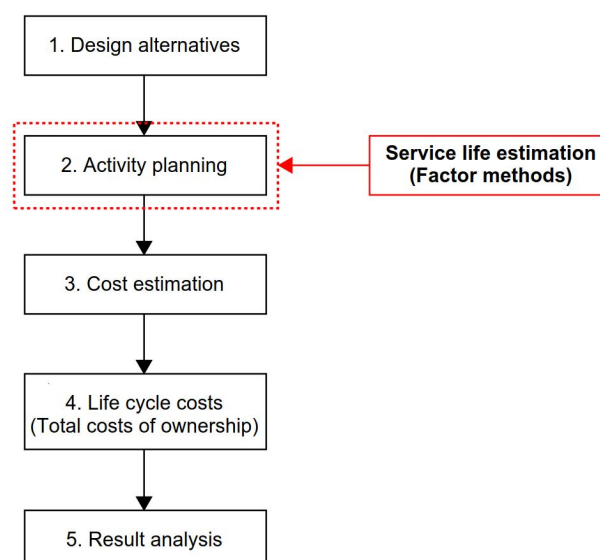
Figure 8.2: Steps in the life-cycle cost analysis

The total costs of ownership are often used as a cost comparison for different alternatives. When using it for this purpose, the analysis can be broken down in the following 5 steps [4], shown in figure 8.2:

This examples follows the steps shown in figure 8.2.

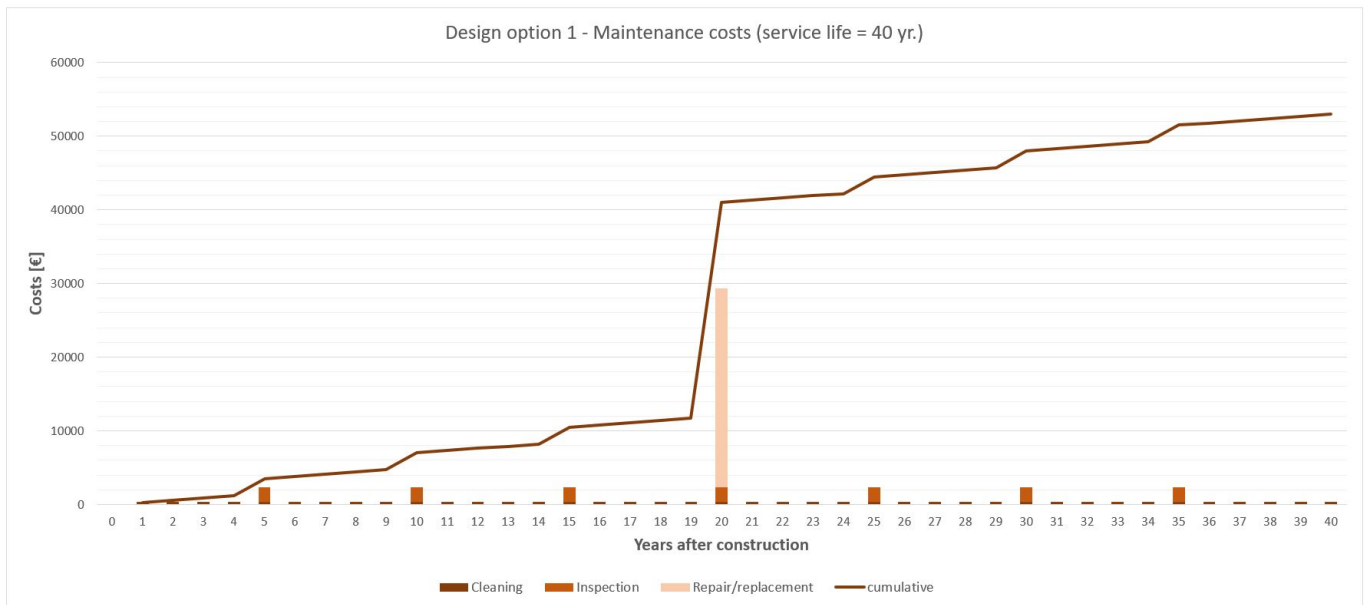
Table 9.4 shows the total costs of ownership for the two design alternatives when the required service life is 40 years. Figure 9.3 shows the development of the maintenance costs for the most economical option (alternative 1) during the service life of 40 years.

Figure 9.3: Development of the maintenance costs for design alternative 1, during the 40 year service life

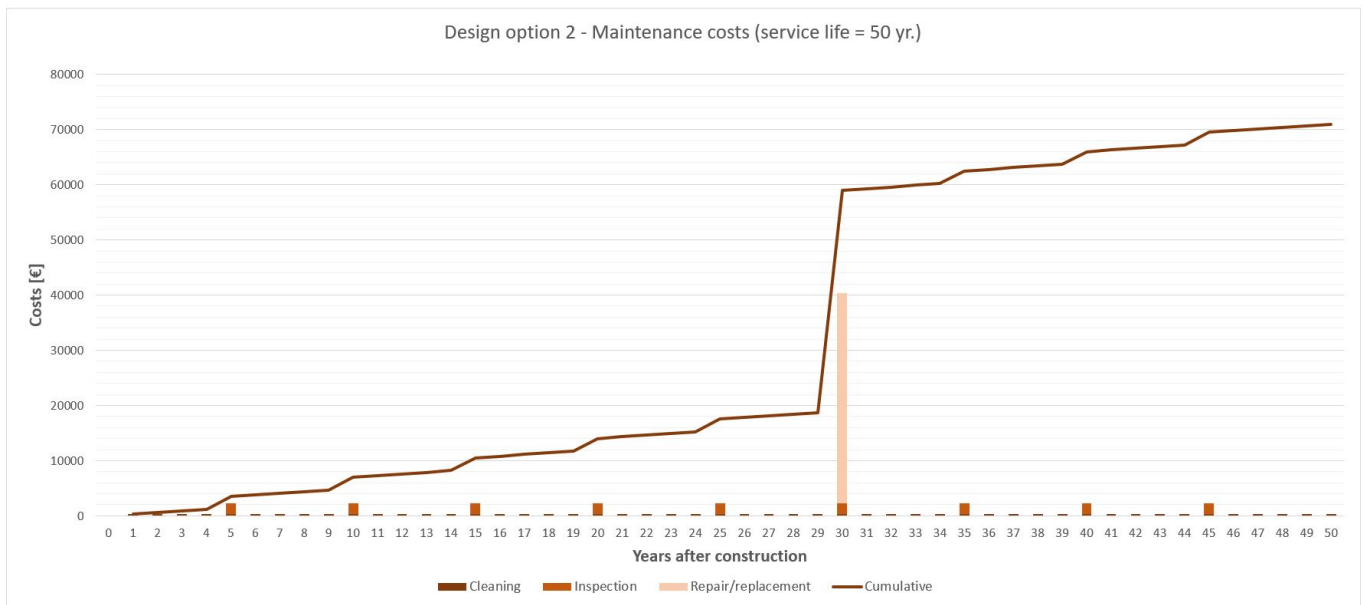
Table 9.5 shows the total costs of ownership for the two design alternatives when the required service life is 50 years. Figure 9.4 shows the development of the maintenance costs for the most economical option (alternative 2) during the service life of 50 years.

Figure 9.4: Development of the maintenance costs for design alternative 2, during the 50 year service life

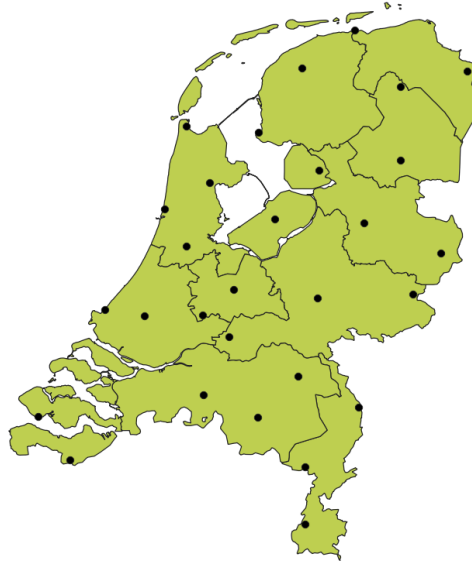
The locations are shown in figure A.2. An example of the weather data is shown in figure A.1.

Figure A.2: Locations of the weather stations from which weather data is obtained.

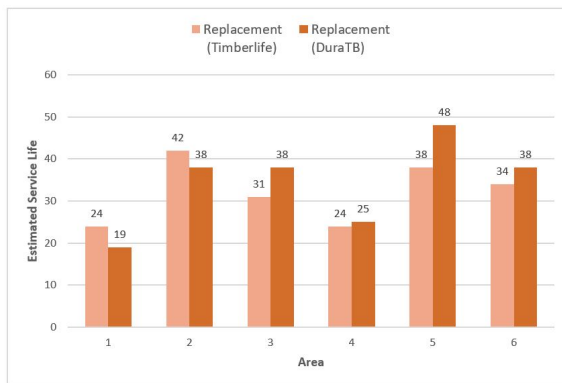
The first design alternative is based on the typical timber bridge design that can be found in 'Het Amsterdamse Bos'. An example of such a bridge is bridge 512, which is discussed in chapter 7. The results from the service life estimation of bridge 512, performed in appendix B is also used for the first design alternative in this example. These results are shown in figure C.2.

Figure 7.4: Cross section with in red the areas of interest

Figure C.2: The results from chapter 6. The figure shows the cross section of the bridge with the highlighted areas of interest. The graph shows the estimated service life of each of these areas.

It follows from figure C.2 that after circa 40 years the top surface of the beams suffer from a significant amount of wood rot. The consequence of this is that the deck board can not be properly attached to the main beams any more and/or will come loose, see figure C.3 for an example of a beam that suffers from woodrot at the top surface. The longitudinal beams are therefore considered to have the need to be replaced after 40 years of service.

**Deck** Figure C.2 shows that the top surface of the deck has an estimated service life of circa 35 years, while the end grain surfaces only have around 25 years estimated. The consequence of a rotten end grain surfaces at a deck board is not that big, therefore the service life of the total deck is set at 30 years.

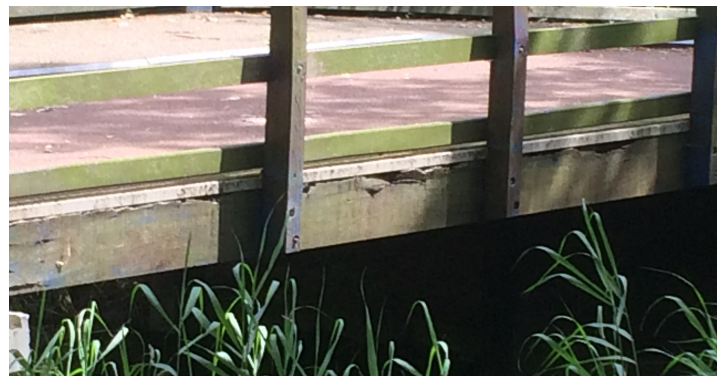
Figure C.3: Example of a timber longitudinal beam suffering from wood rot at the top surface.
