Lecture Delivered before
the 1957 Conference
of The Ship Machinery
Manufacturers' Association
in Japan

By T. W. BUNYAN, B.Sc.(Eng.),
M.I.Mech.E., M.I.Mar.E.

Held in Tokyo on 17th January, 1957

T. W. BUNYAN, B.Sc.(Eng.), M.I.Mech.E., M.I.Mar.E.,
Principal Engineer Surveyor for Research to Lloyd's Register of Shipping.

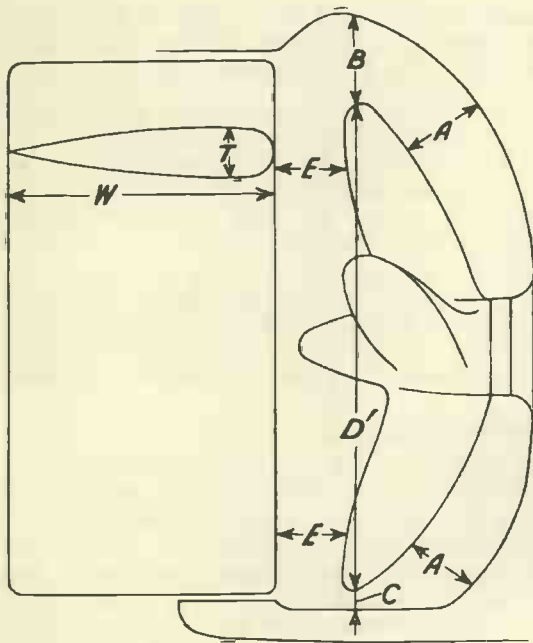
FIG. 3.—SINGLE SCREW APERTURE CLEARANCES

Position	Clearances
A=	$0.15 \times D$ feet
B=	$0.10 \times D$ feet
C=	$0.03 \times D$ feet
E=	$0.08 \times D$ feet or T feet, whichever is the greater

The realistic step in the early stages is for the machinery contractor to have some small say in the design of the after body, aperture of the ship and also the propeller. Were he allowed to do this, then he could almost guarantee beforehand that no problem of machinery vibration due to propeller-excited modes of hull vibration would arise. Aperture clearances should be as large as practicable. The stream lines of the stern frame should be sharply tapered and the rudder should be as slim as practicable with a sharpish nose. Fig. 3 gives proportions of the significant aperture clearances which should be regarded as minima.

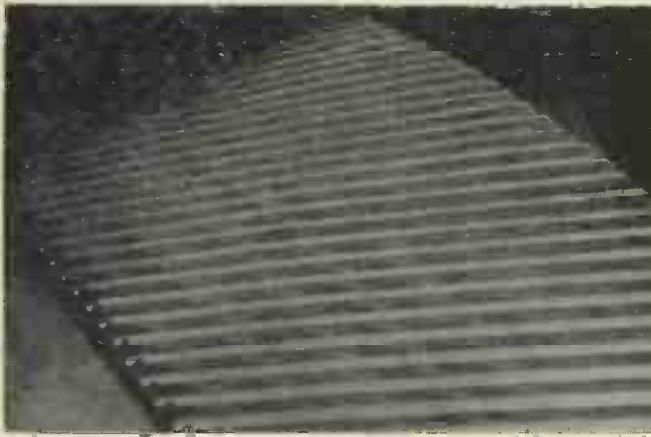
FIG. 5.—MAIN WHEEL SHOWING DIURNAL UNDULATIONS ("DAILY BANDS")

By this means two very important hobbing errors will be effectively dealt with; the first being hobber or "worm wheel cyclic" errors and the second "diurnal errors", both of which are magnified both in amplitude and wave-length by the larger diameter of the cut gear. By choosing a large number of teeth in the master wheel of the hobbing machine, a very important reduction in the undulation wave-length is achieved: this produces three important advantages. Firstly, the undulation amplitude is automatically reduced, secondly, the noise resulting from hobber errors in the gear will be approaching supersonic frequencies, and last but by no means least, post hobbing processes such as shaving or lapping can be completely effective in removing these undulations, which is not the case where the undulation wave-length is large, i.e. more than 3 in. produced by a master wheel with fewer teeth. The diurnal error, that is the error caused by day to night changes of temperature, is, of course, independent of the number of teeth in the master wheel and of the quality or condition of the gear hobbing machine, and will be of the most serious proportions for machines housed in the open shop when cutting large gears. On a large bull gear a temperature variation of $\pm 2\frac{1}{2}^{\circ}\text{F}$. will be clearly evident as a noisy gear-frequency about octave "C" at full power, and will most probably cause pitting at the crest of the diurnal undulations.

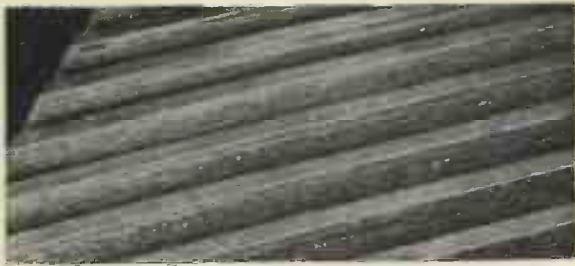
FIG. 6.—SHOWING PITTING BELOW PITCH LINE ON MAIN WHEEL (FORWARD END, AFTER HELIX)

While pitting is in itself largely a self corrective process normally and may take several months to stabilise, in cases where certain hard materials are necessary because of high "K" factors, once pitting commences due to any reason, such as undulations or malalignment, then there is a good chance that no stability will be reached and the gear will have to be replaced.

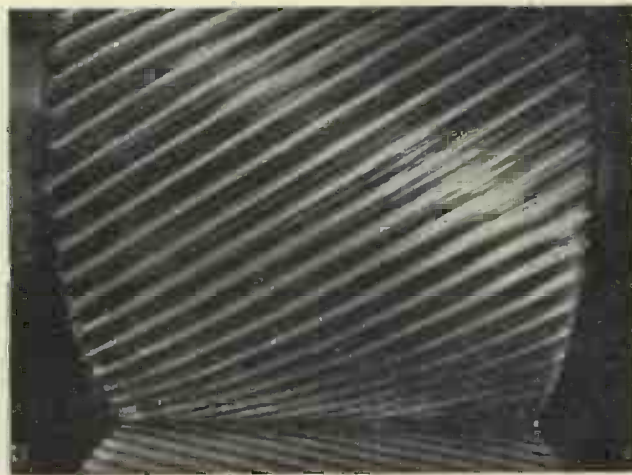
FIG. 7.—SCUFFED SECOND REDUCTION PINION (7/10-IN. DEEP TOOTH): ASTERN

Scuffing of gear teeth, which may show up in the first few running hours on load, is always a cause for anxiety; the process is often non-stabilising and will progressively damage the gear teeth. On the assumption that a normal tooth profile has been used with normal slide roll ratios and normal pitch line speeds, then corrective measures are usually straightforward. Lack of tip relief is most commonly the reason—usually on pinions where it is a simple matter by smooth filing and stoning to re-apply the necessary relief, the greatest care being taken that the relief is not more than about $.002$ in. at the tip being washed away to zero at about $1/5$ th of the tooth height from the tip. Excessive tip relief will considerably increase the specific load on the gear teeth. At the same time the lubricating oil should be changed to an E.P. oil and the load on the gears limited to about 70 per cent for a period of weeks for bedding in purposes. It is, of course, concluded that magnetic filters are installed in the lubricating oil system, this being a "must" anyway.

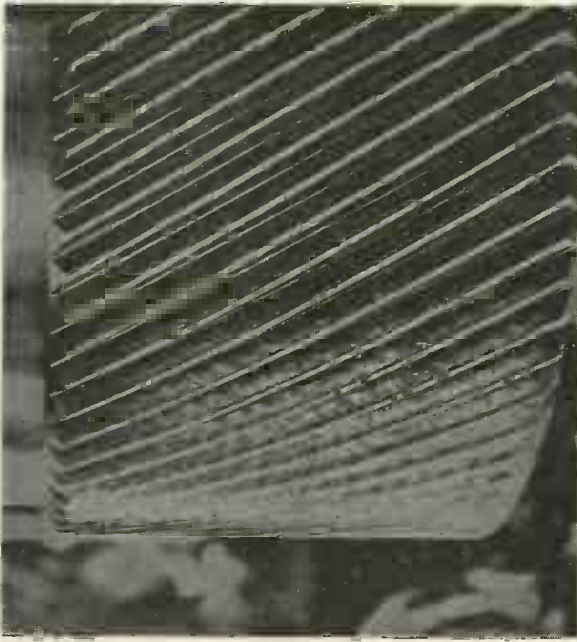
FIG. 8.—SCUFFED A.A. L.P. FIRST REDUCTION PINION SHOWING UNDULATIONS.

Incidentally the lapping process can remove tip relief quite effectively and Fig. 8 shows the serious scuffing produced entirely through this means.

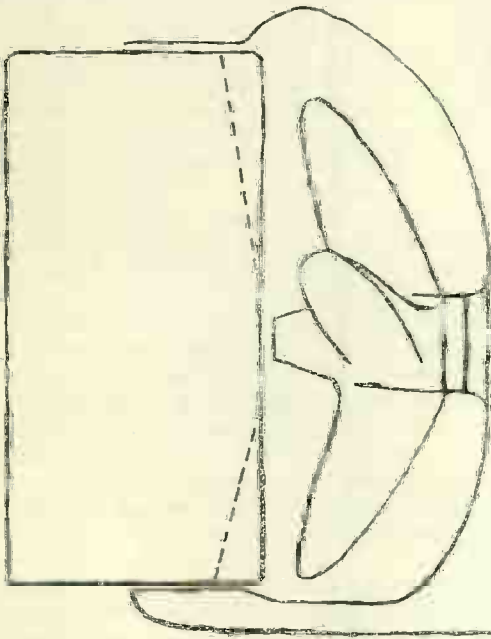
FIG. 9.—RUDDER NOSE CUT BACK TO INCREASE PROPELLER TRAILING EDGE CLEARANCE

Before leaving the subject of gearing, a few remarks on torsional and axial vibration may be of interest. It can be said with almost complete assurance that the torsional and axial vibration problem in geared turbine installations is reduced to normal proportions by good propeller and aperture design. There was a very spectacular demonstration of this when we were called to investigate a serious hull and gearing vibration problem on two large tankers. Both problems were severe. The hammering in the gearing at the l-node critical was impressive and covered a speed range three times what would be normal. The after part of the ship was complete bedlam with propeller-excited vibration. The ship was drydocked and on our recommendation the rudder nose was cut back as shown in Fig. 9, in order to increase the excessively small trailing edge clearance. The results were most satisfactory.

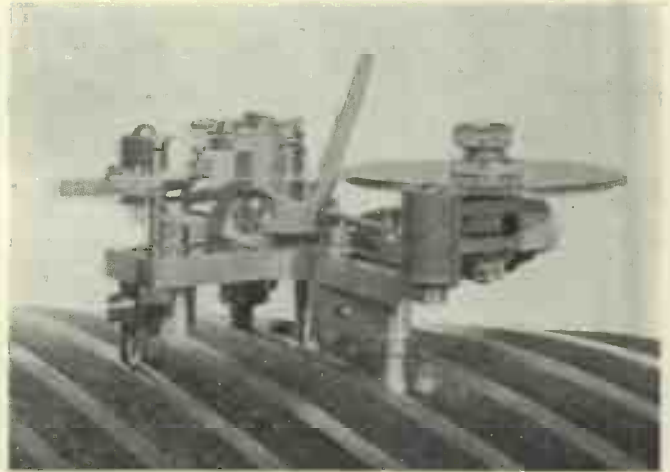
FIG. 10.—TOMLINSON UNDULATION RECORDER (N.P.L. TYPE)

One final matter before we start asking one another questions: In any study of gearing and the control of the quality of gearing, it is necessary to have apparatus designed specifically to do these jobs. The first essential, in my opinion, is a good undulation recorder. I have brought along Dr. Tomlinson's N.P.L. undulation recorder, which is straightforward to use. Fig. 10 shows the instrument in question, and I would again refer you to Mr. Archer's paper, which details the simple formulæ for setting the instrument and assessing the magnification factors.

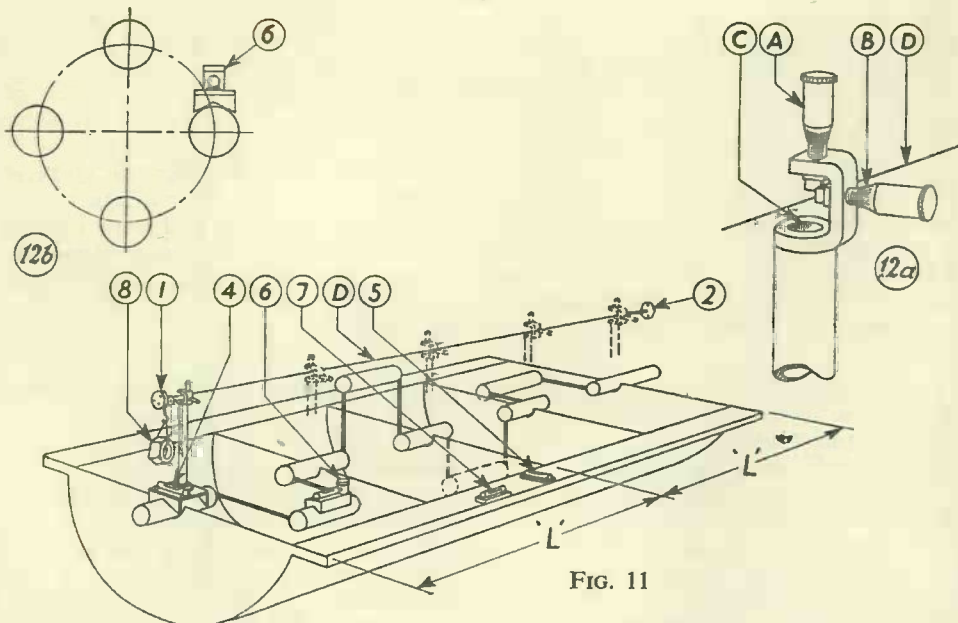
FIG. 11

Alignment of Journals

Take clinometer readings (6) when mounted on vee block on pin—the clinometer to be read only when master level (7) reads zero—take readings on the four quarters as shown in Fig. 12(b).

- (1) Weight (8)=42lb.
- (2) Spirit levels (4) (5) (6) (7) sensitivity=0.001 per ft.
- (3) Piano wire is 0.018 in. diameter.
- (4) Sag of wire to be allowed for = $\frac{L^2}{8}$ thousandths of an inch where L =half length of engine (feet).

A simple and accurate shaft or bedplate alignment indicator was developed by the department which is now widely in use in Europe on all types of engines, but is of particular attraction in the case of the Doxford, where a set of alignment readings can be obtained in two hours, using the access to the journals provided by the oil supply holes in the bearing keep. The figures show the arrangement.

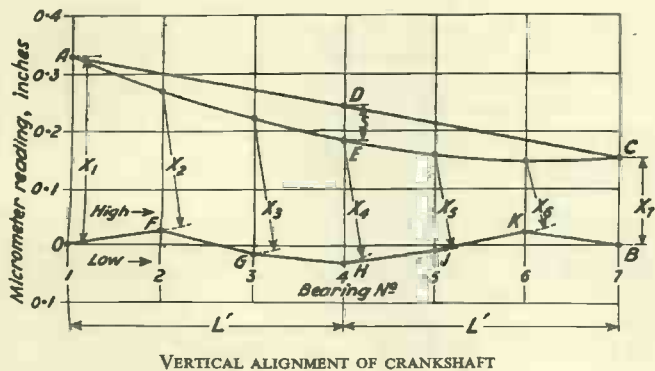
VERTICAL ALIGNMENT OF CRANKSHAFT

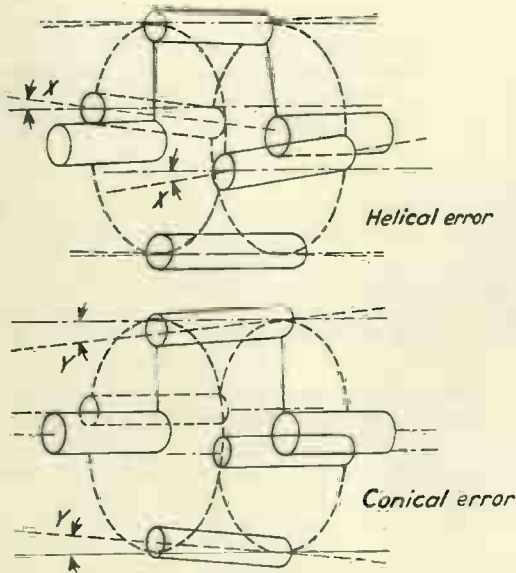
FIG. 12.—SCHEMATIC DIAGRAM OF CRANKPIN ERRORS

(c) The top end bearing, as many of you may know, can, without any apparent reason, develop the most alarming symptoms. Overheating or hammering out of the white metal is a common feature, and renewing the bearing, dressing up and re-surfacing the pin will not produce the desired results. This trouble can develop in new engines or in engines that have given trouble-free service for years. The cause of the trouble, however, more often than not does not lie in the crosshead, but is brought about by eccentric loading or uneven loading of the crosshead pins; in some double acting engines this eccentric loading does not affect the crosshead bearings but fractures the piston rod. Such eccentric loading is caused by "weaving" of the bottom end bearing—by that I mean the backwards and forwards movement of the bottom end bearing from web to web. There will be evidence of bright marking on both webs which will confirm this action. There are three factors, all associated with the crankshaft itself, which can cause this condition. In a new engine, helical or conical errors in the crankpin resulting from inaccurate machining are one factor. Fig. 12 will demonstrate what I mean.

While the engine is in the shop, these errors are checked by sensitive spirit level and a vee block. With engines that have run satisfactorily in service there are two factors to look for, the first is malalignment of the crankshaft due to unequal wear down, particularly so if No. 1 top end is involved as No. 1 main bearing rate of wear down is less than the others and so is that of the last bearing adjacent to the thrust. The last factor to look for is the barrelling wear pattern of the crank pin. Once the cause is established it is a straightforward matter to proceed with the rectification.

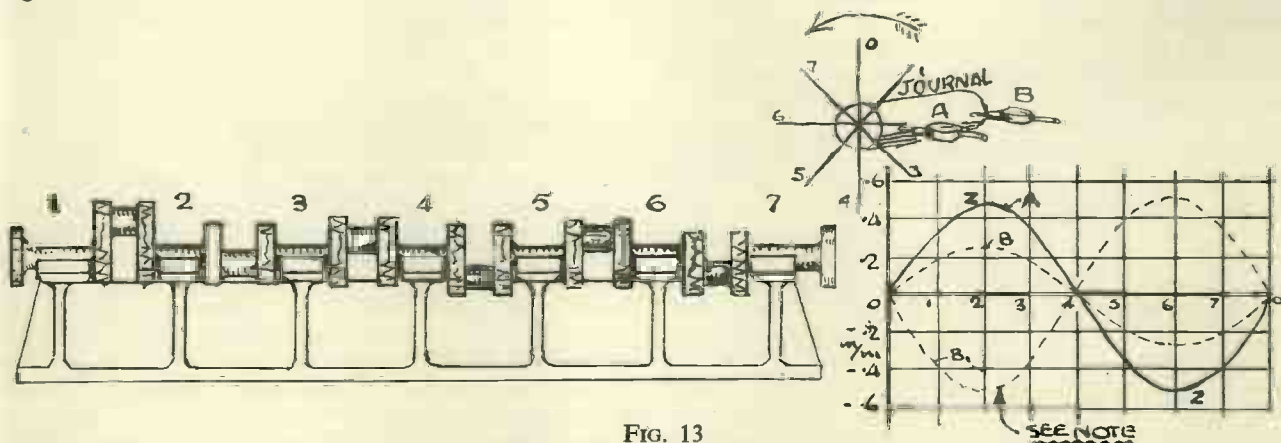
FIG. 13

Procedure: Starting with No. 2, remove bottom half main bearing, fix clock gauges "A" & "B" horizontally against No. 2 journal as shown, plot readings from "A" & "B" for 45° rotation of crankshaft as shown—difference between readings from "A" & "B" should be less than $\frac{D}{5000}$ m/m, where D=journal diam. m/m. total throw "Z-Z" to be less than $\frac{2000}{D}$ m/m, curve B₁ denotes serious wobble of journal—repeat for journals 3, 4, 5, 6, excessive errors to be filed and lapped out progressively commencing at No. 2 journal

Main bearing failures may involve alignment and this is the first thing to check. In a new engine hot main bearings may be indicative of crankshaft journal errors, and an excellent way to gauge these is to proceed as indicated in Fig. 13.

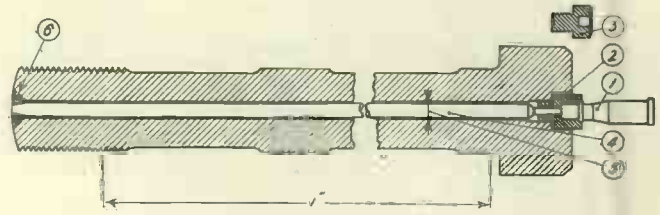
FIG. 14.—MICROMETER GAUGE FOR INDICATING BOLT STRAIN
($=0.0006 \times L$ INCH FOR M.S. BOLTS)

(1) Standard 0- $\frac{1}{2}$ inch micrometer head; (2) brass bush screwed $\frac{1}{4}$ -in. Whit. into bolt head; (3) steel $\frac{1}{2}$ -in. Whit. socket screw for plugging hole; (4) $\frac{1}{4}$ -in. diameter ground silver steel rod; (5) $\frac{1}{8}$ -in. diameter hole drilled the length of the bolt; (6) rod inserted and welded or brazed there.

With large bolts, particularly where access is cramped, it is very difficult to get sufficient pre-stress by the use of the flogging hammer. A simple fitment shown in the next figure enables the correct pre-stress to be obtained.
