Fire Resistant Structural Glass Beams

Developing design recommendations for future development
and fire certification of structural glass beams

P5 Master thesis

Delft University of Technology
Building Technology
31st of October 2018

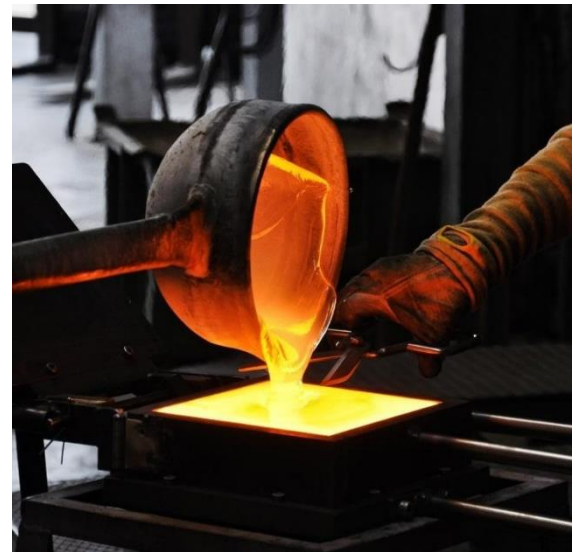
Cast glass starts off with a large bath of molten glass from which a certain amount is taken and poured into a mould. When cooled down the glass will have solidified in the desired shape.

Figure 5 - Molten glass poured in to glass brick mould - source: Faidra Oikonomopoulou - Re3 Glass, Delft University of Technology

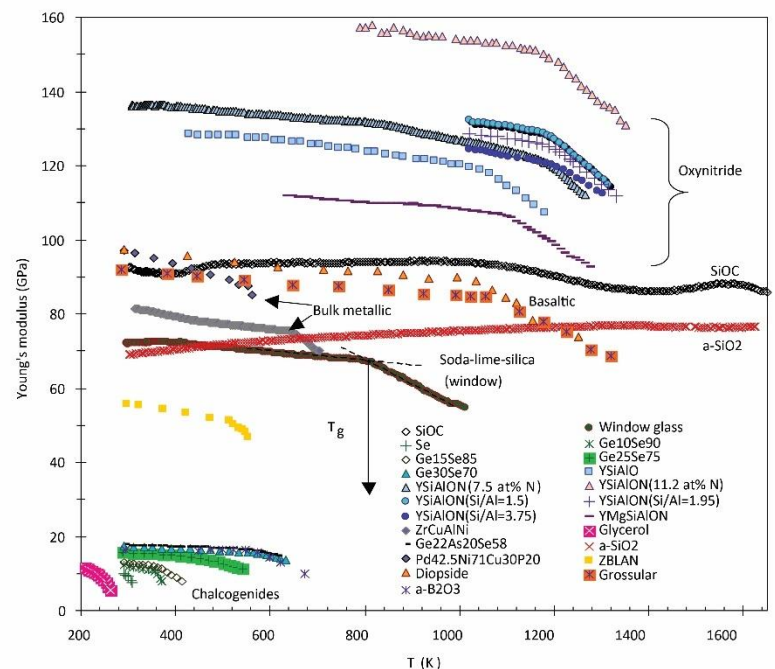
Figure 17 – Temperature dependency of the young's modulus for a number of ceramics
Source: Elastic Properties and Short-to Medium-Range Order in Glasses - Rouxel

Rouxel's data continues the description of the young's modulus. With increase in temperature the modulus slightly decreases until the annealing point or glass transition temperature of 527 Celsius. Above this temperature the young's modulus drops almost steadily until the reaching the softening temperature measured by Rouxel at 727 Celsius. Beyond 727 Celsius the young's modulus currently has not been measured for standard Soda lime glass.

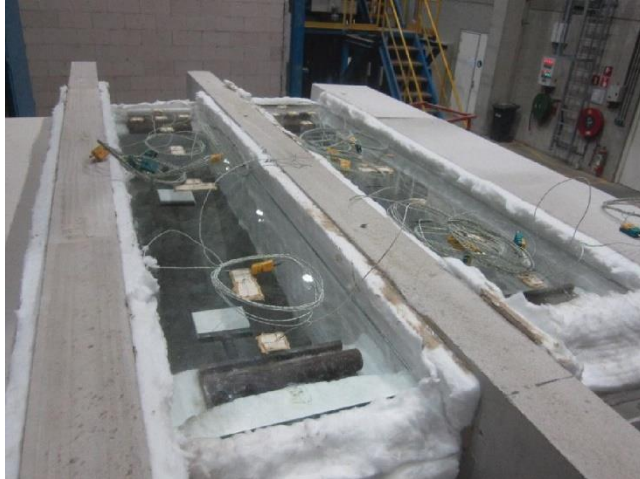
Figure 20 – Set-up of two glass panes above the fire furnace at Efectis
Source: Behaviour of structural glass at high temperatures - Nodehi

combined with the outer edge of the glass being unaffected by the increase in temperature due to the steel support a strong temperature gradient is built up between glass loaded by the fire furnace and glass slightly protected by the supports.

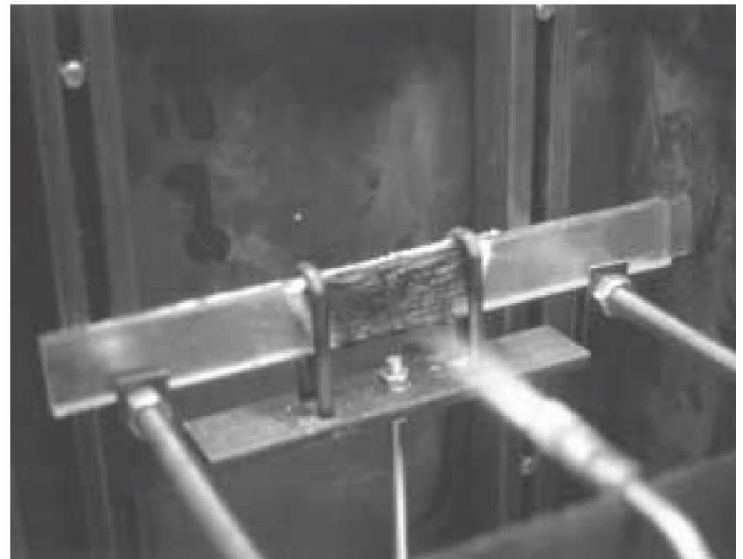
Figure 22 – Burner 4 point bending set-up

The 4-point bending test uses weights that enforce a stress with a maximum of 24 MPa. The beams are loaded by a propane burner on one side of the beam with a flame at a constant temperature of 650 Celsius. On the other side of the beam a surface thermocouple measures the temperature.

The beams compositions test beams with annealed glass, chemically toughened glass, chemically toughened in combination with polycarbonate foils and a special laminate with an insulating cavity. Each beam is tested without addition and a version which has a layer of intumescent coating applied. The intumescent coating is Flameguard HCA-TR.

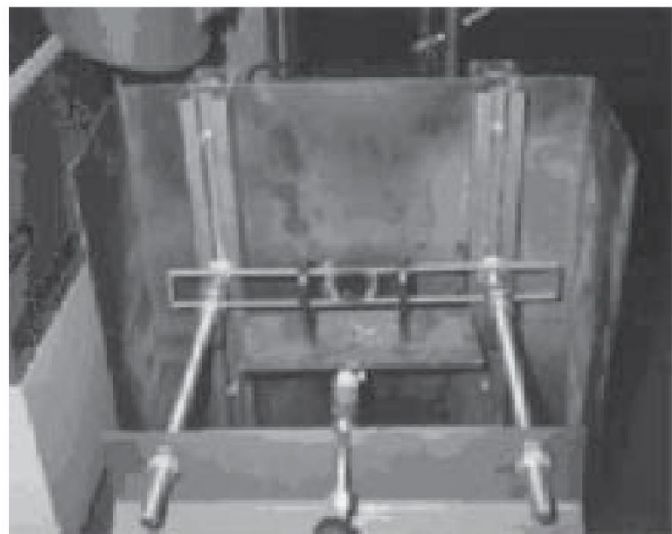
Figure 23 – 4 point bending set-up used by Bokel
Source: Fire resistance of glass - Bokel

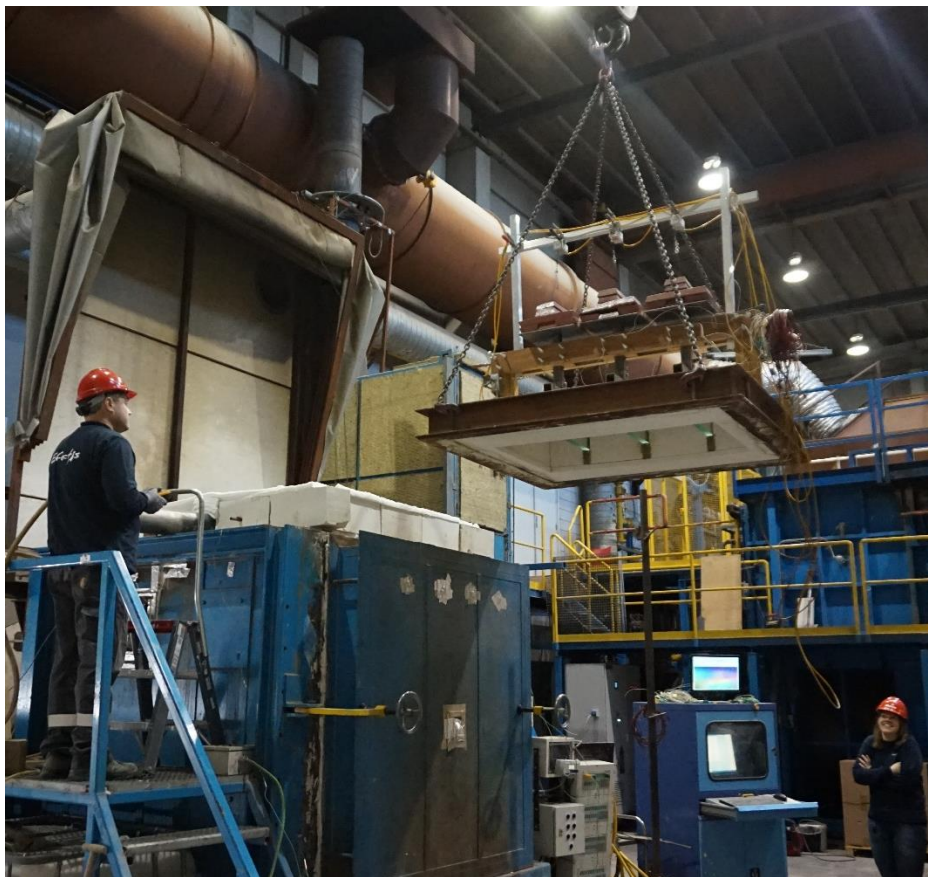
Figure 25 – The test set-up is hoisted on top of the fire furnace at Efectis

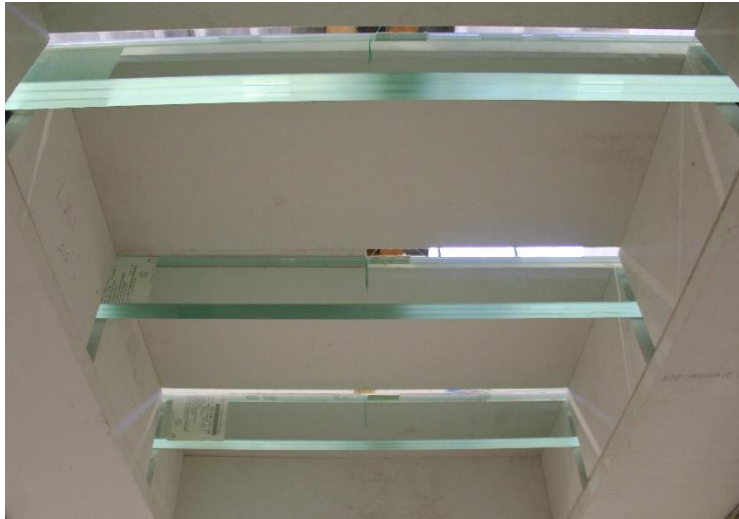
Figure 27 – Three glass beams placed in the test set-up, seen from beneath

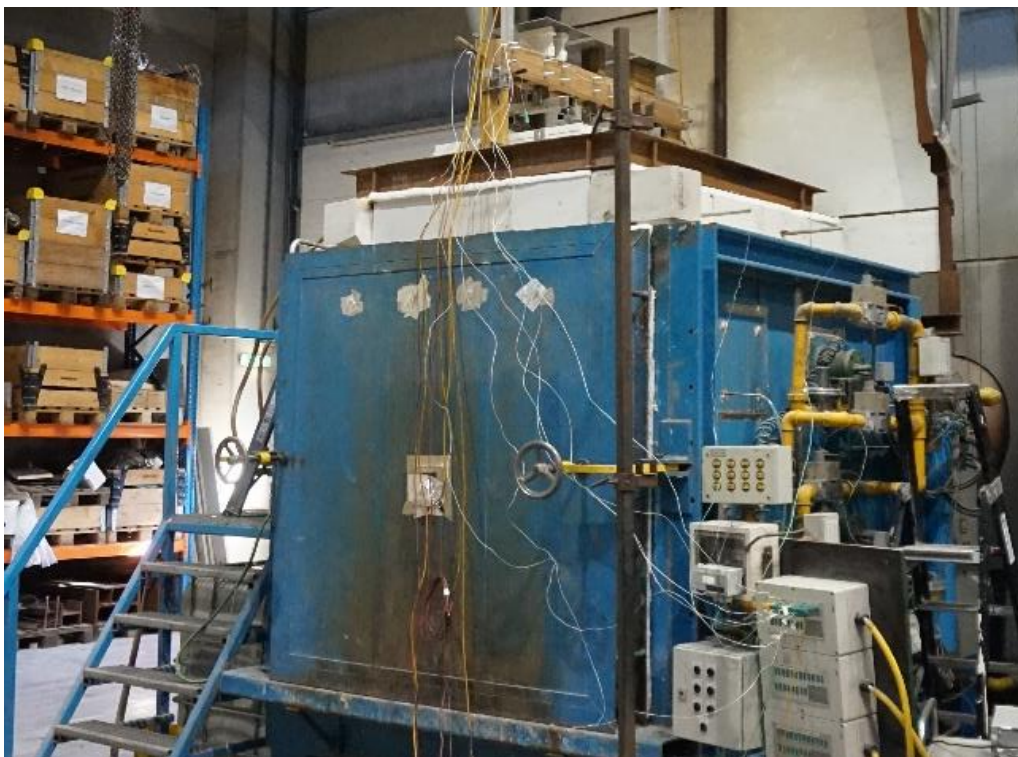
Figure 28 – Small fire furnace at Efectis with the test set-up on top and all measuring equipment hooked up to the computer, Bleiswijk – The Netherlands

To place the test rig nicely on top of the oven a so-called OR-Frame is used. The OR-frame, provided by Efectis, is a rectangular steel frame with fastening points to attach an overhead crane. The testing rig is built inside the OR-frame to easily lift the rig on and off the oven.

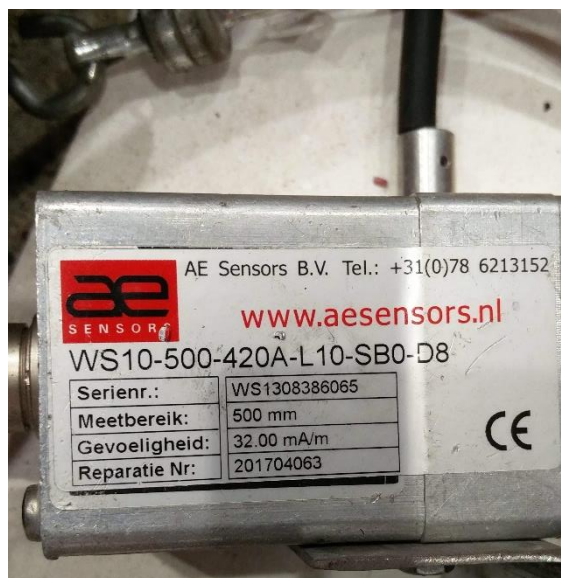
Figure 30 – Displacement sensor used during test

The glass beams are tested until they eventually fail. This failure is determined by either the rate of displacement or the overall displacement of the beam. To measure the displacement of the beams, analogue displacement sensors are used. The sensors are manufactured by AE sensors, an image can be seen on the right in figure 30.

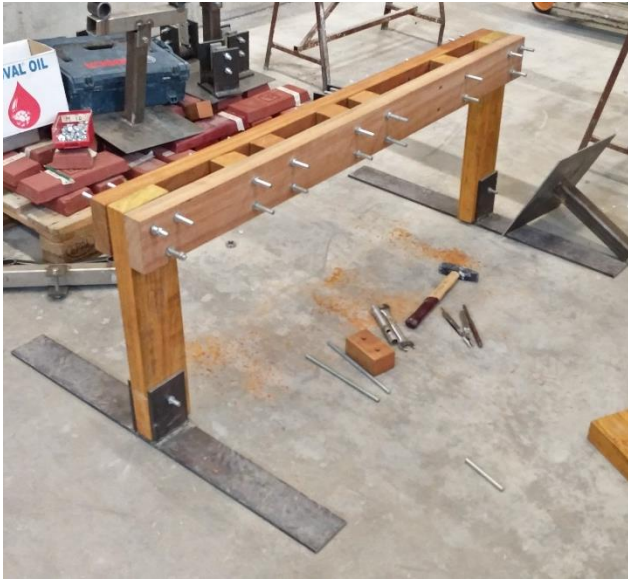
Figure 34 – Build up of the wooden portal spanning the oven

A wooden frame spans over the glass beams supporting the 4-point-bending set-up. Between the parallel wooden beams slots of 54mm x 54 mm are realised through which the load resting on top of the glass beams can slide down. The loading set can move a maximum of 60 mm in the vertical direction, ensuring to load the beam until full failure, while preventing to drop fully into the hot oven.

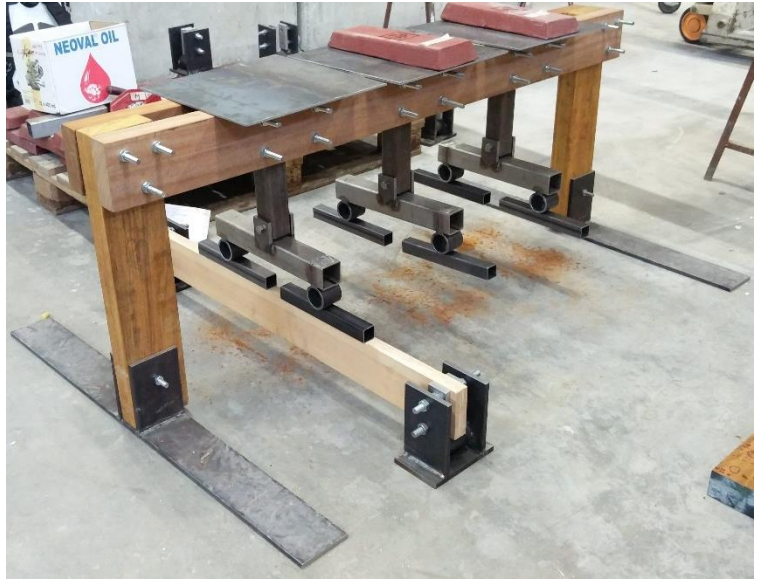
Figure 35 – Placement of the steel 4 point bending loading set

After sliding the top of the loading set into the wooden frame a bolt fixing the bottom to the top. The bolt connects the two parts in the vertical direction while allowing for rotation. To follow the deformation of the beam 2 extra rotation points are created by welding circular tubes to a rectangular section. The rotational point is situated between the circular tube and the smaller rectangular tubes that rest on top of the glass beams, this connection is made by two small loosely fixed bolts allowing for rotation.

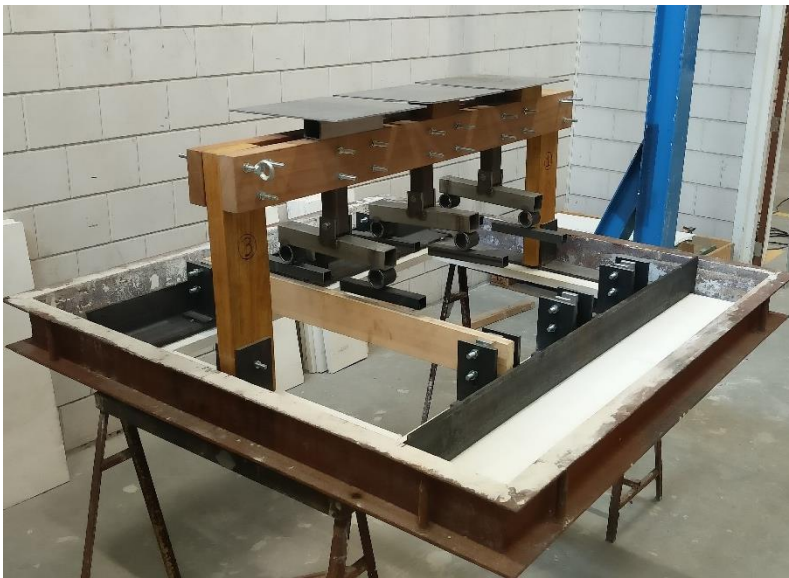
Figure 32 – Promatect panels are placed underneath the set-up to shield from heat

As can be seen in figure 33 and 34 white Promatect panels are placed underneath to protect the

wooden frame and the L-profiled beam from direct heating of the fire furnace. These fire protective panels are continued on the inside of the supports starting to build an insulating box around the glass beams. After each test the panels are checked if they can be reused for the next test. Promatect panels are developed to withstand a fire loading of at least 4 hours. Therefore, multiple tests should be possible with one set. In the end two sets of Promatect panels have been used during 4 tests.

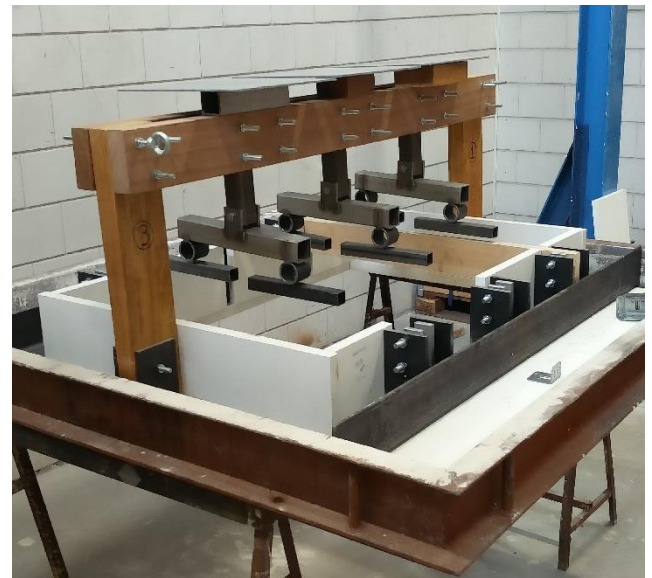
Figure 33 - The promatect box is built up between the supports

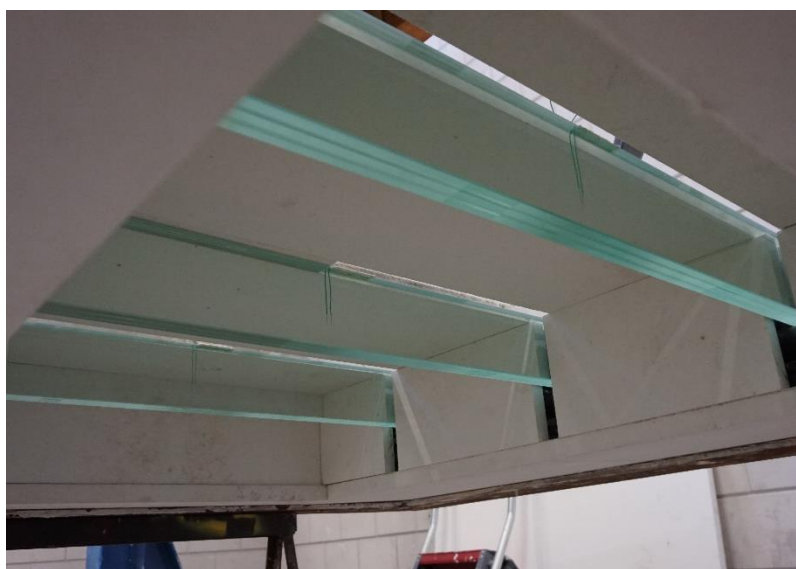
Figure 39 – 3 Glass laminated beams placed in the test set-up

The next step in assembly of the test set-up is placing the glass beams onto their supports. Care is taken not damage the glass when placing in the steel and aluminium supports. When in place an integrated clamping system on the side of the glass fastens the beam in place.

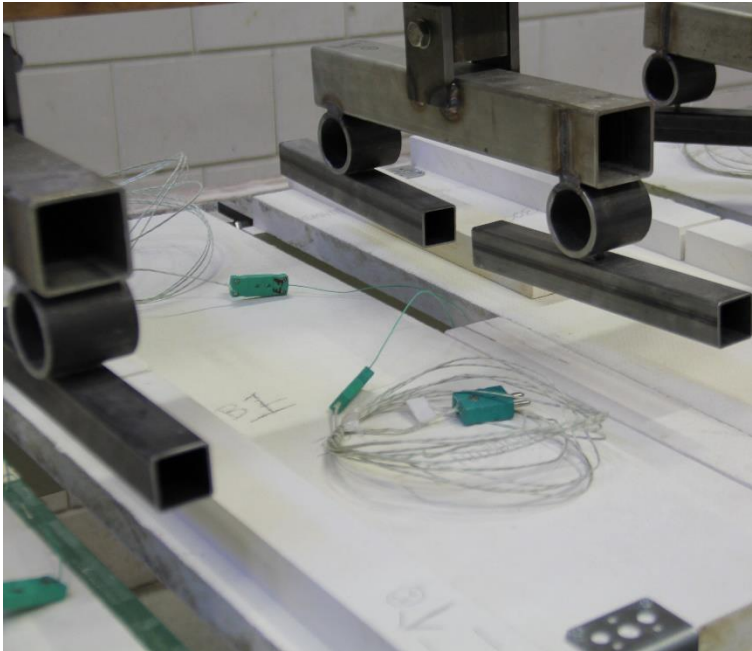
Figure 41 – Connecting of the thermocouple K extension cables

The thermocouples laminated inside the interlayers come out of the top of the beam, these small wires come up between the two narrow Promatect panels. The thermocouple wires are connected to small thermocouple type K plugs to extend the rather short wires with larger thermocouple K wires.

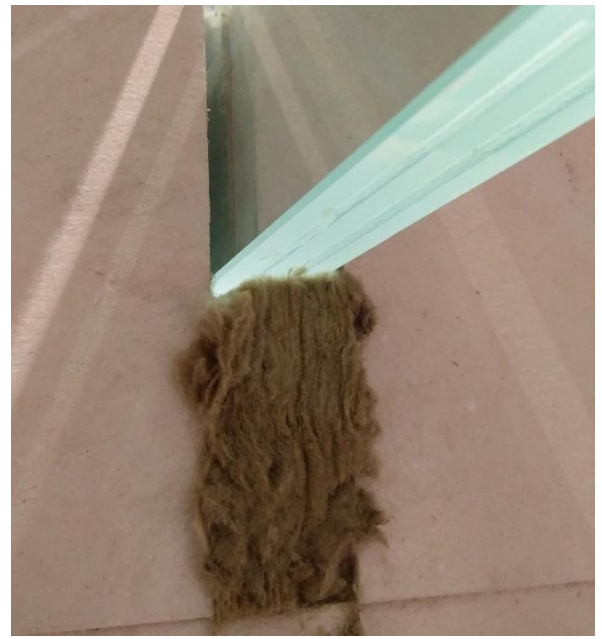
Figure 43 – Glass fibre mineral wool underneath the beam to close of the set-up and leave room for displacement

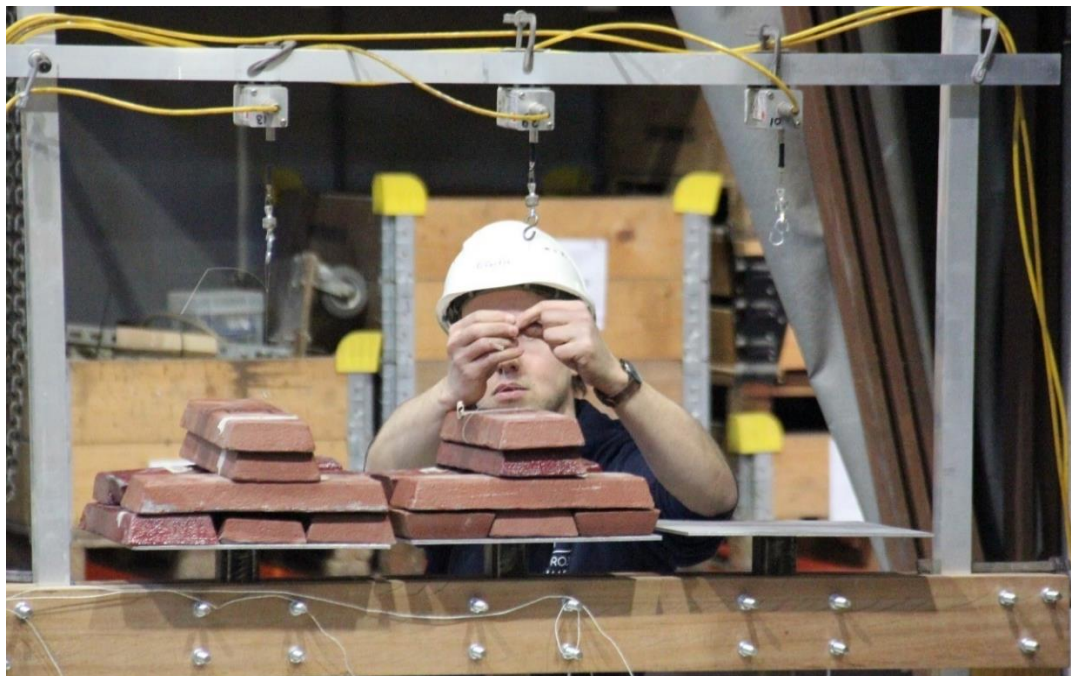
Figure 44 – The displacement sensors are attached to the loadcase which rests on top of the glass beams

The second value of displacement is measured by recording the displacement of the set of weights. This can be seen in the following **figure**. The measuring device is suspended above the weight and attached to the weights with a small cable.

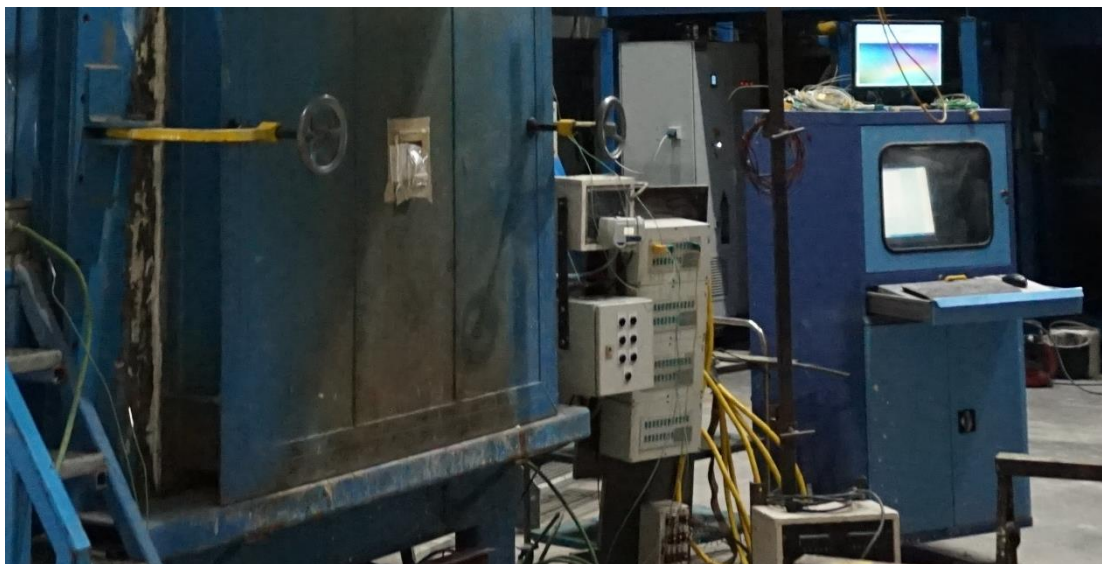
Figure 45 – The monitoring computer at Efectis that registers all data during the test.

As a final step the thermocouples, displacement devices and the oven camera are connected to the computer. The computer has a program written by Efectis to combine all the data acquired during testing, at the start of each test all the values are set to zero to calibrate the values retrieved.

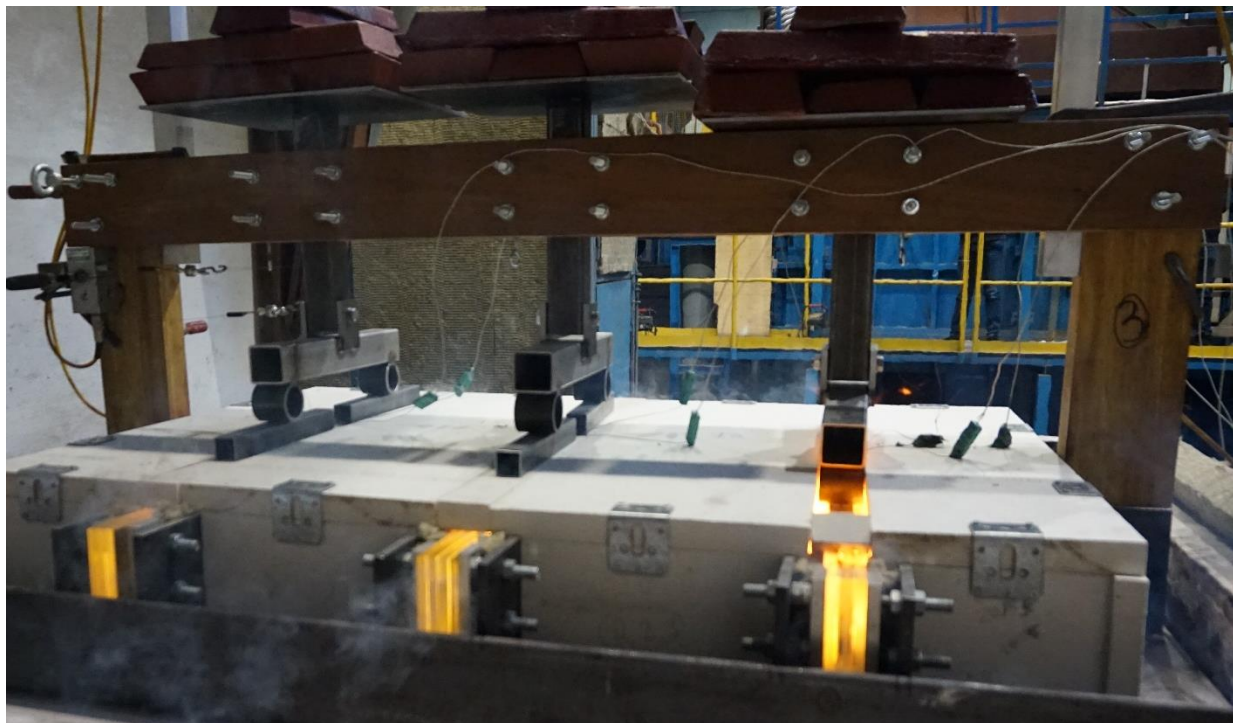
Figure 47 – Image of the glass beams and test set-up during test 1 – Beam 3 has failed

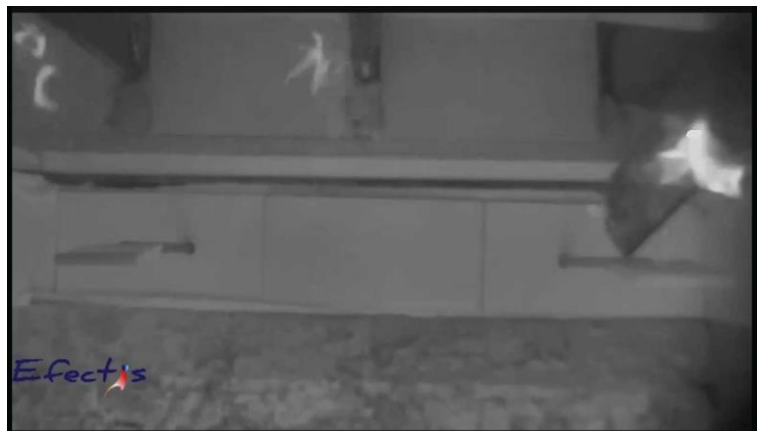
Figure 49 – Failure through thermal fracture of beam 3

At exactly 8 minutes into the test on of the glass panes in beam #3 crack due to thermal fracture, followed by collapse of the beam (8.19min) under the applied load. The fracture occurs at the side of the beam near the vertical fire Promatect panels closing off the set-up. Two panes crack one side of the set-up and the third pane cracks on the opposite side, resulting in a scissor motion during failure. The annealed glass beam with sentryglas interlayer fractures with a clean single continuous crack from top to bottom as would be expected from annealed glass. During failure the beam slowly slides down due to the softened interlayer between the glass. No flames occur at the moment of failure.

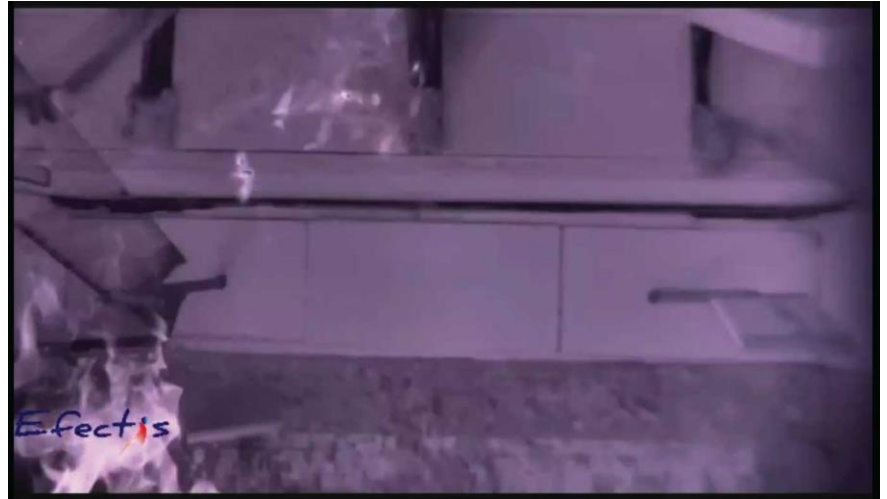
Figure 50 – Failure through thermal fracture of beam 1

At 15 minutes and 24 seconds into the test, beam #1 can be seen to collapse on the oven camera. This is the result of sudden glass fracture in beam #1. There is no warning before fracture and the beam drops rapidly. The beam is an annealed PVB laminated glass beam, the fracture pattern as can be seen in figure 51 is very similar to the break pattern of beam #3 also annealed glass. The fracture occurs at the vertical fire protective panels on either side.

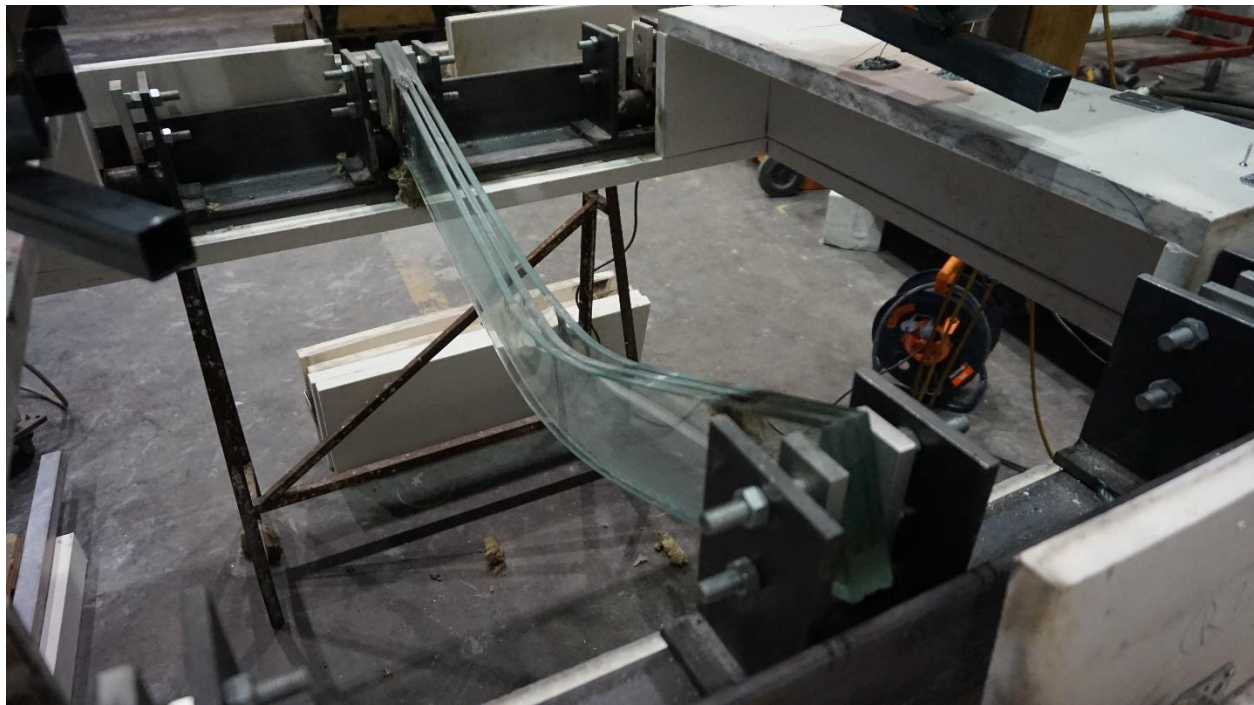
Figure 52 – The displaced beam 2 which remained in the test set-up after the test, which shows clear delamination of the 3 glass panes and no remaining interlayer between the glass.

During the last minutes of the test the laminated glass panes displace laterally and away from each other. In the middle section of the beam the interlayer has completely burned up and decomposed the laminate allowing the glass to sag vertically as well as laterally. This is clearly visible after the test, the beam remains in the set-up and cools down in it's displaced form. If you compare the remaining laminate inside the supports with the middle of the beam, the distance between the glass panes has become larger.

The interesting thing is that the beam remains laminated inside the supports. The interlayer that creates the lamination between the glass panes does not fully melt, however there are bubbles from decomposition visible inside the interlayer. The temperature inside the supports does not result in delamination of the outer edge of the beam.

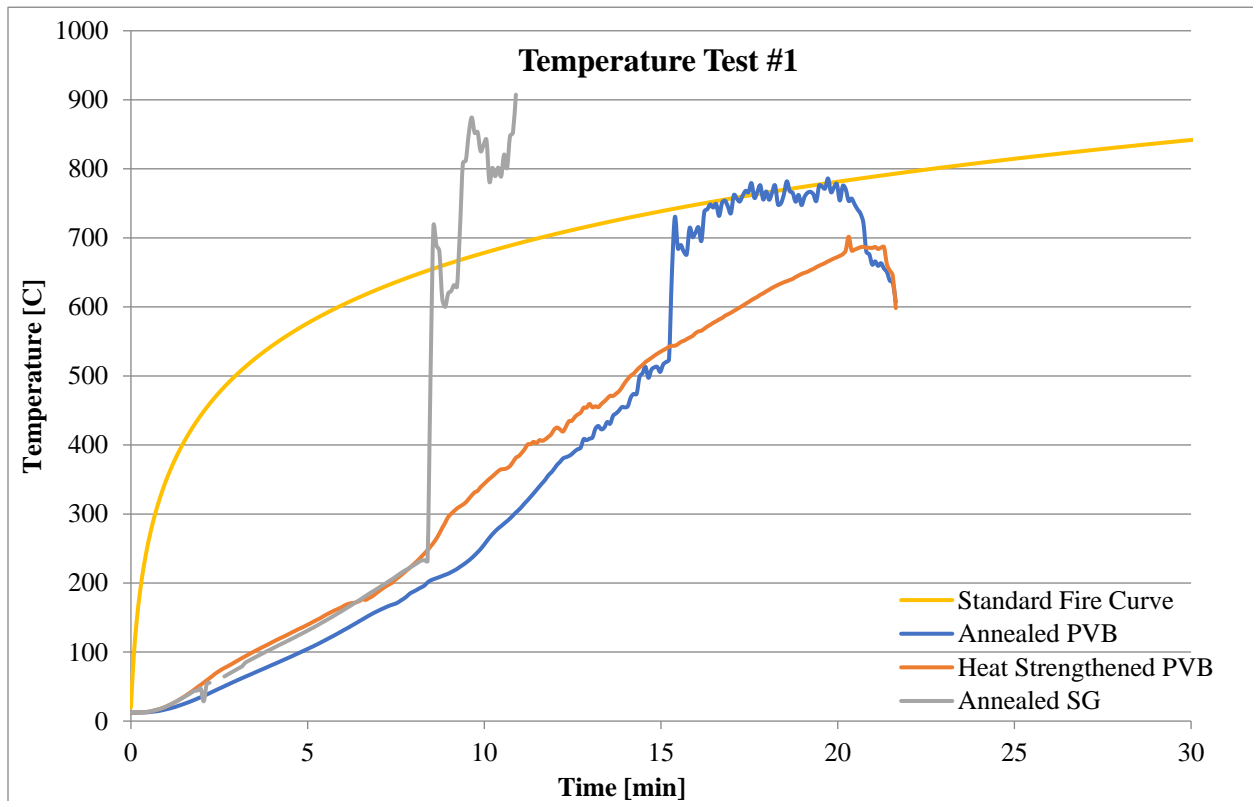
Figure 53 - Thermocouple temperature readings of the beams in test 1 - Annealed PVB, Heat Strengthened PVB and Annealed SentryGlas

The thermocouple readings from the test are plot in the figure above. What we can see in first glance is the moment at which both annealed beams fail due to fracture. The steep and almost vertical rise in temperature of both temperature curves approximates the temperature of the fire furnace.

interlayer in the annealed and heat strengthened beam shows a sharp increase in heating. At this same temperature the SentryGlas annealed beam fails.

At this moment the PVB interlayer has dripped out on the underside of the beam for a few minutes. The interlayer around the laminated thermocouples will have softened as well, possibly exposing the end of the thermocouple to more direct heating of the oven. The temperature curve for the interlayer shows small temperature peaks which may be caused by the flames created by the burning interlayer.

The end of the test is visible in the temperature curve, showing a decrease at approximately 20 minutes.

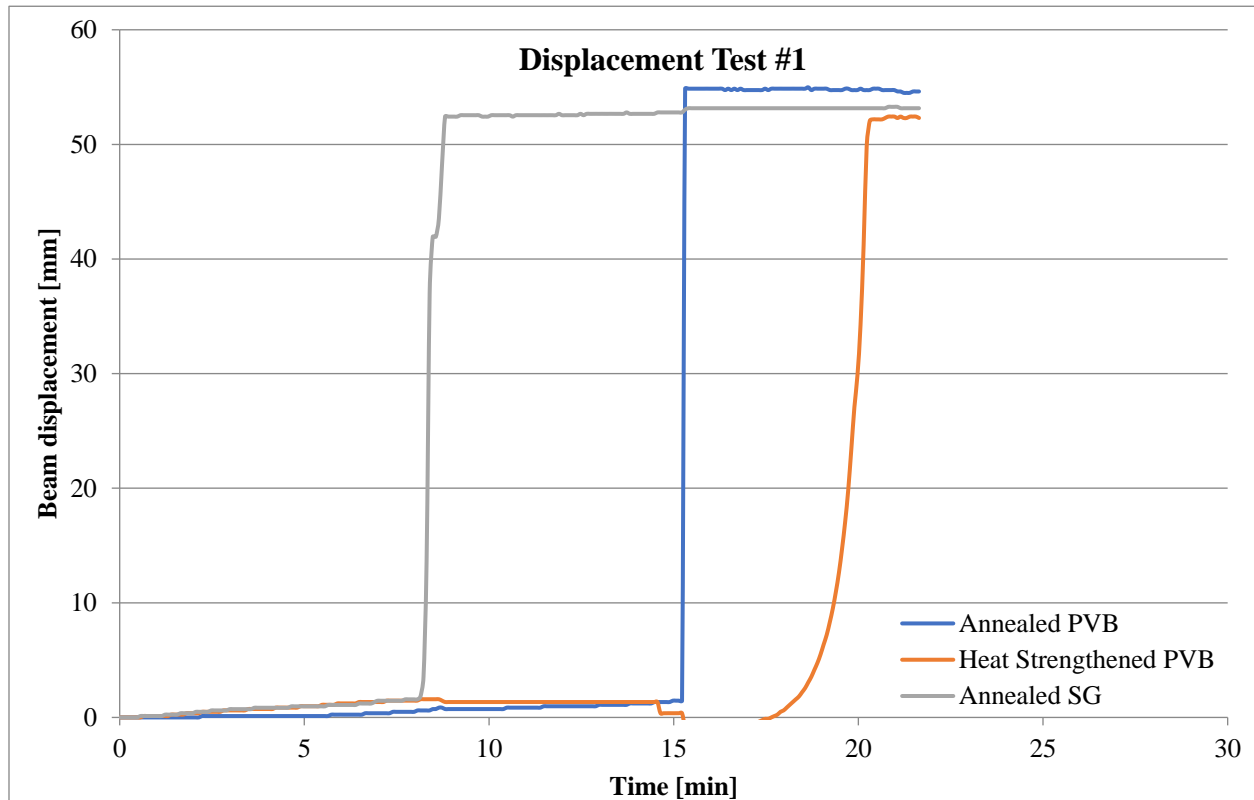
Figure 54 – Displacement readings of the beams in test 1 – Annealed PVB, Heat strengthened PVB and Annealed SentryGlas

When plotted the displacement of the two fractured annealed beams shows an abrupt and sudden displacement, which reaches the maximum displacement almost immediately. The heat strengthened beam on the other hand shows a gradual increase of the displacement resulting from the decreased material strength of glass at high temperature. The rate at which the beam displaces increases over time

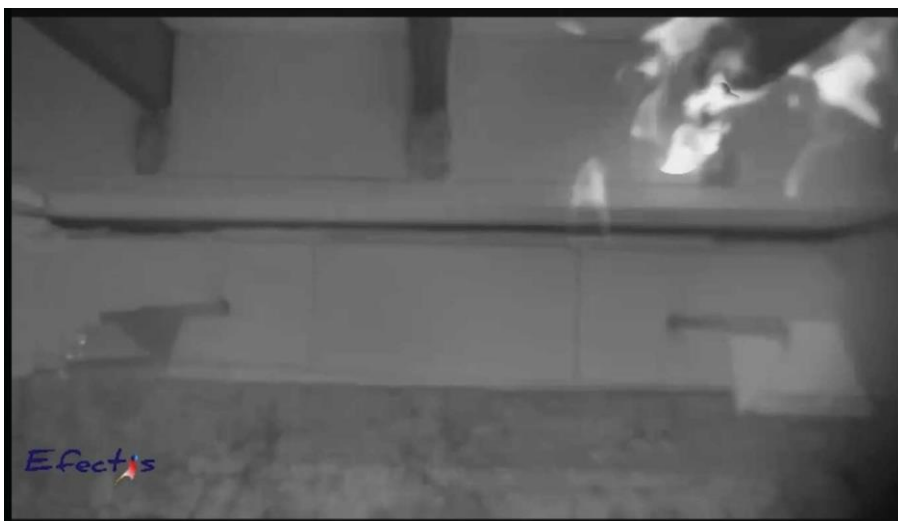
Figure 57 – Flames of burning interlayer underneath beam 3

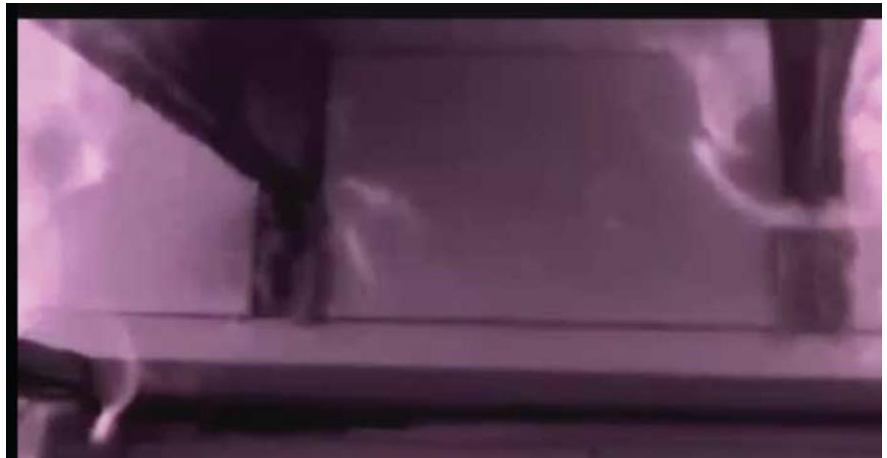
Figure 58 – Delamination in beam 2 on the right hand side and a decomposition pattern visible in beam 1 on the left

At 11 minutes the middle beam #2, starts to show signs of delamination of the glass pane facing beam #3. The interlayer on this side seems to have melted away completely while the other interlayer still forms a laminate between two glass panes. The glass pane facing beam #3 slowly deforms laterally showing a gap between the rest of the beam. This can be seen in figure 59 below.

The direction of the melting process of the interlayers becomes visible in the reflection of one of the flames during the test. Figure 1 shows beam #1 in which a slight dark curvature is visible in the glass. The interlayer decomposes from the middle bottom of the beam towards the top and sides of the beam. This probably due to the direction of the heating of the beams.

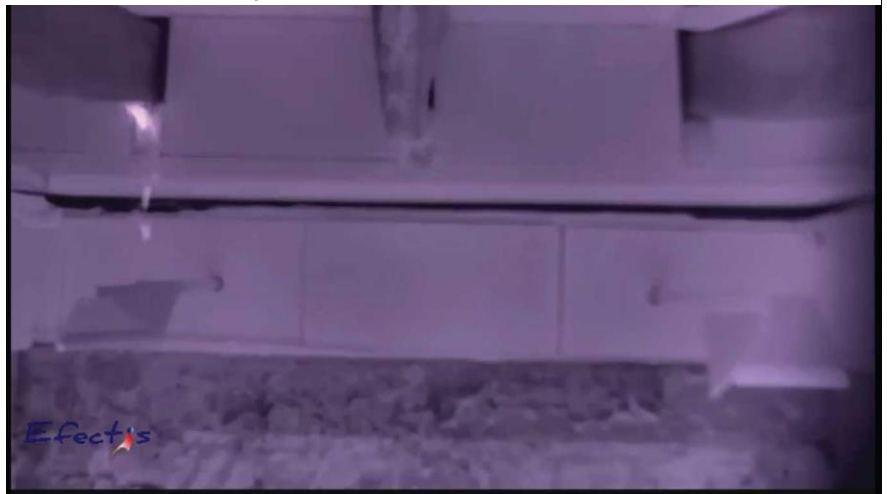
Figure 59 – Deformation of all 3 beams with a slight torsion in beam 2. Flames have stopped at this point.

Contrary to the expectations before the test, beam #2 is the first to start deforming (14.46). The fully tempered beam starts to deform before the flames of the burning interlayer have decreased or stopped. The beam clearly starts to sag and even twist a little at almost 18 minutes into the test(17.58min). The torsion that can be seen later in the test in figure 60 may be caused by a different heating rate of the individual glass panes in beam #2, a lower temperature of the glass means a tougher material or young's modulus and thereby giving it different mechanical properties.

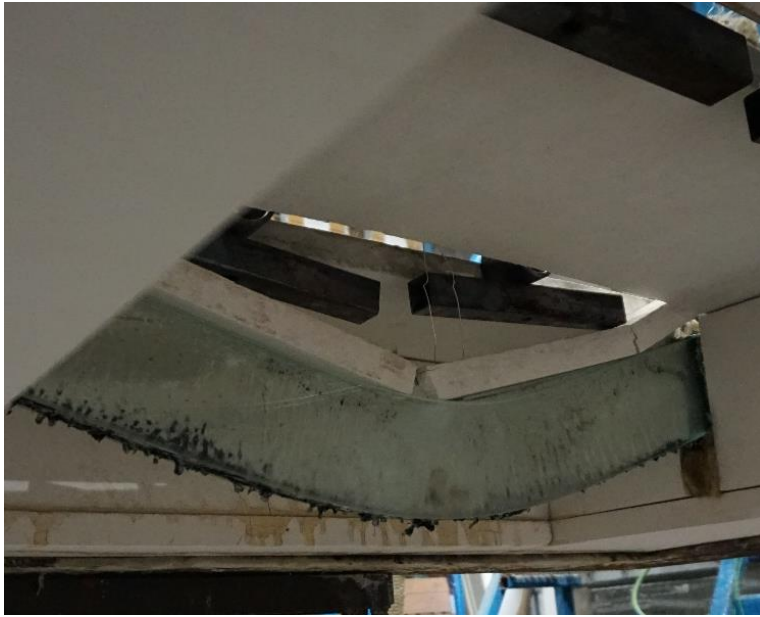
Figure 60 – Displaced beam which remained in set-up after test with a strong curvature. The residue on the glass is from burned up SentryGlas interlayer

What can be seen from the residue on the beam is that PVB interlayer burns a lot cleaner than the SentryGlas interlayer as can be seen in the figure to the left. The PVB beam from test #1 had clean glass panes with hardly any residue, while the SG leaves white and black residue.

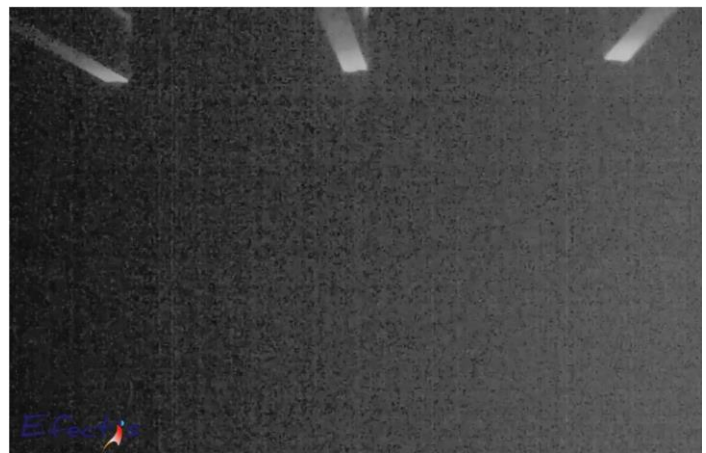
Figure 65 – Image of oven camera during the first minutes showing light transmitting into the oven from outside.

The oven camera in the test starts off focussed on the light transmitting into the oven. Luckily for the observation of the rest of the test the focus slowly shifts to the inside of the oven. Four minutes into the test the light transmittance through the glass becomes minimal as the interlayer becomes affected by the rising temperature.

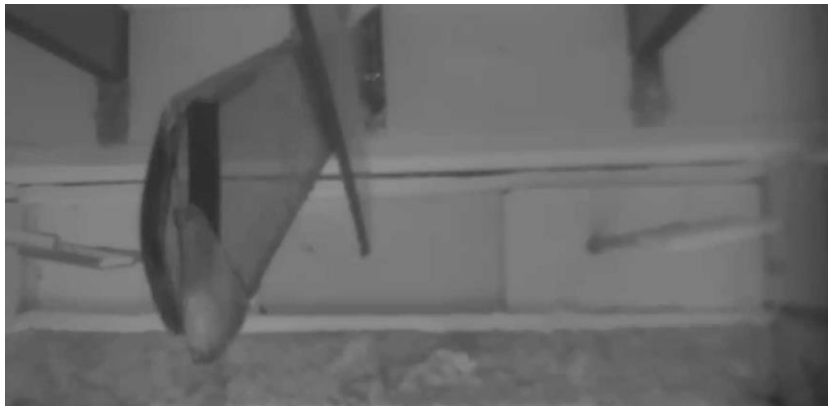
Figure 66 – Failure of beam 2, showing the single vertical fracture in each beam, typical to annealed glass. The beam fails in a scissor like motion.

Beam #2 fails after just 7 minutes and 55 seconds due to thermal shock. The failure pattern is very similar to the failure of the annealed glass beam from test #1. The glass panes fracture close to the vertical promatect panel and the beam fails in a scissor like deformation as the panes slide apart. The glass panes crack on one side of the beam in a clean single vertical fracture from top to bottom. This can be seen in figure 67 , which shows two fractured glass panes that drop passed the oven camera and

rotate away from the single glass pane that has cracked on the other side of the beam. Due to the slightly soft interlayer the beam slowly drops instead of dropping immediately. Another interesting observation that can be made from the failing beam is that in the SentryGlas interlayer drops have formed

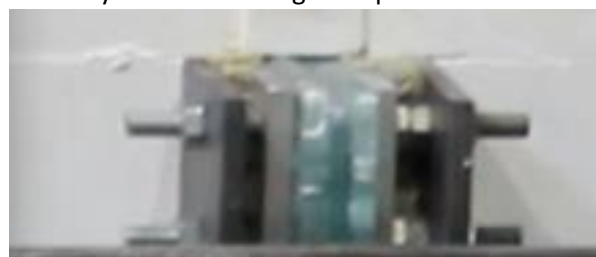
Figure 77 – A still of further fracture in beam 2 visible on video footage

The colour of beam #1 and #2 changes(11.01min) from the blue/green tint to the intense yellow and orange glow of the flames underneath. During the intense flames created by the adhesive and interlayer of beam #2, the beam undergoes some additional cracking. This is visible on the camera footage as one of the outer panes undergoes additional fracture, the glass becomes a bit lighter in colour.

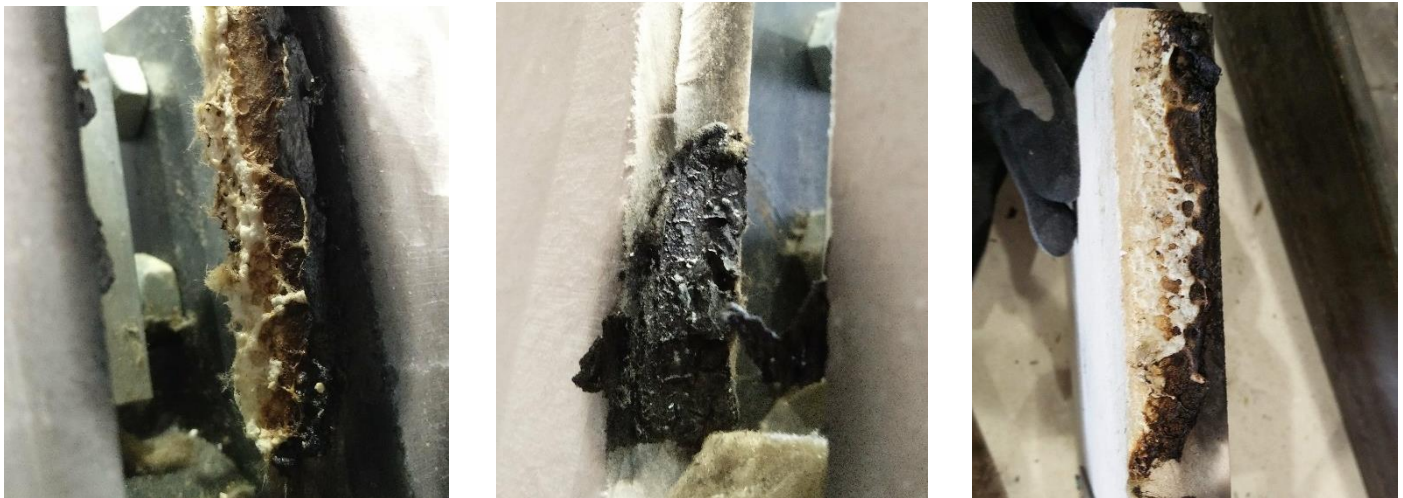
Figure 78 – Intumescent residue of the HCA-TR intumescent coating on the test set-up after test 4

In the meantime, beam #1 & #3 show no flames. Beam #3 doesn't even show the reflection of the flames underneath #2. This is a confirmation that the intumescent paint applied on three sides of the glass beam is functioning as expected, blocking light and protecting the glass from direct heating. What the expanded intumescent coating looks like or how thick the layer has become cannot be seen from the camera footage on the outside of the oven, it is therefore unfortunate that the oven camera was not available. Afterwards, photos are taken of the test set-up that shows residue of the expanded intumescent coating, these can be seen below.

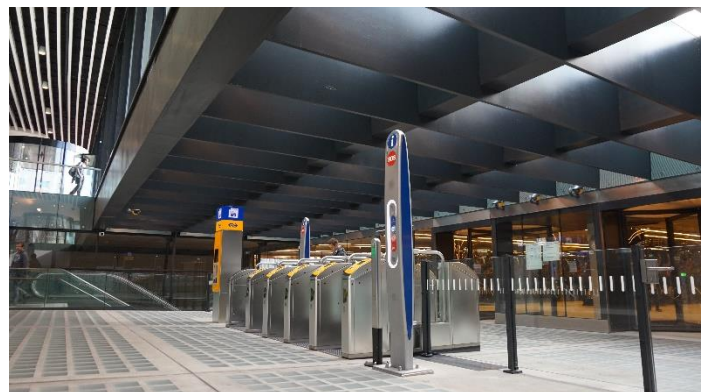
Figure 90 – When standing in the station, the glass floor panels are not visible and the dark steel flanges create a somewhat darker atmosphere
Source: Author

This relatively new building has attempted to realise the daylight intrusion into the underground spaces using glass elements. The daylight is captured using structural glass floor panels. These floor panels are supported by a roster of steel flanges that can be seen in the top of figure 90. The side view however does not show daylight, commuters look against the side of dark, high steel construction elements, which in turn creates a somewhat darker atmosphere.

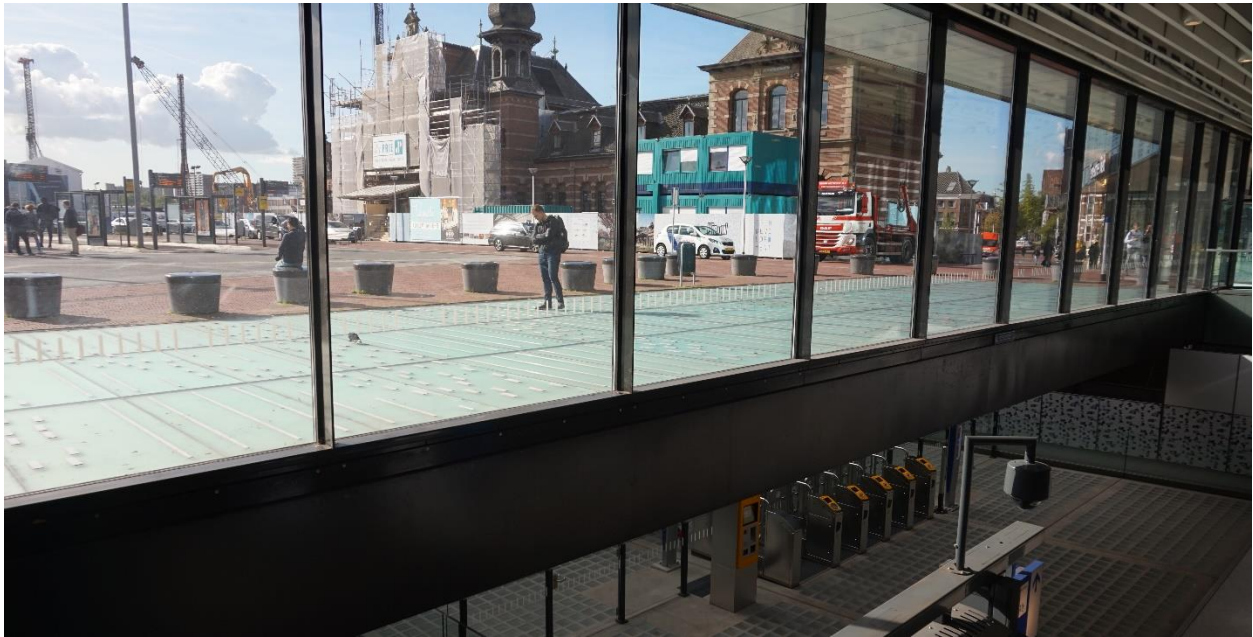
Figure 91 - View of the bus square from inside the station, showing the large spanning I-beam just beneath the facade windows

The bus square above ground has an area with glass floor panels. The panels are approximately 800 centimetres wide and 2 metres long laid out in a grid of 3 x 23 structural glass floor panels. These panels rest on top of a network of steel flanges that span the length of the glass panels. The spanning steel flanges are supported by two steel I-beams, covered by wooden panels. Each glass pane is supported on 4 sides by an aluminium frame which rests on top of the steel beams.
