Fire Resistant Structural Glass Beams

Developing design recommendations for future development
and fire certification of structural glass beams

P5 Master thesis

Delft University of Technology
Building Technology
31st of October 2018

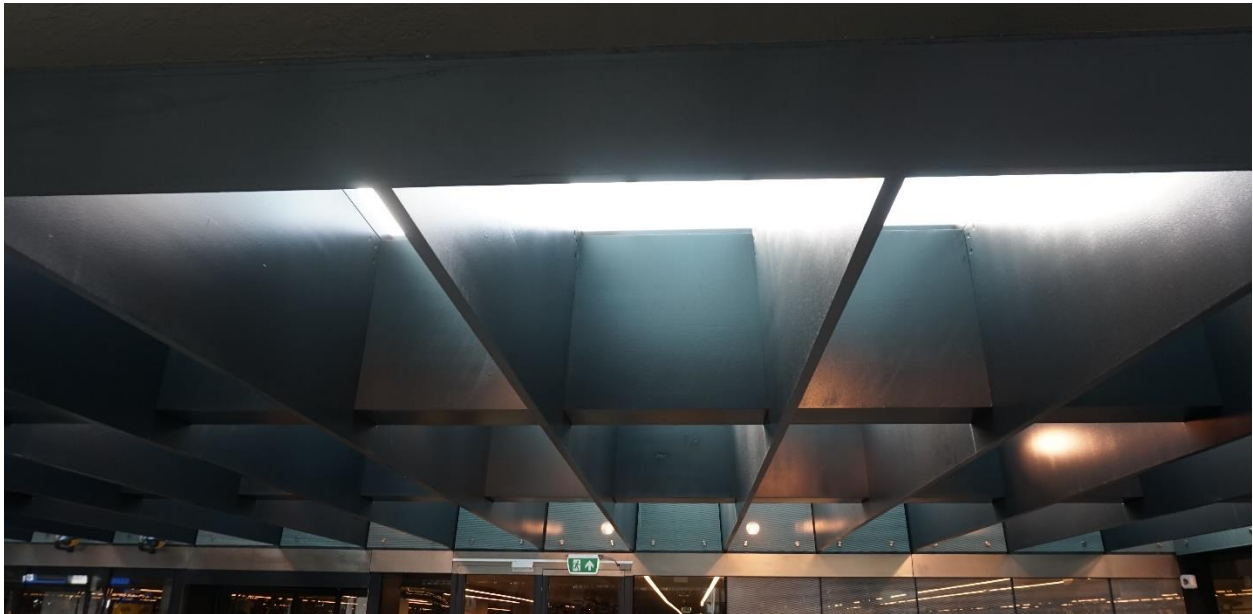
Figure 92 - The dark steel beams underneath the glass floor panels

The bus square above ground has an area with glass floor panels. The panels are approximately 800 centimetres wide and 2 metres long laid out in a grid of 3 x 23 structural glass floor panels. These panels rest on top of a network of steel flanges that span the length of the glass panels. The spanning steel flanges are supported by two steel I-beams, covered by wooden panels. Each glass pane is supported on 4 sides by an aluminium frame which rests on top of the steel beams.
