Buckling and failure assessment of curved butt-joint stiffened thermoplastic composite panels with roller boundary conditions

van Dooren, Kevin; Waleson, Jan; Chapman, Mark; Bisagni, Chiara

Composites Science and Technology

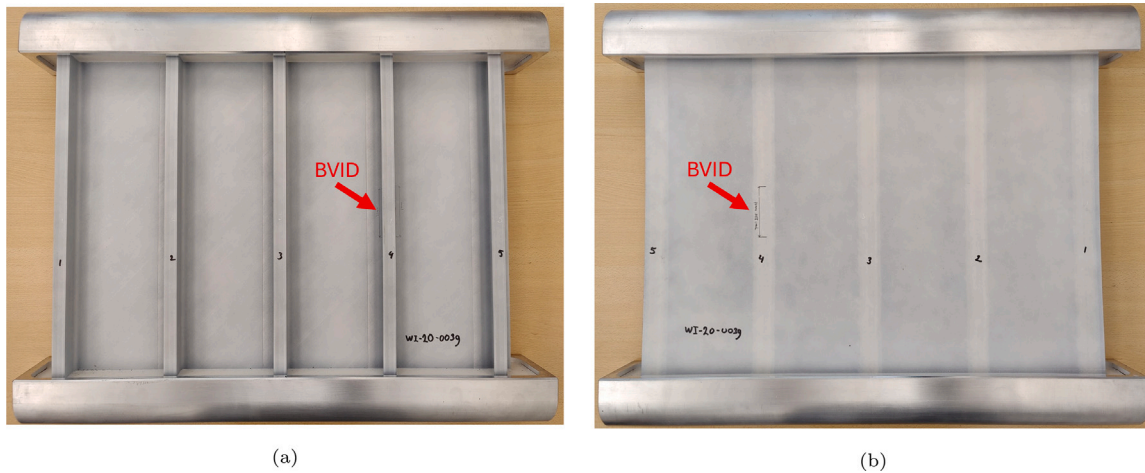
Fig. 1. Panel: (a) stringer-side; (b) skin-side.

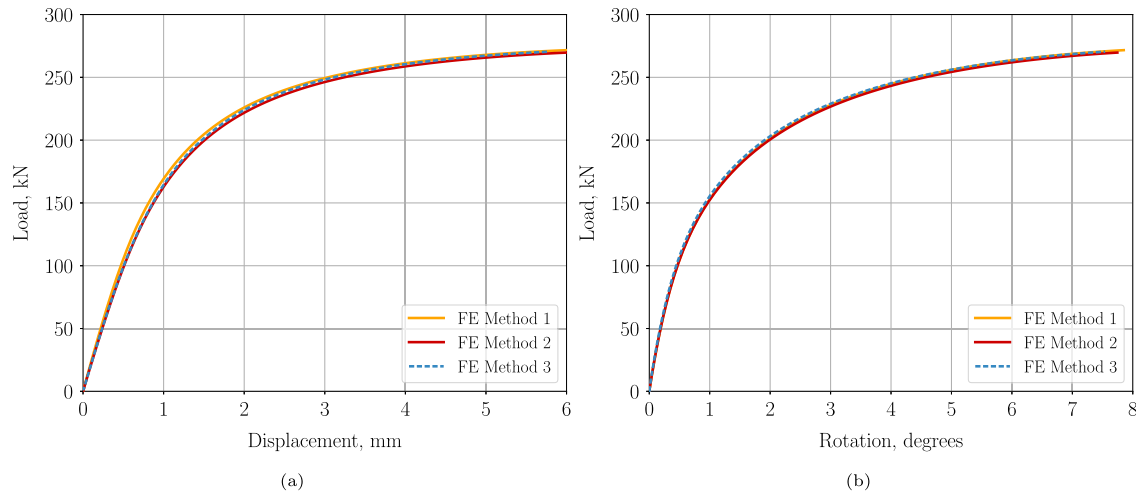
Fig. 5. Load displacement (a) and rotation (b) curves of the analyses with different boundary conditions.

The load–displacement graph of the three analyses is reported in Fig. 5(a). The difference in load–displacement behaviour is minimal between the three different boundary condition methods. Method 1 shows an initial higher stiffness compared to methods 2 and 3 but converges with method 3 at higher displacements. Method 2 matches with method 3 initially but shows a slightly lower load at higher displacements. The roller load–rotation of the three analyses is reported in Fig. 5(b). Only the top roller rotation is reported for conciseness, as the rotation of both rollers is indistinguishable in the analysis. All analyses show similar behaviour, with method 3 initially presenting a higher rotational stiffness and method 2 having a lower overall stiffness. The two outer stringers, stringers 1 and 5, displace in the lateral direction during loading, as illustrated in Fig. 6(a). The maximum lateral displacement of stringer 1 and minimum of stringer 5 are reported in Fig. 6(b) and (c), respectively. Method 2 and 3 have very similar behaviour, while method 1 has a higher stiffness, especially for stringer 1. This is most likely caused by the rigid body tie in the potting region of method 1, instead of the physical modelling of the potting for methods 2 and 3.

This comparison shows that method 1 is an efficient option for a similar load–displacement behaviour compared to method 3, which should be the method closest to reality. However, taking into account the differences in the deformation of the panel and the implementation of damage evolution in the following analyses, method 2 is considered a good compromise in terms of results and computational time. All analysis results in the following sections are obtained using method 2.

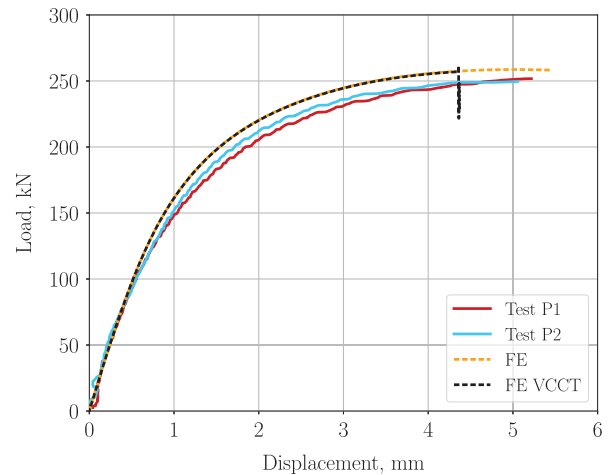
Fig. 9. Load–displacement curves from tests and numerical analysis.

The load-displacement curves of the tests and numerical analysis are reported in Fig. 9. The panels show a decreasing stiffness due to the curved geometry and roller boundary condition, clearly seen at loads above approximately 120 kN. At higher loads close to failure, the load-displacement behaviour starts to plateau. The stiffness of panel 1 and panel 2 are similar. The stiffness of panel 1 is slightly lower between

approximately 1 and 4 mm of displacement, which can be caused by material softening due to the pretest. Panel 1, with BVID, fails at a load of 251 kN and 5.22 mm of displacement, while panel 2 fails at a load of 249 kN and 5.06 mm of displacement. Unexpectedly, the panel with BVID shows a slightly higher failure load and displacement, which indicates that the BVID is not critical for the failure mode that causes the collapse.

The numerical analysis predicts the initial stiffness well, but above 100 kN it starts to over-predict the stiffness. However, the plateau behaviour at higher loads is predicted well. The analysis with VCCT is conservative in predicting failure due to skin–stringer separation, which did not appear to be the critical failure mode in the test. The following sections, therefore, only show results from the analysis without VCCT.

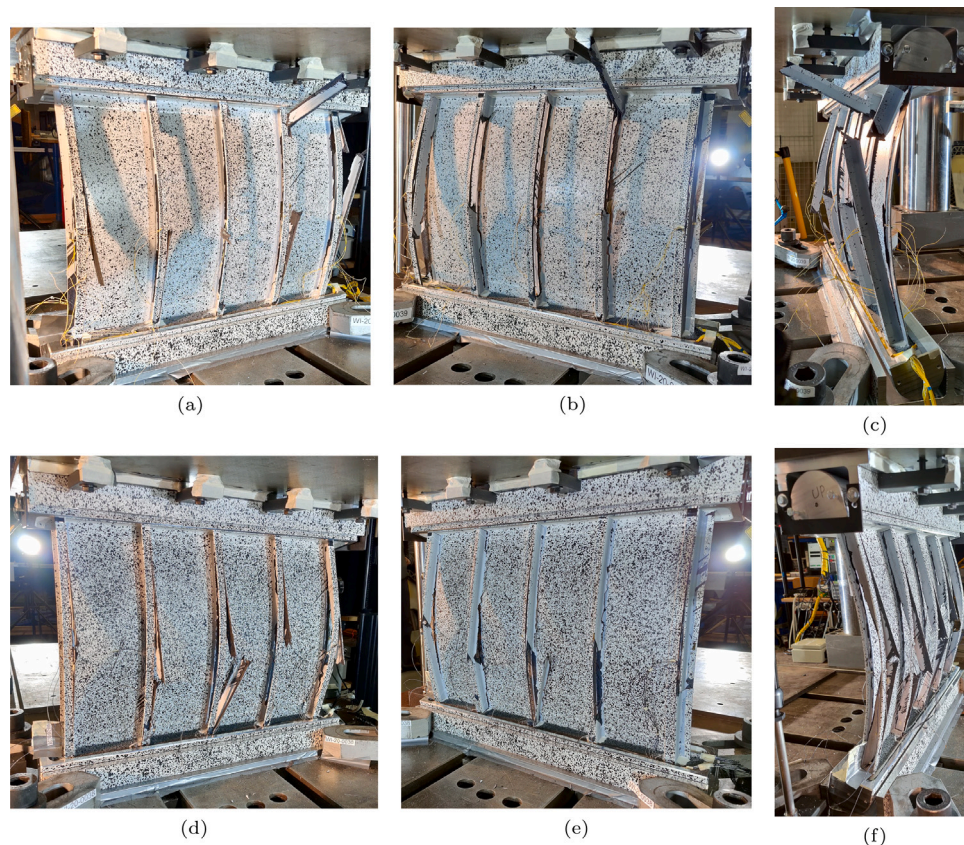
Fig. 15. Post-failure photos: (a) panel 1 left-view; (b) panel 1 right-view; (c) panel 1 side-view; (d) panel 2 left-view; (e) panel 2 right-view; (f) panel 2 side-view.

Photos of panel 1 after failure are reported in Fig. 15(a–c). The caps, once separated from the webs, show fractures in several locations.

The caps of stringers 1, 2 and 5 are also partially pulled out from the potting material. The failure between cap and web seems to occur in two different ways, with the top ply of the web being delaminated and pulled off partially, and with separation between the web and the short fibre filler. In the middle of the panel, it seems that failure and delamination of the web plies is more common, with small pieces of the ply still attached to the cap, while towards the top and bottom of the panel, failure occurs at the interface between the web and short fibre filler. All the webs separated from the skin at the butt-joint. The webs present one or more fractures in each web and parts of the web are no longer attached to the panel. The failure in the web and skin region is mostly in the butt-joint. Stringer 1 has a part of the ply delaminated from the skin at the bottom of the panel, and the remaining butt-joints only show minimal pulled-off fibres. Failure in the butt-joint can be roughly divided into three types of failure: failure at the interface between skin and butt-joint, failure in the short fibre filler and failure at the interface between web and butt-joint. There are no visible fractures in the skin, but there is likely damage inside the laminate. There are indications of damage at the back of the skin, with paint chipped off.

Photos of panel 2 after failure are reported in Fig. 15(d–f). The failure modes, that are initially visible, are similar to panel 1. Stringer 2 fails first and has considerable amounts of fibre pullout from the skin, especially towards the top of the panel. The biggest difference, however, is that the edge of the skin, on the side of stringer 5, shows a large fracture. A close-up picture of this fracture is reported in Fig. 16. The skin is fractured across the thickness of the laminate and has a visible length of approximately 60 mm as seen from the stringer-side of the panel. Further propagation is visible on the back side of the skin, with propagation in a downward direction, leading to a total visible length of approximately 100 mm.

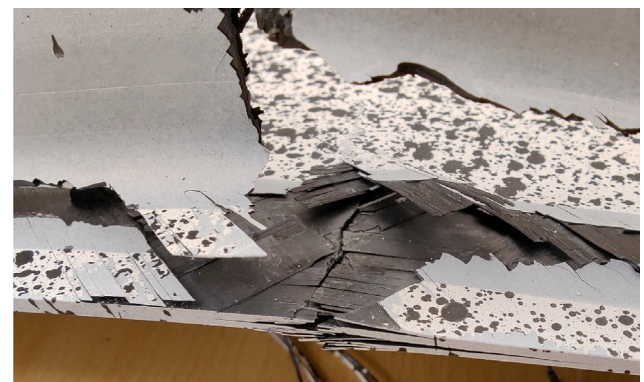
Fig. 16. Skin fracture of panel 2.
