Damage evolution in GLARE fibre-metal laminate under repeated low-velocity impact tests

Research Article

Abstract: An experimental study was performed on the repeated low-velocity impact behaviour of GLARE. Damage evolution in the material constituents was characterised with successive number of impacts. Records were correlated with visual inspection, ultrasound C-scan and chemical etching. The stiffness of the plate varied when cumulating the number of impacts. Damage accumulation was limited thanks to the synthesis of unidirectional composite and metal. The glass/epoxy plies with high elastic tensile strength could withstand several impacts before perforation despite delamination growth in the vicinity of the impacted area. The damage tolerant aluminium layers prevented the penetration of the projectile and avoided the expansion of delamination. This efficient mechanism preserved the structural integrity of GLARE until first aluminium cracking at the non-impacted side. Among the different failure modes, plate deformation absorbed most of the impact energy. The findings will support the development of a generic quasi-static analytical model and numerical methods.

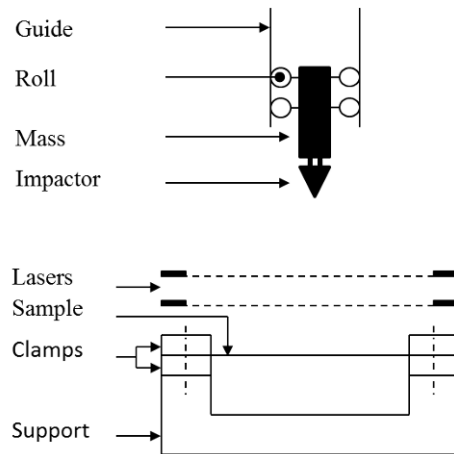
Figure 2. Schematic of the drop test set-up.

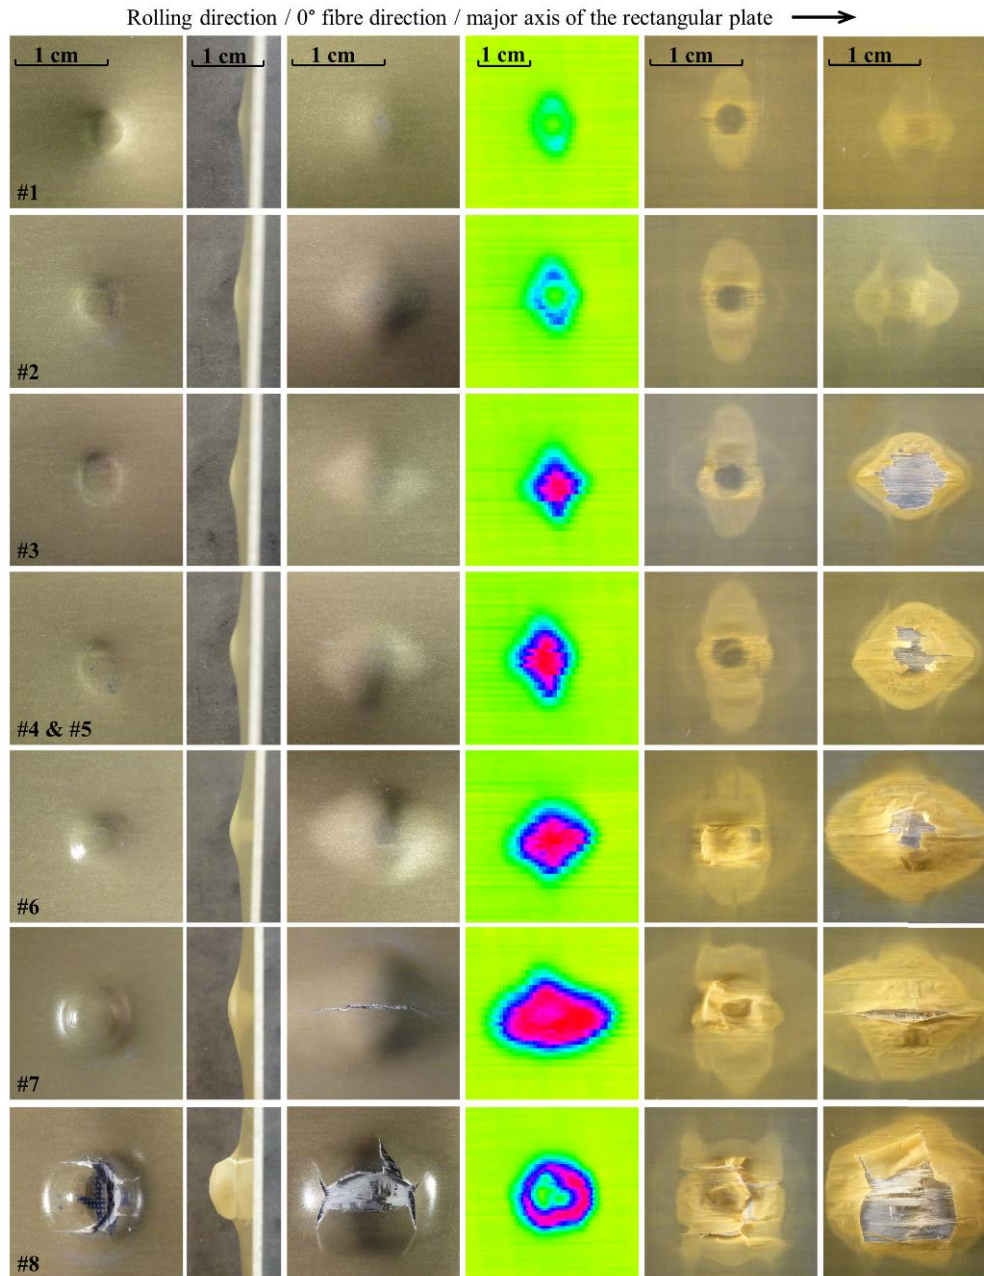
Figure 3 describes the damage evolution in GLARE 5-2/1-0.3 under repeated low-velocity impacts until the penetration threshold. The front, lateral and back sides are

Figure 3. Views of front, lateral and back sides, C-scan, etched front and back sides of GLARE 5-2/1-0.3.

presented with the corresponding C-scanned and etched views. As obvious from these pictures, the entire damage contour increased with higher cumulative number of impacts. The following description states when the different types of damage initiated.

1st impact: Damage occurred. A lateral permanent deformation amounted to 3 times the plate thickness. By inspecting the etched views, matrix cracking was detected thanks to white stripes along the 0° fibre direction that

were visible on both sides. Despite internal damage in the composite plies, both top and bottom interfaces with the metal layers were intact. Concurrently, delamination (dark green zone in C-scan view) initiated between the composite plies at the periphery of the impact location at the top side and developed along the minor axis of the plate. Nevertheless, it started under the impacted zone at the bottom side along the major axis. In the impacted aluminium layer a visible dent was delimited by a circular

2nd impact: Delamination slightly expanded in the same directions as described earlier. Matrix cracking was more pronounced as seen in the etched views. Though it initiated previously, it was detected from that moment in the blue region of the C-scan view. No variation was found with respect to the aluminium layers. The lateral plastic deformation rose to 3.5 times the plate thickness.

3rd impact: A few fibres started to fracture (etched sides and red area in C-scan image). At the impacted side fibres broke around the impact location while it happened in the middle of the impact location at the non-impacted side. Delamination kept growing. Disbonding took place in the bondline between aluminium and composites (dark blue region in C-scan picture and the adhesive could be peeled off as seen in the etched back view). The impacted aluminium side disbonded to composites at the periphery of the contact area whereas at the non-impacted side it happened in the whole delamination zone. No change in damage type was found for the aluminium layers. The lateral deformation marginally increased.

6th impact: Unlike impact #5, a crack in the distal aluminium initiated from the centre of the impacted zone along the rolling direction while the top aluminium layer remained intact with a visible dent. Disbonding at the impacted side reached finally the centre of the impacted zone. Since then, both aluminium layers were completely disbonded at the impact location as pictured in the etched views. Two clear lines of fibre fracture along the rolling direction were observed at the periphery of the contact area at the impacted side whereas fracture was in the middle of the impacted zone at the non-impacted side. The other aforementioned failure modes enlarged and the permanent flexure reached 4.2 times the plate thickness.

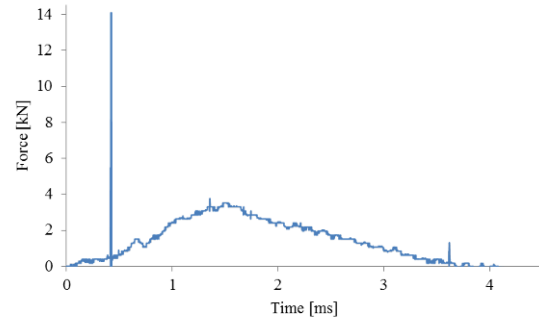
Figure 4. Recorded force-time curve at impact #7 with damage initiation stages.

Test records indicated also damage initiation. It could be tracked from the force-time curves as shown in Figure 4. The magnitude of the kink loads varied between 1 kN and 14 kN. Given that about 4000 points were recorded in each test, a simple moving average on 100 points was used in the force-time data series to reduce data scatter and report longer-term fluctuations. Beforehand, the kinks highlighted in Figure 4 were deleted. From the modified curves in Figure 5 all the plots present ripples except #1 that is less affected.

The kinks observed in the force-time curves are reported in Table 2 in correlation with the observed damage. The difference in magnitude between the kink loads and the main curve suggests what type of damage initiated. High kinks are seemingly related to aluminium cracking whereas small kinks describe fibre failure.

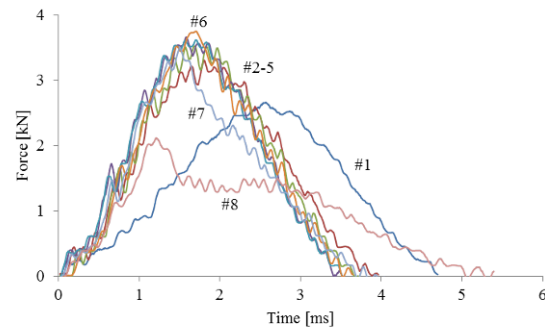
Figure 5. Mean force-time records.

In Figure 5, stiffness increases with the maximum force [6]. Moreover, the sooner the maximum force, the more brittle the laminate becomes [20]. The maximum force increased by 24% from impact #1 to #2 and it remained constant until first cracking at impact #6. Impact #7 is the transition stage where the bottom crack propagated: the unloading path of the curve happened more rapidly. At impact #8 the maximum force dropped by 40% as penetration occurred. Aluminium cracking is the ultimate failure mode in a FML under impact loading.

Zhou [20] indicated that an undamaged laminated plate presents an impact response like half a sine wave. However, damage was present in all the coupons of this investigation: ripples in Figure 5 show evidence of delamination [20]. It was present in all the impact tests except for #1 in which it barely started. Undeniably, the sooner the peak force, the larger the damage extent is. In curve #8, the penetration of the plate should be manifested by a final load drop at the peak of the force-time curve. In this test, the impact force was followed by a plateau at a lower level. As the conical nose was going through the plate, the contact area increased. Hence, the residual force stayed rather stable before actually reaching zero force.

plots #2-7 than for #1 and #8. The analogous shape of #2-7 indicates that the glass/epoxy plies are dominating the flexural behaviour at these impact stages while #1 and #8 with larger permanent flexure demonstrate that plastic deformation occurred in the aluminium layers. In comparison with Figure 5, the higher the stiffness, the sooner the maximum displacement becomes.

When relating Figure 5 to Figure 10, the resistive stiffness of the plate increased until impact #5 because the contact time became shorter. When approaching penetration from impact #6 onwards, contact time increased: the residual stiffness of the plate was drastically reduced. Three cases are highlighted [20, 21]. If time at maximum force equals half of contact duration, the impact is purely elastic. If time at maximum force is shorter than half of contact duration, the larger the damage area becomes as illustrated in Figure 3. A time at maximum force longer than half of contact duration implies aluminium yielding. A dent was visible at impact #1 on the top surface of the plate.

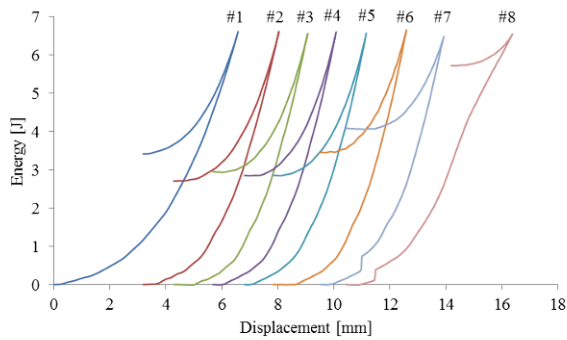
Figure 6 plots the absorbed energy versus the recorded displacement at each number of impacts. In order to better assess any differences, the permanent displacement from the previous test was added to offset the graphs starting from impact #2. Two distinct aspects can be reported. A kink in the curve #7 happened at 0.39 J and in #8 at 0.28 J. The slope in #8 leans towards larger displacement.

Figure 6. Energy-displacement curves with displacement off-set from impact #2.

As seen in Figure 6 and Table 1, the flexural displacement becomes larger with the energy absorbed by the plate. This remark refers to the formula of strain energy in which strain energy is directly proportional to strain [19].

The kinks presented in Figure 6 show evidence of discontinuities in the plate response when penetration occurs. Relating these features to the observed phenomena, the kink at 0.39 J in the curve #7 is probably due to the growth of the crack that initiated in the non-impacted aluminium layer. The one at 0.28 J in the curve #8 is possibly the result of the crack initiation in the impacted aluminium layer. The flexural gain in the curve #8 that emanates from petaling of aluminium certainly helps in absorbing a larger quantity of impact energy. This behaviour demonstrates that the plate is being penetrated.

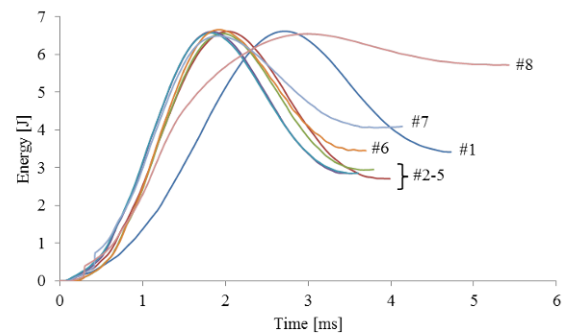
Figure 7. Energy-time records of repeatedly impacted panels.

Figure 7 illustrates the energy absorption ability of the impacted plates. The exact values of the absorbed energy at each impact are presented in Table 1. Successive impacts increased damage size, resulting in higher absorbed energy. Curves #6–8 verify this trend. In these samples, metal layers were cracking and undergoing petaling which led to immediate penetration of the plate. However, at impacts #2–5 the absorbed energy remained steady even if the delamination area was enlarging and fibres were breaking as seen in Figure 3. Thus, both delamination and fibre failure are quite low-energy absorbing failure modes. Despite the similarity in material thickness between composite and metal in GLARE 5-2/1-0.3, *i.e.* the metal volume fraction amounts to 54%, aluminium failure modes absorb a significant quantity of energy whereas the glass/epoxy ones appear to be negligible.

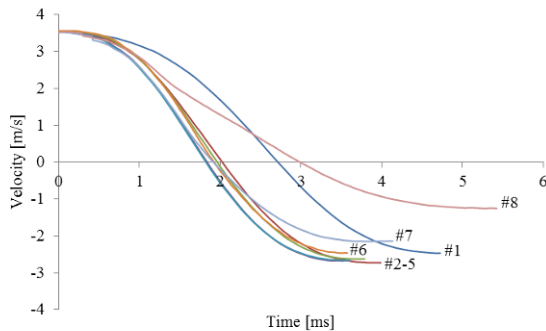
The observations quoted before could be made likewise with the velocity-time curves as illustrated in Figure 8. In the kinetic energy formula, the energy is a function of the velocity.

**Figure 8.** Velocity-time records of repeatedly impacted panels.

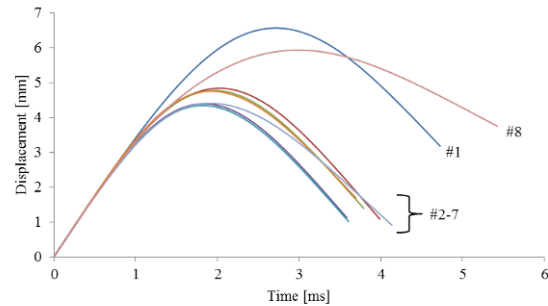
The influence of glass/epoxy composite and aluminium alloy on the displacement-time curve can be depicted in Figure 9. The maximum displacement occurred 1 ms sooner for the

**Figure 9.** Recorded displacement-time curves.

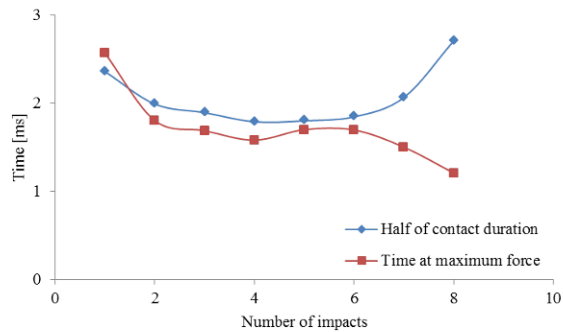
Figure 10. Half of contact duration and time at maximum force vs. the number of repeated impacts.

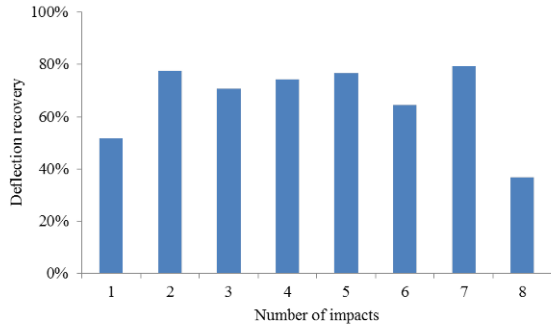
Figure 11. Deflection recovery vs. number of impacts.

Deflection recovery at each number of impact is illustrated in Figure 11. The deflection recovery in steps #2–7 ranges between 65% and 79%. It means that the plate returned to 65–79% near the initial position prior to impact. The high level of recovery elucidates the excellent impact performance of FMLs over composites and monolithic aluminium alloys. In contrast with the quasi-elastic recovery of composite layers, the recovery amounts to 52% only at impact #1. Plasticity of aluminium and matrix prevented then the glass fibres to fully spring back to their initial position. Furthermore, when penetration occurred, the deflection recovery amounted to just 37% at impact #8: all fibres were fractured at the impact location. The glass fibres contribute effectively to delay the perforation of the plate and maintain little permanent deflection.

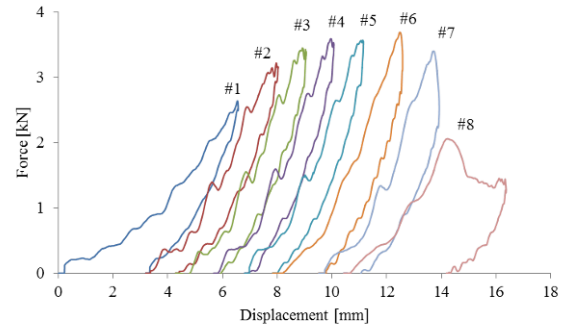
From this observation the idealised plate behaviour under repeated impacts can be reconstructed. Figure 12 depicts the force-displacement relations until penetration with the permanent displacement off-set of the previous test starting from record #2.

With a repetitive quasi-elastic behaviour – slope of loading path is similar to the unloading one but at larger displacement – GLARE 5-2/1-0.3 could recover from 5 impacts of

Figure 12. Force-displacement curves with displacement off-set applied from impact #2.

a large mass before first cracking at impact #6. Two more impacts were necessary to reach the penetration threshold. The outstanding damage tolerance capability of GLARE is the result of the high level of elastic recovery after successive impacts.
