Interface adhesion assessment of composite-to-metal bonded joints under salt spray conditions using peel tests

Teixeira de Freitas, S.; Banea, M.D.; Budhe, S.; de Barros, S.

Composite Structures

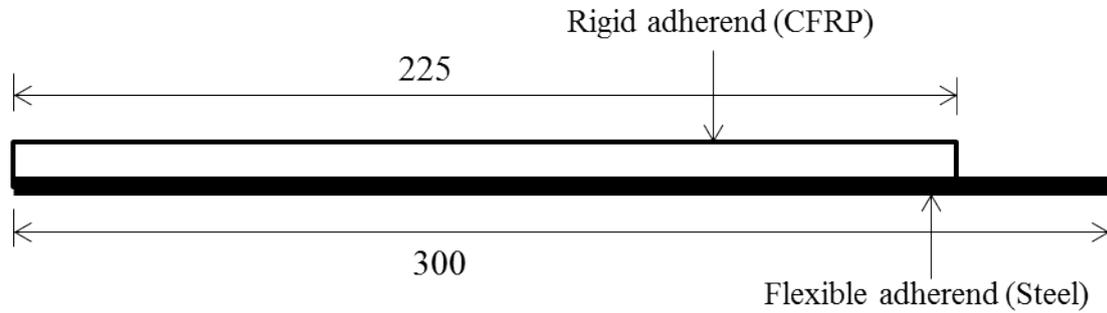
adhesively bonding the carbon steel as the flexible substrate with the CFRP as the rigid substrate (fig.1).

Figure 1. Peel sample with different peel length adherends (dimensions in mm).

Peel test specimen dimensions were based on the standard test method ASTM D 3167 [38] floating roller peel tests for metal bonding. Specimens were 25 mm in width and 300 mm long with a total thickness of 4.8 ± 0.3 mm (average \pm standard deviation) – see Fig.1.

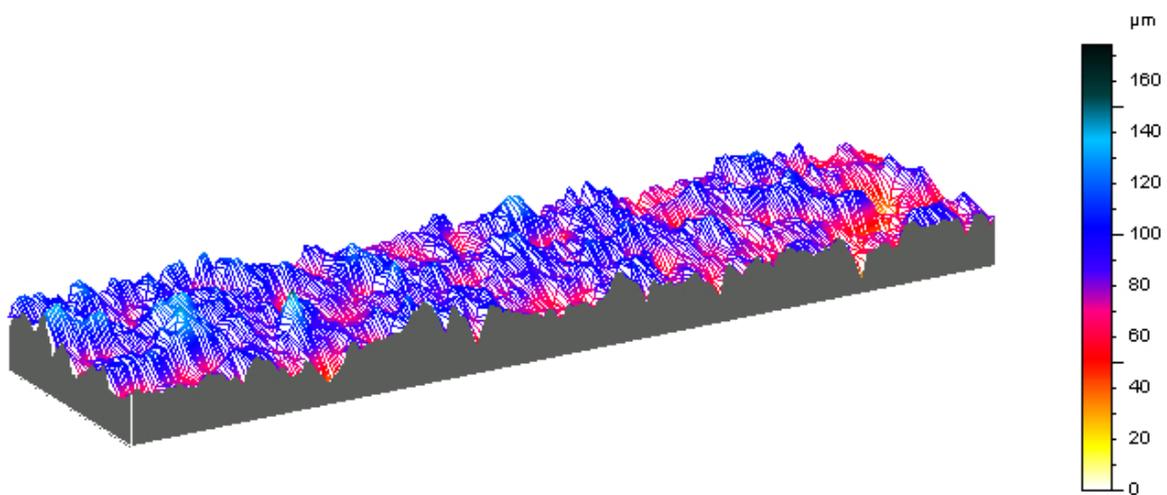
The carbon steel plate was cleaned and passed through a grit blasting process with G-40 steel shot then it was degreased using acetone. The surface was analysed in a Taylor Hobson roughness Talyscan 150 (Leicester, UK) equipped with a 2 μm diameter styles probe. The scan speed was 1000 $\mu\text{m}/\text{s}$ under temperature and humidity control (23°C and 60% RH). Figure 2 presents the 3D surface profile of the grit-blasted steel plate. The roughness parameters are presented in Table 1.

Figure 2. 3D surface profile of grit-blasted steel.

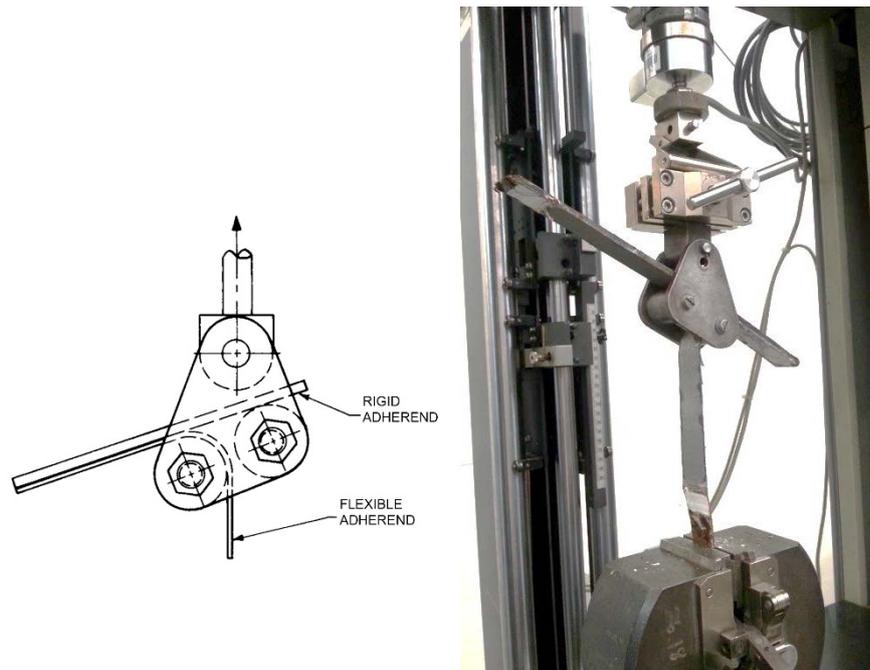
During testing, the flexible adherend (steel) is peeled off from the rigid adherend (CFRP). Standard floating roller peel tests (FRPT) were performed on both aged and non-aged specimens at room temperature (RT) conditions. Testing was carried out using an electro mechanic Zwick machine with maximum capacity of 20 kN, coupled with a load cell of 1 kN. The testing speed was 125 mm/min as per standard ASTM D3167 [45]. Figure 3 shows the tests set up of the peel test. In order to study the long term durability of the joint, the specimens were kept inside the salt spray cabinet (5% NaCl) for 30 days and 90 days. Three specimens were tested in each condition. During testing, load-displacement curves were recorded.

Figure 3. Floating roller peel test set up.

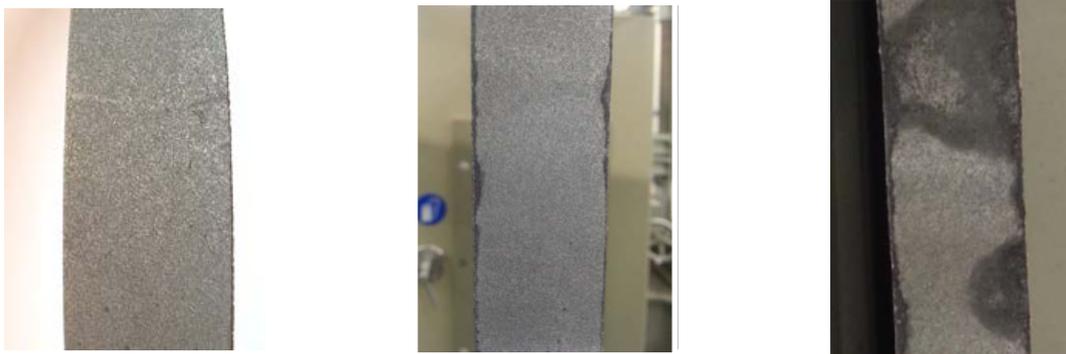
(a) non-aged

(b) 30 days in Salt Spray

Figure 4. Examples of fracture surfaces of the flexible adherend (steel) after peel test.

Figure 4 shows a typical fracture surface of the steel substrate after testing. It can be seen that the cohesive failure was the dominant failure mode for the non-ageing condition – see Fig. 4(a). This indicates a good adhesion quality of the bonded joints. Cohesive failure was also the dominant failure mode after 30 days in salt spray condition, but small adhesive failure areas (less than 5%) were observed at the edges of the specimens – see Fig. 4(b). This implies

that after 30 days in SS the interface is marginally affected by the ingress of moisture. After 90 days of exposure, the adhesive failure areas increase significantly, which is also shown by the decrease in peel load. The pattern of the adhesive failure is also mainly at the edges of the specimens, but in some area crosses the complete width of the specimen, as shown in Fig 4 (c). The fracture surface of the ageing specimens shows that the moisture ingress is through the edges to the center of the specimen and it is not always affecting the complete adhesion surface. Increasing exposure times increases the moisture ingress and consequently adhesive failure areas and decreases the peel loads.

The 90 days salt spray aged specimen presented in Figure 4 (c) was selected to conduct a fractographic analysis of the different failure surfaces present along the peel length. The analysis consisted in, firstly, visually observe the exposed fracture surfaces, secondly, select areas of interest using optical microscopy and finally characterize the selected areas using Scanning Electron Microscope (SEM).

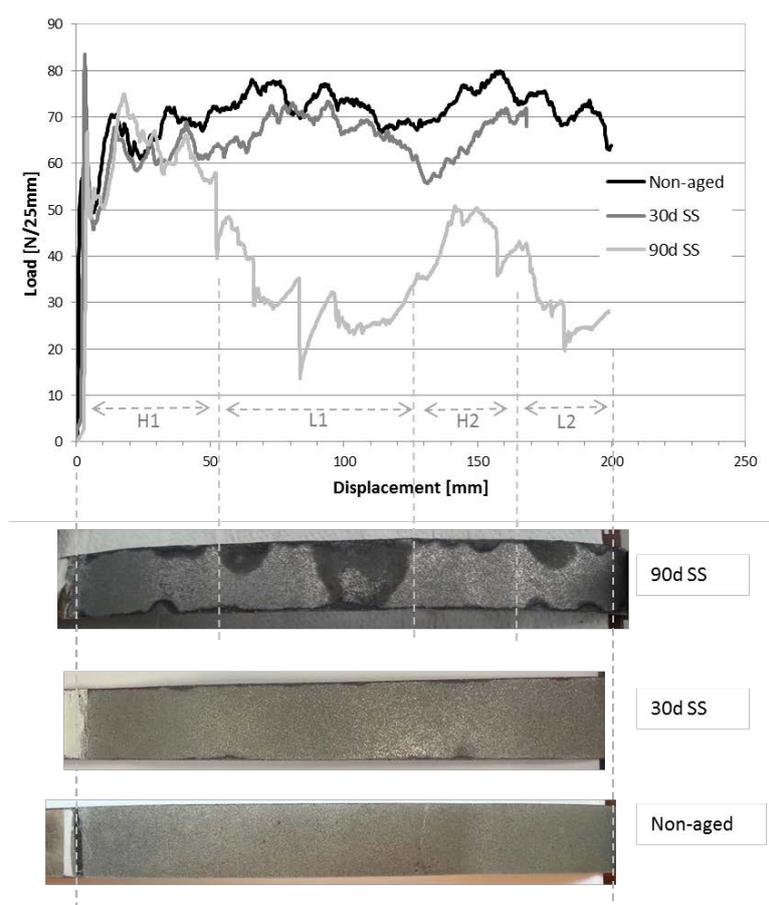
Figure 5 shows typical load-displacement curves measured during testing and the corresponding fracture surfaces of the flexible adherend (steel substrate).

The non-aged specimen presents a steady peel force along the complete displacement. Moreover, the peel load is within the range of 70N/25mm. The corresponding fracture surface is cohesive failure along the complete peel displacement.

Figure 5. Load displacement curves non-aged, 30 days and 90 days aged on SS and the correspondent failure surface of the flexible adherends.

After 30 days in the SS cabinet, the peel strength decreases slightly. This corresponds well with the fracture surfaces since most of the failure observed is cohesive along the complete peel length.

The specimen aged for 90 days in the salt spray presents more unstable peel strength. The peel strength can be divided in four different areas along the displacement. In zone H1 – highlighted in the Figure 5, between 0 mm and +50 mm of displacement, the peel strength is very similar to the non-aged specimen, as is the failure surface which is mainly cohesive. In this area, the adhesive failures are located at the edges of the specimen. This is where the adhesion degradation starts, as this area is in direct contact with the outside environment. This is followed by an area of lower peel strength – zone L1, between 50 mm and 125 mm, where

the peel strengths decrease significantly. This is justified by the change in failure mode from cohesive to adhesive failure, as can be confirmed in the corresponding fracture surface. In some areas the entire width of the cross section has been affected. This significantly decreases the peel strength, as a consequence of a loss of adhesion at the interface. Between 125 mm and 165 mm of the displacement, the peel strength increases again – area H2, but not reaching the initial peel strength. In this area the aging has progressed less from the edge to the center than in area L1 and therefore the peel strength is higher than in L1 but still significant adhesive failure is present. Finally, in zone L2, the area of adhesive failure increases due to further degradation at the interface, which results in a lower peel strength.

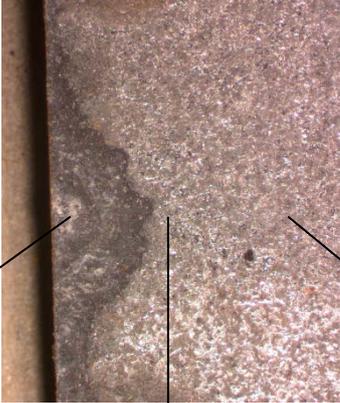
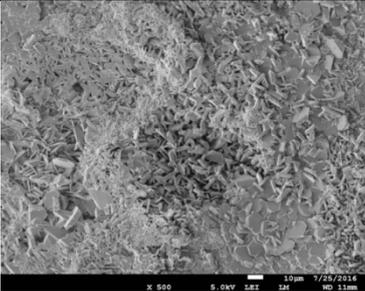
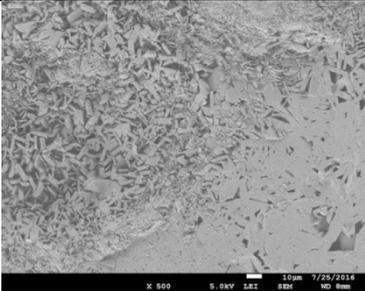
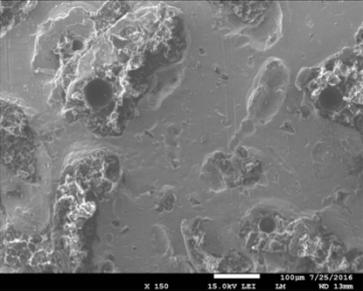
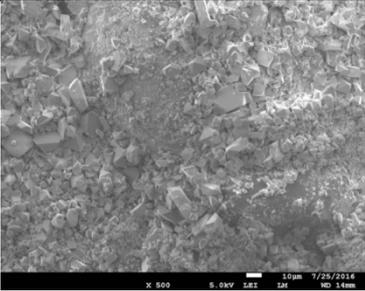
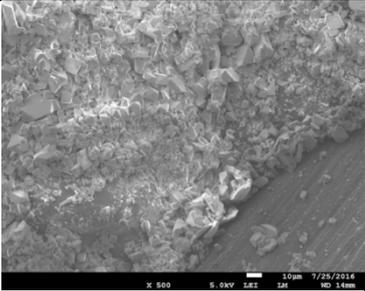
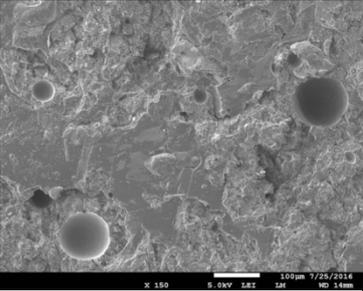
Table 3 – SEM pictures of typical fracture surfaces of the peel specimens.

Flexible adherend (x1)

<div style="display: flex; justify-content: space-around; margin-top: 10px;"> (1) (2) (3) </div>		
Flexible ad. (Steel)

<p data-bbox="295 1377 454 1422">(SEMx500)</p>

<p data-bbox="675 1377 834 1422">(SEM x500)²</p>

<p data-bbox="1054 1377 1214 1422">(SEM x150)¹</p>
Rigid ad.(CFRP/Adhesive)

<p data-bbox="295 1780 454 1825">(SEM x500)</p>

<p data-bbox="675 1780 834 1825">(SEM x500)</p>

<p data-bbox="1054 1780 1214 1825">(SEM x150)</p>

Table 3 shows pictures taken from an area at one of the edges of the specimen where moisture ingress can be visually observed. The optical microscopic images (top) show the typical failure modes: adhesive failure (AF) and cohesive failure (CF), and a “flower-like” pattern of the moisture ingress from the edge to the center of the specimen’s width. SEM pictures were taken from three spots: (1) at the very edge of the specimen (AF), (2) farther from the edge, but still in the degraded area (AF) and (3) a non-degraded area with cohesive failure. SEM pictures were taken both at the steel side and correspondent CFRP side (2nd and 3rd row, respectively).

The fracture surfaces at the edge of the specimen –spot (1), 1st column, present a very rough fracture surface and particularly at the steel side, the surface texture suggest a deposition of salt crystals. At spot (2) – 2nd column, one can observe the same rough surface as in spot (1) with a transition to a smoother surface at the right bottom corner of both pictures (flexible and rigid adherends). Finally, on the cohesive failure area – spot (3), 3rd column, on the flexible adherend (steel side), there are areas of smooth surfaces and areas of rough surfaces. The rougher surfaces include also air voids which suggest that, adhesive is present on those areas. The smoother surfaces can indicate an area of the interface with steel. On the rigid

adherend side the air voids can also be observed on the adhesive. Smoother and rougher surfaces can also be identified.

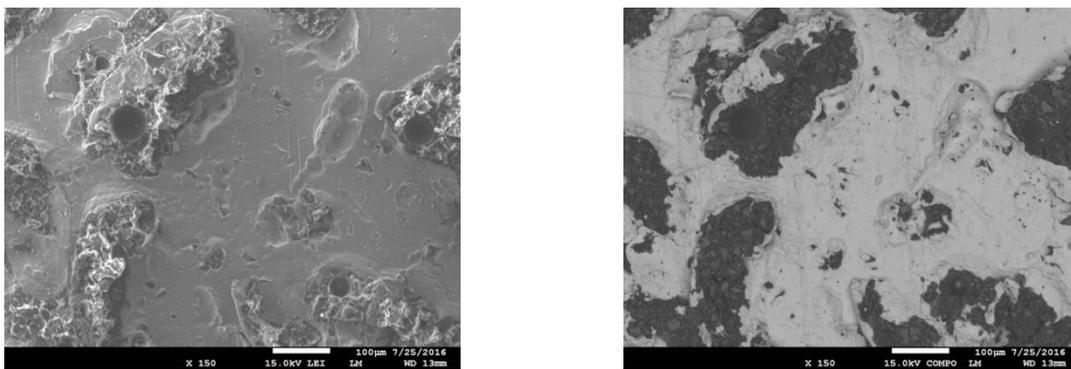
(a) SEM

(b) EDS

Figure 6. Typical SEM cohesive failure fracture surface (a) and corresponding EDS grey scale image (b).

Figure 6 compares the SEM picture with the EDS scale grey using back scatter. The image corresponds to a spot (3) steel side of Table 3. The white areas in Figure 6 (b) are predominantly metal and the black areas are carbon, meaning adhesive. This picture shows that, in the cohesive failure zone, the crack grows very close to the flexible adherend, in some areas within the adhesive (black areas in Fig. 6(b)) but also at the interface (white areas in Fig 6 (b)).

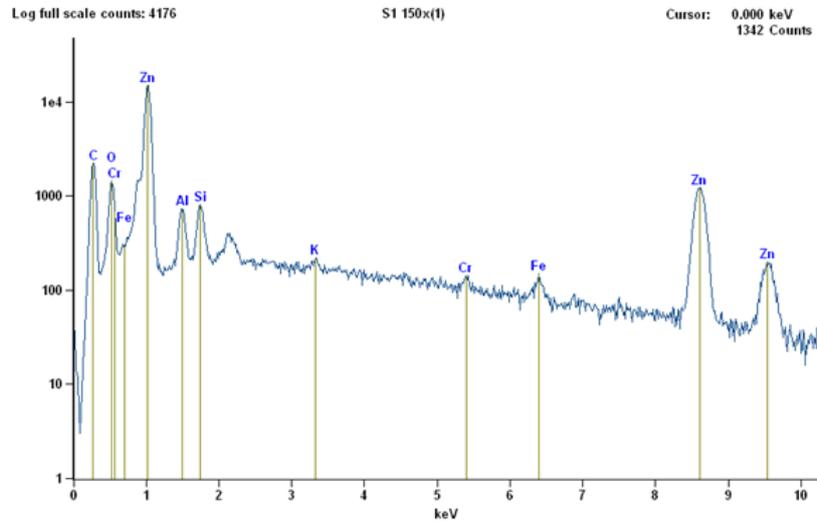
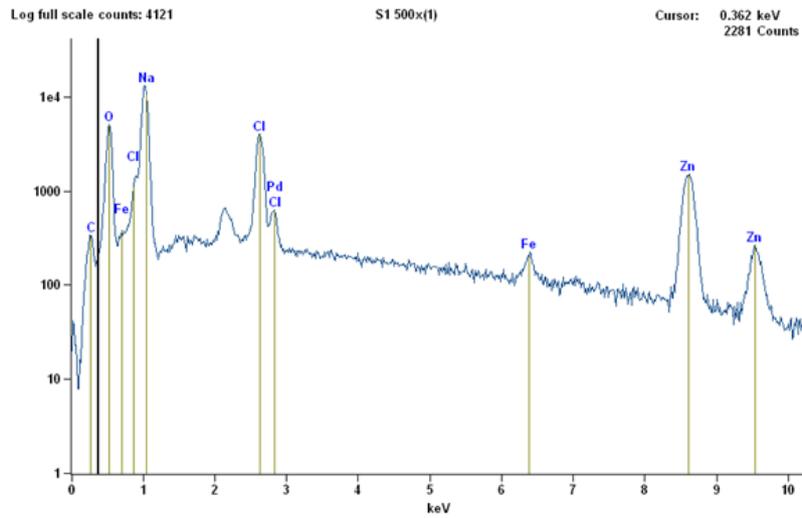
(a)

(b)

Figure 7. EDS spectrum of typical (a) CF and (b) AF.

Figure 7 compares the EDS spectrum of a typical cohesive failure – Fig. 7(a) and adhesive failure – Fig 7(b). The results of this spectrum suggest the presence of Chloride (and Sodium) in the adhesive failure fracture surfaces Fig. 7(b), which is not present in the cohesive surfaces (Fig 7(a)). This confirms that the crystals shapes observed in the SEM pictures of adhesive failure (spot 1 and 2 in Table 3) are NaCl crystals which were typically present at the adhesive failure areas due to ingress of salt within the interface.
