**Calcium silicate against clay brick masonry  
an experimental comparison of the in-plane behaviour during light damage**

Korswagen, Paul A.; Longo, Michele; Rots, Jan G.

Bulletin of Earthquake Engineering

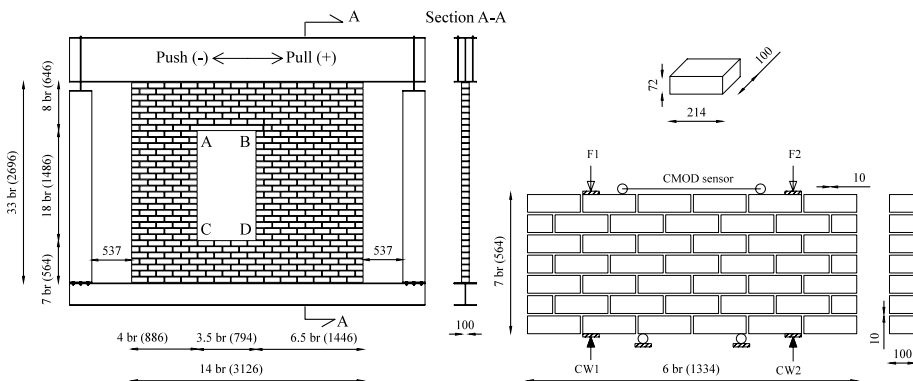
**Fig. 1** Left (a), dimensions of the full-scale wall; and right (b), dimensions and loading scheme of the spandrel specimens. Values in millimetres

Two nominally identical full-scale walls (see Fig. 1.a) were identically tested in their plane under a small, constant pre-compression stress of 0.12 MPa and a displacement-controlled, cyclically-increasing lateral drift. The walls were single-Wythe and approximately 3.1 m in width and 2.7 m in height. A window opening, positioned asymmetrically in the wall, was included to better mimic field cases where cracks are usually seen around windows (corners), see for instance Grünthal et al. (1998). The wall was fixed to a bottom steel beam and to a top steel beam, the latter of which was allowed to displace and rotate in the plane of the wall thus simulating a cantilever boundary condition. The lateral edges of the walls were free to minimise the complexity of the tests while simulating typical structural cases where structural or infill walls are only tied to neighbouring (transversal) walls without interlocking of bricks.

Additionally, five spandrel samples (Fig. 1b) were tested in a modified four-point bending setup under a crack mouth opening displacement (CMOD) controlled scheme. This setup allows for the possibility of applying one-way cyclic loading by employing counterweights (CW) aligned on the underside of the sample opposing the location of two hydraulic jacks (F). Additional details about the experimental setup of the walls can be found in Messali and Rots (2018), and about the setup of the spandrels in Korswagen et al. (2019). The specimens were built to replicate calcium-silicate brick masonry as found in the Groningen area. A characterisation campaign was conducted to establish the material properties of the existing masonry and build laboratory equivalents of these, see Jafari et al. (2017). The wall also included a reinforced concrete lintel which did not participate in the development of damage.

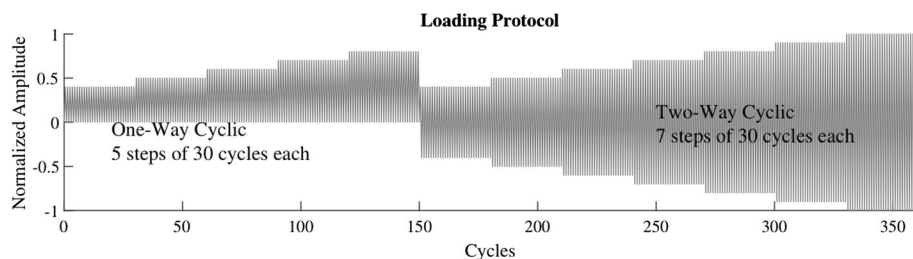
**Fig. 2** Loading protocol of the full-scale walls

The loading protocol for the walls consisted of five incremental steps of one-way cyclic loading in the positive (or pull) direction, followed by another seven incremental steps two-way cyclic. Each step consisted of 30 cycles. The amplitude of the first step was 0.26‰ (lateral drift) and was increased 0.07‰ in every subsequent one-way cyclic step (until 0.55‰), and restarted at 0.26‰ at the beginning of the two-way cyclic portion of the protocol until finally reaching 0.70‰. A representation of the loading protocol, which was identical to the one used to test the clay-brick walls, is drawn in Fig. 2. The high number of small cycles included in the protocol are to mimic the effect of numerous light seismic or

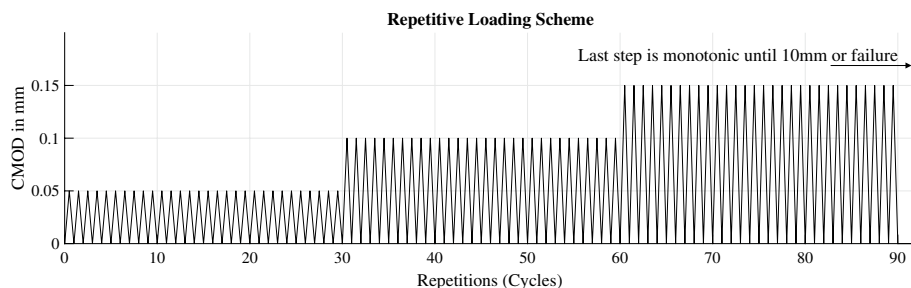
**Fig. 3** Loading protocol of the spandrels

The spandrels were tested under a one-way cyclic scheme where the CMOD was first repeated 30 times at values of 50  $\mu\text{m}$ , 100  $\mu\text{m}$ , and 150  $\mu\text{m}$  (for a total of 90 cycles) before being driven monotonically to 10 mm (though failure occurred before reaching this value). The repetitions had a lower boundary of a force of 1 kN to maintain stability in the system. Note also that the CMOD sensor was placed spanning the three top head joints to account for the possibility of a crack opening in any of these joints (Fig. 1b). See Fig. 3 for a representation of the loading protocol of the spandrels. A summary of the tested specimens and their protocols is given in Table 1.

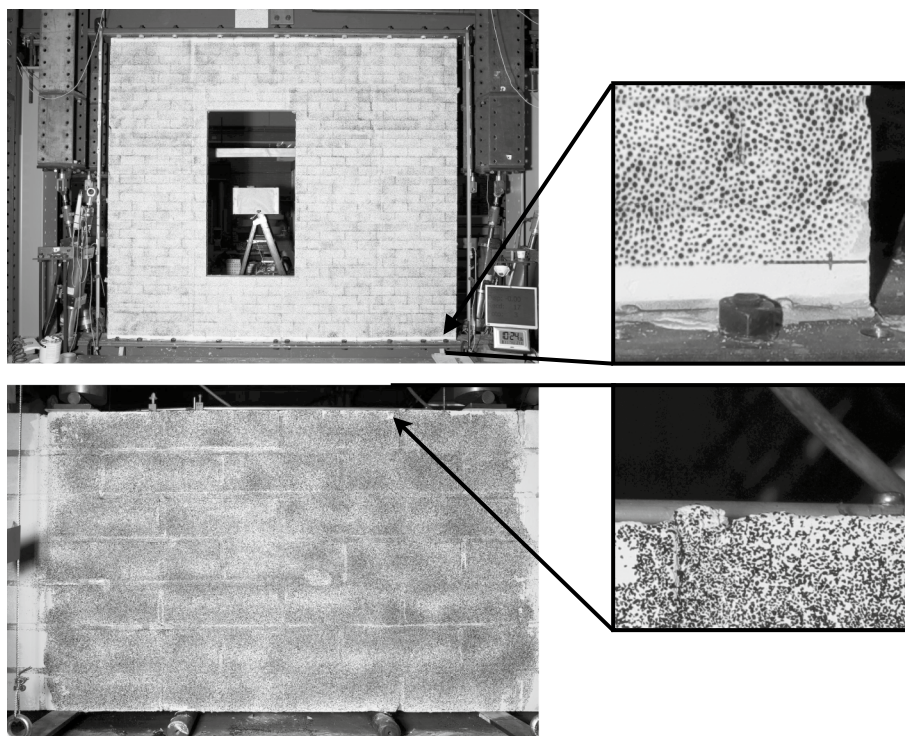
**Fig. 4** Specimens of wall (top) and spandrel (bottom) with DIC pattern zoomed in

Both types of tests were monitored using the photogrammetry technique of Digital Image Correlation (DIC). The surface of the specimens was covered with a purposely-optimised random speckle pattern and photographed at specific time points throughout the tests (see Fig. 4). This allowed high-resolution measurement of the entire 2D, in-plane displacement field of the samples; in the case of the walls, approximately one million points were monitored at a distance of 2.8 mm between the points, and for the spandrels, 75,000 points at 2.4 mm distance were observed. The precision of the walls' measurement was 20  $\mu\text{m}$  while for the spandrels, 5  $\mu\text{m}$ . Additionally, traditional sensors and LVDTs were placed at the back of the wall and spandrels, and between the walls and the steel frames. Moreover,

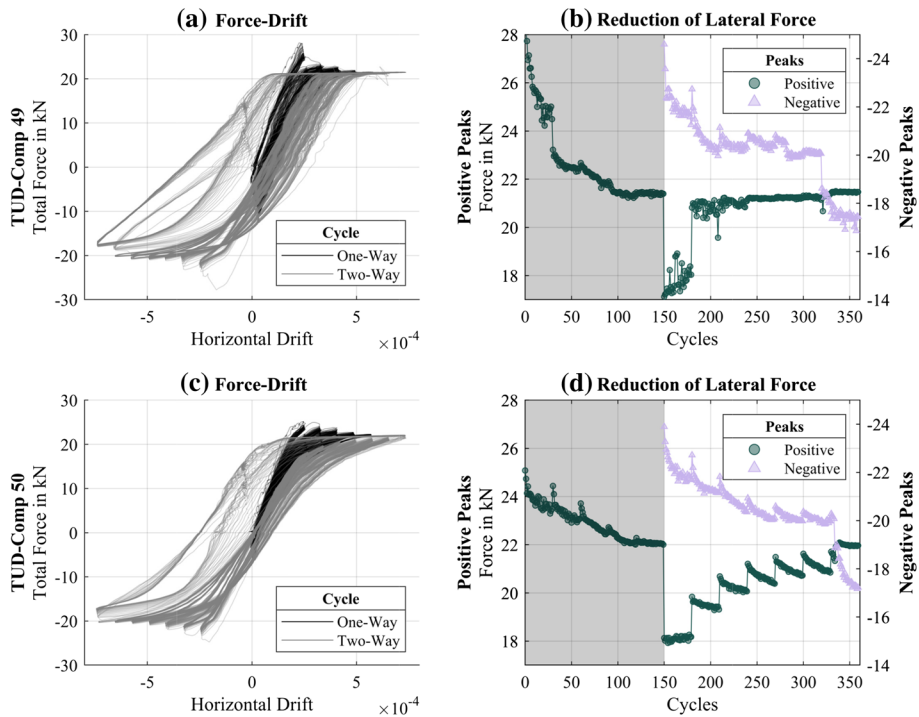
**Fig. 5** Force-drift curves and cyclic degradation graph for the full-scale walls: TUD-Comp49 in **a, b**, and TUD-Comp50 in **c, d**

Both full-scale walls were incrementally displaced in-plane up to a drift of 0.7‰, which is low compared to drift associated with near-collapse in the order of 1–3%. Nevertheless, the walls exhibited considerable degradation in their cyclic force–displacement behaviour, see Fig. 5, left. Already after five one-way cyclic repetitions of the first imposed drift (0.26‰), the first wall had lost 2 kN of its peak lateral capacity (see Fig. 5b), which corresponds to about 7% of its strength. The right side of Fig. 5 shows thus the decline in peak force capacity (the absolute maximum attained in the positive and negative directions) for each consecutive cycle. Throughout the tests, a consistent decrease in peak force capacity can be observed for both walls of about 5% per step. Moreover, after the one-way test (initial 150 cycles with drift only in the positive direction and shaded in Fig. 5, right) had been finished and the initial positive drift was repeated, the walls showed a considerable reduction in strength of up to 30%: from approximately 25 to 17 kN, and from 24 to 18 kN for each wall respectively. Conversely, the capacity in the negative drift direction at the beginning of the two-way test was unaffected and began to degrade in a manner similar to that of the positive direction during the one-way test. Accordingly, for the first wall, the positive capacity showed almost no degradation during the two-way test, presumably because the one-way test had already damaged this direction; however, the second wall did show degradation but its capacity never exceeded what had been achieved during the one-way part of the test. Furthermore, both walls seemed to develop what would later have become the ultimate failure mechanism during the last step of the test; this is visible in all four graphs of Fig. 5. Both walls seem to accumulate significant lateral deformation leading to an increase in the hysteresis of Fig. 5a, c.

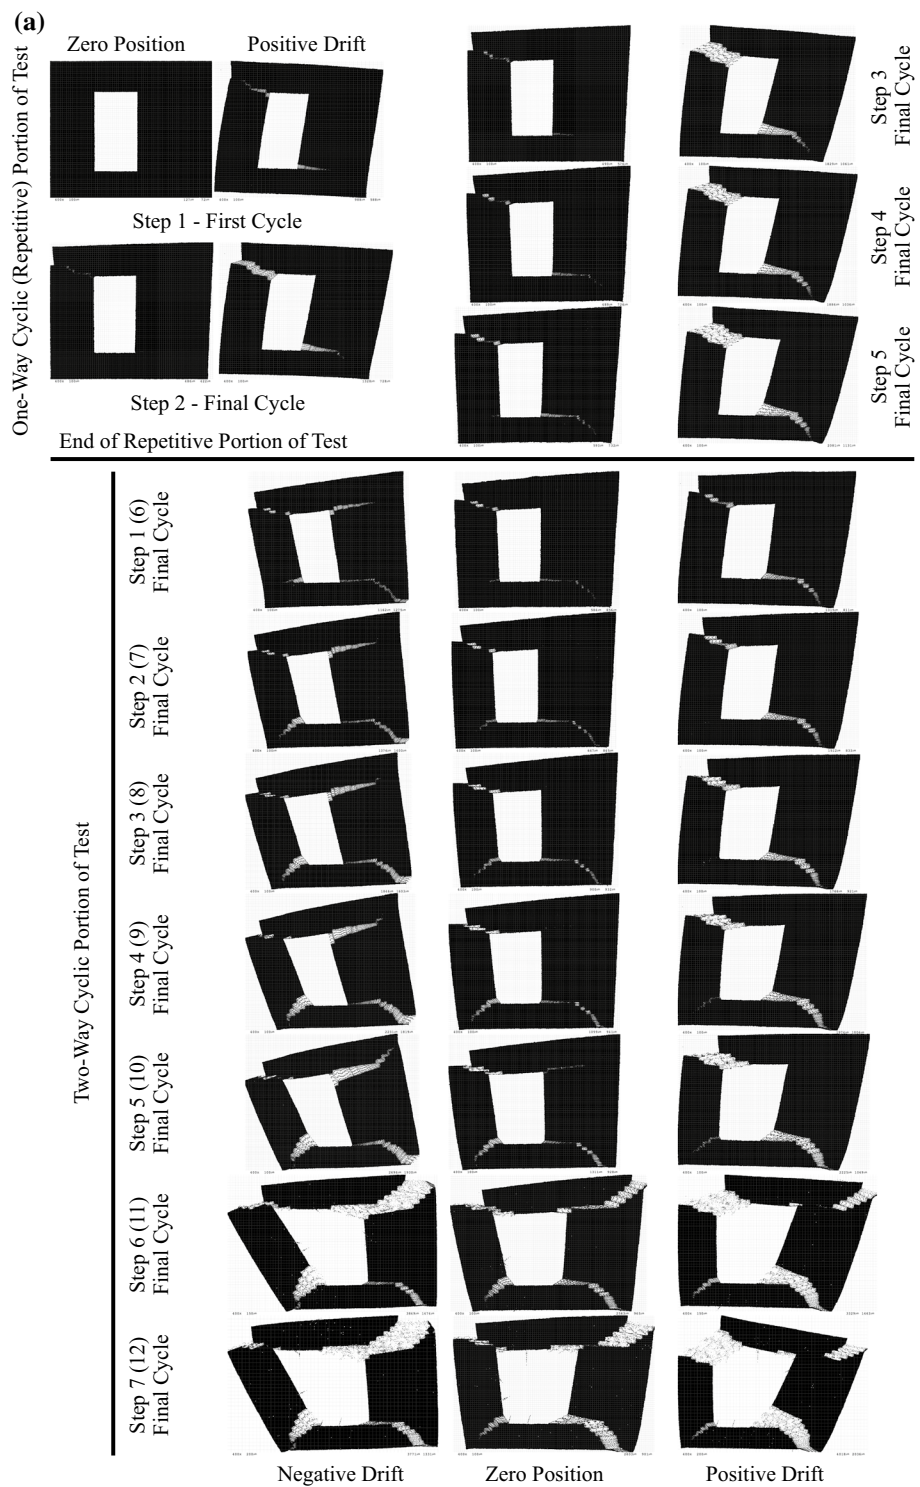
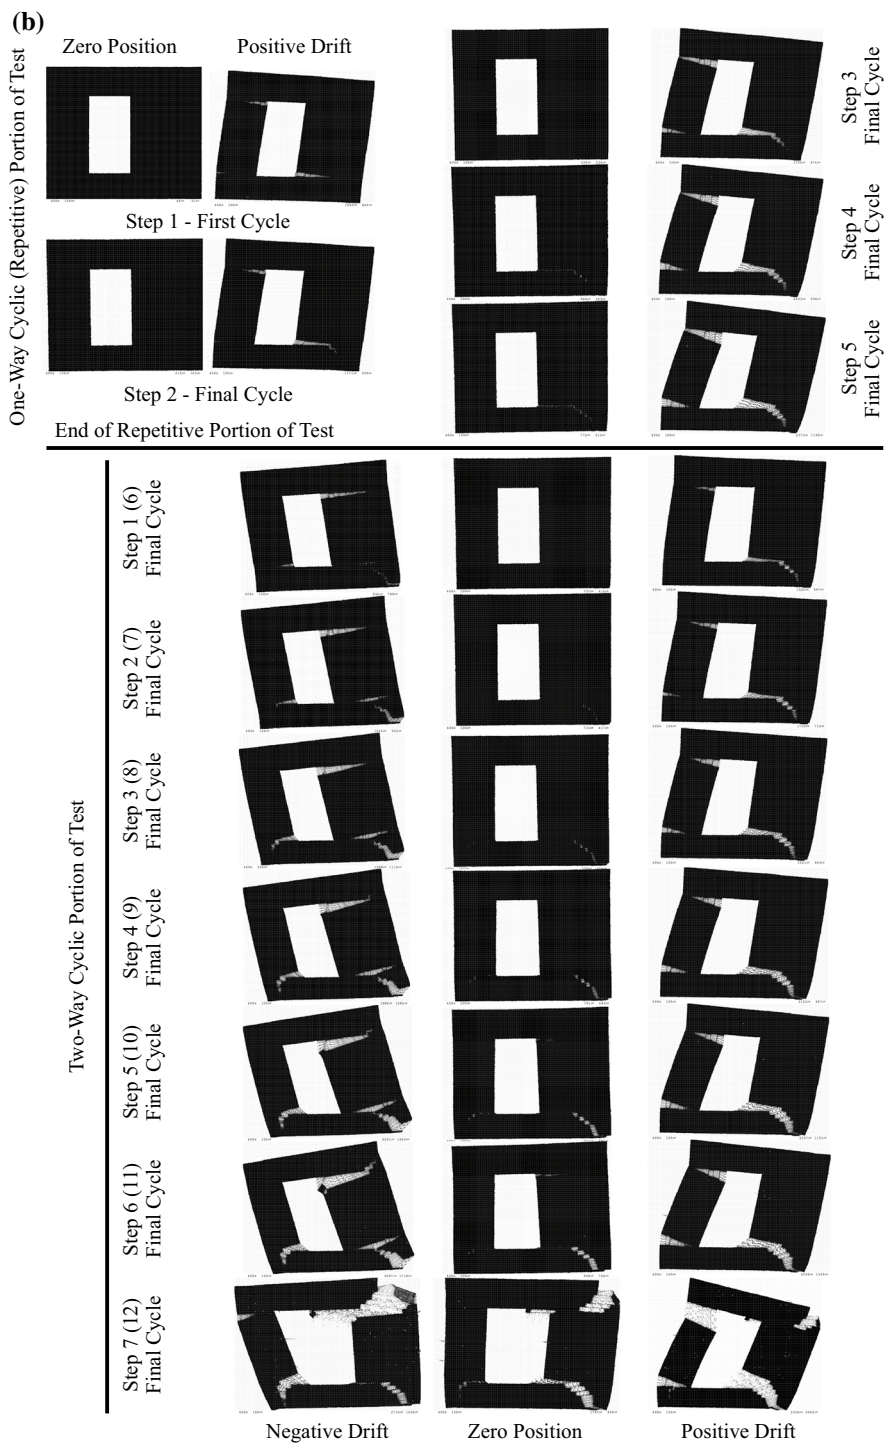
**Fig. 6** 400x magnified displacement field (deformed shape) for the **a** first wall, TUD-Comp49, **b** second wall, TUD-Comp50. Steps refer to the protocol of Fig. 2: 5 steps one-way cyclic (repetitive) followed by 7 steps two-way cyclic, (12) total steps

The force-drift and strength degradation of the wall throughout the test can be well traced to their behaviour and progressing damage which was accurately captured with DIC. Figure 6 shows the displacement field composed by tracking one million individual points; note that here the displacements have been magnified by 400 times and in reality no crack exceeded a width of 2.5 mm. During these observations, no lifting or rocking was detected in the walls and the out-of-plane deformations were negligible.

In Fig. 6a-1 (referring to step 1 in Fig. 6a, this notation continues) and Fig. 6b-1, the initiation of visible cracks can be appreciated. The protocol was designed such that the first

step corresponded to the start of DS1. Yet, for the first wall, Comp49, Fig. 6a-2 shows that the top crack (A, see Fig. 1) has propagated fully through the pier in a diagonal manner. This is not the case for Comp50, where crack A runs horizontally to the edge of the wall in step 3, and while open, remains horizontally connected to the top spandrel throughout the entire test (no crack sliding displacement). Conversely, crack A leads to accumulated sliding for Comp49 and the pier becomes fully detached from step 11 onwards (Fig. 6a-11). This residual damage is then also clearly visible at the zero positions of Fig. 6a and hints at a mixed mode (mode I and mode II) behaviour for this crack. For Comp50, it is crack D the one to accumulate the most sliding as begins to show in Fig. 6b-9. The ultimate failure mechanism develops fully in Fig. 6a-10 for Comp49 comprising cracks A and B, and in Fig. 6b-11, the last step for Comp50, with crack B. It is remarkable that the walls, after this repeating damage, ultimately decompose in four rigid bodies which slide and rotate against each other, with little elastic deformation remaining.

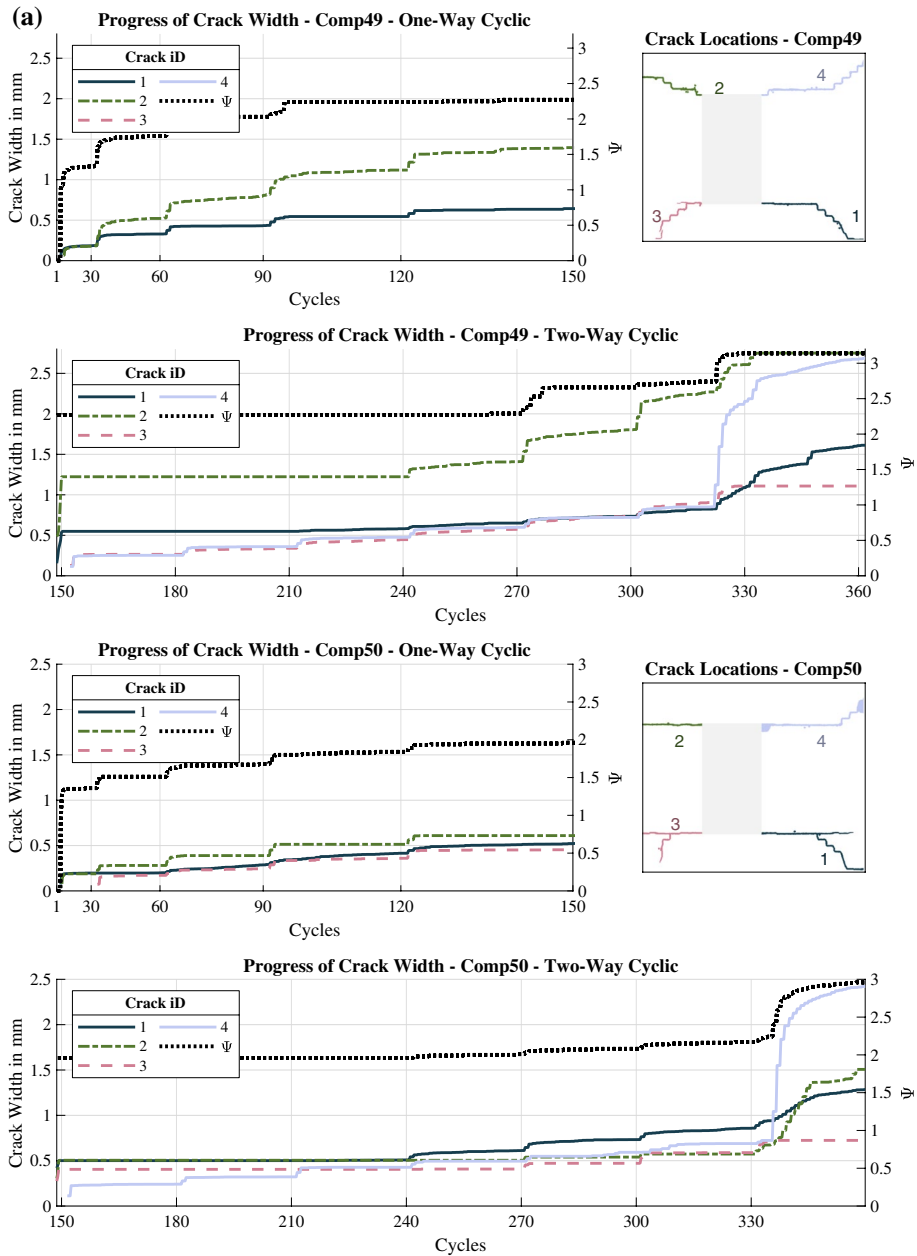
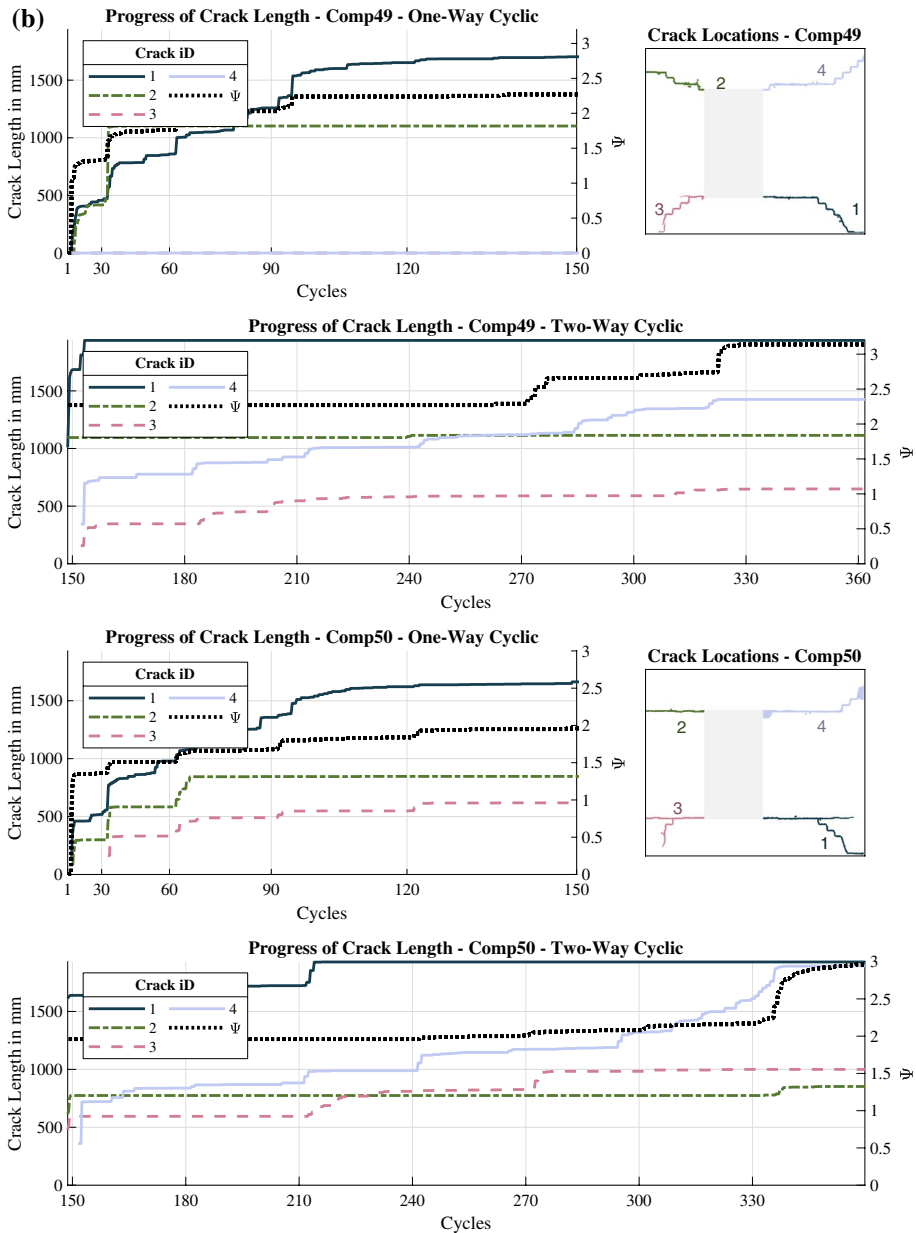
**Fig. 7** **a** Progression of crack width for the full-scale walls. Maximum crack width of each crack for the entire cycle. Note that  $\Psi$  is drawn on the right axis and corresponds to the damage intensity of the entire specimen. Top: Comp49; bottom: Comp50. **b** Progression of crack length for the full-scale walls. Top: Comp49; bottom: Comp50. Note that  $\Psi$  is drawn on the right axis and corresponds to the damage intensity of the entire specimen

The individual progression of the cracks and their representation of damage can also be extracted from the DIC data. This is shown in Fig. 7a where the crack width is plotted on the left axes and the damage parameter  $\Psi$  is measured on the right, the parameter is computed using the maximum crack width of each crack during each cycle. These graphs evidence the propagation of the cracks in every step, but also during certain steps, especially towards the end of the test. It can be observed that the behaviour of the cracks is linked as multiple cracks grow at the same time. During DS1 ( $\Psi < 3$ ), cracks grow from 0.1 mm up to 2 mm and most have similar widths at any given time. For Comp50, crack 3

(C) propagated from both the outer edge of the wall during the one-way cyclic portion of the test as from the corner of the window later on. The propagation of the cracks is clearer in Fig. 7b where the length of the cracks (to a cut-off minimum crack width of 80  $\mu\text{m}$ ) is drawn. Here, the substantial increase in length within steps demonstrates that crack propagation must be (partly) responsible for the strength degradation observed in Fig. 5. Figure 7b also shows that crack 2 (A) is the first to propagate fully, revealing no growth in length already after the second step for both walls; then, crack 1 (D) reaches its full length at the beginning of the two-way portion of the test. This is presumably because both cracks are triggered by the one-way part of the test and hence experience a greater number of cycles.

It is also worth noting that cracks C and D, and also B for Comp50, run through bricks. This can be seen in the overview of Fig. 7 (and later Fig. 8), where, as cracks approach the edge of the wall, their paths become fully vertical instead of stair-case diagonal. Before these points, cracks follow the path of the mortar joints, and apparently, as the vertical weight of the wall rests on a few bricks when the wall is pushed laterally (see Fig. 6a-6 and -8 or Fig. 6b-9), the brick positioned in front of the vertical mortar joint at the edge of the crack is forced to split. For crack C, the split is fully vertical, while for crack D, the split is slightly inclined following the apparent path of the resultant force vector, suggesting that failure of the bricks is a mixture of bending and compression-induced tension-splitting (or compression-shear at the bed joint level). The path of the cracks is summed up in Fig. 8 overlaid on photographs of the wall.

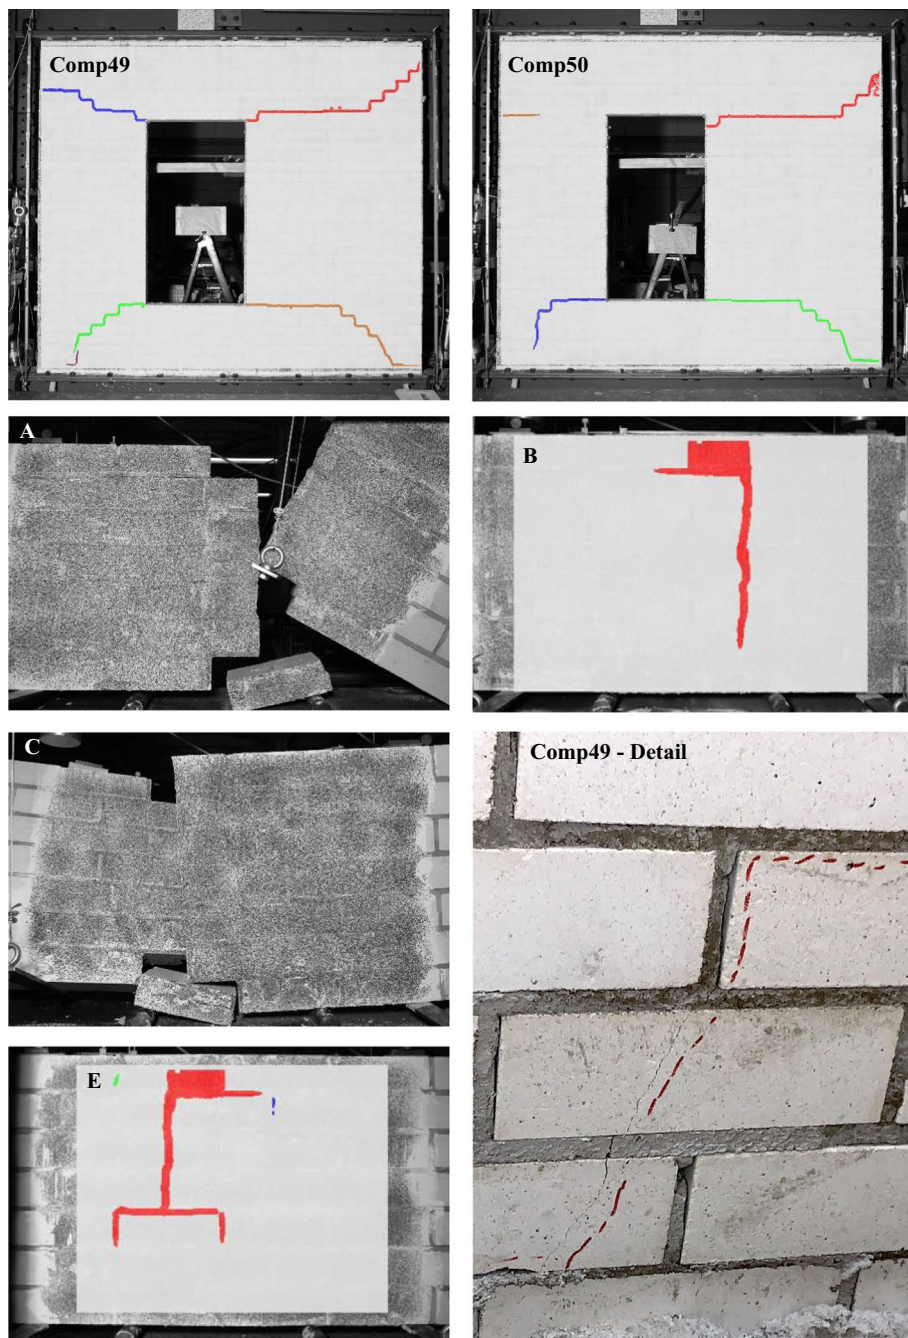
**Fig. 8** Crack patterns showing brittle behaviour of walls top) and four of the five spandrels. Spandrels A and C are shown after failure, while spandrels B and E are overlaid with the detected crack path right before failure. Bottom right: backside of Comp49 showing real crack on the left of dashed highlight

The final crack pattern during the spandrel tests is also depicted in Fig. 8 and shown to run through both mortar joints and bricks; in these cases however, failure of the bricks is not associated with compression-induced splitting but corresponds to flexural failure of the bricks and in general, the specimens. The failure occurred in such a brittle manner that in two of the tests, the final crack pattern could not be captured by DIC and can only be inferred from the final photographs (A and C). Before failure, cracks grew from one of the top three head joints and found their way downwards, initially by following the mortar joints, but sooner or later, by cutting the bricks. This is illustrated in Fig. 9 where the progression of the cracks is drawn throughout the test. For many specimens, the cracks could not be reliably detected in the first or the first two steps (i.e. until cycle 60) and hence no crack is shown. Moreover, the detected crack width does not always match the CMOD-controlled value. This is because multiple head joints are cracked simultaneously (see Samples C and D) and together amount to the set opening (defined crack mouth); later, one of the joints progresses while the other unloads. Nonetheless, the progression of the cracks is clearly visible during the final monotonic part of the tests (beyond cycle 90) until failure. These parts evidence how for some specimens (B, C and E), failure occurred progressively, while for specimens A and D, failure was too sudden to be controlled. As seen later in Fig. 10, eventual failure was brittle in all cases.

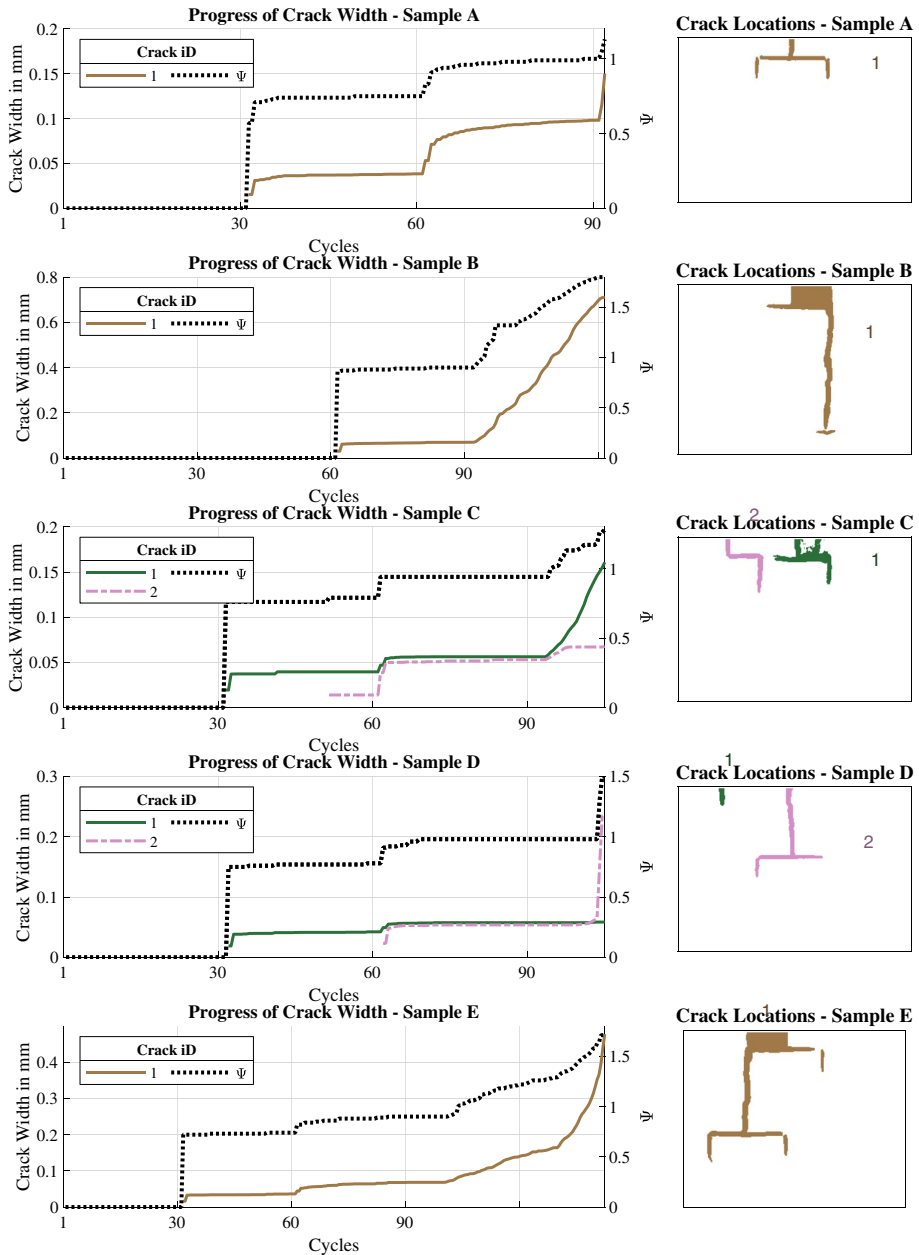
**Fig. 9** Progression of crack width for the spandrel tests during 90 loading cycles and a final monotonic phase

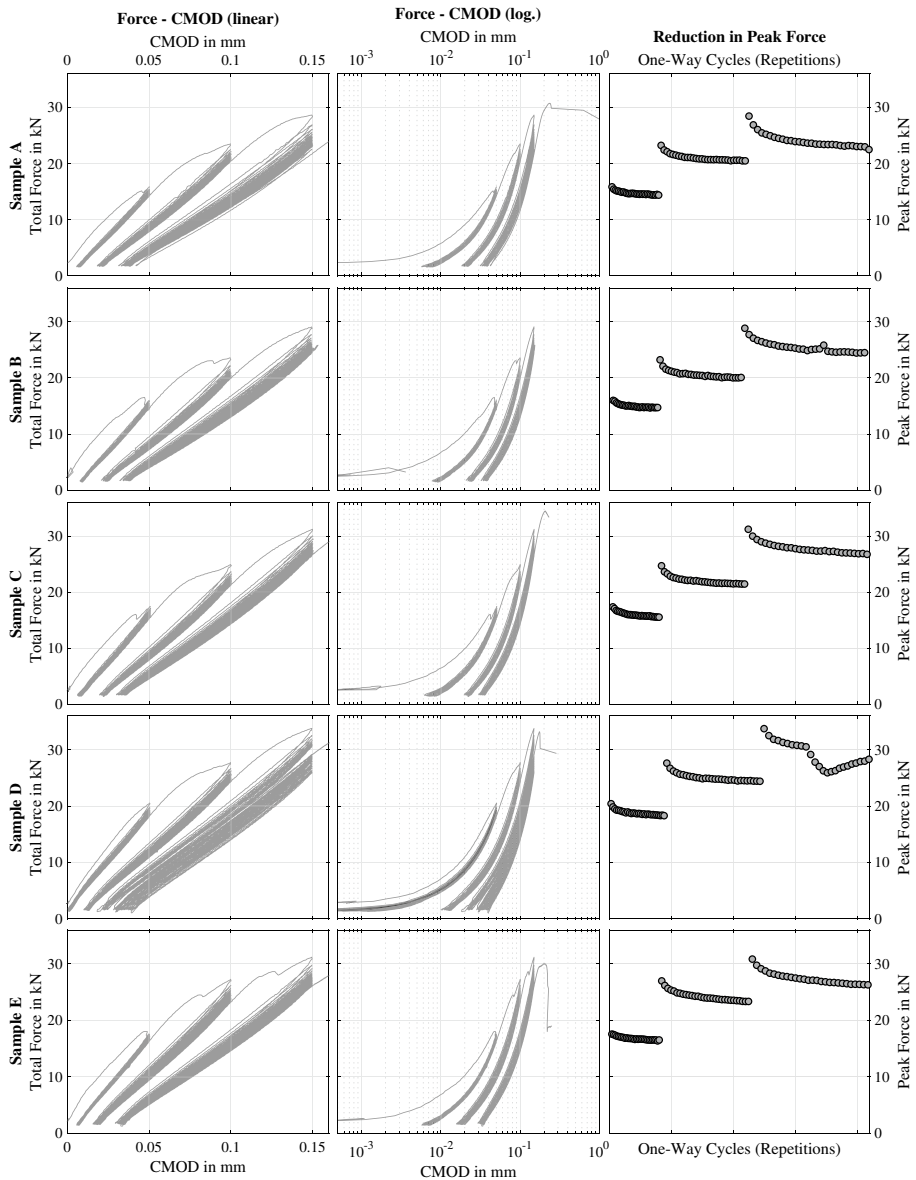
**Fig. 10** Force against CMOD for spandrels tests, plotted linearly showing the cyclic steps (left), and logarithmically showing the entire test (middle). The force reduction identified via the peak of each cycle is also shown (right)

The sudden failure of specimen D, for example, can also be seen in Fig. 10, where the force-CMOD of the spandrels is shown. Figure 10 also evidences how the strength degradation that occurs during the cyclic steps is due to an accumulation of plastic, irreversible CMOD deformation at the lower force limit value of 2 kN, possibly due to sliding at the crack interfaces. The slope (stiffness) of each cycle is mostly unaffected.

(see erratic behaviour of force peaks, right in Fig. 10). It has not been possible to find a sensible explanation for this behaviour, albeit an out-of-plane influence cannot be neglected in this case.

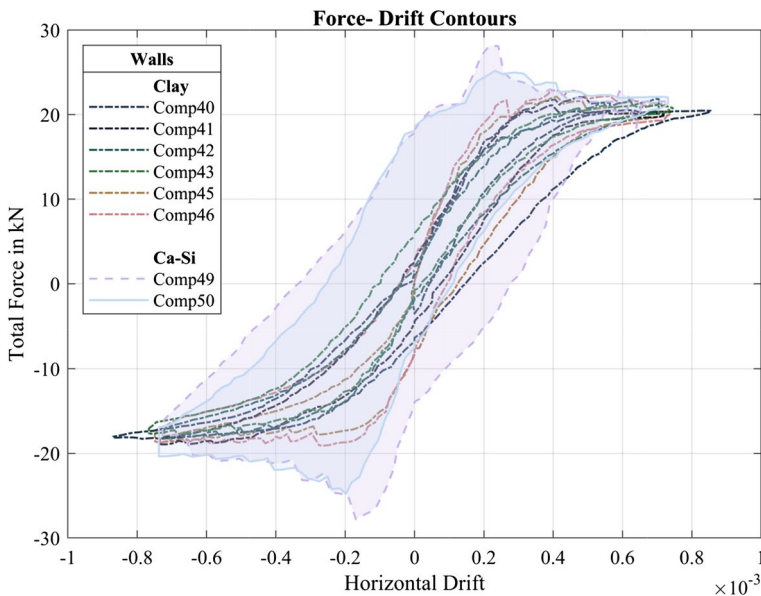
**Fig. 11** Comparison of absolute envelopes (contours) between similar clay walls (dash-dotted) and the two calcium-silicate walls (shaded areas)

The two calcium-silicate walls were stiffer and stronger than all of their clay counterparts: This is visible in Fig. 11, where the absolute envelopes (positive and negative loading) of all the cyclic test results for all the tested walls are drawn (though only the area delimited by the CaSi walls is shown shaded for easier identification). The part of the envelope produced by the first step of the calcium-silicate walls is noticeably stiffer than the clay specimens, see peaks of shaded envelope area. Moreover, the calcium walls are stronger in both positive and negative directions. Nonetheless, the calcium-silicate walls experienced more damage at similar drift-values; this is particularly evident by the larger area contoured by the envelopes, indicating a higher hysteresis energy. This is also related to the total cyclic degradation which is higher for the calcium-silicate walls. Yet, the strength degradation during each step, as depicted by the jagged drops in the curves, is comparable for both clay and calcium-silicate specimens.

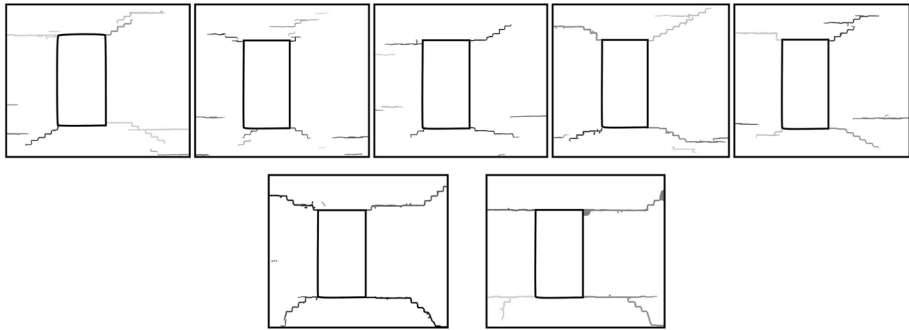
**Fig. 12** Comparison of cumulative crack patterns between 5 clay walls (top) and 2 Ca–Si specimens (bottom). This is a summary of all cracks detected throughout the tests

The increased damage of calcium-silicate walls is also observable in the crack patterns of these specimens when compared to the clay walls. Figure 12 shows five clay walls where cracks are spread into a larger number of individual cracks, and follow predominantly diagonal patterns of off the window corners. Figure 12 displays a cumulative summary of all cracks throughout the entire tests, hence, in contrast, the two calcium-silicate walls display only four cracks which propagate first horizontally from the window corners, then diagonally, and later run vertically through the bricks. The splitting of bricks was something only observed in the calcium-silicate specimens. In fact, spandrel tests, which were to mimic a vertical crack underneath the window bank of the walls, also displayed no brick-splitting in the clay material, but did allow for this brittle failure mechanism in the calcium-silicate specimens. Figure 13 shows that the vertical crack in CaSi spandrel

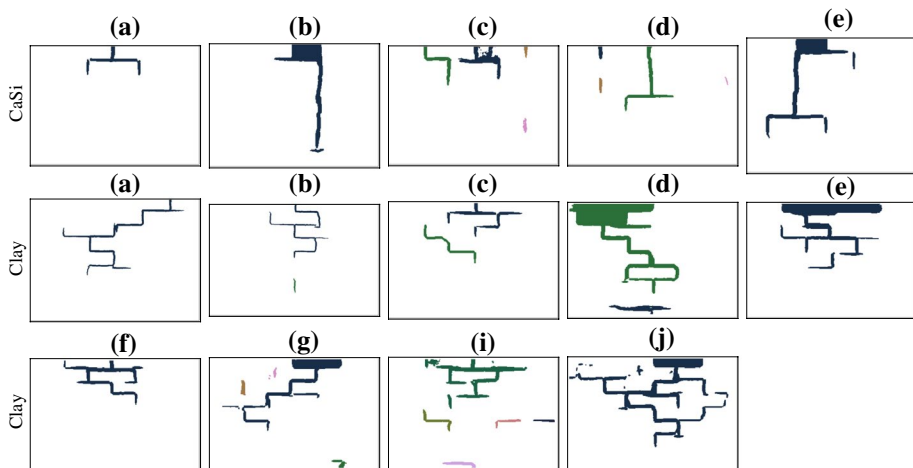
**Fig. 13** Comparison of final crack patterns between calcium-silicate spandrels (top five) and clay specimens (bottom nine)

samples did cut straight down, while the vertical crack of identically-tested clay specimens, zigzagged down forming a toothed crack with complex patterns and bifurcations.

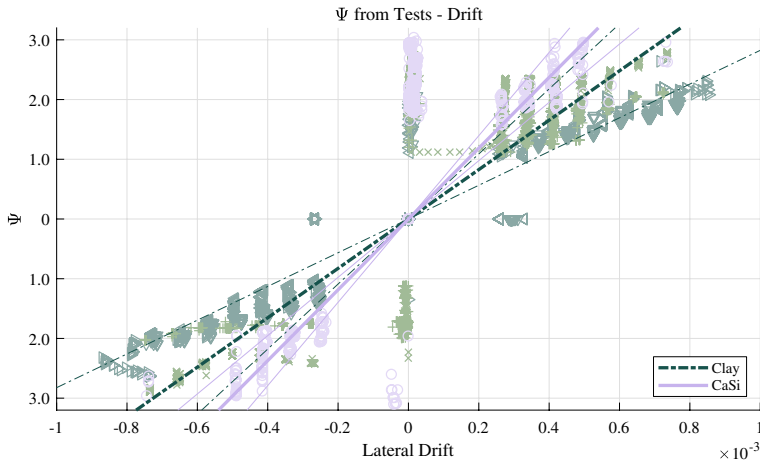
**Fig. 14** Linear regression of the relationship between (non-zero) drift and damage measured in  $\Psi$  for clay and calcium-silicate (CaSi) walls at zero, positive and negative drift values for each cycle. Thinner lines show one standard deviation. Circles show CaSi data while angular shapes show clay data

The higher sensitivity to damage of this type of calcium-silicate masonry is further expressed in Fig. 14, where the damage values, as computed with the  $\Psi$  parameter, are shown for numerous values of drift. The maximum value of  $\Psi$  is computed for each cycle

at the zero position and positive and negative directions (see also Fig. 6). First, in Fig. 14, the values corresponding to calcium-silicate walls reach values higher than any of the clay walls. Moreover, residual damage (at or close to zero drift) also displays a larger value of  $\Psi$ . Furthermore, a linear regression using the Theil–Sen method of slope fitting (Theil 1950) is produced for all the non-zero data. This fit does not consider that walls are progressively damaged during the cyclic steps; yet, it is clear that calcium-silicate walls have a steeper drift-damage relationship. If the range of  $1 < \Psi < 3$  is considered as DS1 (Korswagen et al. 2019), damage starts to be detectable at drift values of 0.25‰ and corresponds to DS1 until 1.1‰ for the clay walls, while, for the calcium-silicate cases, DS1 appeared already at values between 0.15 and 0.65‰. These values consider the one-standard deviation shown.

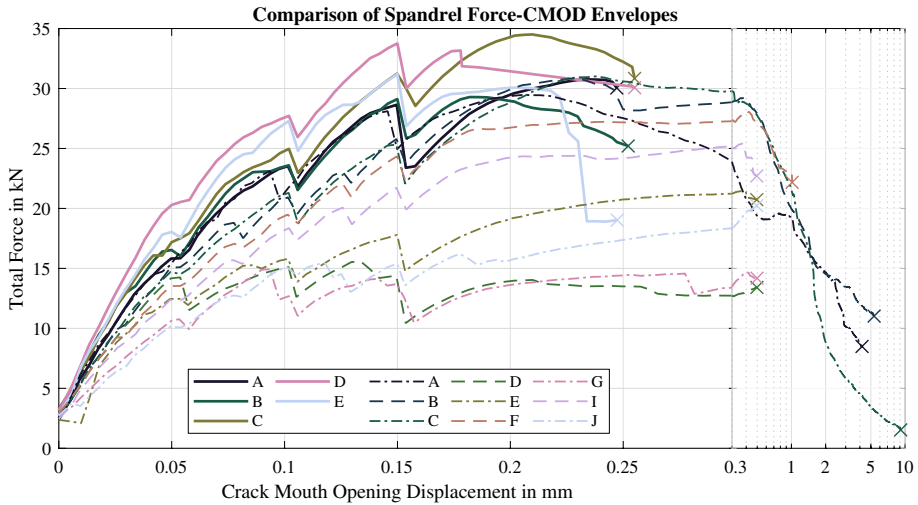
**Fig. 15** Comparison of force–displacement (CMOD) envelopes between spandrel tests of calcium-silicate brick (solid lines) and clay brick (interrupted lines) masonry

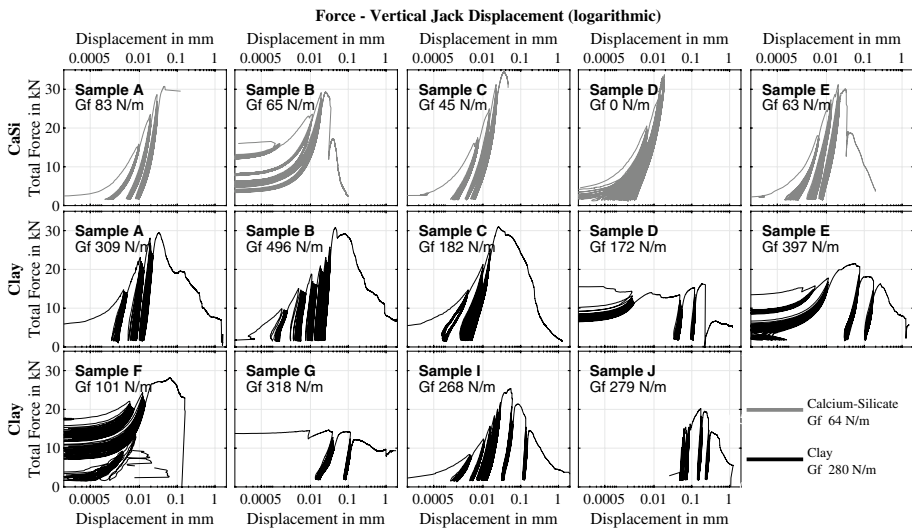
**Fig. 16** Force-displacement (vertical at jacks, not CMOD) for spandrels showing the interpreted tension fracture energy ( $G_f$ )

material. This parameter can serve to further compare the materials. Here, neglecting sample D of the calcium-silicate tests which reached failure early on, the average of the clay spandrels is 4 times higher than the value of  $64 \text{ N m/m}^2$  calculated from the calcium-silicate tests (see Table 3 for a summary). This confirms the more brittle behaviour of this type of calcium-silicate brick masonry in comparison to the replicated clay brick masonry of this study. The larger value for clay is possibly due to the sliding and
