Prototype of a diagnostic decision support tool for
Structural damage in masonry

Prototype of a diagnostic decision support tool for structural damage in masonry

Supplement to the PhD thesis of Ilse A.E. de Vent:

Structural damage in masonry: Developing diagnostic decision support

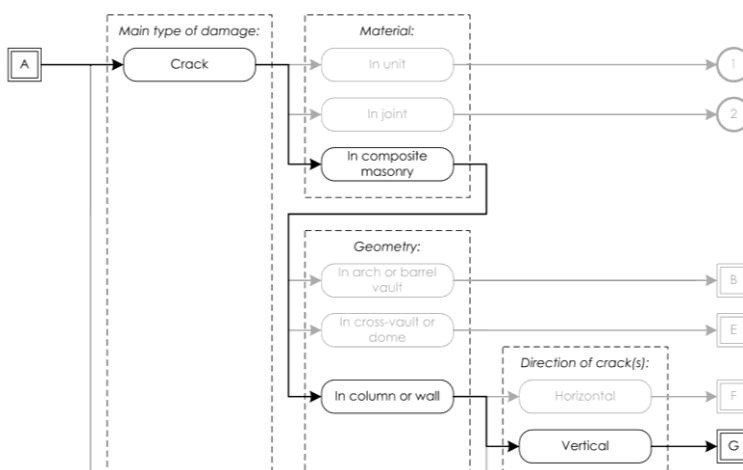
Illustration of Part I: determining the relevant damage pattern, e.g. for a wall with a vertical crack.

The first step in using this diagnostic tool is to determine which of the 60 structural damage patterns corresponds best with the damage you are investigating. This is done through the help of a decision tree, which can be found in **Part I** of this book. Starting at **A** each column of the tree presents a statement on the appearance of the damage. Carefully

read all options that are contained within the dashed rectangle, and choose the one that best suits the damage you have under investigation. Then, following the arrow linked to this option, you proceed with the next statement in the second column, and again choose the most suitable option.

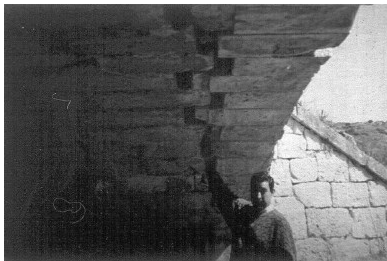
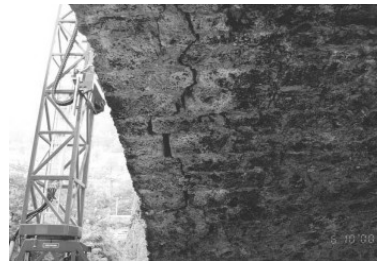
- G: damage appears in arch or barrel vault
- G: damage appears in vault web

Examples. [Onsiteformasonry et al. 2002] par. 7.8.4 GEOCISA, [Harvey 2004] case 24, [Onsiteformasonry et al. 2002] par. 7.5.6 ZAG.

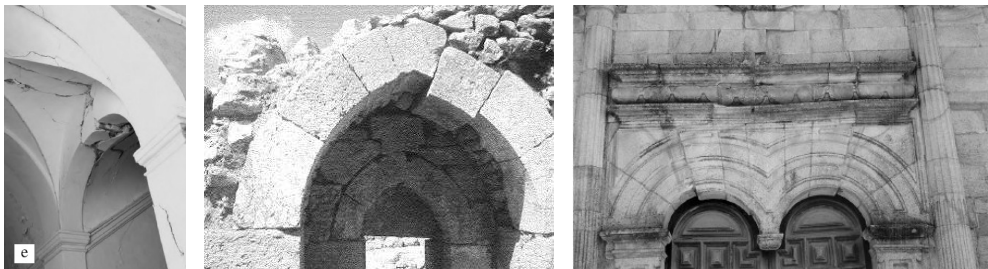
Examples. [Ceci et al. 2010] Fig. 15e, [Croci 1998] Fig. 2.41, [Lourenço 2005] Fig. 3.

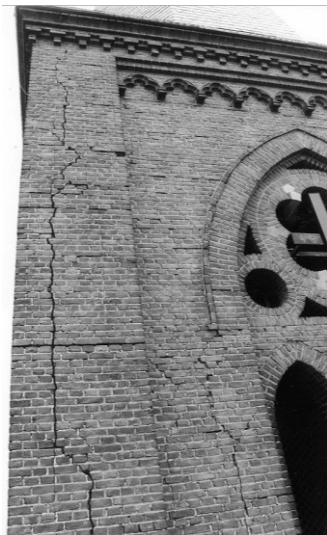
context conditions included in pattern:

- G: damage appears in column or wall

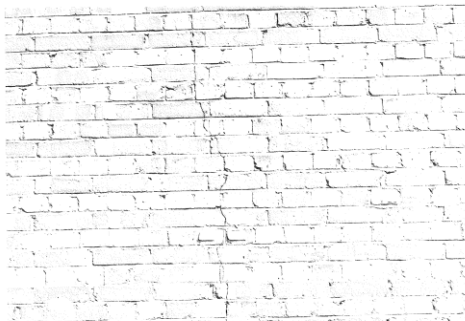
Damage pattern 37

Crack - in column or wall - combination of directions - including horizontal crack(s) - horizontal plus vertical cracks - crack pattern \perp

context conditions included in pattern:

- G: damage appears in column or wall

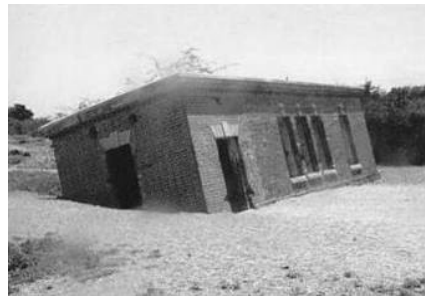
symptoms:

■ S: tilt

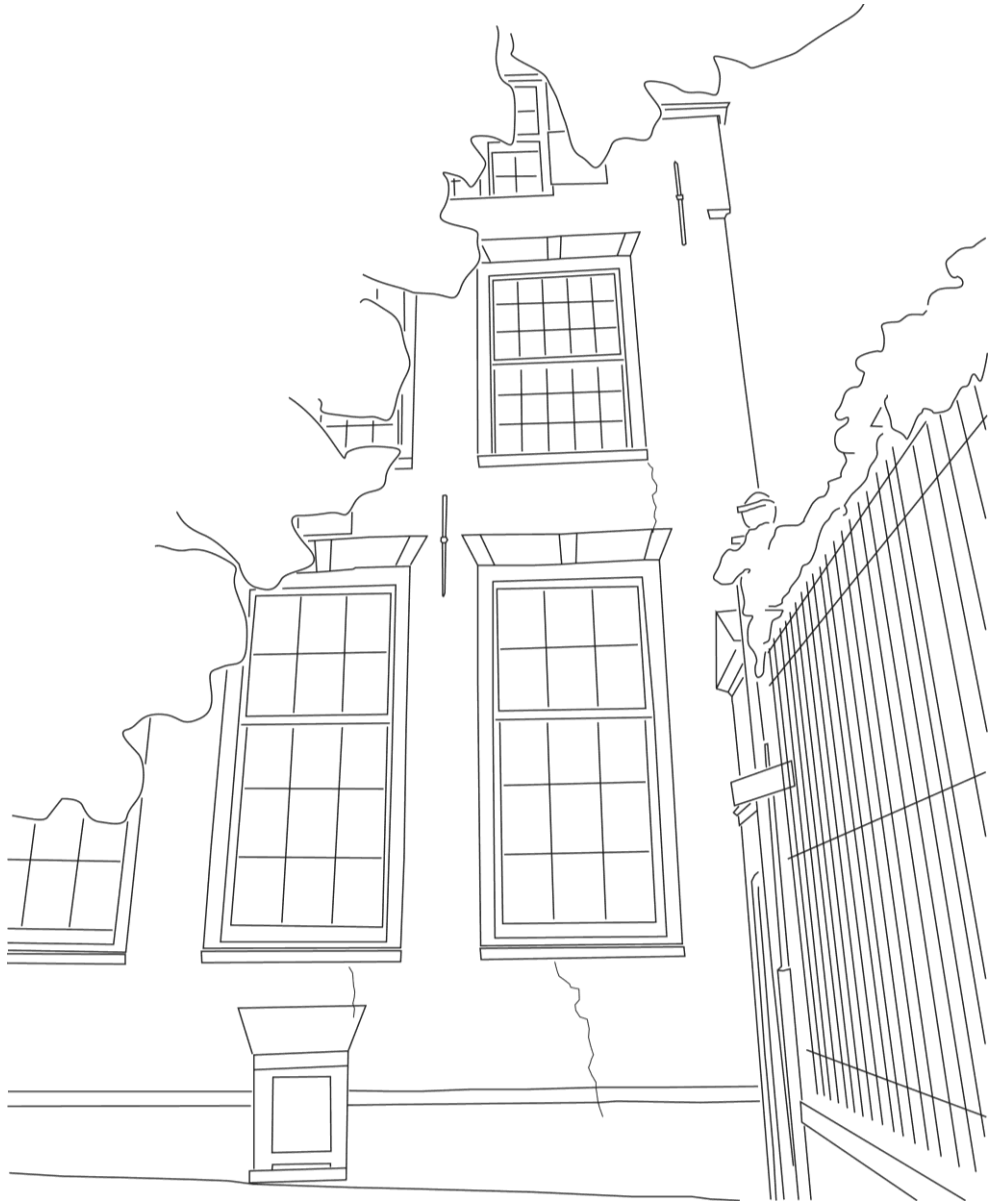
Hypotheses and essential conditions for settlement

Vertical settlement
