In-situ impact analysis during fatigue tests of open-hole carbon fibre reinforced polymer specimens

Zarouchas, Dimitrios; van Dien, Casper; Eleftheroglou, Nick

Composites Part C: Open Access

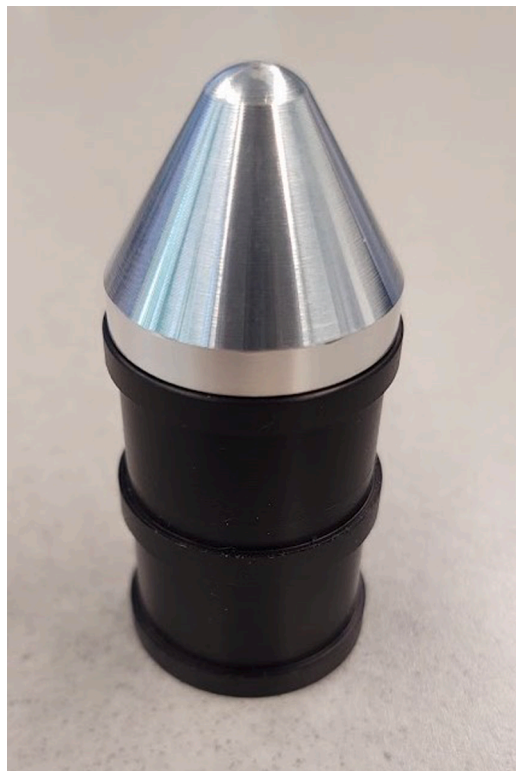
Fig. 4. The aluminium projectile screwed into a POM rear section.

To serve as impactors, custom bullets were produced with an aluminium tip screwed into a POM (Polyoxymethylene) rear section, see Fig. 4. The tip is hemispherical with a radius of 5 mm and the plastic rear section acts mainly to seal the gap between the barrel and the bullet. A secondary function is to ensure the centre of mass of the impactor lies in front of the centre of pressure, which guarantees stable flight. The mass of a single bullet was 30.7 g. The variation in mass between the bullets was less than 0.1 g, not enough to cause significant differences in the impact energy.

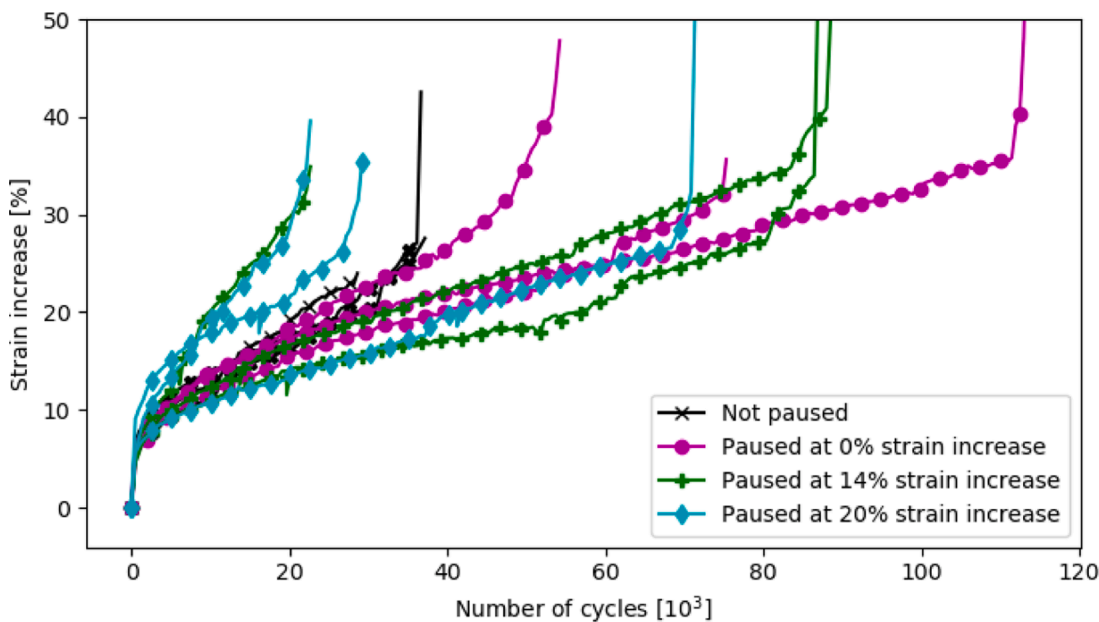
Fig. 8. (a) The strain curves for all the specimens subjected to fatigue and (b) C-scan images for specimens 29 – paused at 0% strain increase and scanned at 20% strain increase (upper) and 37 – paused and scanned at 20% strain increase (lower).

Fig. 8a shows the strain increase of the specimens as a function of the fatigue life. Although there is significant scatter related to the fatigue life, the strain increase at the moment of failure is similar for all specimens and it ranges between 40% and 50%. Furthermore, it can be observed that the strain curves follow an S-shape, where initial strain increases quickly until about 10–12%, after which the increase slows down to an almost linear path. This part consumes most of the fatigue life of the specimens. After about 25–30% increase, it starts to speed up again and critical failure is imminent.

Fig. 8b shows two specimens that were loaded up to a strain increase of 20%. Specimen 29 was paused at 0% directly at the start, after which it was loaded until the 20% threshold was reached. Specimen 37 was first fatigued until 20%, after which it was paused and stopped. Both images look very similar, indicating that the moment at which a fatigue program is interrupted does not have a severe effect on the damage area for specimens subjected to fatigue loading only. Furthermore, during the pause AE did not record any hits, so it reasonable to assume that no damage occurred during this time.

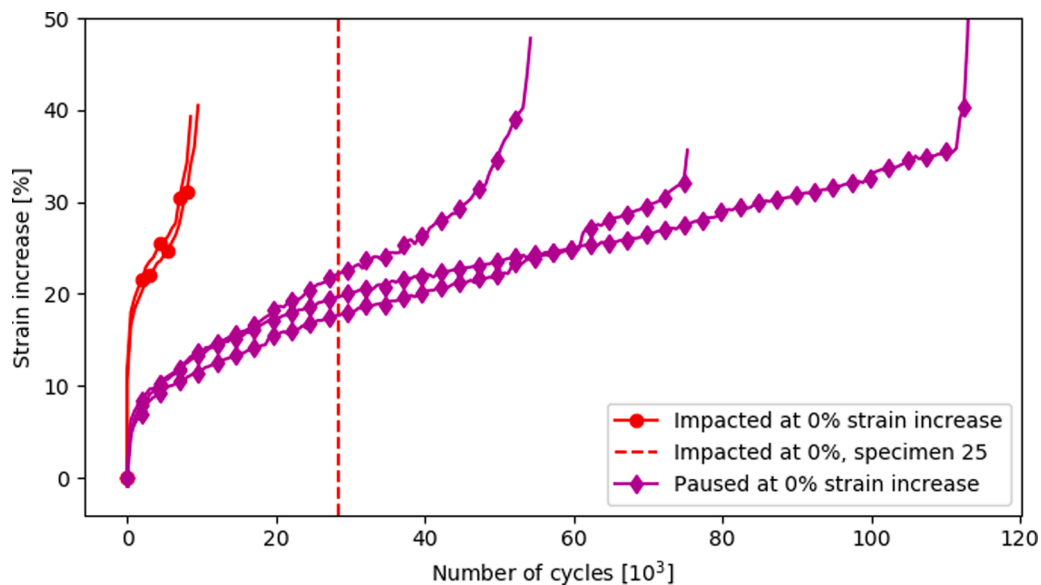
Fig. 9. The strain curves for all the specimens paused at 0%.

Fig. 9 shows the difference in strain increase for the 0% samples.

Note that some paint chipped off from specimen 25 during the impact which compromised one of the virtual extensometers. No local strain data was therefore collected, so a dashed line is drawn at the fatigue life of this specimen. It is clear from the graph that the impacted specimens accumulate damage faster than the specimens that are merely paused. There is however not much difference in final failure strain values, it is just that the slow growth part is skipped. One could speculate that the impact caused delamination that entered the damage propagation zone and it drastically accelerated the fatigue failure. This hypothesis is supported by the DIC and C-Scan analysis.

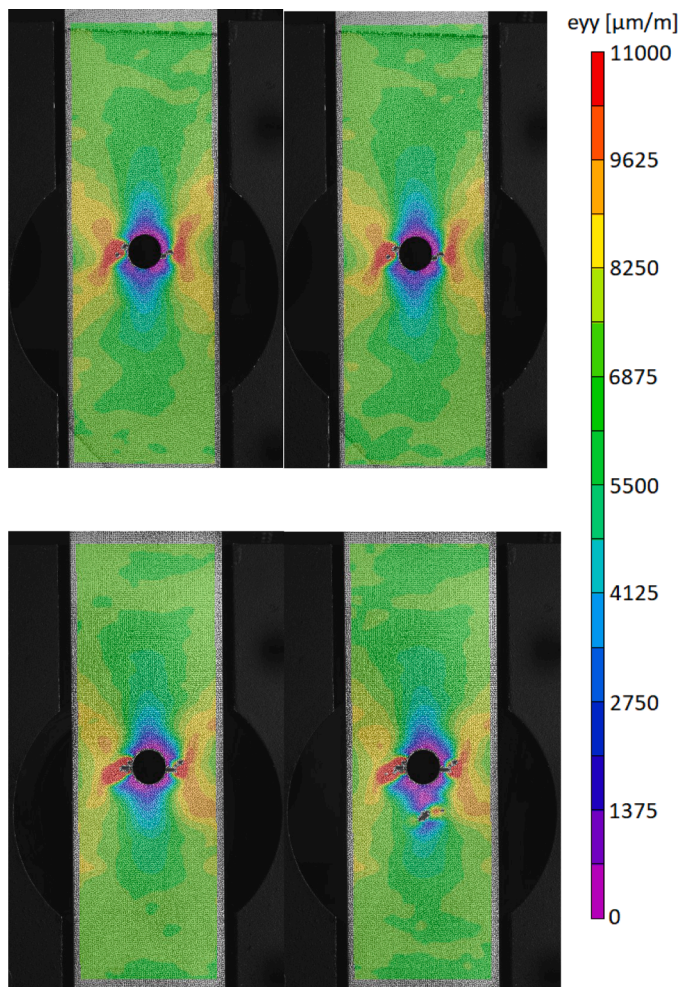
Fig. 16. Longitudinal surface e_{yy} strain for samples paused (top, specimen 45) and impacted (bottom, specimen 41) after 14% longitudinal strain increase.

The longitudinal ϵ_{yy} surface strain field of specimen 45 (top) and the impacted specimen 41 (bottom) is shown in Fig. 16. The top two images show specimen 45 right before and after pause without impact, and the bottom images show specimen 41 right before and after impact. The bottom row clearly shows the impact location where the paint chipped

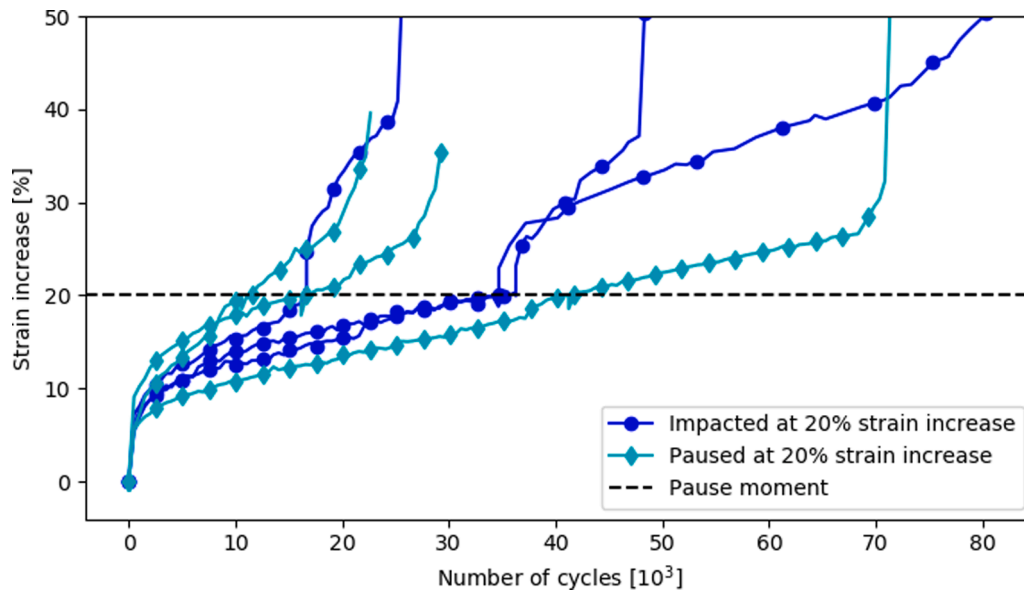
Fig. 21. The strain curves for all the specimens paused at 20%.

Similar to the previous results of the 14% strain increase, there is no clear distinction between the fatigue life of specimens with and without impact as Fig. 21 showcases. However, directly after the pause moment, the impacted samples make a large jump upwards within a short time span. Although the fatigue life is not necessarily shortened by impact, the strain increase is typically about 10% higher.

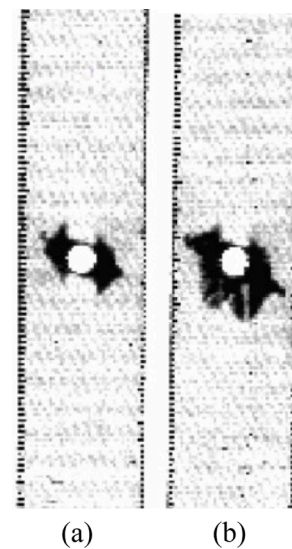
Fig. 24. C-scan images for specimens 37 paused and scanned at 20% strain increase (a) and 32 paused, impacted and scanned at 20% strain increase (b).

Fig. 24 shows the C-scans of specimens 37 and 32 paused at 20% strain increase and subjected to impact respectively. The areas left and right of the hole look similar, with the addition of the large delaminated area due to impact. As it was mentioned for the C-scan analysis for the specimen of the 14% strain increase, the impact introduced damage below the hole and outside the fatigue damage propagation zone and it joined the already existing damage. Considering that the impact didn't alter the fatigue life of the specimens, it can be concluded that the impact damage didn't interfere with the fatigue damage; it just enlarged the damage area around the hole.
