Post-buckling damage tolerance of welded omega-stiffened thermoplastic panels with initial damage

van Dooren, Kevin; Bisagni, Chiara

Composite Structures

Delft University of Technology, Faculty of Aerospace Engineering, Delft, The Netherlands

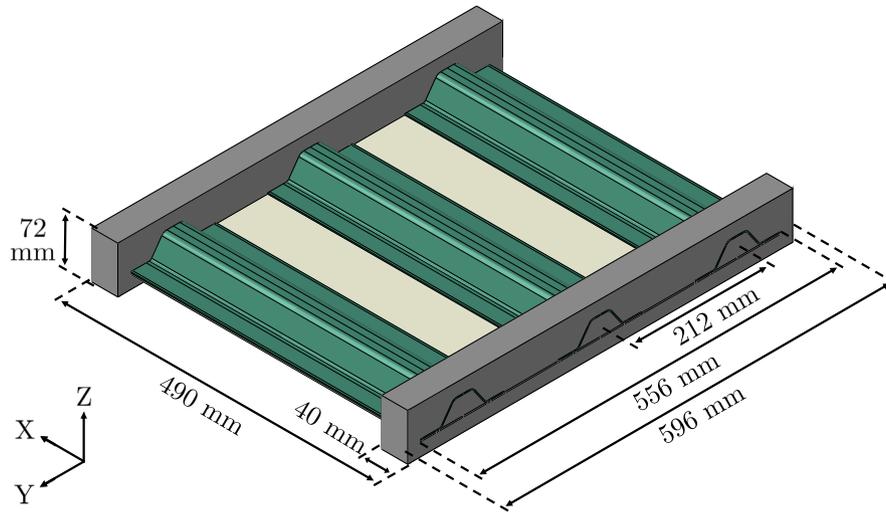
Fig. 1. Welded omega-stiffened thermoplastic panel.

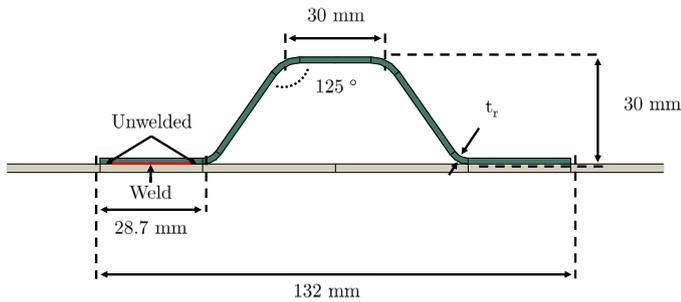
Fig. 2. Omega stringer geometry and weld.

In this study, VCCT is utilized for both panels in a pristine state and with initial damage, with a weld width of 18 mm. The VCCT method is normally limited to structures with initial damage due to the pre-crack requirement. However, the weld has small unwelded regions on both sides of the weld, as shown in Fig. 2, allowing VCCT to be used

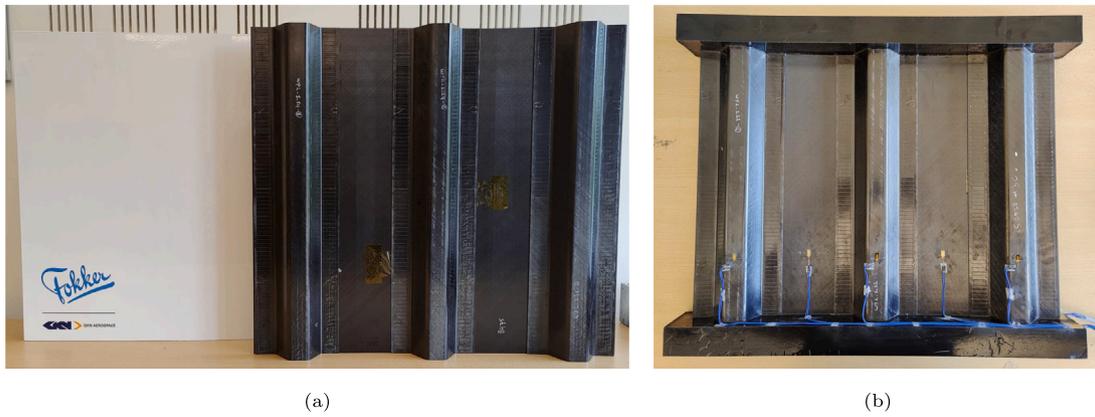
Fig. 3. Omega-stiffened panels: (a) as received; (b) with potting and strain gauges.

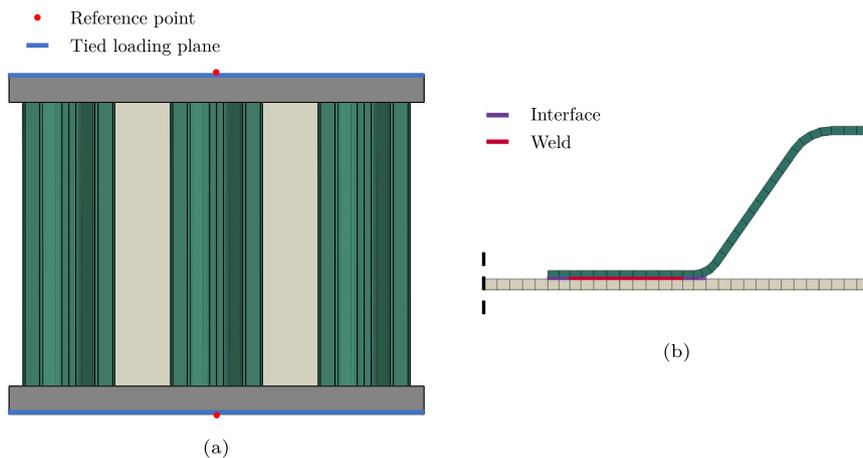
Fig. 5. Model details: (a) reference point placement; (b) mesh cross-section.

for pristine welded joints. This results in a relatively efficient analysis for a panel-level structure due to the coarser mesh allowance of VCCT compared to other methods. In this model, skin-stringer separation can only occur at the interface between skin and stringer, as reported in Fig. 5(b), and cannot grow into the laminates, to limit the complexity of the model and analysis. Also, due to the unwelded region on both sides, it is less likely that separation will migrate.

The mesh size of the laminated sections is 2.5 mm, which is based on a mesh convergence study. The mesh of the skin and stringer is reported in Fig. 5(b). The potting material has a variable mesh size, between 2.5 and 10 mm. The potting mesh starts fine where it joins to the laminated sections, and becomes coarser in an outwards direction. The laminated sections are modelled with continuum shells (SC8R), and the potting is modelled with reduced integration solid elements (C3D8R) for improved computational efficiency.

The laminated sections and the potting are joined with shared nodes in the potting region. The skin and stringer between the potted sections are joined with the Virtual Crack Closure Technique (VCCT), to resemble the welded joint as reported in Fig. 5(b).

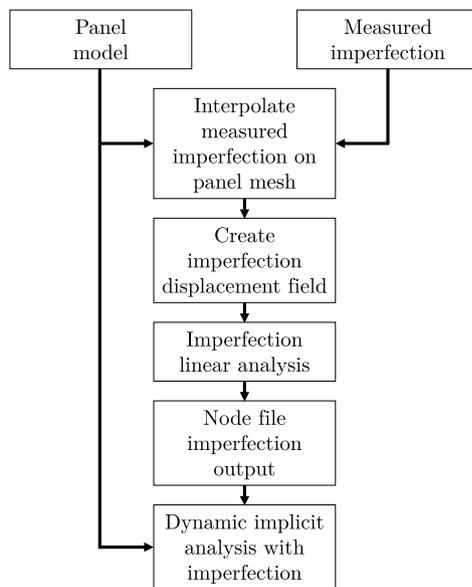
Fig. 6. Flowchart for including imperfections in the analysis.

The analysis of the panels can include imperfections that are measured from the panels. The flowchart for including the imperfections is reported in Fig. 6. The chart starts out with the panel model that is created in Abaqus, and the measured imperfections. The measured imperfection is then interpolated onto the mesh with a python script. The next step in this script is to translate the interpolated imperfection into a displacement field representing the imperfection. This displacement field is then used in a linear analysis to deform the panel to the

imperfect shape, from which a node-file is the output. This node-file includes the imperfection, without the internal stresses. The last step is the dynamic implicit analysis, which uses the panel model and the imported node file to include the imperfection.

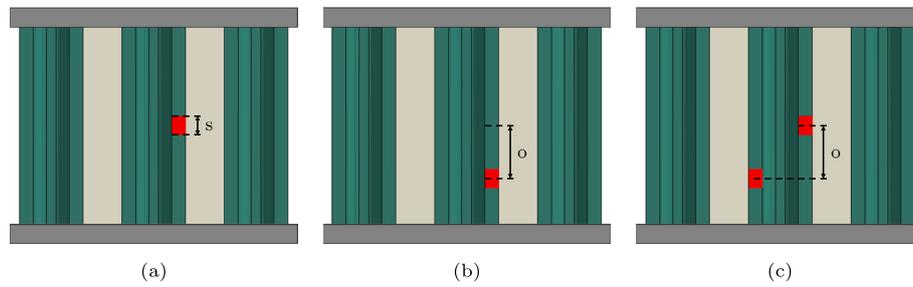
Fig. 7. Panel illustrations of three sensitivity parameters: (a) damage size; (b) damage 1 offset; (c) damage 2 offset.

This section focuses on the analysis of panels with different damage sizes and damage locations. The first study considers the damage size of an initial damage in the centre of the panel, as shown in Fig. 7(a). The considered damage sizes are reported in Table 4. The results of the study are reported in terms of the initiation load and the final failure load. Initiation is considered the start of skin-stringer separation, and final failure is considered when unstable separation leads to panel collapse.

The second study considers the location of the initial damage, for a panel with one initial damage and a panel with two initial damages, both for a damage size of 40 mm. The location is defined as the offset between the panel's centre and the damage's centre, as reported in Fig. 7(b–c). The study considers one initial damage (Fig. 7(b)) and two initial damages, where the first damage in the right flange will remain in the centre, and the second damage in the left flange will be offset (Fig. 7(c)). The damage offset range of the study is reported in Table 4.

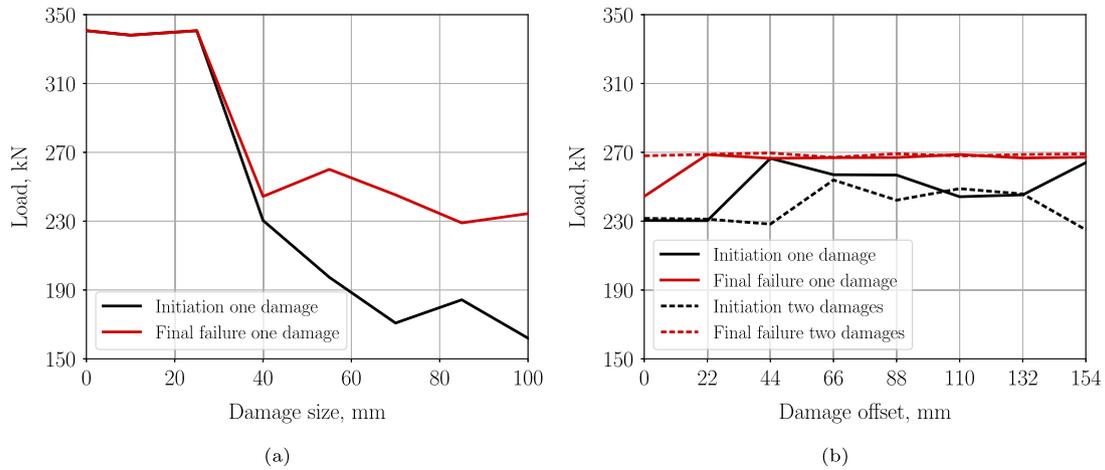
Fig. 8. Sensitivity study of: (a) damage size; (b) damage offset.

The initiation load and failure load for a panel with one initial damage of different sizes are reported in Fig. 8(a). The panel has a low sensitivity to initial damage sizes of 10 and 25 mm, and for a damage size of 40 mm both the initiation and final failure load drop considerably. A buckling shape change most likely causes this drop. The panel starts out with three half-waves in the bays, reported in Fig. 9(a), and the panel with a damage size of 40 mm presents a gradual

The initiation load and failure load for a panel with one and two initial damages at different locations are reported in Fig. 8(b). For panels with one initial damage, the initiation load is similar for offsets of 0 and 22 mm, and then for higher offsets the initiation load increases.

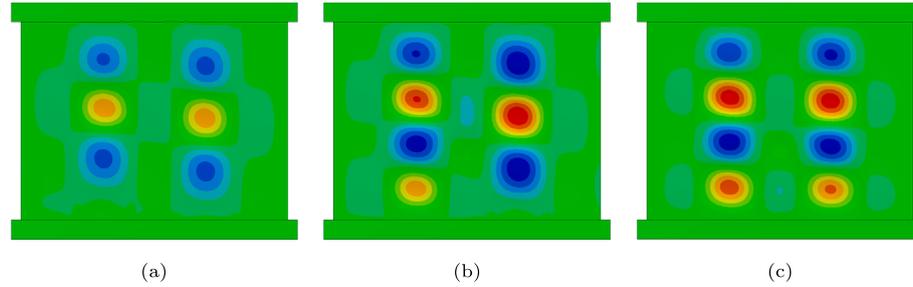
Fig. 9. Buckling shapes: (a) three half-waves; (b) three and four half-waves; (c) four half-waves.

shape change to four half-waves, reported in Fig. 9(c). A damage size of 25 mm and below did not show this buckling shape change. The initiation load drops further for larger damage sizes, while the failure load does not go below 230 kN for the damage sizes in this study. Based on these results, it is chosen to use a 40 mm damage size for the test panels, as reported in Fig. 10(a). This damage size presents a considerable drop in final failure load, while there is still a margin between the buckling load of approximately 170 kN and the initiation load of 230 kN. Since the strength of the welded joint is unknown at the time of the design, a conservative damage size is deemed best.

This is caused by differences in the buckling shape evolution. The panels have an initial three half-wave buckling shape, as reported in Fig. 9(a), that changes to four half-waves in one bay for 0 and 22 mm offset, as reported in Fig. 9(b). Higher offsets do not exhibit this buckling shape change. The initiation load does go down between 44 and 110 mm offset, which seems to be caused by the relative position of the damage w.r.t. the outward half-wave being more critical for separation. The failure load is lowest for 0 mm offset, for higher offsets it plateaus at approximately 270 kN. An offset of 0 mm is chosen for the test panel with one initial damage, which is reported in Fig. 10(a).

The panel with two initial damages shows an initiation load of approximately 230 kN for 0, 22 and 44 mm of offset, and increases to approximately 255 kN for an offset of 66 mm. This difference is caused by the change in buckling shape from three to four half-waves in both bays, as reported in Fig. 9(c), and four half-waves seems to be more critical. The failure load is approximately 270 kN for all cases, which seems to be dominated by a certain amount of separated area after which separation becomes unstable and the panels collapse. Offsets of 88, 110 and 132 mm present similar behaviour in terms of initiation load, but the case of 110 mm is deemed to be most interesting, as the separation starts at the damage in the middle, while the opposite flange also starts to separate in the middle of the panel which grows towards the second initial damage. This interaction is considered interesting, while it has a low risk of the initial damages quickly causing tunnelling behaviour, and far enough from the potting to minimize the influence of boundary conditions. Therefore, an offset of 110 mm is chosen for the panel with two initial damages, as reported in Fig. 10(b).

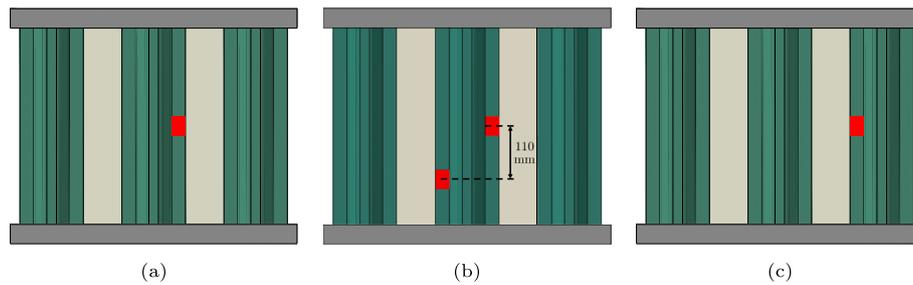
Fig. 10. Panels with initial damage of 40 mm: (a) panel 2; (b) panel 3; (c) panel 4.

The last configuration has one initial damage of 40 mm in the side stringer, as reported in Fig. 10(c). This allows to study the effect of initial damage in different stringers.

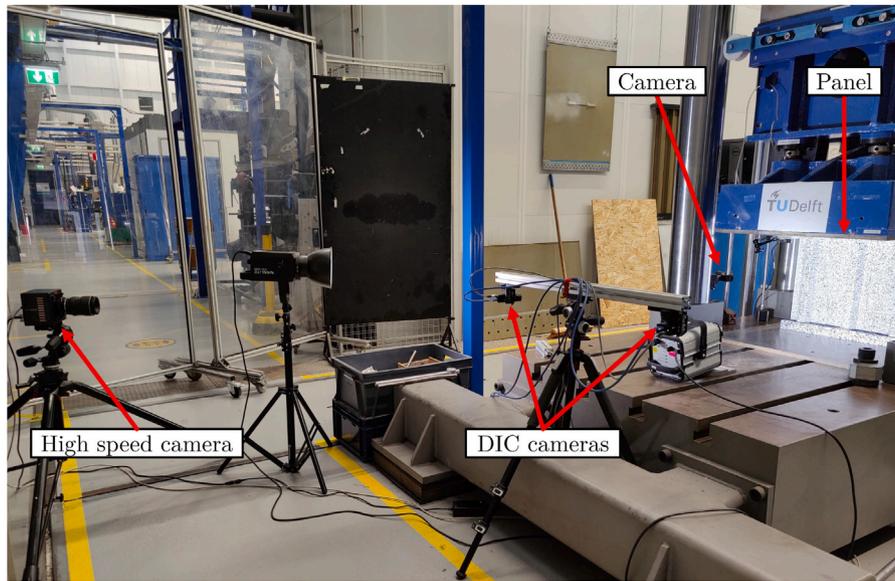
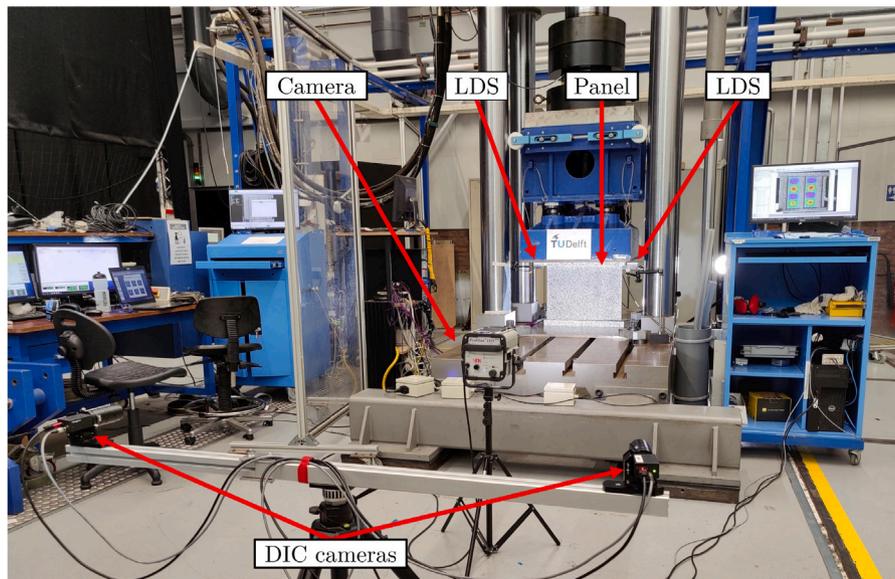
Fig. 11. Test setup seen from: (a) stringer side; (b) skin side.

The test setup is reported in Fig. 11 from the (a) stringer side and (b) skin side of the panel. The panels are positioned in the test machine and a preload of 2 kN is applied to keep the panel in place. The test

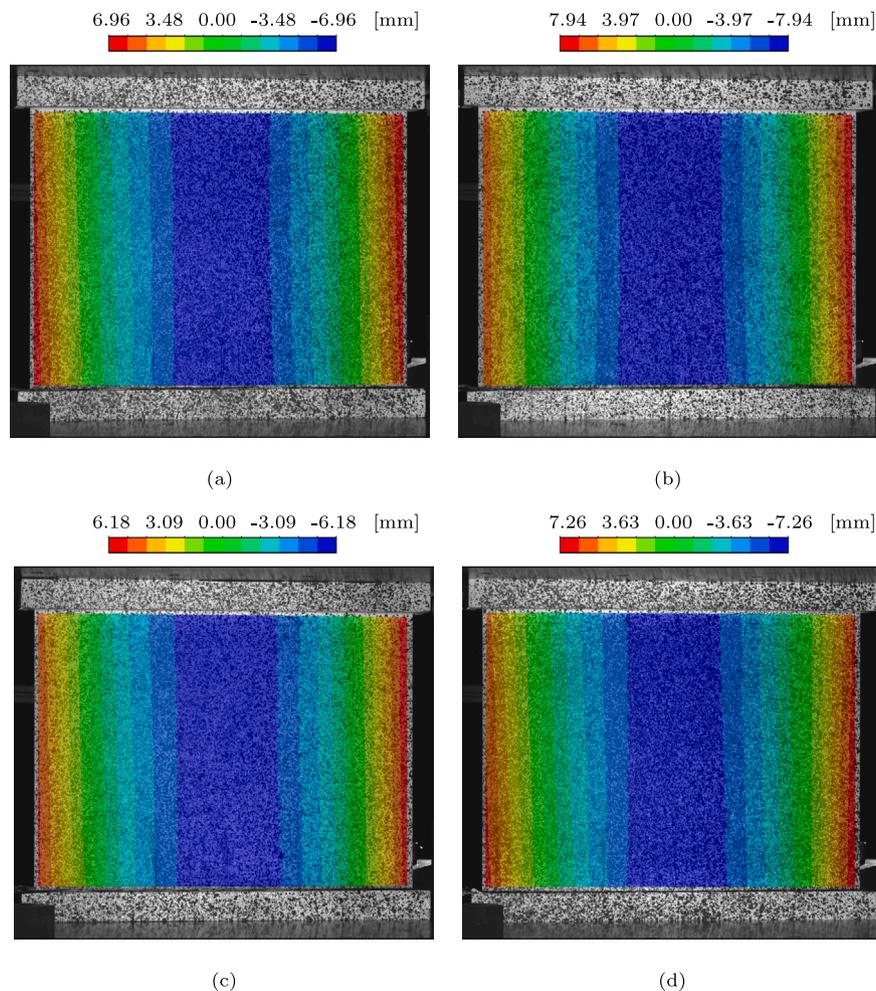
Fig. 12. Out-of-plane imperfection of test panels: (a) panel 1; (b) panel 2; (c) panel 3; (d) panel 4.

The first imperfection that is measured is the out-of-plane imperfection of the skin, for which DIC is used. The nominal design has a flat skin, and the imperfection is the deviation of the skin w.r.t. a flat plane. The out-of-plane imperfections of all four panels are reported in Fig. 12. All four panels have a similar curved imperfection in the width direction, with a total magnitude of the imperfection ranging from 12.36 mm to 15.88 mm. The imperfection has a counterclockwise skew, probably caused by the layup and the outer -45 ply. The panels are also slightly curved in the longitudinal direction, but it is minimal compared to the imperfection in the width direction. The highest curvature in the width direction is in the welded area, as the imperfection is mostly caused by the local heating of the conduction welding process, which results in thermal stresses.

The study is executed for different imperfection amplitudes, as reported in Table 5. The damage size sensitivity study will be done for both panel 1 and 2 imperfections, which are reported in Fig. 12(a)

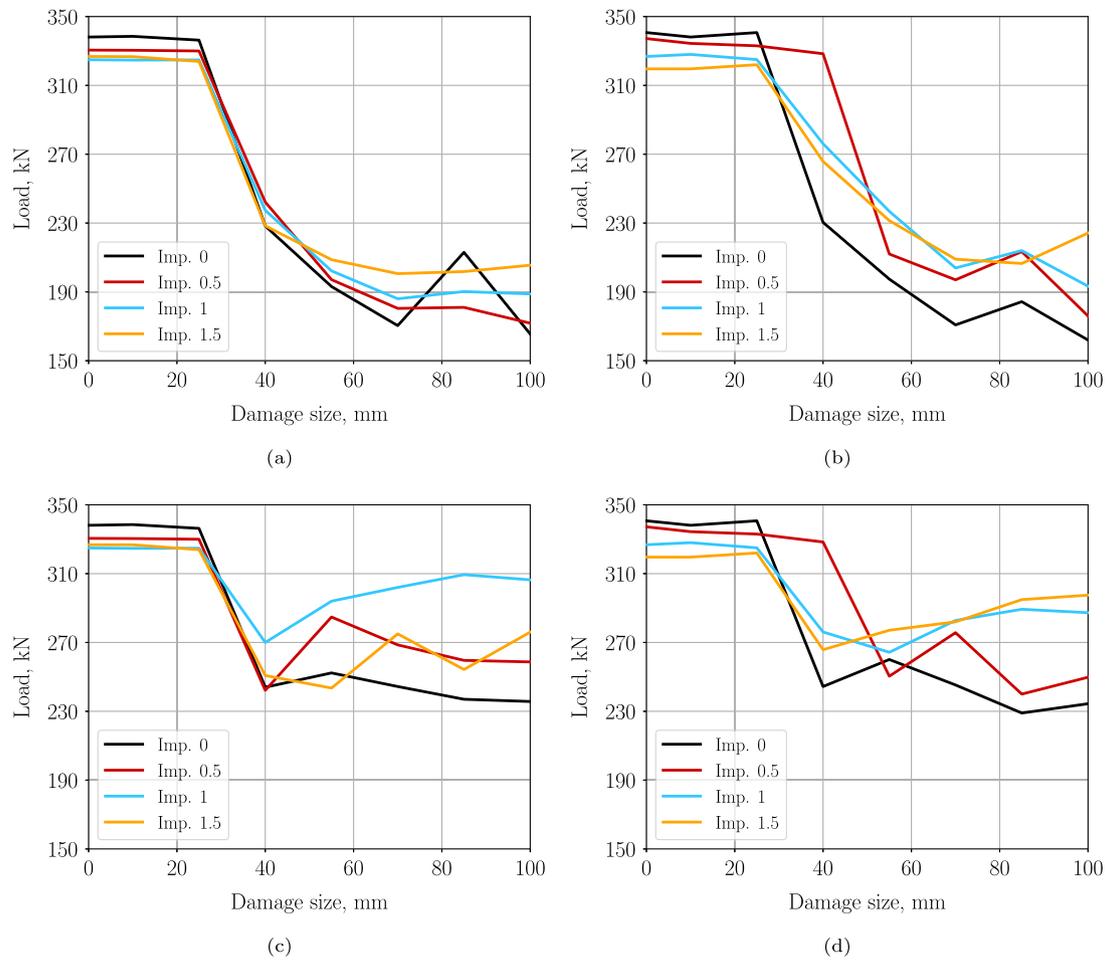
Fig. 13. Damage size sensitivity study results for different imperfection amplitudes: (a) initiation panel 1 imperfection; (b) initiation panel 2 imperfection; (c) final failure panel 1 imperfection ; (d) final failure panel 2 imperfection.

The initiation loads for the damage size sensitivity study with panels 1 and 2 geometrical imperfections are reported in Fig. 13(a) and (b),

respectively. For small damage sizes, a higher imperfection amplitude lowers the initiation load, especially for the imperfection of panel 2. At a damage size of 40 mm and larger, the initiation load drops considerably for most cases, except for an imperfection amplitude of 0.5 of panel 2. The initiation load is generally higher for higher imperfections at large damage sizes. This is probably due to the curvature of the imperfection leading to less opening of the initial damage. The

average initiation load for a damage size of 40 mm is 275 kN for the imperfection of panel 2, while it is 234 kN for the imperfection of panel 1. This is a decrease in the failure load compared to a pristine panel of 30% and 17% for panels 1 and 2, respectively. The initiation loads drop further for larger damages, with the case of no imperfection presenting the highest sensitivity to the damage. The failure loads of the damage size sensitivity study are reported in Fig. 13(c) and (d), for panels 1 and 2, respectively. When comparing the results to the initiation loads in Fig. 13(a) and (b), it can be concluded that for damage sizes of 40 mm and smaller, the panels show final failure at or shortly after the initiation of skin-stringer separation. At larger damage sizes, the failure load increases for the imperfection of panel 2 and an amplitude of 1 and 1.5. This is also seen for the imperfection amplitude of 1 of panel 1, while imperfection amplitudes of 0.5 and 1.5 have varying results. At damage sizes of 40 mm and larger, the panels without imperfection have the lowest failure loads, and the geometrical imperfection seems to lower the sensitivity to damage for skin-stringer

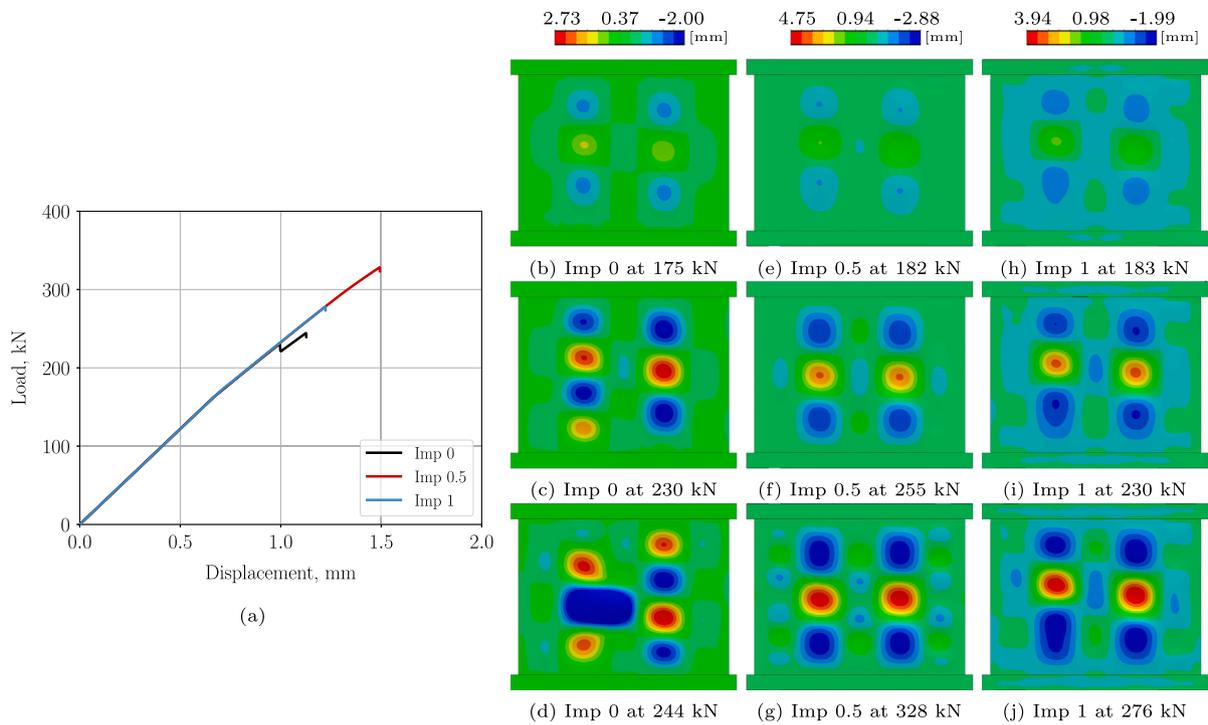
Fig. 14. Panels with 40 mm damage and panel 2 imperfection: (a) load–displacement; (b–g) out-of-plane displacement contour plots.

The first investigation focuses on the damage size of 40 mm for different imperfection amplitudes of panel 2, as both the initiation load and failure load are highly affected. The load–displacement behaviour for the three imperfection amplitudes of 0, 0.5 and 1 is reported in Fig. 14(a). For no imperfection, a small load drop is seen at 230 kN, due to the opening of the initial damage and the start of separation, and final failure occurs at 244 kN. The imperfection amplitudes of 0.5 and 1 have a failure load of 328 and 276 kN, respectively, and experience no

load drop before final failure. Out-of-plane contour plots are reported in Fig. 14 (b–d), (e–g) and (h–j) for imperfection amplitudes 0, 0.5 and 1, respectively. The initial damage of 40 mm is on the left side of the panel. All three cases start initially with three half-wave buckling shapes with a clockwise skew regarding half-wave placement. At higher loads, a fourth half-wave appears in the bay with the initial damage for no imperfection, while the other two cases present no additional half-waves in the bays. For an imperfection amplitude of 0.5 the skew of the half-waves rotates anti-clockwise with increased load, and additional half-waves appear underneath the stringers.

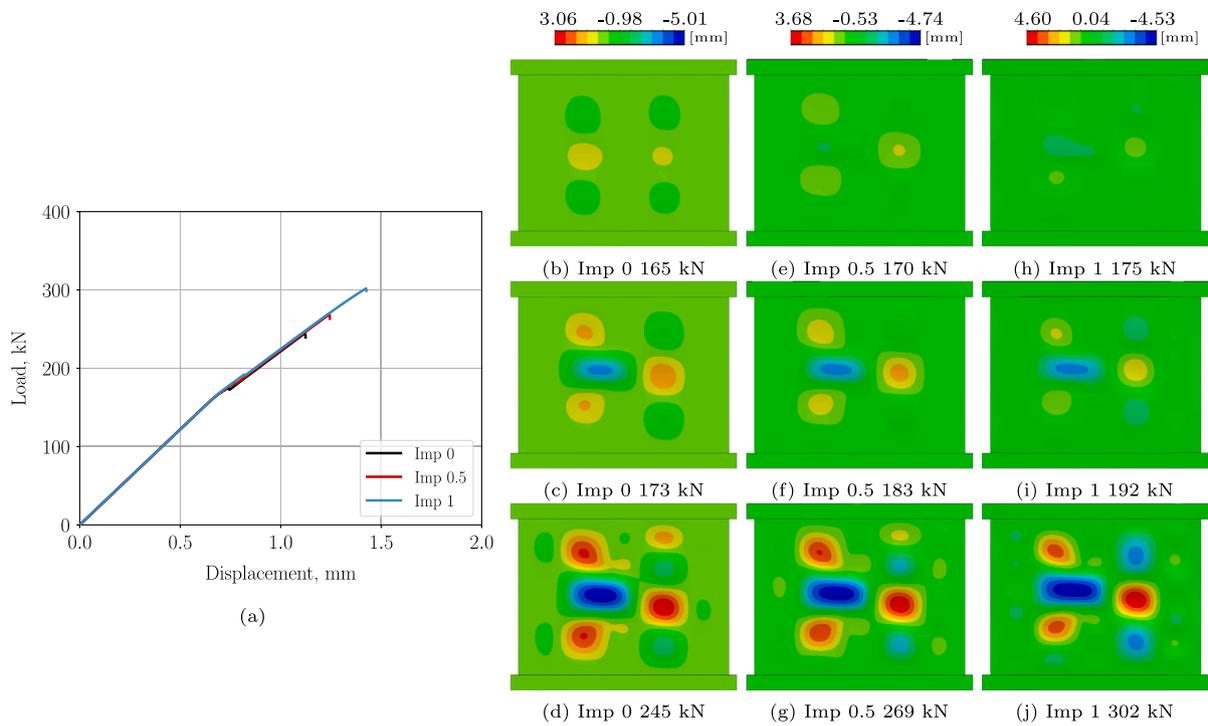
Fig. 15. Panels with 70 mm damage and panel 1 imperfection: (a) load–displacement; (b–g) out-of-plane displacement contour plots.

behaviour for the three imperfection amplitudes of 0, 0.5 and 1 is reported in Fig. 15(a), which present higher failure loads for a larger imperfection. After buckling, all three imperfection amplitudes experience a small load drop, which is caused by a small separation event at the initial damage location. Out-of-plane contour plots are reported in Fig. 15 (b–d), (e–g) and (h–j) for imperfection amplitudes 0, 0.5 and 1, respectively. For no imperfection, the initial buckling shape has three half-waves (b), and the initial damage opens shortly after a small load increase which results in an anti-symmetric buckling shape (c). The imperfection amplitudes of 0.5 and 1 present opening of the initial damage at the start of buckling (e–h), with an anti-symmetric buckling shape. All three amplitudes show stable separation growth of the initial damage after the first separation event, until final failure. The final failure of imperfection amplitudes 0 and 0.5 starts with the right bay switching buckling shape to four half-waves (d–g). This buckling shape change is not seen for an imperfection amplitude of 1.

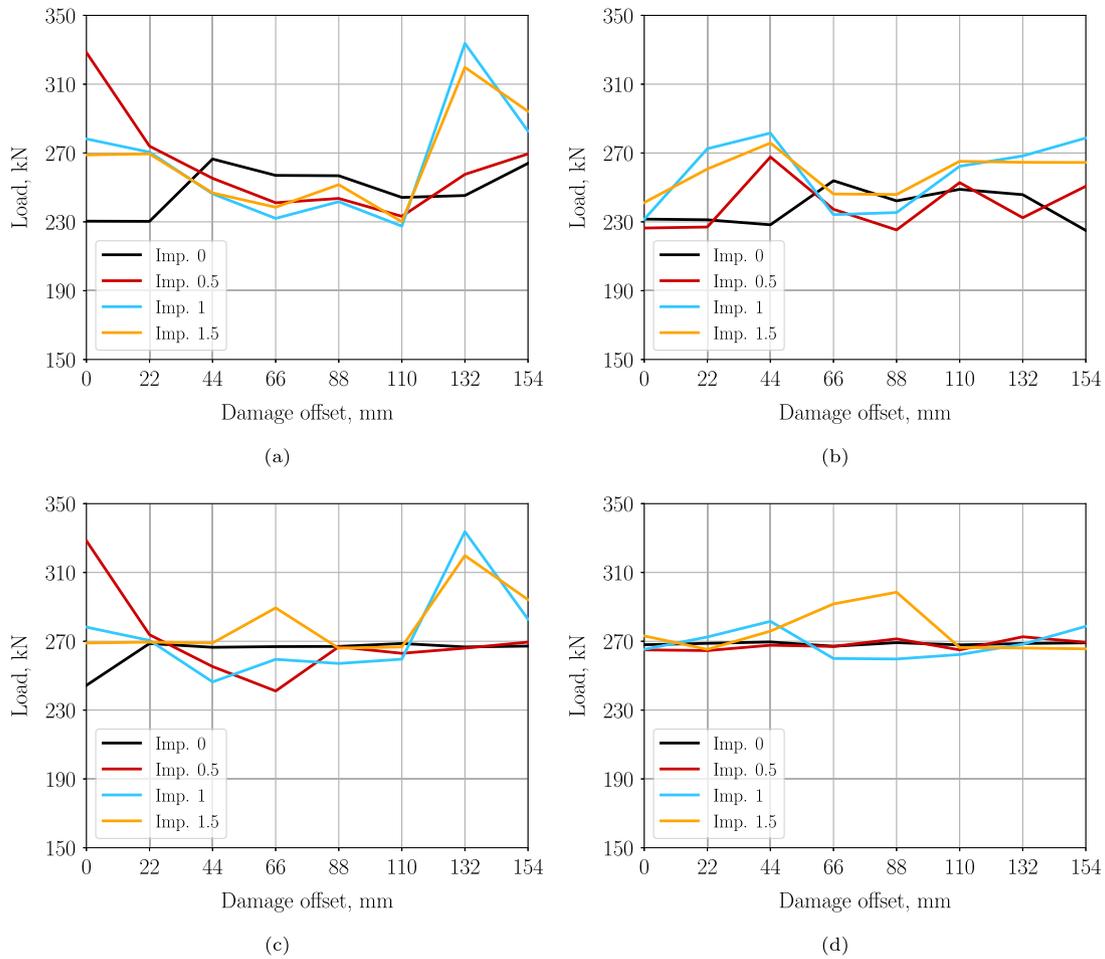
Fig. 16. Damage offset sensitivity study results with Panel 2 imperfection: (a) initiation damage 1; (b) initiation damage 2; (c) final failure damage 1; (d) final failure damage 2.

The initiation loads for single damage have a lower bound of approximately 230 kN, as reported in Fig. 16(a). For an offset of 0 mm, the initiation load is highly influenced by the imperfection amplitude, with the imperfection amplitude initially increasing the initiation load considerably and then converging to an intermediate load level between 230 and 270 kN. The results from different imperfection amplitudes converge for offsets between 44 and 110 mm, with the highest initiation load for no imperfection. The results diverge at offsets above 110 mm, with larger imperfections leading to higher initiation loads. This effect is caused by all cases between 44 and 110 mm offset presenting similar three half-wave buckling shapes, and more varying buckling shapes below 44 mm and above 110 mm offset. The higher sensitivity to the damage location between 44 and 110 mm offset is most likely caused by the relative location of the damage w.r.t. an outward buckling half-wave. The lower sensitivity at 132 mm for imperfection amplitudes 1 and 1.5 are caused by a buckling shape change underneath the stringers, and results at 154 mm offset are most likely starting to get affected by the proximity of the potting.

The final failure loads for single damage show less variance than the initiation loads, as reported in Fig. 16(c), with a lower bound of

The results of the sensitivity study with two initial damages shows initiation loads between 230 and 280 kN, as reported in Fig. 16(b). Imperfection amplitudes 1 and 1.5 result in similar behaviour over the whole offset range, while imperfection amplitudes 0 and 0.5 result in varying behaviour. There are three different ways in which initiation starts. Firstly, the damage at the middle of the panel starts, followed by the second damage. Secondly, the second damage with the offset starts, followed by the damage in the middle of the panel. Lastly, both damages experience initiation simultaneously. Offsets of 0 and

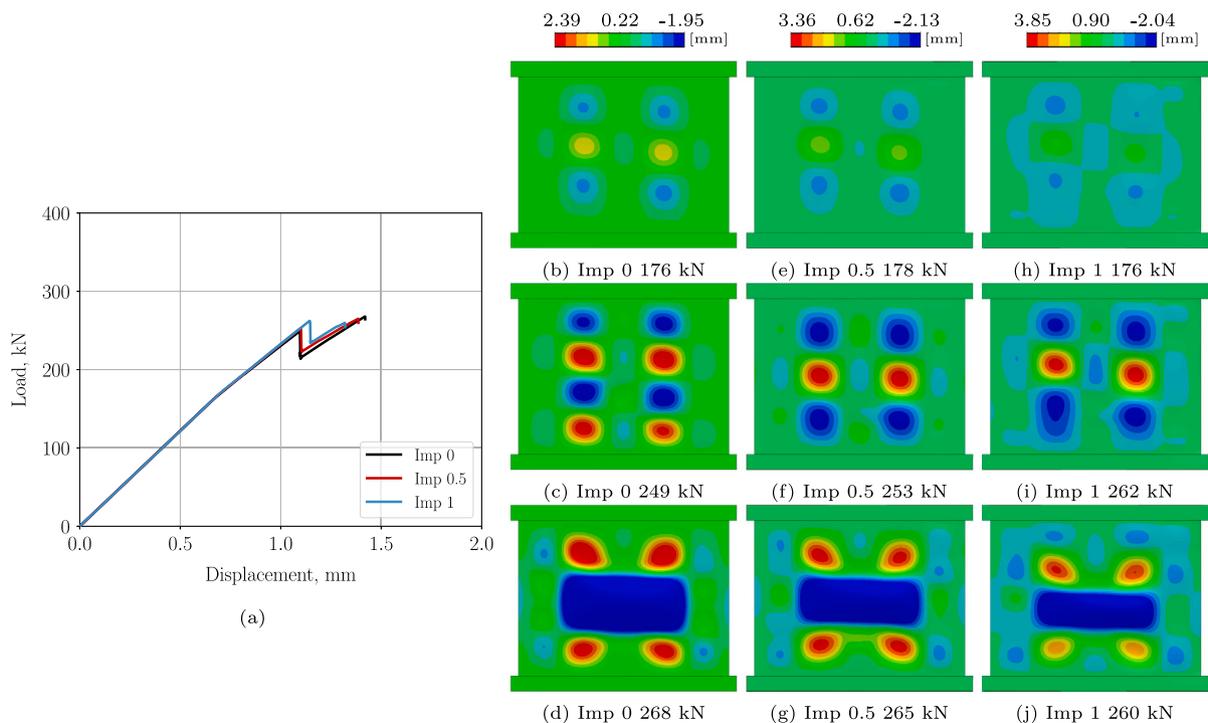
Fig. 17. Panels with two 40 mm damages with a 110mm offset, and panel 2 imperfection: (a) load-displacement; (b-g) out-of-plane displacement contour plots.

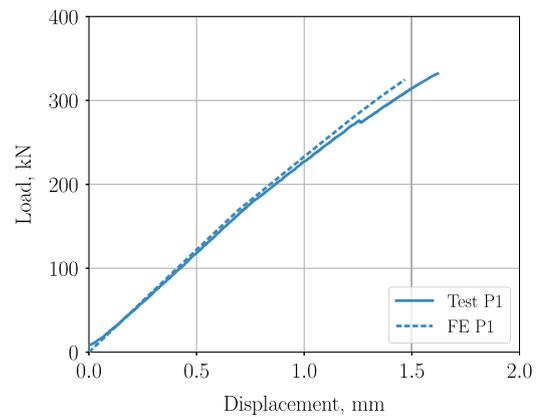
Fig. 18. Load–displacement curves from tests and numerical analysis of pristine panel.

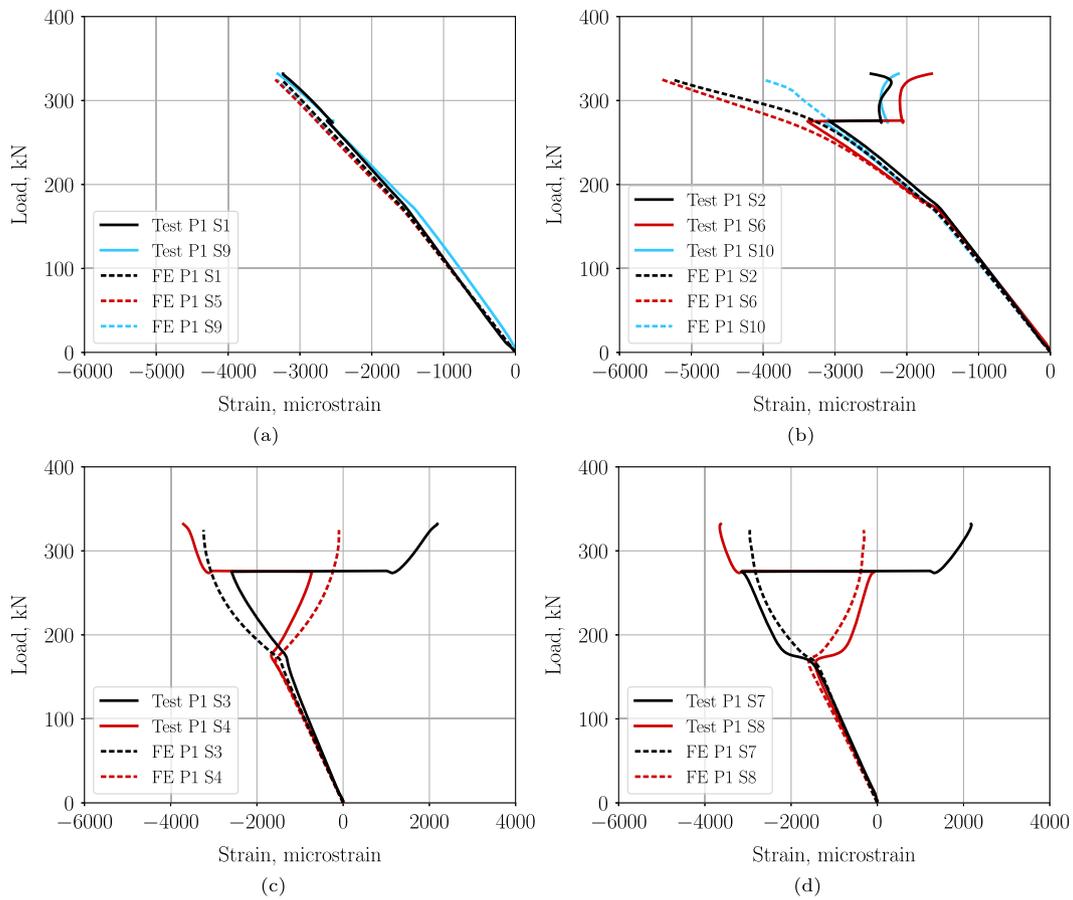
Fig. 19. Experimental and numerical compressive strains of the pristine panel: (a) caps; (b) skin under stringer; (c) bay 1; (d) bay 2.

The strains of the stringer cap are reported in Fig. 19(a). The loading imperfection is small, and in the post-buckling range, there is a small jump in strains which is caused by the sudden buckling shape change. The strains under the stringers are reported in Fig. 19(b). The strains underneath the stringer show equal loading and a drop in stiffness after buckling. The strains only diverge slightly and experience a sudden jump in strain due to a buckling-shape change.

The strains in bay 1 show a large jump due to the buckling-shape change, as reported in Fig. 19(c). This jump in strain is not seen in the numerical results, due to the lack of a buckling-shape change. The strains in bay 2, as reported in Fig. 19(d), show a higher bending component compared to bay 1, with a similar jump in strains due to

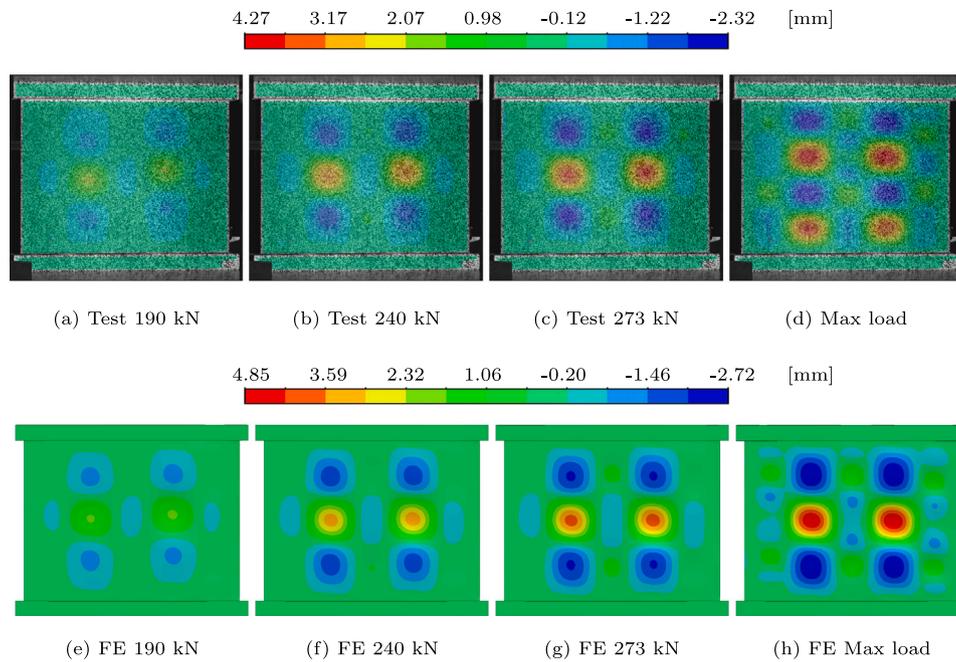
Fig. 20. Experimental (a-d) and numerical (e-h) out-of-plane displacement of the pristine panel.

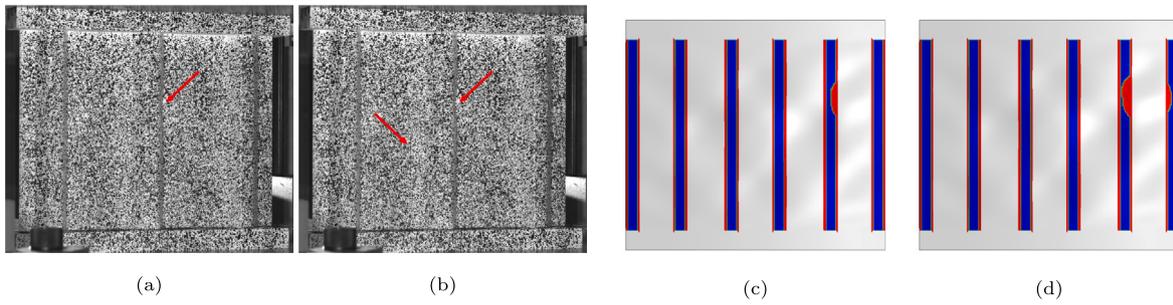
Fig. 21. Comparison of failure behaviour of pristine panel: (a) start of failure during test; (b) propagation of failure during test; (c) start of failure in analysis; (d) propagation of failure in analysis.

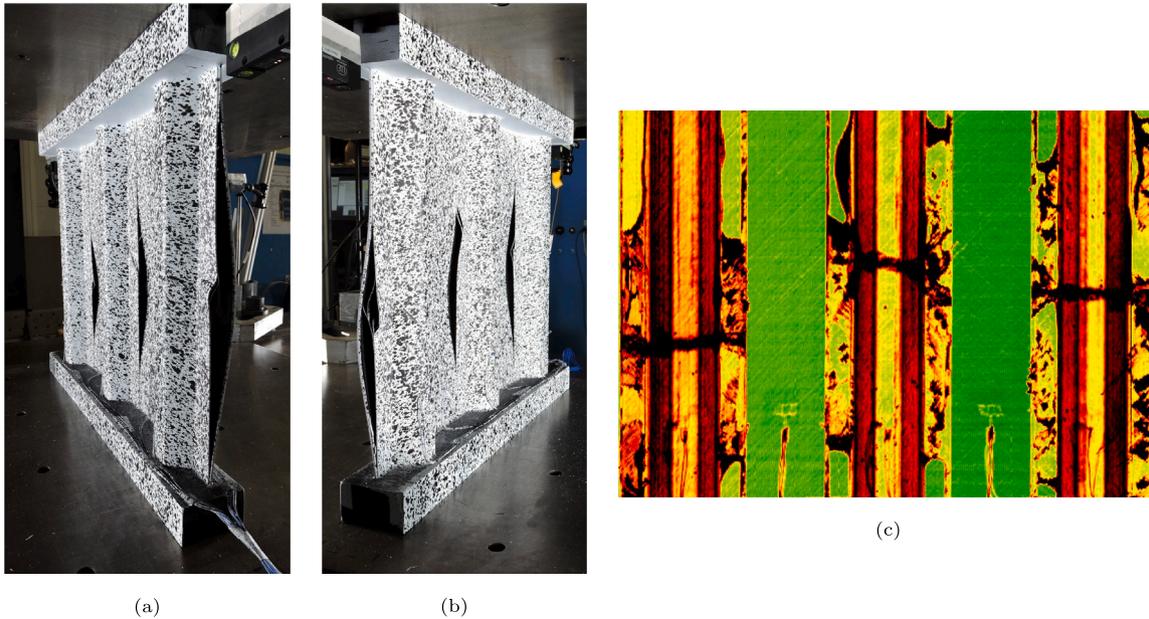
Fig. 22. Post-failure of pristine panel: (a) photo from right side; (b) photo from left side; (c) c-scan.

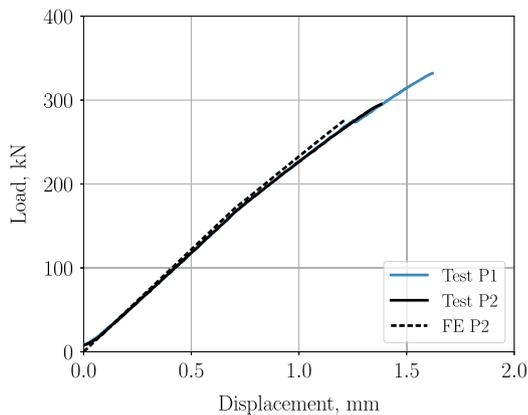
Fig. 23. Load-displacement curves from tests and numerical analysis of panel 2.

The load–displacement behaviour of the panel with one initial damage in the middle stringer is reported in Fig. 23, in a comparison with the pristine panel. The panel has a stiffness of approximately 237 kN/mm and buckles at a load of 168 kN. Panel 2 fails due to skin-stringer separation at a load of 295 kN, while the pristine panel fails at a load of 332 kN. This is a reduction of the failure load of 11.2% due to the damage in the flange of the middle stringer. The numerical analysis of panel 2 is able to predict the overall structural behaviour well. The biggest difference is seen for the failure load, which is conservative with a 6.4% lower failure load compared to the test.

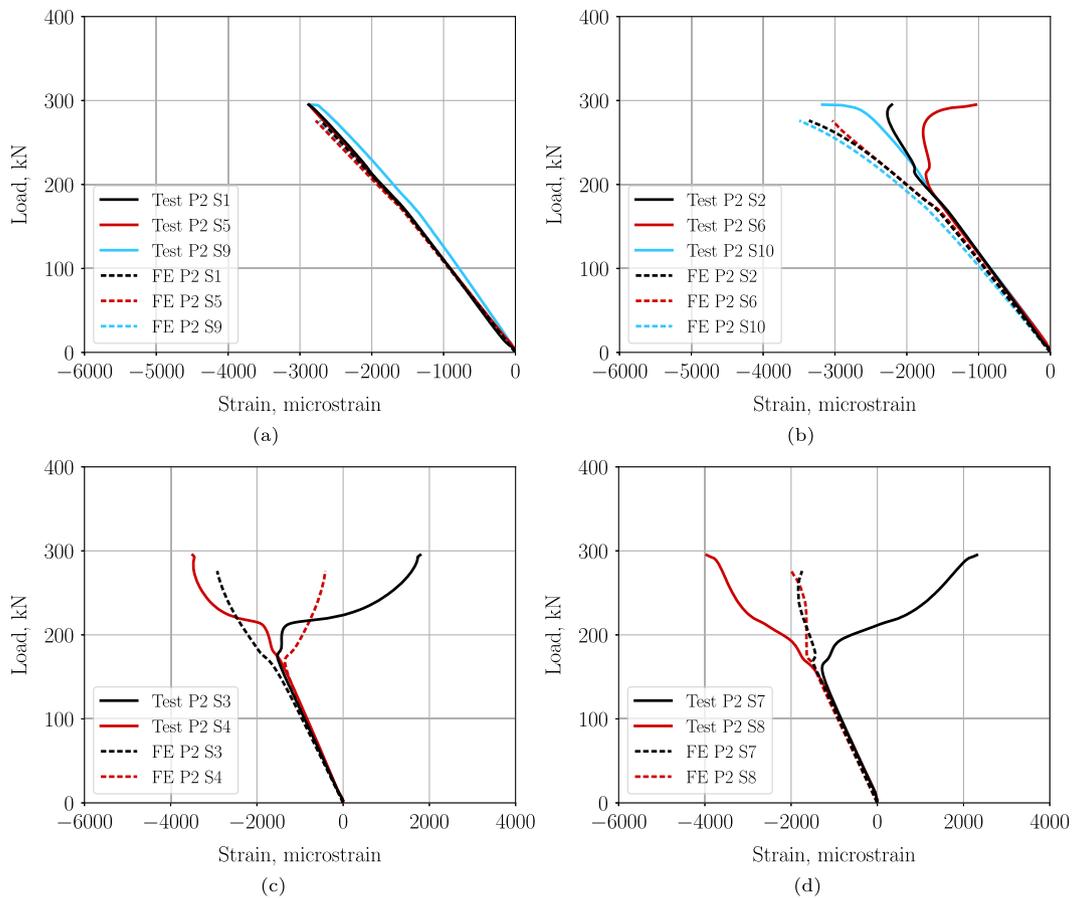
Fig. 24. Experimental and numerical compressive strains of the panel 2: (a) caps; (b) skin under stringer; (c) bay 1; (d) bay 2.

The strains on the cap of the panel are reported in Fig. 24(a), where it is seen that S9 shows lower strains compared to S1 and S5. A small loading imperfection can cause this difference. The strains under the stringers are equal, and there is no sign of unequal loading

of the skin Fig. 24(b). A slight drop in stiffness can be seen initially when buckling occurs after which the strains diverge, probably due to the different half-wave positions underneath each stringer, with more divergent behaviour close to the failure load.

The strains in bay 1 present slight divergent behaviour initially after buckling, as reported in Fig. 24(c). When the buckling-shape further develops, the strains diverge more and experience a large bending component. The numerical prediction shows less divergent strains and

in opposite direction, due to differences in buckling shape. The strains in bay 2 are reported in Fig. 24(d). There is comparable behaviour to the strains in bay one, with slightly more divergent behaviour. The numerical prediction, however, predicts almost linear strains, with only a small bending component which switches sign several times.

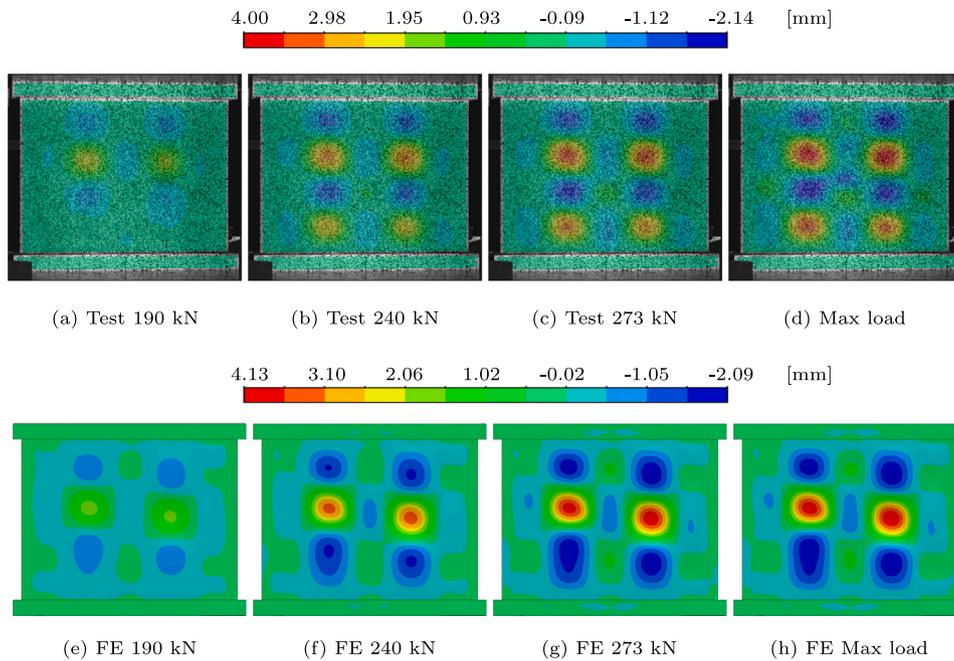
Fig. 25. Experimental (a–d) and numerical (e–h) out-of-plane displacement of panel 2.

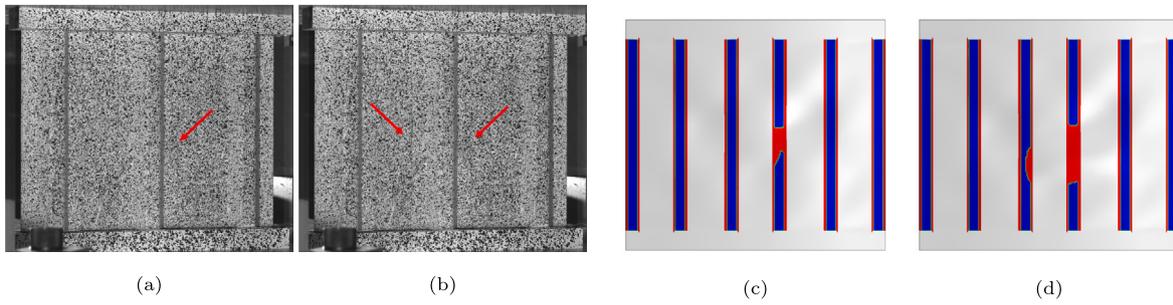
Fig. 26. Comparison of failure behaviour of panel 2: (a) start of failure during test; (b) propagation of failure during test; (c) start of failure in analysis; (d) propagation of failure in analysis.

The start of failure is reported in Fig. 26(a), which is captured by a high-speed camera at 10000 fps. Separation starts in the right flange of the middle stringer, at the initial damage location. This is followed by separation of the left flange, as reported in Fig. 26(b), and then the stringer further separates in upwards and downward directions. The numerical analysis also predicts this behaviour, as reported in Fig. 26(c-d). There is an elliptical crack front shape for the separation at the initial damaged location and in the opposing flange.

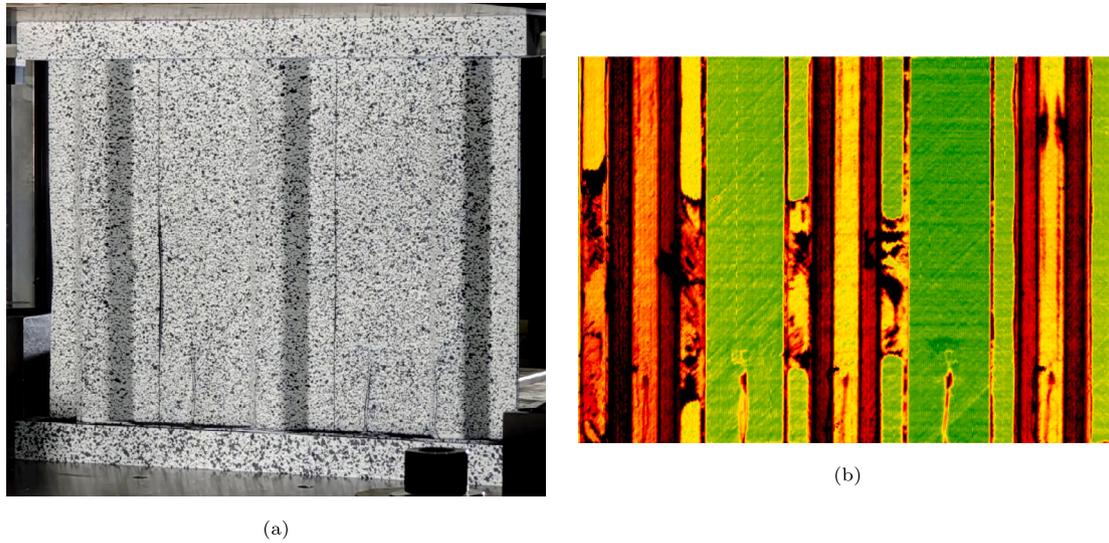
Fig. 27. Post-failure of panel 2: (a) photo; (b) c-scan.

The post-failure state of panel 2 is reported in Fig. 27(a-b). It is seen that both the left and middle stringer have large separations. The left stringer has a larger separated area compared to the middle stringer, while the middle stringer had initial damage in the right flange. Final failure started with separation at the damaged location, which caused further large separations in the left-hand side of the panel. The right stringer's interface has some small separated areas, and the weld presents small elliptical fronts. The right flange of the left stringer shows material damage, with a fracture that starts from the lower radius to the flange edge.

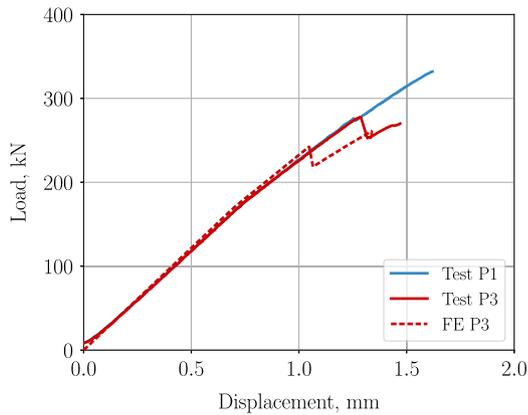
Fig. 28. Load-displacement curves from tests and numerical analysis of panel 3.

The load–displacement behaviour of panel 3 is reported in Fig. 28. Panel 3 has a stiffness of approximately 236 kN/mm, and it buckles

at a load of 173 kN. The panel experiences a maximum load of 277 kN at 1.29 mm of displacement, after which a load drop occurs. The panel fails at a load of 270 kN and 1.48 mm of displacement. This maximum load is 16.6% lower compared to the pristine panel. The

numerical analysis predicts similar behaviour with a load drop due to a skin-stringer separation event before final failure. It is, however, seen that this load-drop occurs at an 11.9% lower load, and the maximum load is 5.8% lower compared to the test.
